SR/CR A1A PEDESTRIAN SAFETY & MOBILITY STUDY

PEDESTRIAN / BICYCLE SAFETY REVIEW

Focus Area A / Peninsula Avenue to E 3rd Avenue (New Smyrna Beach)

Project Title: Focus Area A Pedestrian/Bicycle Safety Field Review

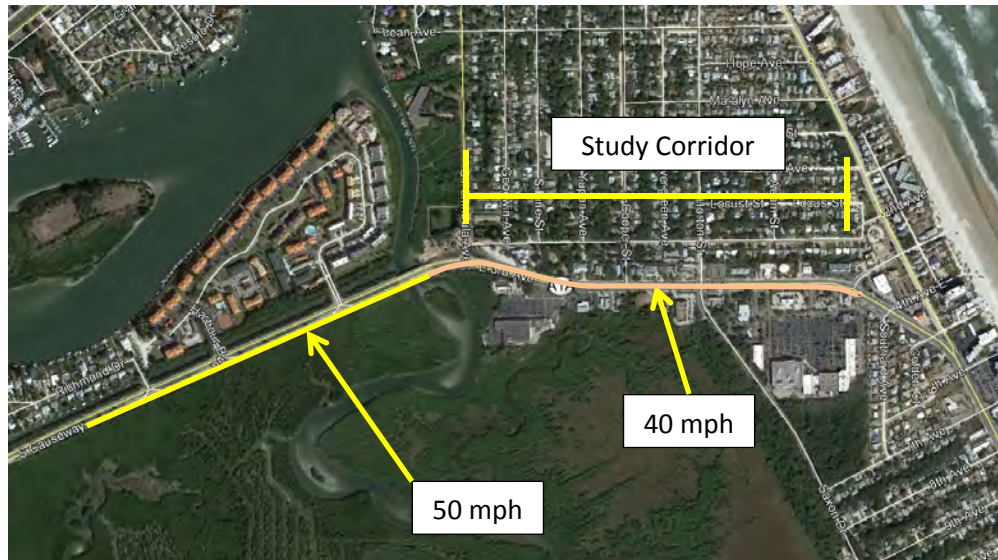
Figure 2

Vehicular speeds appeared to be in excess of the posted speeds along the entire length of the study corridor. The posted speed limits are 40 mph within the study corridor, but 50 mph just west of the study limits (**Figure 2**). The causeway portion of SR A1A, just west of the study limits, has limited driveway access and traffic regularly exceeds the posted 50 mph speed limit, especially in the eastbound direction where there are no driveways accessing the south side of the roadway. Along the corridor, the center two-way left-turn lane (TWLTL) ranges between 15' and 22' wide (**Figure 3**), contributing to high

- Near Term –
 - Reduce amount of cross sectional width for the travel lanes:
 - Currently 5' unmarked bicycle lanes are present along with four 12' lanes.
 - Restripe the pavement to have 11' lanes and a 7' buffered bike lane during the next resurfacing project.
 - Increase speed enforcement to encourage vehicles to drive closer to the posted speed limit based on the results of the speed study. Speed feedback signs that display how fast the vehicle is traveling may help deter speeding along the corridor.
- Long Term –
 - Perform an access management study to review the feasibility of:
 - A raised median between Peninsula Avenue and Horton Street/Saxon Drive.
 - Spot median installations between Horton Street/Saxon Drive and 3rd Avenue.

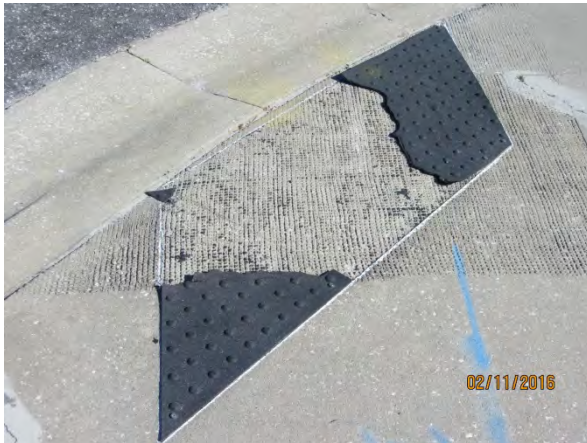
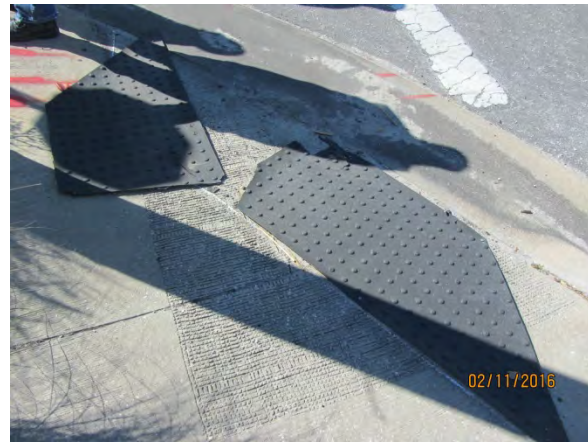
Along the south side of the study corridor, the study team observed the detectable warning surfaces to be broken or missing at multiple driveways to major commercial developments, as displayed in **Figure 4** and **Figure 5**.

Consider replacing/installing detectable warning surfaces at major driveways on the south side of the corridor per FDOT Design Standard Index 304.

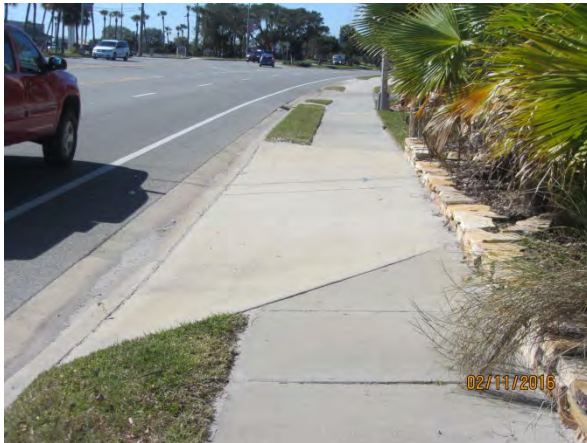
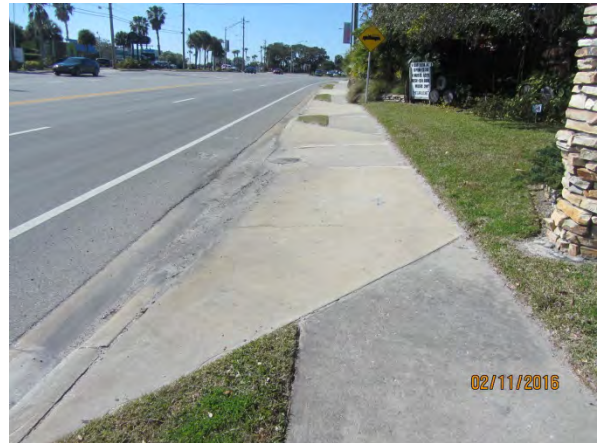
At most of the driveways/driveway aprons throughout the corridor, the sidewalk merges into the existing driveway, as displayed in **Figure 6** and **Figure 7**, providing no level path for pedestrians (maximum two (2) percent cross slope per section R302.6 in the ADA PROWAG guidance).

Along the study corridor, properties were observed as having multiple driveways/driveway aprons onto SR A1A, with most of those driveway aprons not currently being utilized by vehicular traffic as displayed in **Figure 6** and **Figure 7**. A number of driveways/driveway aprons were also noted to be longer than the 36' maximum driveway width as specified per FDOT Standard Index 515. While there was not a high amount of pedestrian/bicycle crashes at driveways (1 out of the 9 crashes), these areas are conflict points between pedestrians/bicyclists utilizing the sidewalk and vehicles exiting properties or turning from SR A1A.

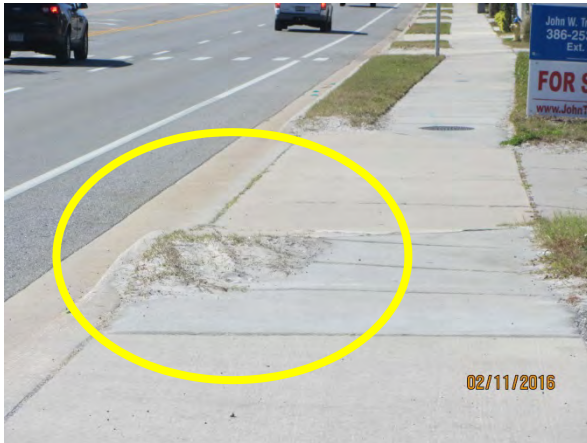
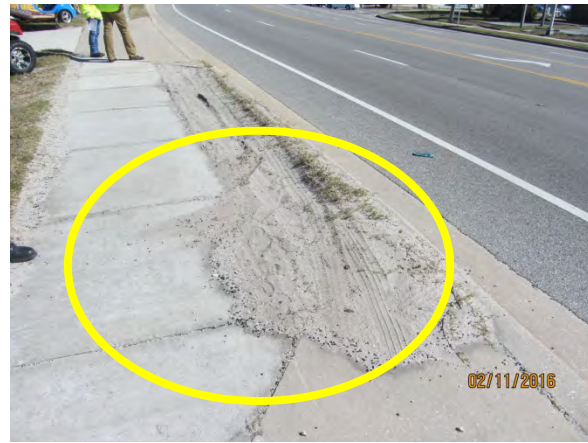
Along the corridor, multiple sidewalk locations were observed as having walkability issues due to sand partially covering the sidewalk (**Figure 8** and **Figure 9**). At these locations, the landscape buffer strip was sand with very little grass which does not allow for water to properly drain, thus creating the ponding/sand on the sidewalk. This reduces the effective width of the sidewalk while also creating potential trip hazards.

Consider removing small landscape buffer strips at locations where water ponding/sand collection is occurring and replace with concrete to create a wider sidewalk area.

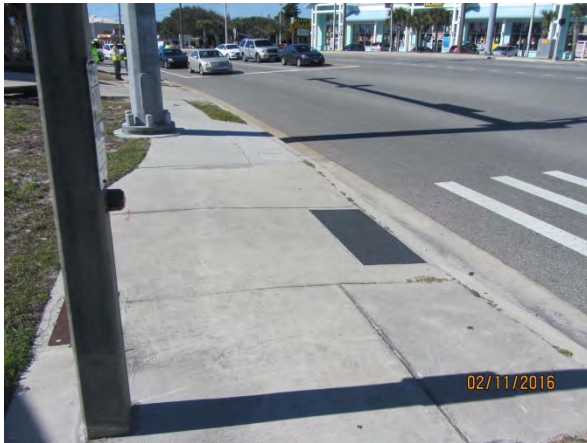
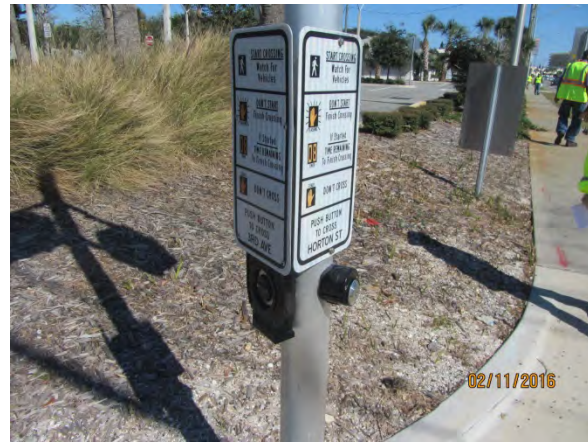
At the three signalized intersections throughout the corridor, the faces of the pedestrian push button detectors are perpendicular to the crosswalk, as displayed in **Figure 10**. Only the accessible pedestrian signal (APS) push buttons on the northeast (**Figure 11**) and southeast corners of the Horton Street/Saxon Drive intersection are properly oriented to be parallel to their corresponding crosswalk.

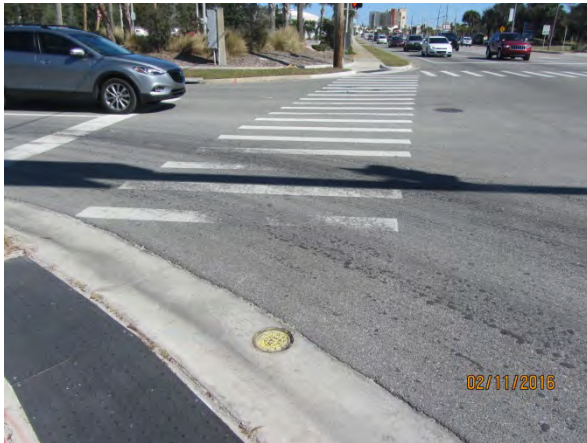
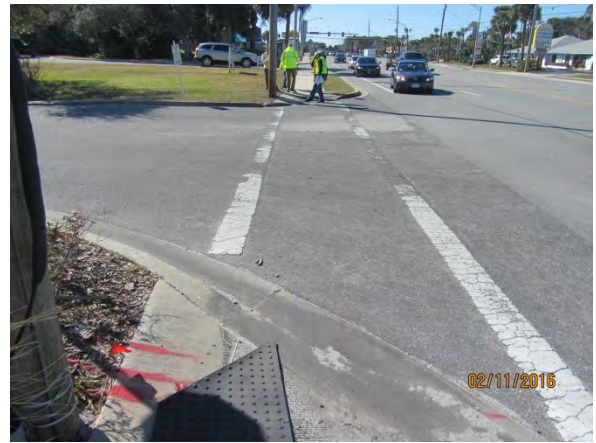
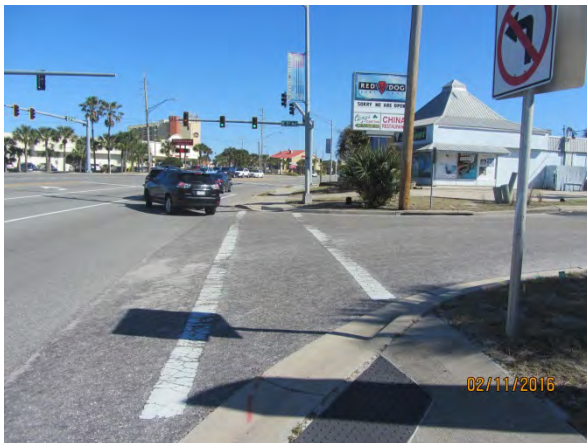
Overall, the existing crosswalk markings along the corridor were faded, as displayed in **Figure 13**, **Figure 14**, and **Figure 15**. At the signalized intersections, the crosswalk markings are the old special emphasis style. Cooper Street is missing crosswalk markings, as shown in **Figure 16**. The study team observed limited retro reflectivity of the crosswalk markings during nighttime conditions. Six of the nine corridor crashes occurred within marked crosswalk areas either at signalized intersections or at minor streets/driveways.

At signalized intersections, consider restriping the crosswalks with special emphasis marked crosswalks as shown on sheet 9 of the FDOT Design Standard Index 17346 during the next resurfacing project. At Cooper Street, consider striping a crosswalk across the stop controlled approach with standard markings as shown on sheet 9 of the FDOT Design Standard Index 17346. Also consider restriping the driveway crosswalks with standard crosswalk markings. Striping/restriping the crosswalks will improve retro reflectivity at night.

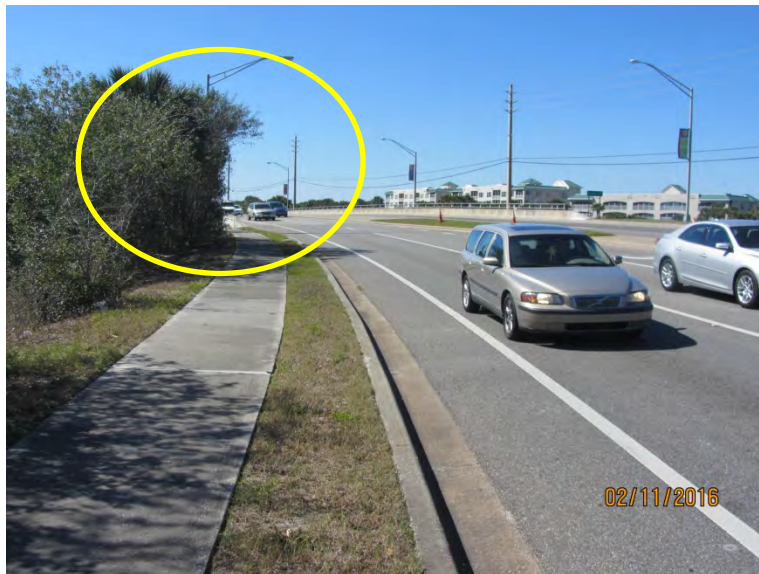
To the west of Peninsula Avenue, the study team observed landscaping/trees in the right of way obstructing the sight distance for vehicles coming eastbound over the causeway. The vehicles could not see the traffic signal at Peninsula Avenue and it was difficult for pedestrians to see vehicles coming around the corner. If the vehicle cannot see the traffic signal and is traveling at a high rate of speed, the potential for red light running and possible vehicle/pedestrian conflicts on the west crosswalk is increased.

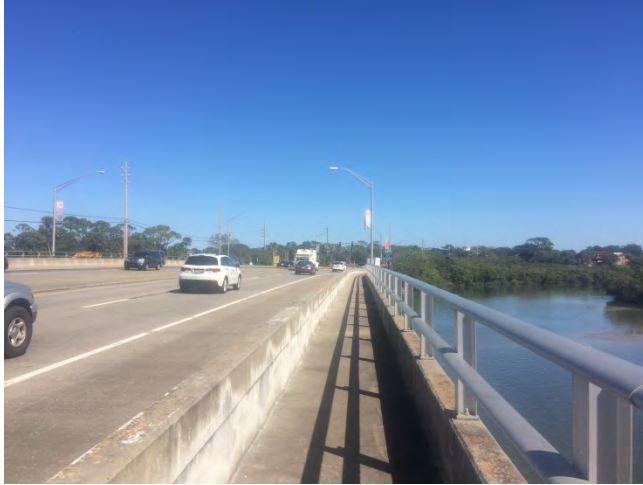
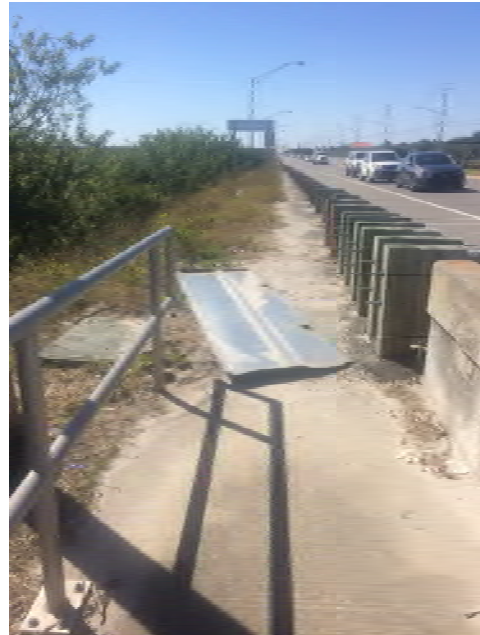
The sidewalk on the south side of SR A1A just west of Peninsula Avenue (**Figure 18**) ends just west of the bridge (**Figure 19**). There are no signs informing pedestrians at the Peninsula Drive intersection that the sidewalk on the south side of the roadway ends just west of the intersection.

The MUTCD does not have a warning sign for the end of a sidewalk, but the PAVEMENT ENDS sign W8-3 could be modified to read SIDEWALK ENDS. A SIDEWALK CLOSED sign R9-9 from section 6F.14 of the MUTCD could also be utilized to inform pedestrians the sidewalk ends. A warning plaque (W16-2aP) reading 200 FT could be installed below the SIDEWALK CLOSED sign to inform pedestrians how far ahead the sidewalk ends. Consider installing the preferred signage on the southwest corner of the Peninsula Avenue intersection to inform pedestrians they need to cross on the west leg crosswalk.

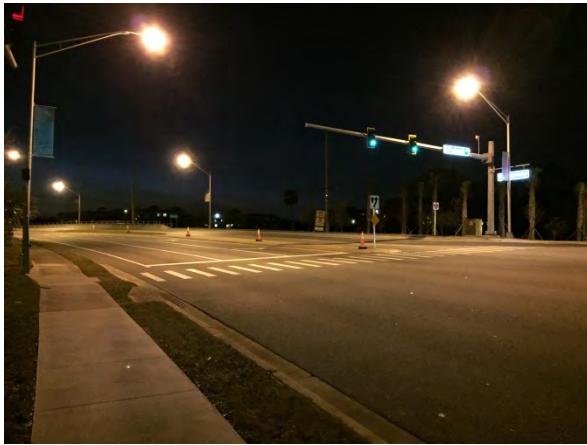
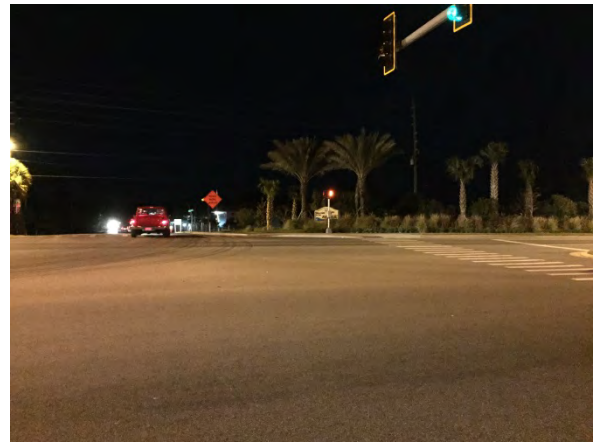
Intersection lighting is provided on the southwest and northwest corners of the intersection as displayed in **Figure 20** but no intersection lighting is provided on the southeast or northeast (**Figure 21**) corners of the intersection.

Consider upgrading the lighting at the intersection to meet the requirements of section 7.3 in Volume 1 of the FDOT Plans Preparation Manual (PPM). This may require the existing lighting to be replaced.

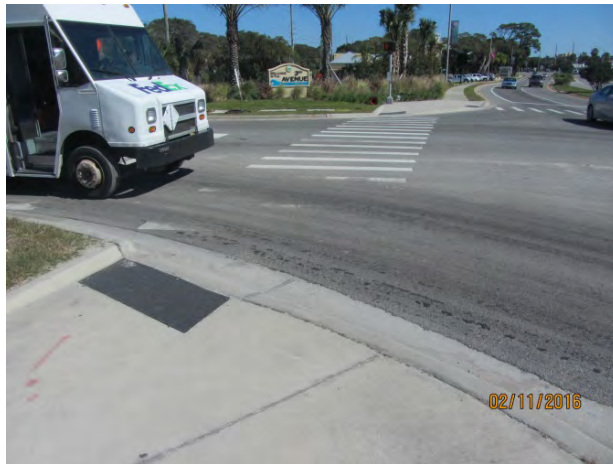
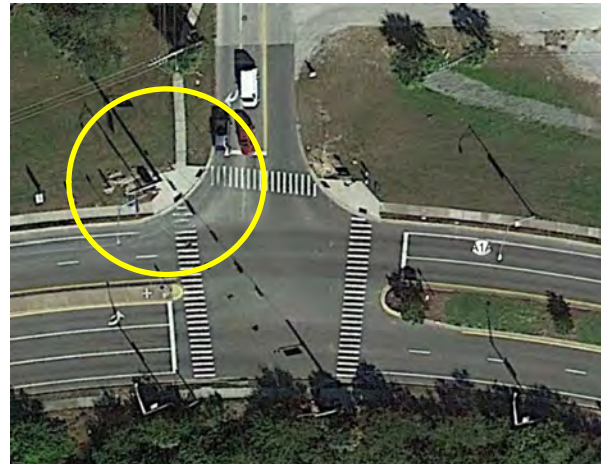
The field review team observed multiple conflicts between left/right turning vehicles from Peninsula Avenue and pedestrians utilizing the crosswalks on the west and east legs of the intersection. The study team also noted southbound right turning vehicles pulling past the stop bar and stopping just short of the north leg crosswalk (**Figure 22**) or stopping within the crosswalk itself. The curb return radius on the northwest corner is large (**Figure 23**) and southbound right turning vehicles were observed slowing, but not necessarily stopping, when making a right turn on red. One crash occurred with a bicycle crossing the north leg of the intersection who was struck by a southbound right turning vehicle.

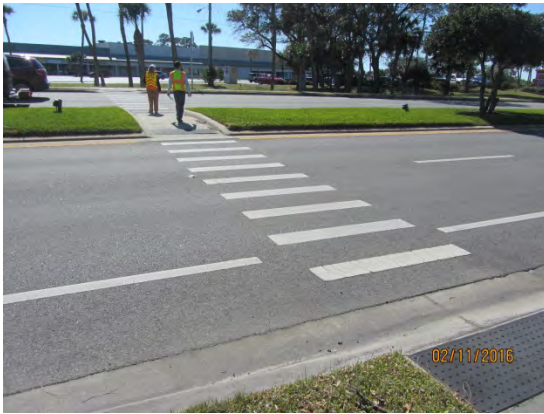
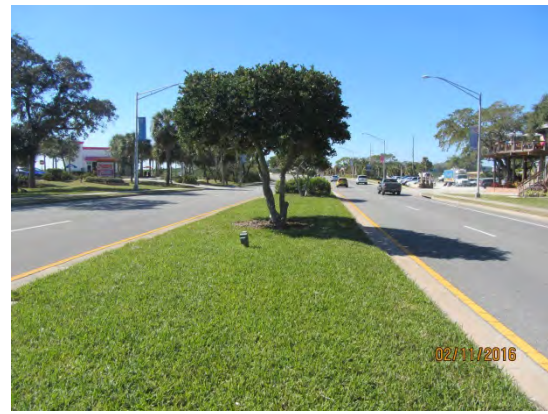
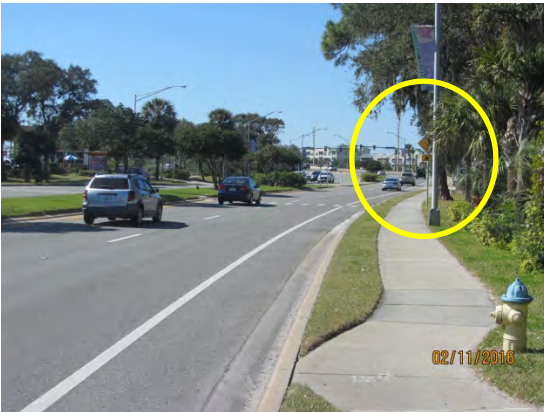
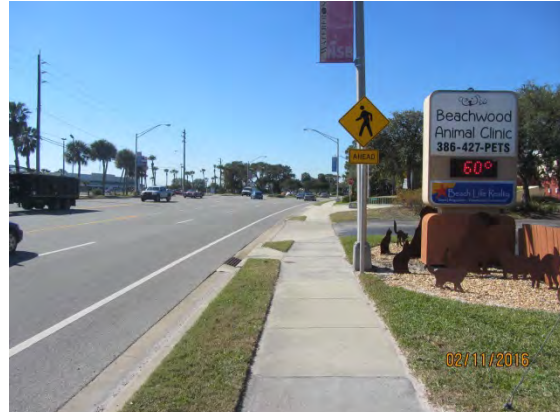
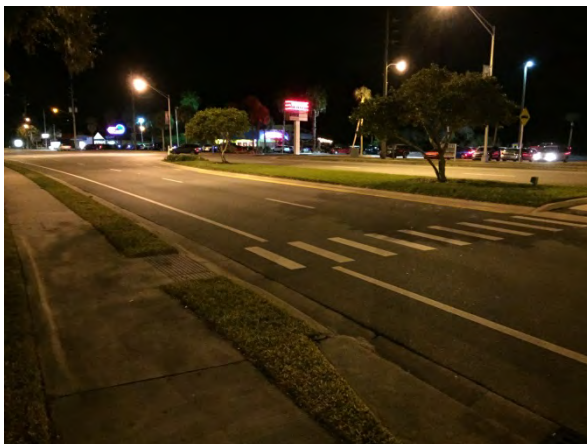
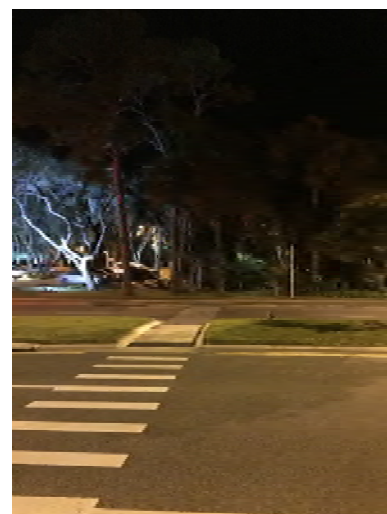
A mid-block crossing is located approximately 650' east of the SR A1A/Peninsula Avenue signalized intersection striped with old special emphasis crosswalk markings (**Figure 24**). The study team observed trees in the median which restricted sight distance for both vehicles approaching the crossing and pedestrians in the median attempting to cross the roadway (**Figure 25**). The study team also noted pedestrian warning signage at the crossing on the right side of the roadway in both directions (**Figure 26**) and advanced pedestrian warning signage approximately 450' west and east of the crossing (**Figure 27**). The pedestrian warning signage in the westbound direction was partially obstructed by a light pole as displayed in **Figure 26**.

During nighttime conditions, a large oak tree was observed casting a shadow across the markings for the westbound travel lanes (**Figure 28**) and the north side of the crossing was dark relative to the south side of the crossing (**Figure 29**).

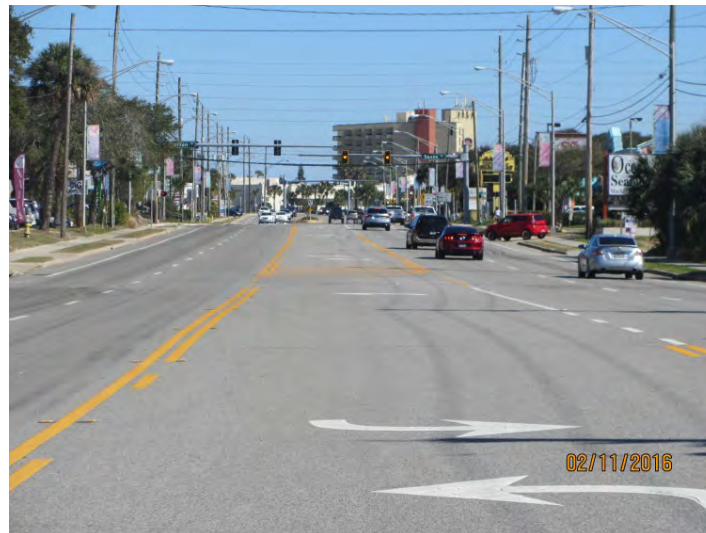
Figure 30

As described in **Issue #1: Vehicular Speed**, the pavement width between Peninsula Avenue and Horton Street/Saxon Drive is wide (**Figure 30**) and presents a challenge for pedestrians attempting to cross SR A1A. Cooper Street is the only unsignalized intersection along the corridor (**Figure 31**), located approximately 650' west of Horton Street/Saxon Drive. One mid-block pedestrian crash occurred just west and one mid-block bicycle crash occurred just east of Cooper Street. Pedestrians/bicyclists were observed coming from Cooper Street and crossing SR A1A.

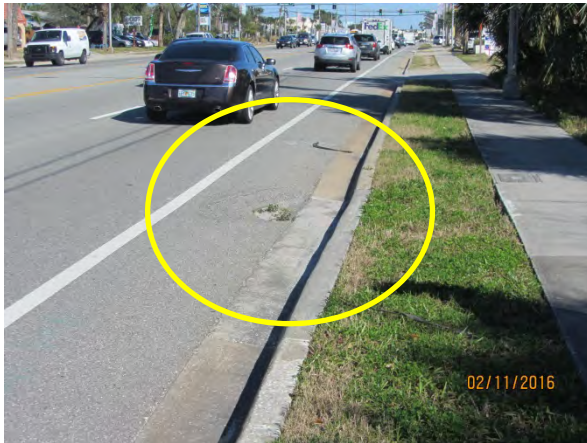
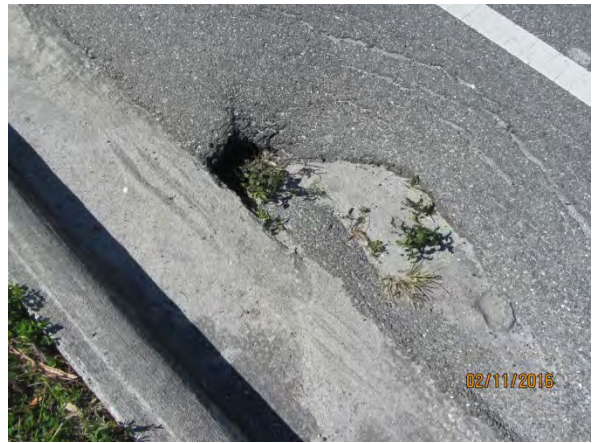
A pot hole is located in the eastbound paved shoulder (south side of roadway) just east of Cooper Street. This pot hole presents a hazard for any bicyclists utilizing the paved shoulder as they ride eastbound.

Consider repairing the roadway in the vicinity of the pot hole area.

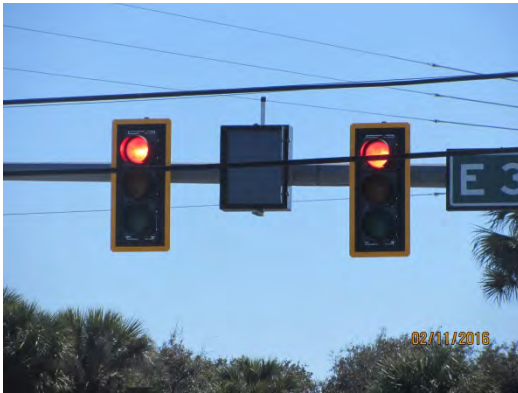
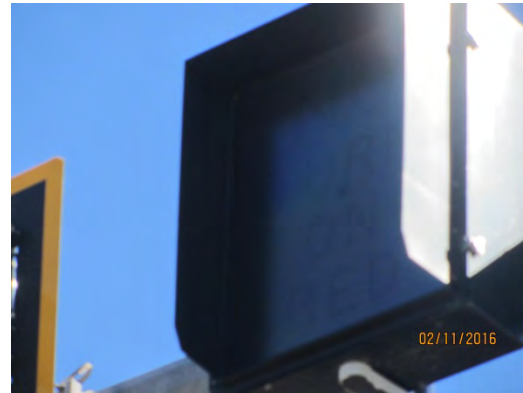
The study team observed a blank-out sign that reads “NO TURN ON RED” for the southbound approach at the intersection (**Figure 34** and **Figure 35**) but that was not working during the field review. The study team also observed a leading pedestrian interval for the west and east leg crosswalks at the intersection (preceding the northbound/southbound phase). Two crashes occurred between left turning vehicles and pedestrians in the west and east leg crosswalks.

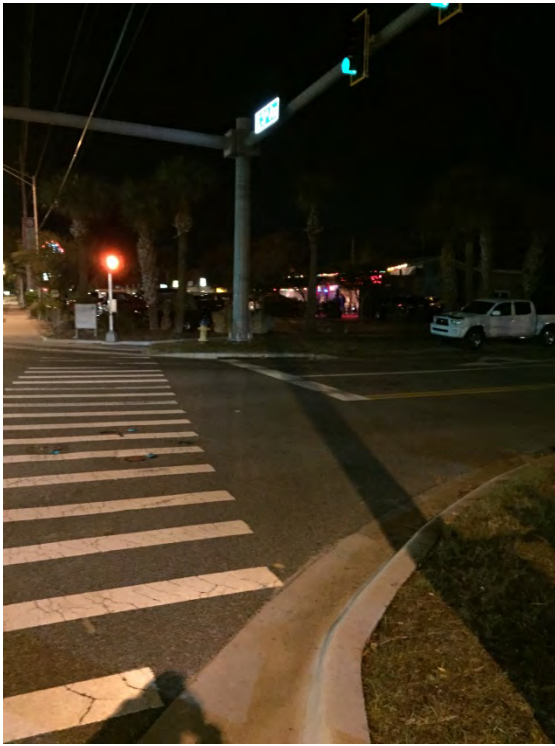
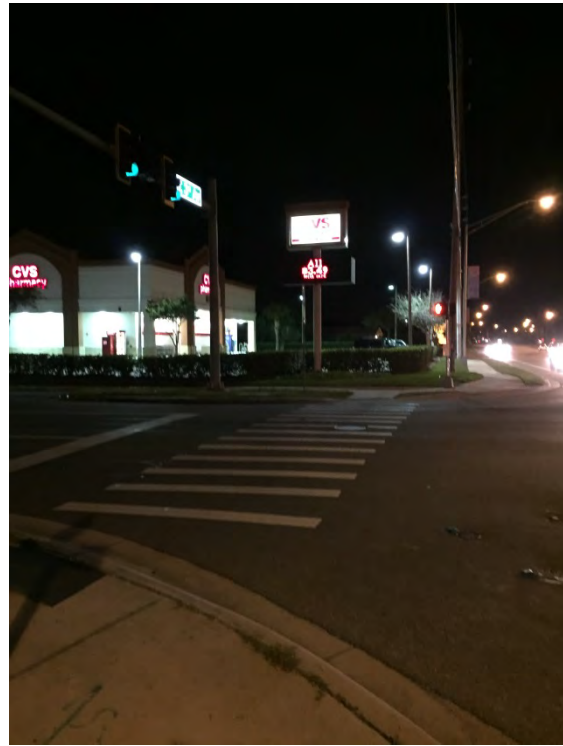
Intersection lighting is provided along SR A1A but the spacing of the light poles leaves the north crosswalk (**Figure 37**) and south crosswalk (**Figure 38**) partially or fully unlit.

Consider upgrading the lighting at the intersection to meet the requirements of section 7.3 in Volume 1 of the FDOT Plans Preparation Manual (PPM). This may require the existing lighting to be replaced.

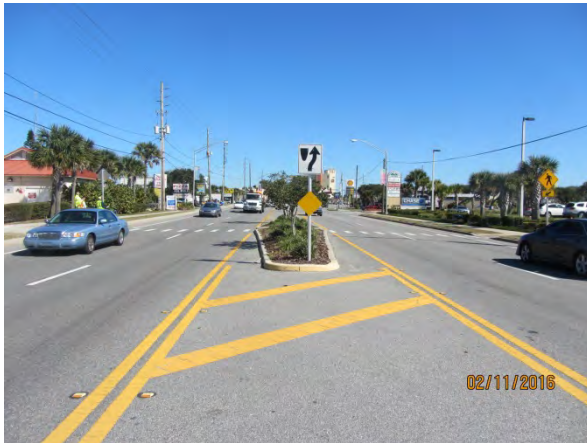
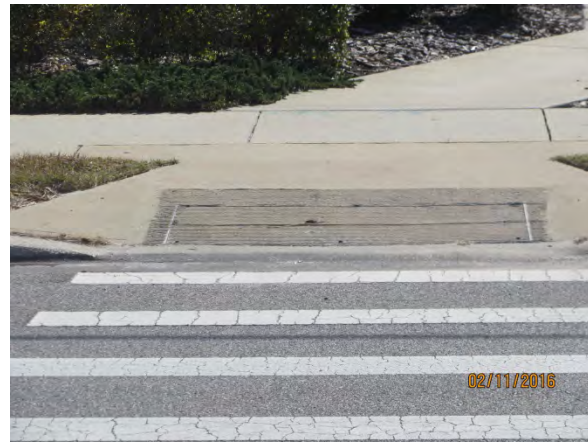
A mid-block crossing is located approximately 650' east of the SR A1A/Horton Street/Saxon Drive signalized intersection striped with old special emphasis crosswalk markings (**Figure 40**). The study team noted pedestrian warning signage at the crossing on the right side of the roadway in both directions and advanced pedestrian warning signage approximately 400' west and 425' east of the crossing. The south side of the crossing was missing a detectable warning surface as displayed in **Figure 41**.

- Install a detectable warning surface on the south side of the crossing per FDOT Design Standard Index 304.

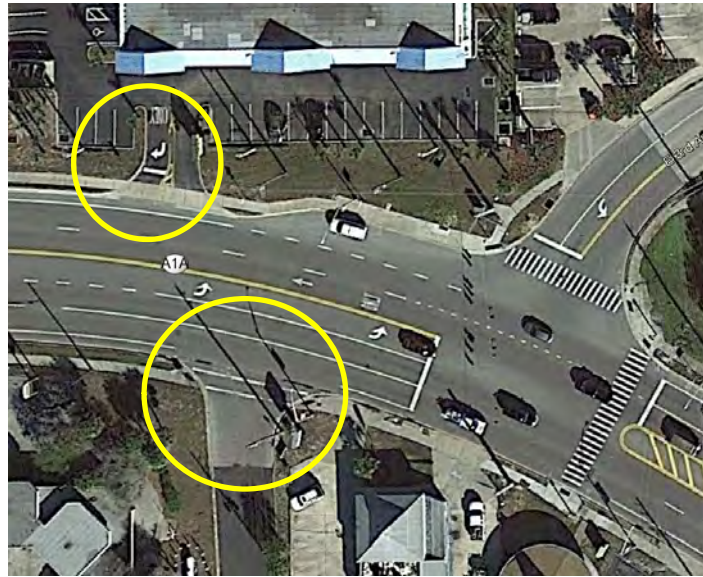
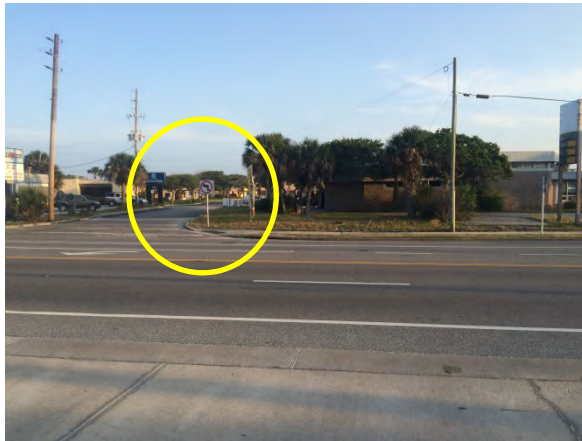
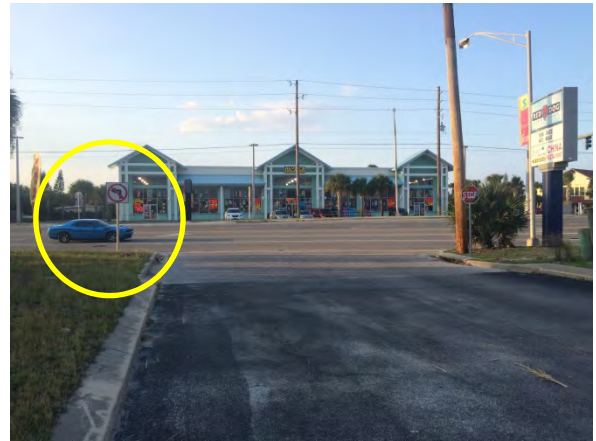
Two driveways are located just west of the 3rd Avenue intersection, as identified in **Figure 42**. The driveway on the north side of SR A1A is right out only and signage prohibiting left turns onto SR A1A are located on the stop sign and across the street on the south side of the roadway, as displayed in **Figure 43**. Even with the signage, vehicles were observed turning left onto SR A1A from the north side driveway.

The driveway on the south side of SR A1A had a sign prohibiting left turns (**Figure 44**) but it is located on the west side of the driveway. The field review team observed multiple vehicles attempting to make left turns from this driveway. With no physical obstruction prohibiting left turn movements, more vehicular

In the near term, consider the addition of a raised 2' or 4' concrete separator extending approximately 200' west of the 3rd Avenue intersection. The separator should be located between the eastbound left turn lane and the inside westbound through lane.

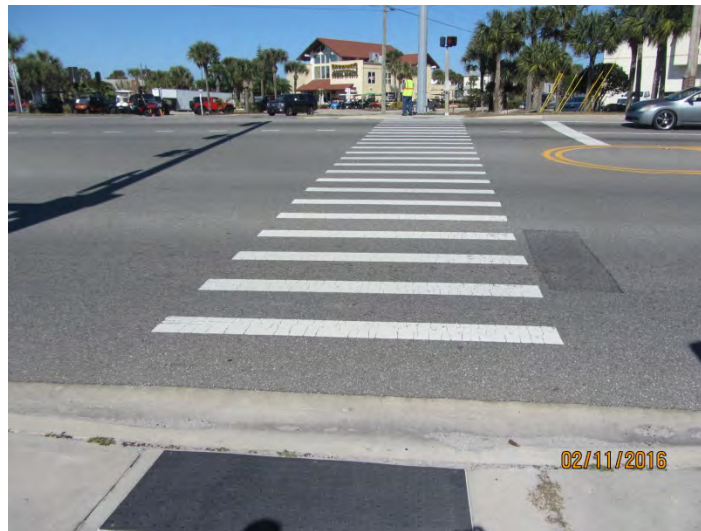
**Figure 45****Description of Issue:**

During the field review, the study team observed multiple southbound left turn/east leg crosswalk pedestrian conflicts even though a leading pedestrian interval is present for the east leg crosswalk (preceding the northbound/southbound phase).

The field review team recorded a 20 second pedestrian clearance interval on the east leg of the intersection. Using the recommended walking speed of 3.5 feet per second as included in paragraph 7 of section 4E.06 of the MUTCD, a pedestrian clearance interval of 22 seconds is needed to accommodate a pedestrian walking across the 76-foot west leg.

The field review team coordinated with Volusia County after the safety review to review the pedestrian clearance interval on the east leg of the intersection and the County has updated the timing accordingly.

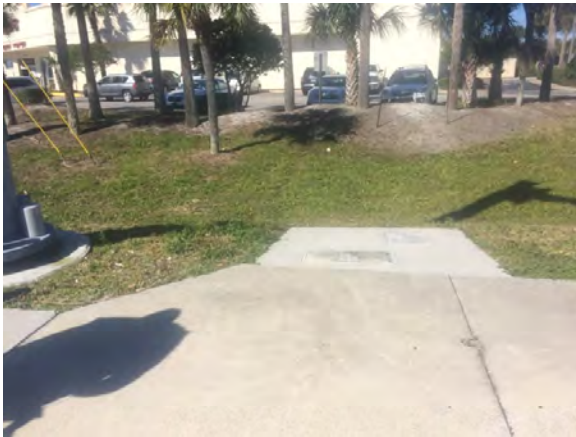
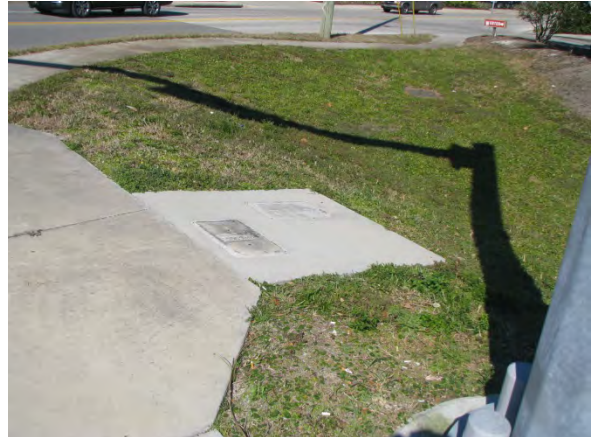
Immediately adjacent to the northeast corner of the intersection, a steep slope down into a drainage area was observed just off the sidewalk (**Figure 46** and **Figure 47**). If a pedestrian/bicyclist is utilizing the sidewalk in this location, they may accidentally step/ride off the sidewalk and fall into the drainage area.
