SR/CR A1A PEDESTRIAN SAFETY & MOBILITY STUDY

PEDESTRIAN / BICYCLE SAFETY REVIEW

Focus Area B / Park Avenue to Ribault Avenue (Daytona Beach Shores/Daytona Beach)

Pedestrian/Bicycle Safety Review Report for Focus Area B: SR A1A from Park Avenue to Ribault Avenue (Daytona Beach Shores/Daytona Beach)

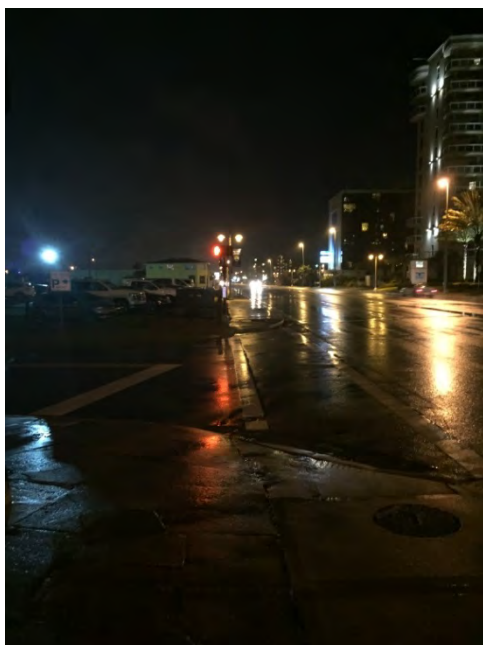
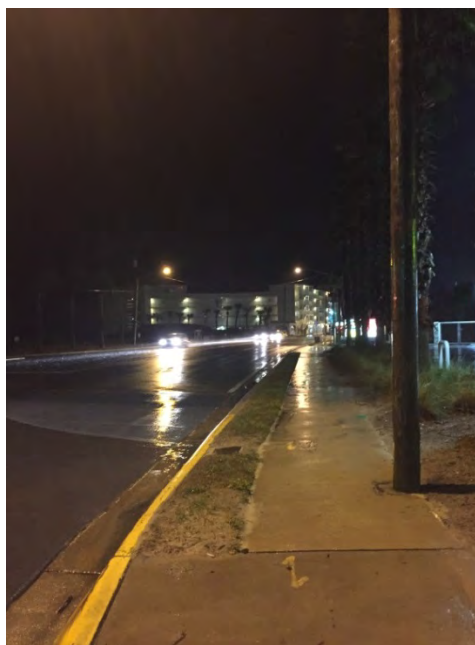
While the five nighttime crashes occurred outside of turtle season, the turtle season lighting measures were still in effect along the corridor. Shutting off lights or using the turtle shields negatively impact the lighting conditions for the roadway users. Reducing the light can make it difficult for drivers to see pedestrians or bicyclists at night, especially those wearing dark clothing. **Figure 2** and **Figure 3** illustrate the lighting levels the safety team observed. The safety study team observed the roadway lighting conditions at night and had the following observations:

- Lighting levels and spacing were inconsistent along the corridor;
- Inconsistent turtle lighting treatments, some light poles on the west side were outfitted with turtle shielding while others were not;
 - Shields were still installed on west side poles even though it was not turtle season.
- Some of the street lights were either off or not working properly;
 - Between Silver Beach Avenue and Frances Terrace, the street lights on both sides of the roadway were completely shut off.

- Replace the lights on the corridor that are burnt out.
- Consider conducting field measurements of existing lighting levels to evaluate lighting uniformity levels and add lighting where necessary. Consider light poles on the east side that are angled westerly away from the beach. These light poles cast their light to the west and illuminate the roadway as needed. The light bulb is not seen by the turtles due to the angle and orientation of the light fixture.

- Consider implementing a lighting plan for the time the sea turtle nesting season is not active as roadway lighting levels should not be reduced at this time.

- Consider implementation of pedestrian-level lighting, with less visibility from the beach, to supplement areas where street lighting is not able to provide adequate illumination.

- As a long-term consideration, upgrade to an adaptive roadway lighting system along the corridor. Lighting levels could be programmed to be reduced during the sea turtle nesting season and increased to normal levels outside of the nesting season. This could be coupled with replacing the current high pressure sodium lighting with LED lighting.

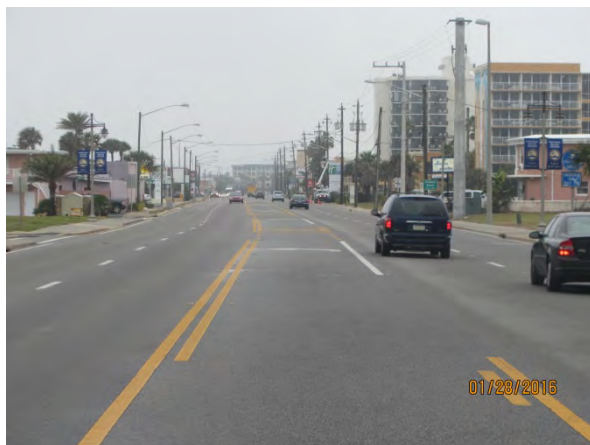
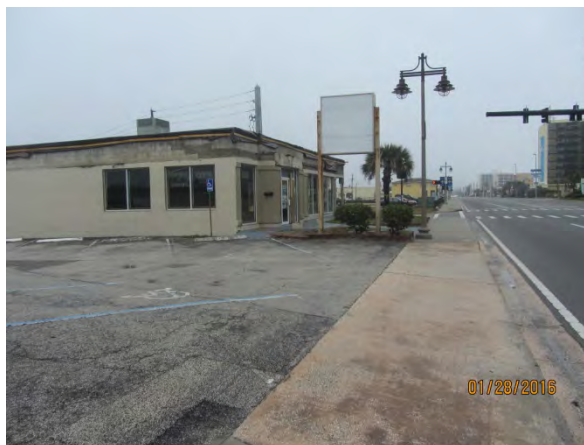
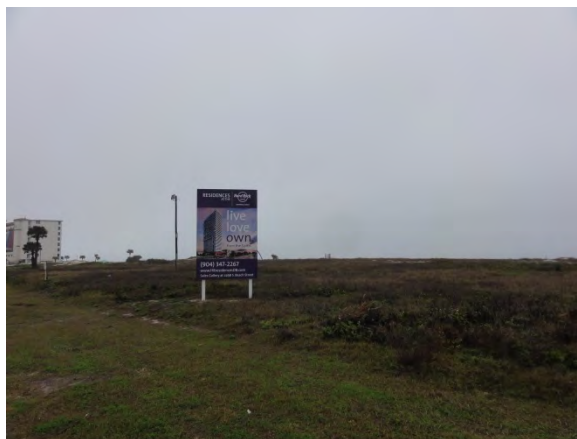
As noted in the background, only two signalized marked crossing locations are present along the corridor at Botefuhr Avenue and Silver Beach Avenue but these signals are spaced approximately 0.70 miles apart. Without the provision of marked crosswalks at regular intervals and the five-lane roadway cross section (**Figure 4**), pedestrians cross SR A1A wherever it is convenient or desirable and they tend to utilize the TWLTL for refuge. Five of the eight (63 percent) pedestrian crashes occurred outside of a marked crosswalk between Botefuhr Avenue and Ribault Avenue.

Current land uses along the corridor encourage pedestrians to cross SR A1A at unmarked locations. Some hotels on the east side of the roadway have their parking on the west side of the roadway. Bus stops are also placed at mid-block locations and pedestrian/bicycle beach access points are located throughout the corridor. The study team counted approximately 20 parcels along the corridor that were vacant with no buildings or had buildings that were unoccupied by a tenant (**Figure 5**). When these parcels develop or new tenants move into the unoccupied buildings, pedestrian/bicycle activity may increase across and along the corridor. On the east side of the corridor near Ribault Avenue, a Hard Rock Hotel is in the planning stages with parking proposed on the west side of SR A1A (**Figure 6**).

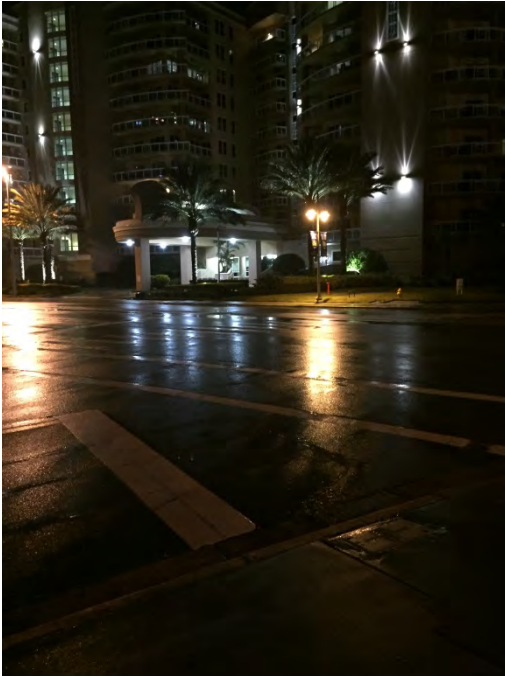
**Figure 7**

Intersection lighting is not provided at all corners of the Botefuhr Avenue (**Figure 7**) and Silver Beach Avenue (**Figure 8**) intersections leaving portions of the marked crosswalks unlit. One pedestrian crash involving a westbound right turning vehicle occurred on the north leg of the Botefuhr Avenue intersection under dark lighting conditions.

Consider upgrading the lighting at the two intersections to meet the requirements of section 7.3.2.2 in Volume 1 of the FDOT Plans Preparation Manual (PPM). This may require the existing lighting to be replaced. FDOT is also considering lighting installed underneath mast arms that hang directly over marked crosswalks at signalized intersections. These two options should be evaluated to see which best meets the lighting requirements for each intersection.

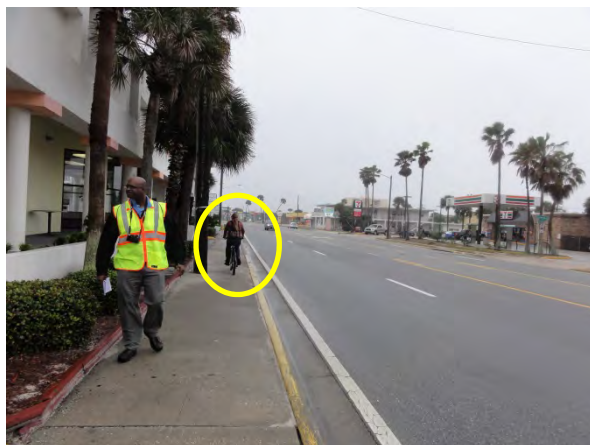
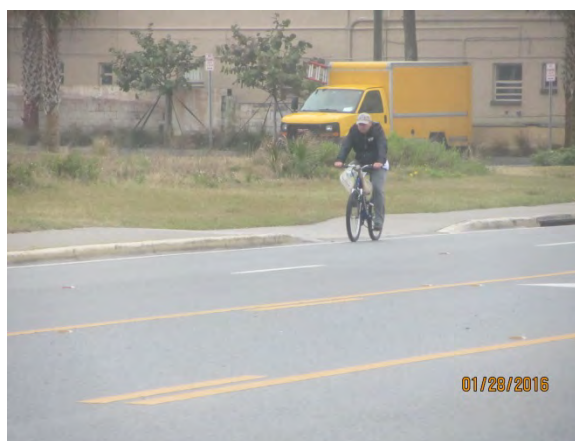
The SR A1A roadway width within the project limits ranges from 57' (four 11.5' travel lanes with an 11' TWLTL) to 61' (four 12.5' travel lanes with an 11' TWLTL). With this configuration, there are no paved shoulders or marked bicycle lanes so bicyclists either ride on the sidewalk (**Figure 9**) or ride in the outside lane near the edge of the roadway (**Figure 10**). Due to rainy field review conditions, not many bicycles were observed by the field review team but team members familiar with the corridor noted that on a nice day, there is a good amount of bicycle traffic along this section of SR A1A.

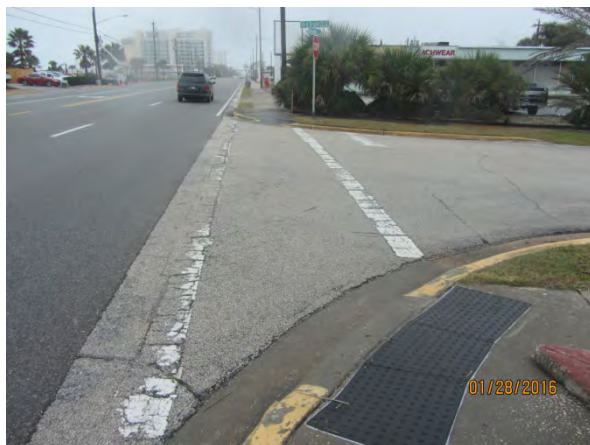
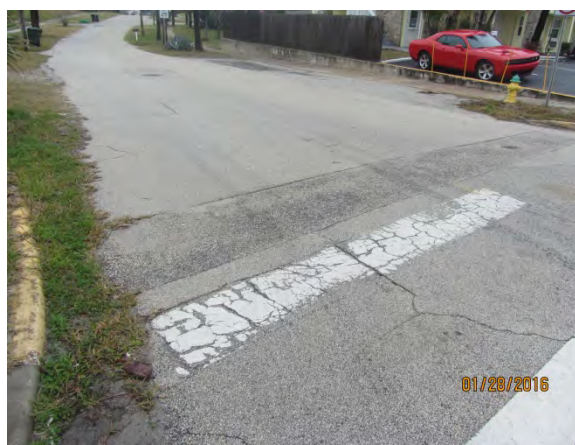
Overall, the existing crosswalk markings and stop bars at minor street intersections along the corridor were faded, as displayed in **Figure 11** and **Figure 12**. The study team observed limited retro reflectivity of the crosswalk markings during nighttime conditions. While there were no pedestrian or bicycle crashes at minor street intersections, emphasizing the pedestrian walking area and vehicle stop location is important for a driver approaching one of these intersections.

As a maintenance activity, consider emphasizing the pedestrian realm across minor street approaches by restriping crosswalk markings as shown on sheet 9 of FDOT Standard Index 17346. Also consider restriping the stop bar as shown on sheets 2 and 4 of FDOT Standard Index 17346 to emphasize where the vehicle needs to stop before making their turning movement. Locations the study team noted during the review included:

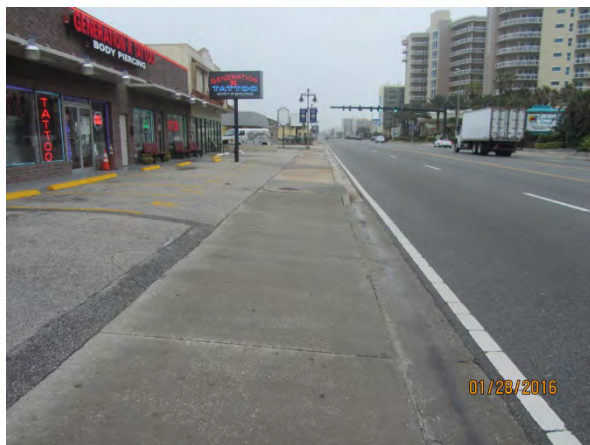
At some driveways throughout the corridor, the sidewalk merges into the existing driveway as displayed in **Figure 13** and **Figure 14**. At many of these locations, a level path with less than two (2) percent cross slope is not provided across the driveway. Per section R302.6 in the ADA PROWAG guidance, the maximum cross slope for a sidewalk across a driveway is two (2) percent.

Along the study corridor, properties were observed as having multiple driveways onto SR A1A (**Figure 13**). A number of driveways were also noted to be longer than the 36' maximum driveway width (**Figure 14**) as specified per FDOT Standard Index 515. While there were no pedestrian/bicycle crashes at driveways, driveways are conflict points between pedestrians/bicyclists utilizing the sidewalk and vehicles exiting the property or turning from SR A1A.

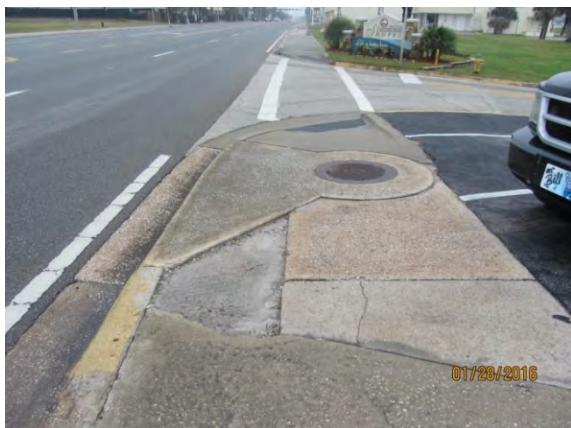
Figure 15

- Trip hazards were present at multiple inlets along the corridor (**Figure 15**) where the top of the inlet is raised above the sidewalk. According to section R302.7.2 of the Americans with Disabilities Act Public Rights of Way Accessibility Guidelines (ADA PROWAG), vertical surface discontinuities shall be $\frac{1}{2}$ " maximum.

- Specific inlets with this issue were noted south of Eastwood Lane and south of Temko Terrace.
- Curb ramps at minor street intersections (**Figure 16**) were greater than the 8.3 percent maximum running slope discussed in section R304.3.2 of the ADA PROWAG. There is also no turning space at the top of the ramps. According to section R304.2.1 of the ADA PROWAG, a turning space of 4' minimum by 4' minimum shall be provided at the top of the curb ramp.

At the locations where trip hazards are present at inlets, consider beveling/grinding the inlet top near the sidewalk joint to reduce/eliminate the trip hazard.

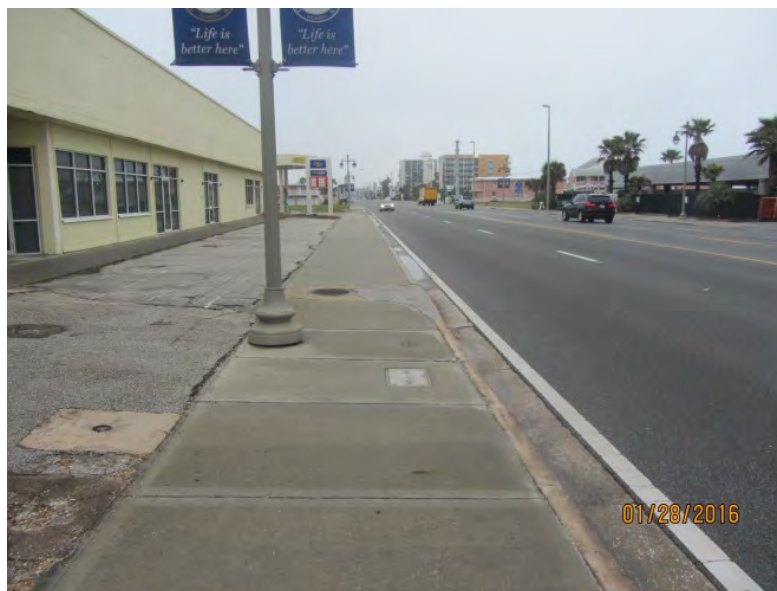
Figure 18

Daytona Beach Shores completed a streetscape project in 2013 where the sidewalks were rebuilt and the utilities along the corridor were put underground, as displayed in **Figure 18**. As a long term suggestion, consider rebuilding the sidewalk in the Daytona Beach section and underground the utilities along the corridor to remove the sidewalk obstructions.

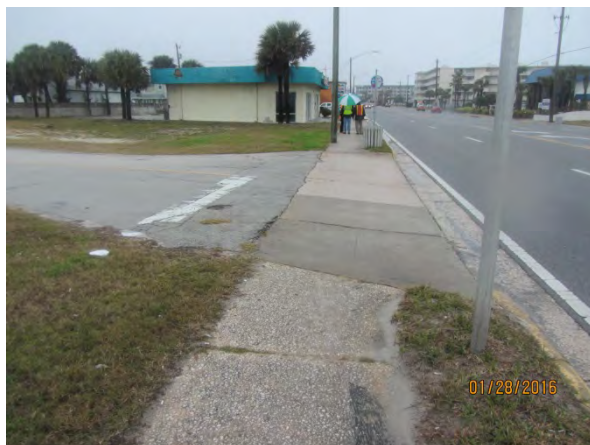
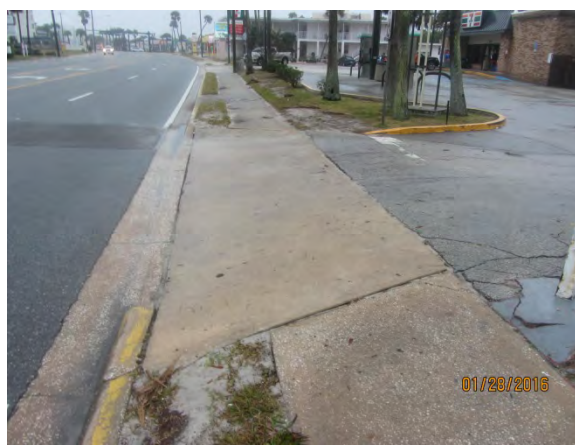
The study team observed the named public minor streets of Temko Terrace (**Figure 21**), Eastwood Lane (**Figure 22**), and Frances Terrace having driveway connections to SR A1A instead of paved asphalt connections. At many of these locations, a level path with less than two (2) percent cross slope is not provided across the driveway. Per section R302.6 in the ADA PROWAG guidance, the maximum cross slope for a sidewalk across a driveway is two (2) percent. These minor streets did not have marked crosswalks or detectable warning surfaces.

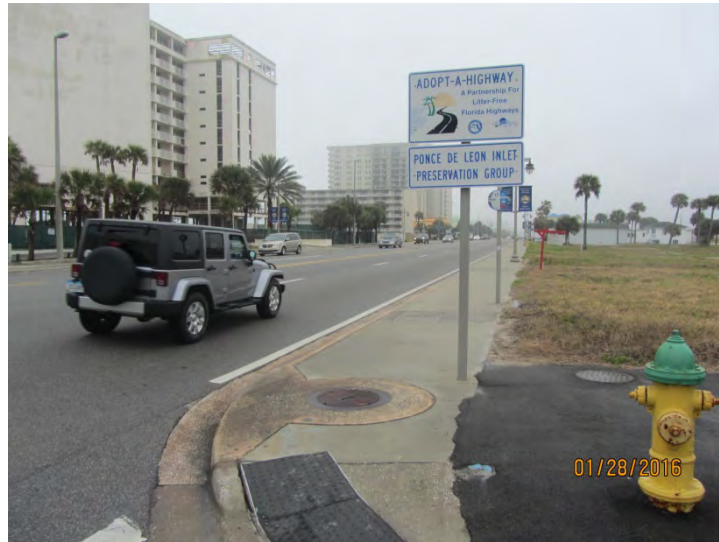
**Figure 23****Description of Issue:**

The secondary sign below the Adopt-A-Highway sign just south of Park Avenue (**Figure 23**) is less than 7' above the sidewalk. Section 2A.18 of the MUTCD states that if a secondary sign mounted below another sign is less than 7' above the sidewalk, the sign shall not project more than 4" into the pedestrian facility.

Consider reinstalling the sign so the secondary sign either does not project more than 4" into the sidewalk or is greater than 7' above the sidewalk. This may be done by moving the sign off the sidewalk or installing the signs on a taller sign post.

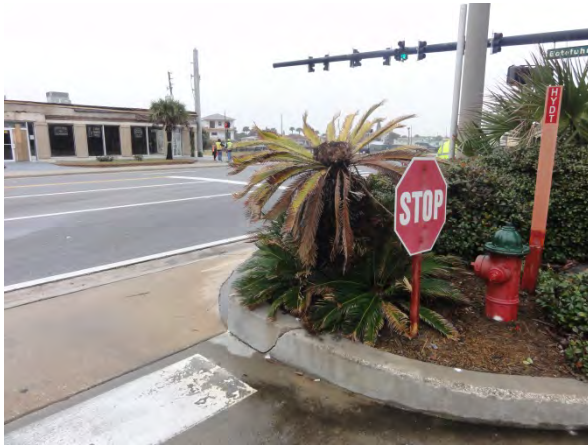
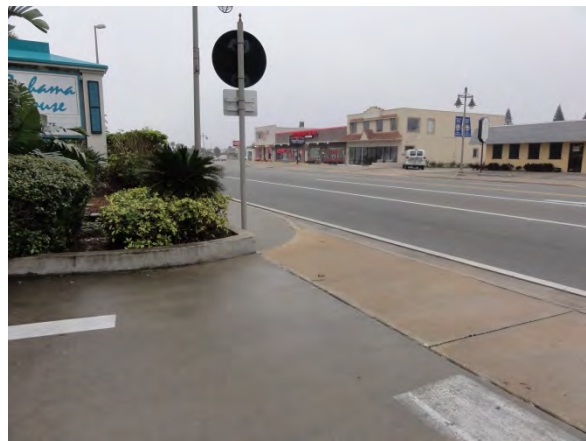
Shrubbery is present on the corners of the Bahama House Hotel driveway, restricting sight distance between vehicles exiting onto SR A1A and sidewalk users (pedestrians/bicyclists) to the south (**Figure 24**) and to the north (**Figure 25**).

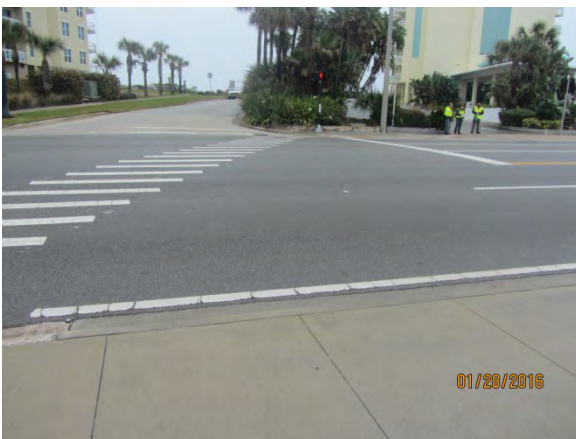
Figure 32

Due to the skew of Botefuhr Avenue, crosswalks on the north and south (**Figure 32**) legs across SR A1A are skewed and do not align with the curb ramps on the corners of the intersection. The curb ramps were observed to be steep and did not meet the 4' minimum clear width according to ADA PROWAG section R304.5.1 (**Figure 33**).

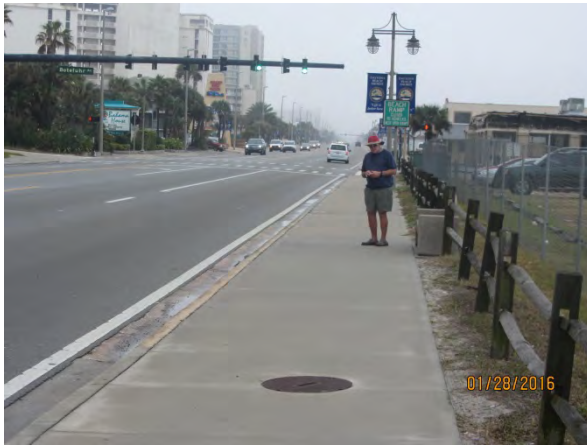
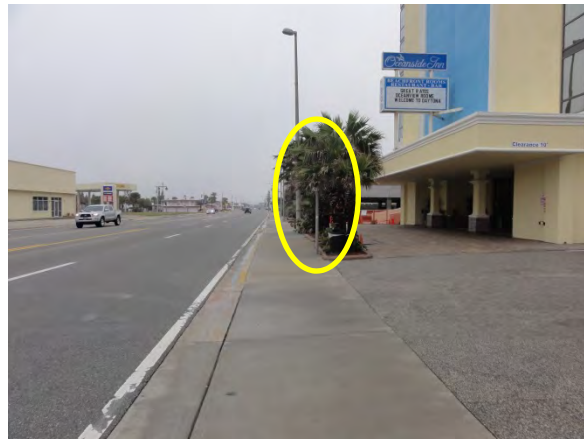
- A Votran sign was missing for the stop between Botefuhr Avenue and Flamingo Avenue on the west side of the roadway (**Figure 34**).
- Landscaping was obstructing the Votran sign between Botefuhr Avenue and Flamingo Avenue on the east side of the roadway (**Figure 35**).
- A Votran sign was missing for the stop just north of the beach access at Frazar Road on east side of the roadway.

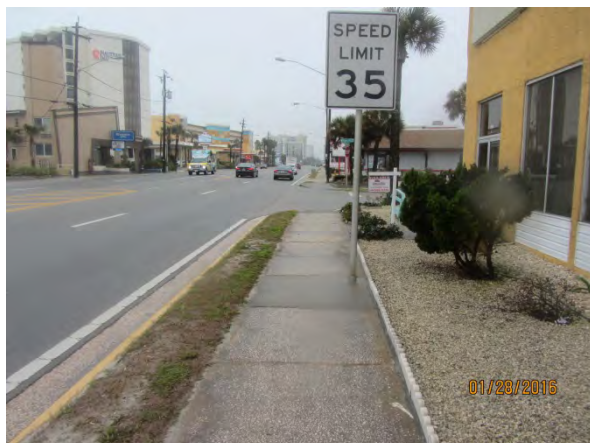
Figure 36

- The sidewalk was cracked and formed a small dip on the east side of the roadway north of Poinsettia Road.
- The speed limit sign is less than 7' above the sidewalk on the west side of the roadway north of Wisteria Road (**Figure 36**). Section 2A.18 of the MUTCD states the minimum height from the bottom of the sign to the sidewalk shall be 7'.
- A trip hazard from a tie down cable on the east side of the roadway north of Wisteria Road (**Figure 37**).
- A metal pole from a previous sign was protruding from the sidewalk on the east side of the roadway near Temko Terrace.
- A grate for the private property on east side of the roadway is not level with sidewalk near Bostwick Avenue (**Figure 38**).

- Replace the sidewalk panels that are cracked on the east side of SR A1A north of Poinsettia Road.
- Reinstall the speed limit sign on the west side of SR A1A north of Wisteria Road by moving the sign off the sidewalk or installing the sign on a taller sign post.

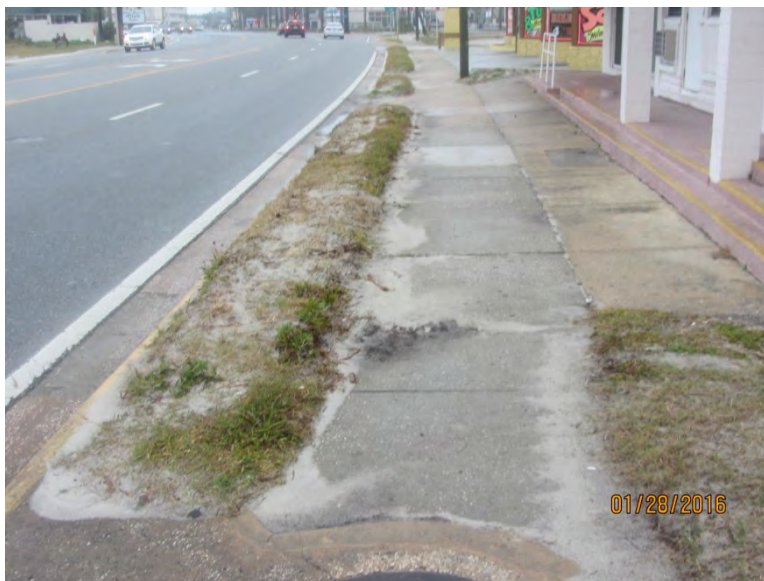
**Figure 47****Description of Issue:**

Between Mobile Avenue and Phoenix Avenue, the sidewalk was observed as having walkability issues due to sand partially covering the sidewalk (**Figure 47**). The landscape buffer strip was raised approximately $\frac{1}{2}$ " to 1" higher than the sidewalk which does not allow for water to properly drain into the grass, thus creating the ponding/sand on the sidewalk.

Consider reducing the height of the landscape strip to be level or just below the sidewalk and replace with new sod. The landscape strip could also be replaced with concrete to create a wider sidewalk in this area.

In lieu of regular sidewalk maintenance by a local jurisdiction, local businesses along the corridor could apply for the FDOT Adopt-A-Highway program. According to the website (found at <http://www.dot.state.fl.us/statemaintenanceoffice/aah.shtm>), volunteers would “enter into a two-year agreement with DOT, during which they agree to conduct litter removal at regularly scheduled intervals. Many miles of highway are adopted statewide by various organizations, allowing civic-minded people to make a difference in their communities. This eases the load of DOT work crews, enabling them to devote more time to other road maintenance and special highway projects.”
