# SR/CR A1A PEDESTRIAN SAFETY & MOBILITY STUDY

## PEDESTRIAN / BICYCLE SAFETY REVIEW

Focus Area C / International Speedway Boulevard to South of Earl St. and  
North of Oakridge Boulevard to North of University Boulevard (Daytona Beach)

## **Project Title: Focus Area C Pedestrian/Bicycle Safety Field Review**

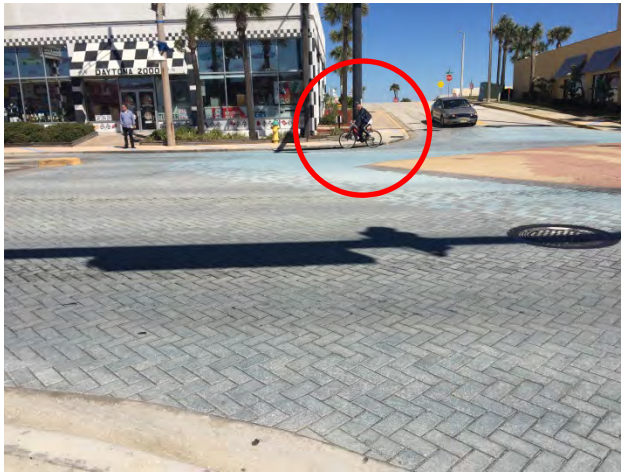
Figure 7

No bicycle lanes are provided along the length of the south section. Bicyclists were observed riding in the road as illustrated in **Figure 7** and **Figure 8**. The study team also observed bicyclists riding along the sidewalk (see **Figure 9** and **Figure 10**). Two bicycle crashes were reported within the south section over the crash analysis period. Right-of-way (ROW) is limited within the south section and bicycle lanes could not be implemented without adjusting the existing curb lines.

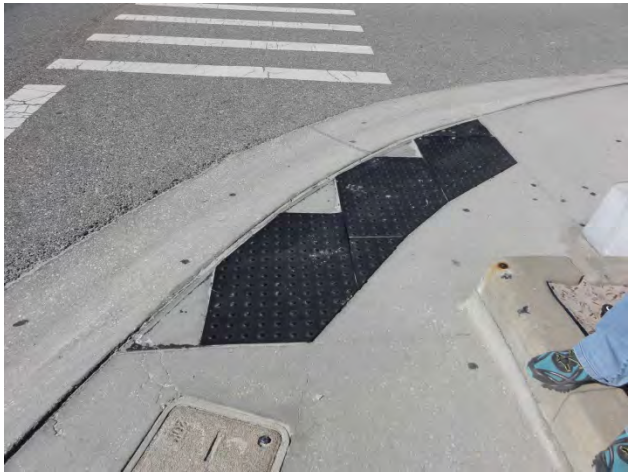
Some detectable warning surfaces were missing or no longer adhere to the curb ramps (examples shown in **Figure 11** and **Figure 12**). Some of the detectable surfaces were worn down as illustrated in **Figure 13**. The safety review team also observed two different types of detectable warning surfaces as some have been replaced recently. **Figure 14** shows a newer detectable warning surface observed along the study corridor.

Consider replacing the worn or deteriorating detectable warning surfaces along the corridor at both the signalized and unsignalized intersections to match the newer detectable warning surfaces as illustrated in **Figure 14**.

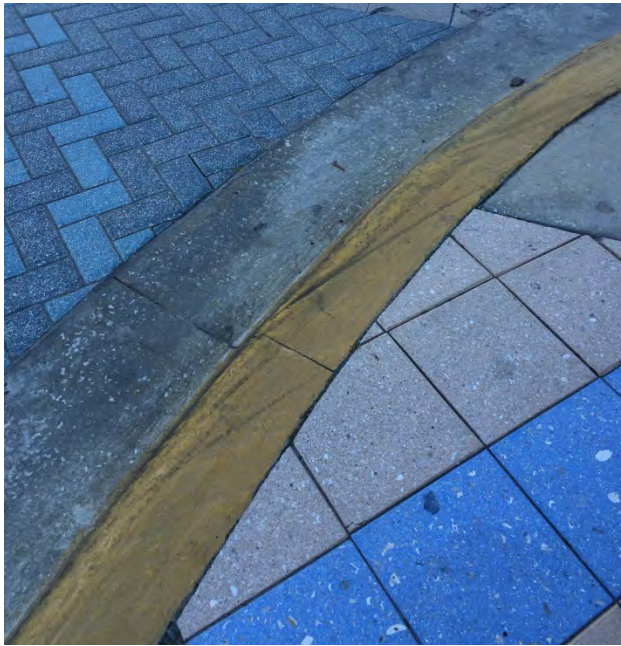
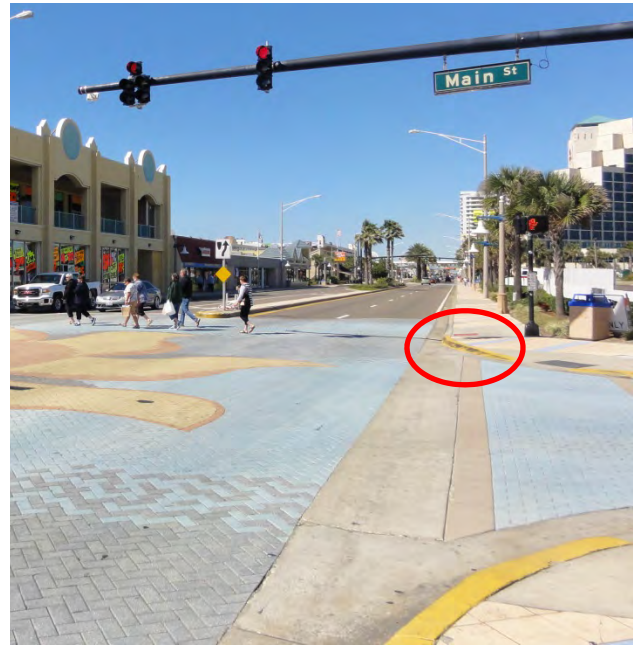
The south section is a four-lane divided section. Many drivers attempt U-turn maneuvers and the narrow ROW results in drivers tracking over the curb near pedestrians standing on the corner of the intersection. The safety review team observed tire marks on the edges of curbs where drivers had tracked over the curb. Examples are shown in **Figure 15** and **Figure 16**. The team also observed drivers completing three-point turns on SR A1A in order to successfully complete the U-turn maneuvers. U-turns are restricted during special events such as Bike Week and portable temporary signs are placed in the medians to indicate to drivers of the restriction.

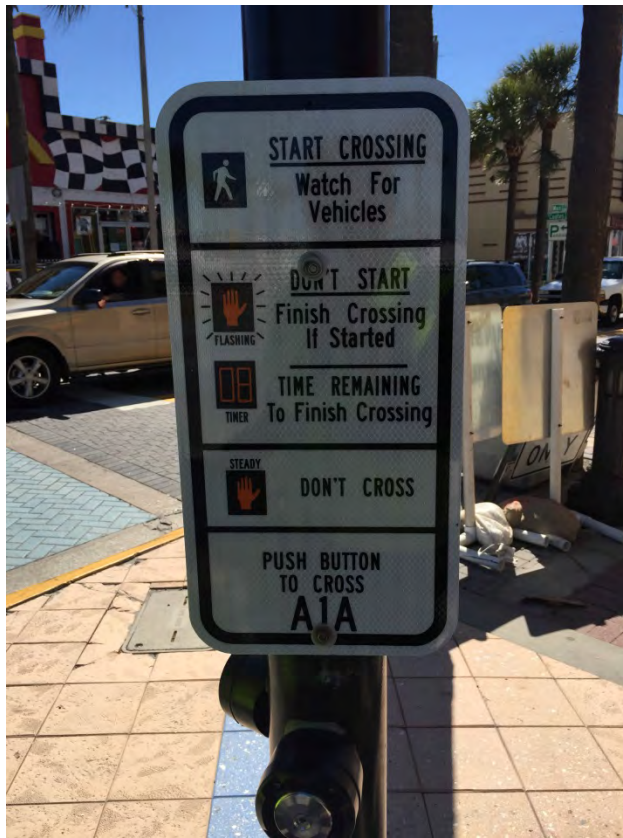
Figure 17

The study review team observed an inconsistency between the street names on push button signage and the existing street name signage. In some cases the push button signage directs pedestrians to cross SR A1A (**Figure 17**), but the existing street name signage present at the intersection states the local street name (Atlantic Avenue – shown in **Figure 18**). The high level of tourists unfamiliar with the state road designation may lead to confusion at the crossings.

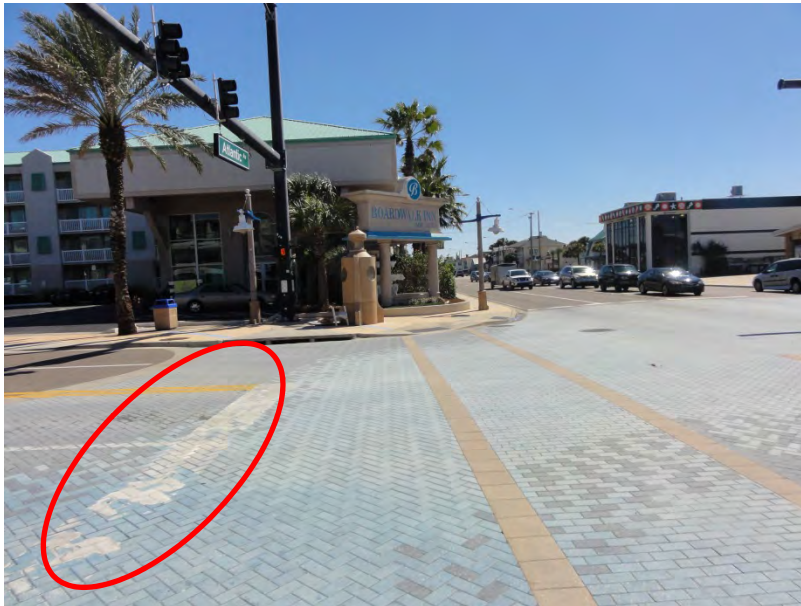
The stop bar on the westbound approach is worn (illustrated in **Figure 23**) and difficult for drivers to see. This may lead to additional conflicts between drivers and pedestrians or bicyclists in the crosswalk.

Consider restriping the westbound stop bar at the intersection.

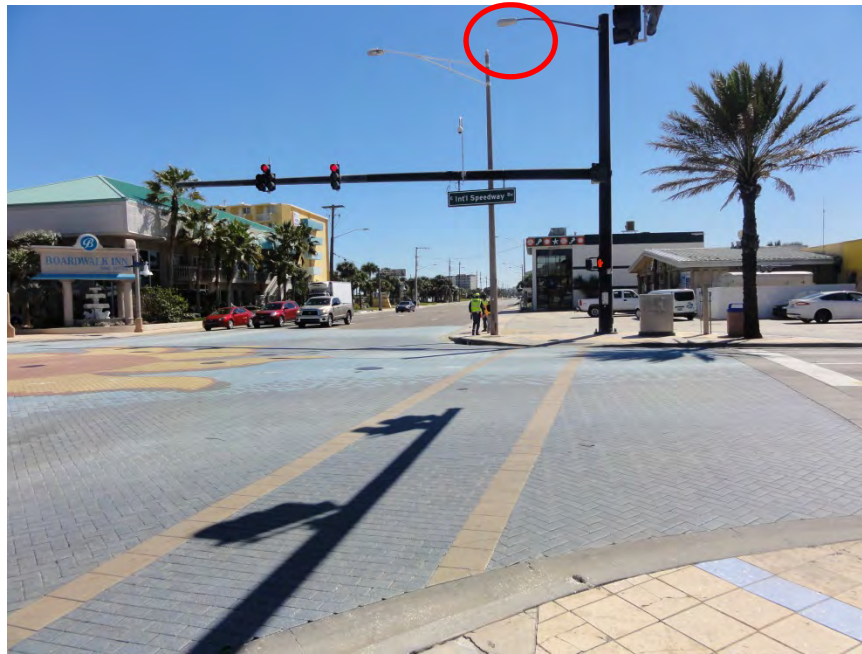
During the nighttime review the review team observed that the mast arm street light is out in the southwest corner of the intersection. The lighting fixture is depicted in **Figure 24**.

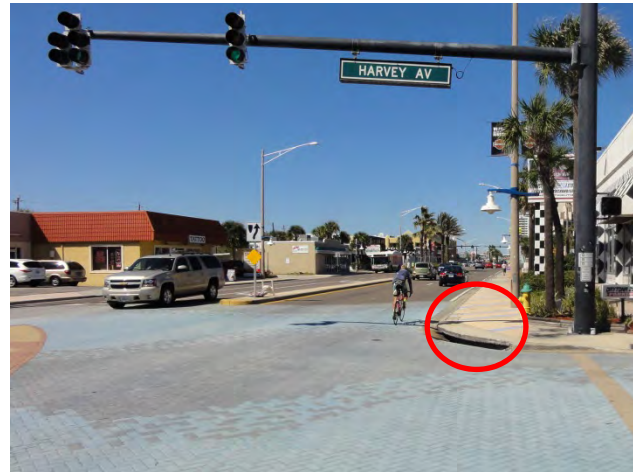
Figure 32

The northeast corner pedestrian ramp is offset from the SR A1A sidewalk alignment as illustrated in **Figure 31**. The sidewalk alignment (shown in **Figure 31** and **Figure 32**) drops into the drainage inlet on the northeast corner. One pedestrian was observed stepping off the curb into the inlet gutter and nearly fell. Local business owners indicated that people accidentally step off into the drainage inlet frequently. This poses a hazard for pedestrians to injure themselves or fall into the street.

Consider painting the curb return yellow on the northeast corner to make pedestrians aware of the hazard and direct them around the corner and to the curb ramp. Also consider reviewing this location based on FDOT Plans Preparation Manual (PPM) Figure 8.8.1 to see if a railing is needed along the curb return due to the drop off into the drainage inlet.

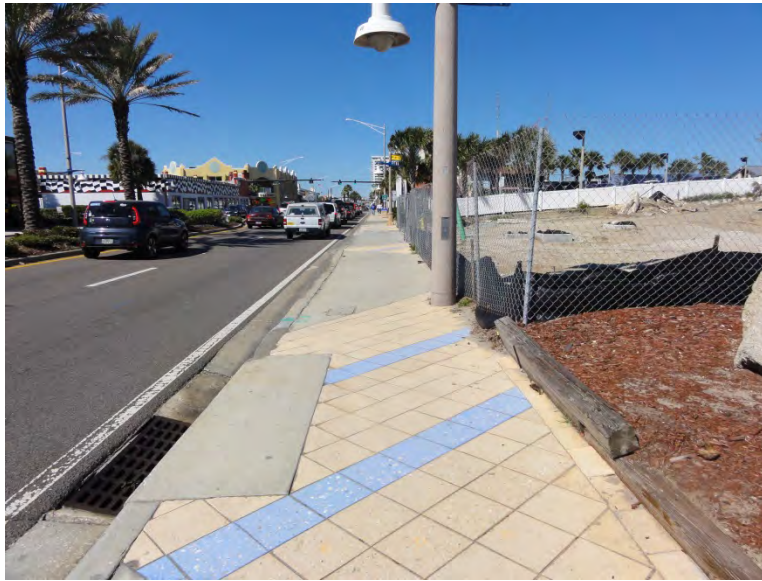
There are two locations along the east side of SR A1A with abandoned/unused driveway cuts as illustrated in **Figure 37**. At these locations, a level path (with a cross-slope less than two percent) is not provided.

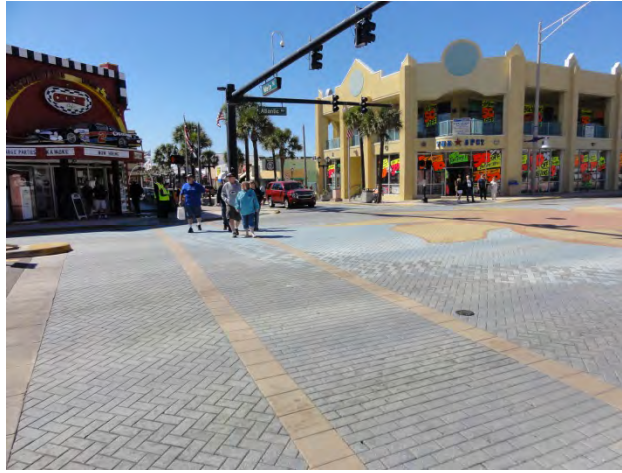
No intersection lighting is provided on the southwest corner as shown in **Figure 40**. Two pedestrian-related crashes occurred in the crosswalk at the southwest corner in nighttime conditions.

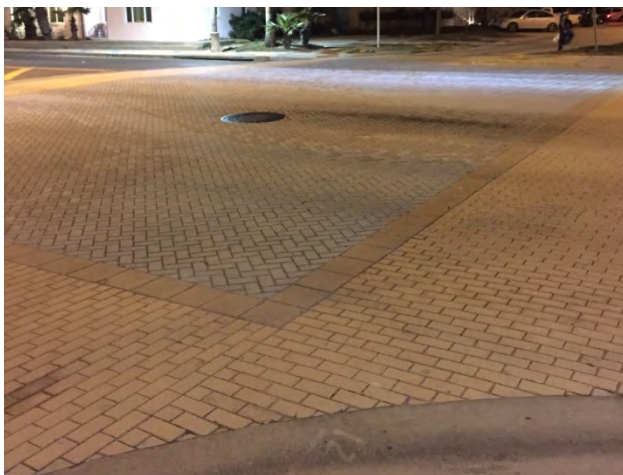
**Figure 46**

There are inconsistencies between the crosswalk markings at the two signalized intersections within the north section. The signalized intersection of Seabreeze Boulevard and the unsignalized intersections of Glenview Boulevard and Riverview Boulevard have the decorative paver patterns (**Figure 44** and **Figure 45**) described in **Issue #1**. As described earlier, the decorative pavers in the intersection make the marked crosswalks less distinguishable to drivers and do not provide retro-reflectivity at night (see **Figure 46**).

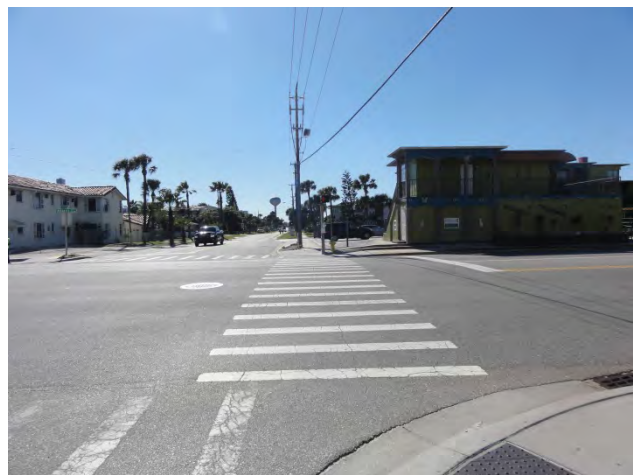
The City's streetscape project ends immediately north of Riverview Boulevard, so the decorative pavers are not included at the signalized intersection of University Boulevard. However, it was noted the marked crosswalks at University Boulevard are old special emphasis markings that are beginning to fade. This is illustrated in **Figure 47**.

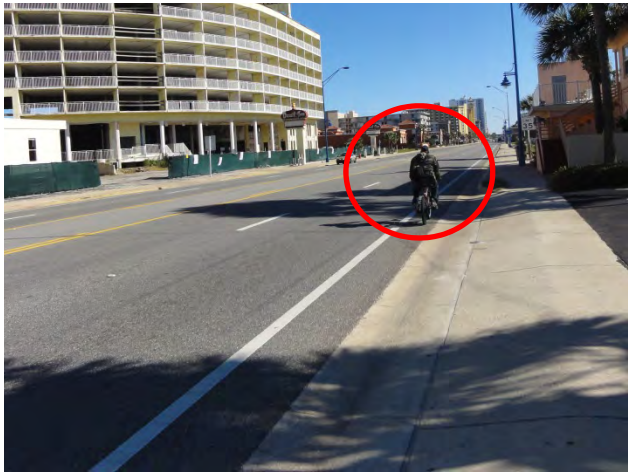
Similar to the south section, no bicycle facilities are provided within the study limits. No bicycle crashes were reported within the north section over the crash analysis period. The majority of bicyclists observed in this section were riding within the paved shoulder as shown in **Figure 48** and **Figure 49**.

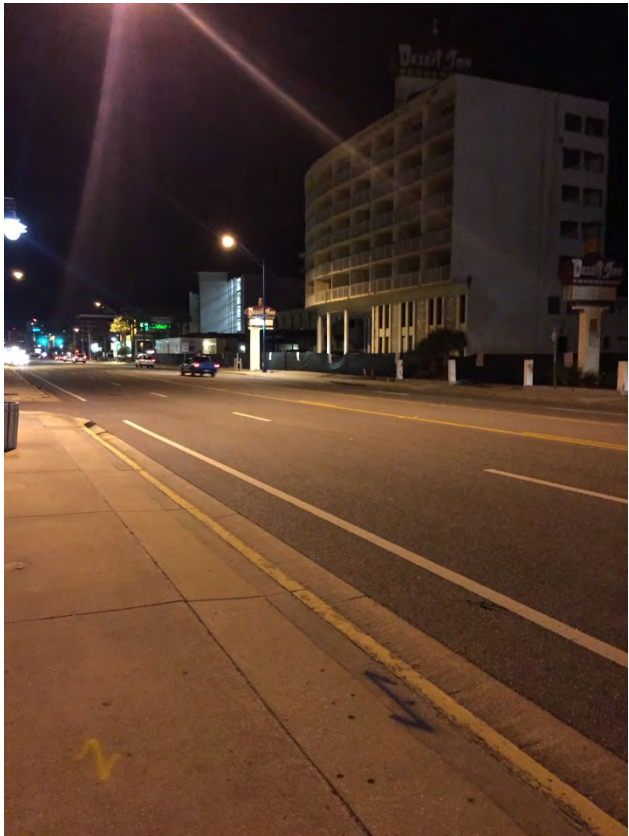
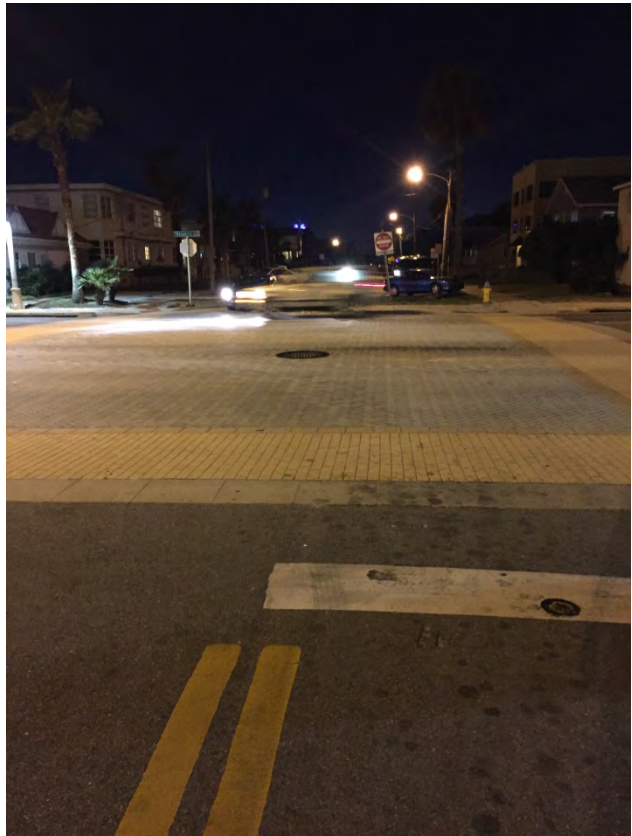
During the nighttime review of the corridors, the review team observed better lighting conditions along the south section due to street lighting, pedestrian-level lighting, and ambient lighting from businesses. There was a noticeable difference between the lighting conditions in the south and north sections. There are fewer businesses in the north section contributing ambient lighting. **Figure 50** and **Figure 51** illustrate the lighting conditions observed by the safety review team during the nighttime review. The field review team noted multiple street lights were burnt out along the corridor. Though pedestrian activity appears to increase along the SR A1A corridor at night, the poor lighting conditions may have contributed to the eight crashes (75% of the corridor's total) occurring at night.

- Replace the lights on the corridor that are burnt out.
- Consider conducting field measurements of existing lighting levels to evaluate lighting uniformity levels and add lighting where necessary. Consider light poles on the east side that are angled westerly away from the beach. These light poles cast their light to the west and illuminate the roadway as needed. The light bulb is not seen by the turtles due to the angle and orientation of the light fixture.

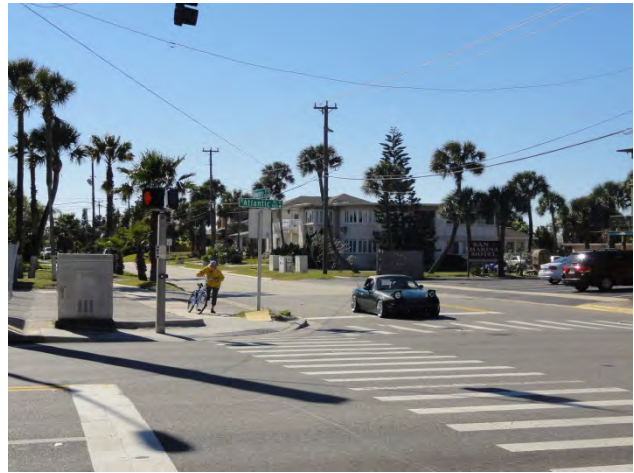
The study review team observed an inconsistency between the street names on push button signage and the existing street name signage along the north section. In some cases the push button signage directs pedestrians to cross SR A1A (**Figure 52**), but the existing street name signage present at the intersection states the local street name (Atlantic Avenue – shown in **Figure 53**). The high level of tourists unfamiliar with the state road designation may lead to confusion at the crossings.

Consider replacing pedestrian push button signage where necessary to be consistent with the street name signage at each of the signalized intersections along the corridor.

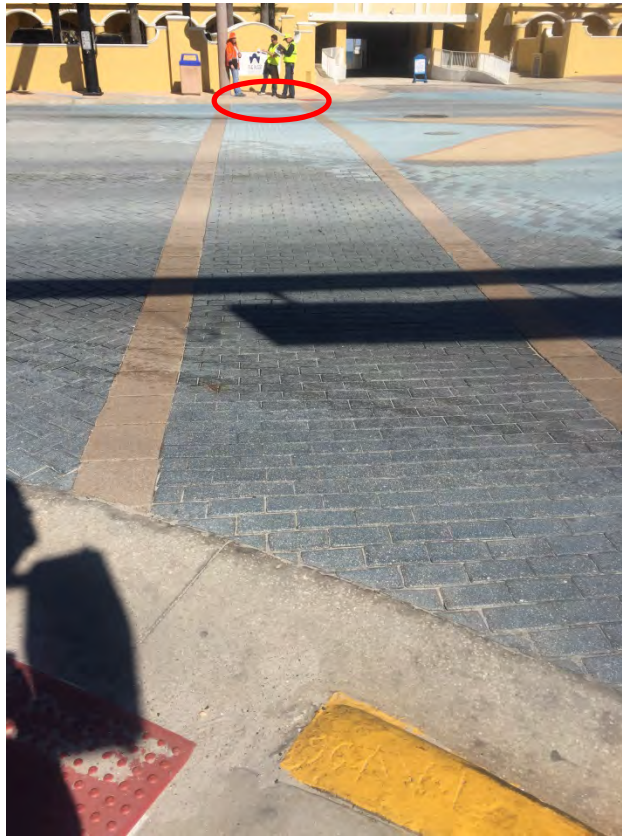
The north crosswalk doesn't tie into a curb ramp on the east side of SR A1A (shown in **Figure 54**).

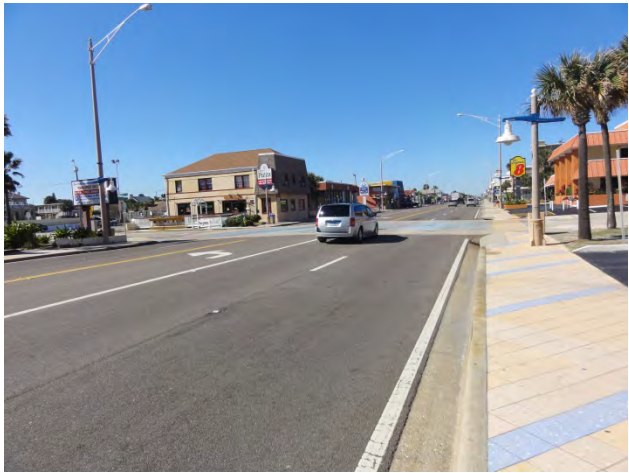
Figure 58

- No pedestrian crossing signage is provided on the uncontrolled intersection approaches as illustrated in **Figure 58**. Vehicular yield compliance was observed to be low in the field.
- There are trip hazards on the northwest and northeast corners. There is a broken curb in the northwest corner and a utility cover that is not flush with the curb ramp on the northeast corner (shown in **Figure 59** and **Figure 60**, respectively).
- Pedestrian-level lighting is present on each corner with the exception of the northeast corner and there is a street light on the southwest corner. During the nighttime review, the northeast corner appeared to be darker than the rest of the intersection. **Figure 61** illustrates the lighting at the northeast corner looking towards the southwest corner.

- Consider installing signage and striping pavement markings consistent with sheet 9 of Design Index 17346.
  - Install pedestrian Crossing signage (W11-2) with the supplemental diagonal downward pointing arrow plaque (W16-7P) for the northbound and southbound approaches of SR A1A.
  - Install Stop Here for Peds signage (R1-5bL)
  - Stripe a stop bar in advance of each crosswalk
- Repair the broken curb in the northwest corner and reconstruct the northeast curb ramp so that the utility box is flush and will not pose a trip hazard.
- Consider increasing the wattage for existing street lights at the intersection.
- Consider removing decorative pavers in the crosswalks and installing material that thermoplastic crosswalk markings will properly adhere to.

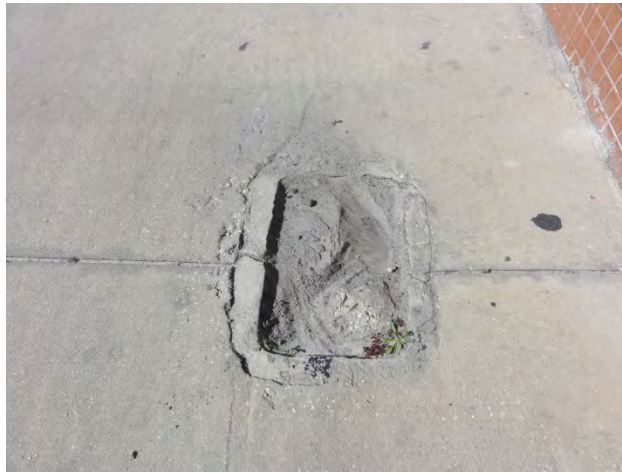
The safety review team noted a trip hazard on the eastern sidewalk in front of the La Quinta Inn (approximately 250 feet to the north of the Riverview Boulevard intersection). There is a utility box cover that has been depressed into the sidewalk and is collecting sand and debris. An example is shown in **Figure 64**.

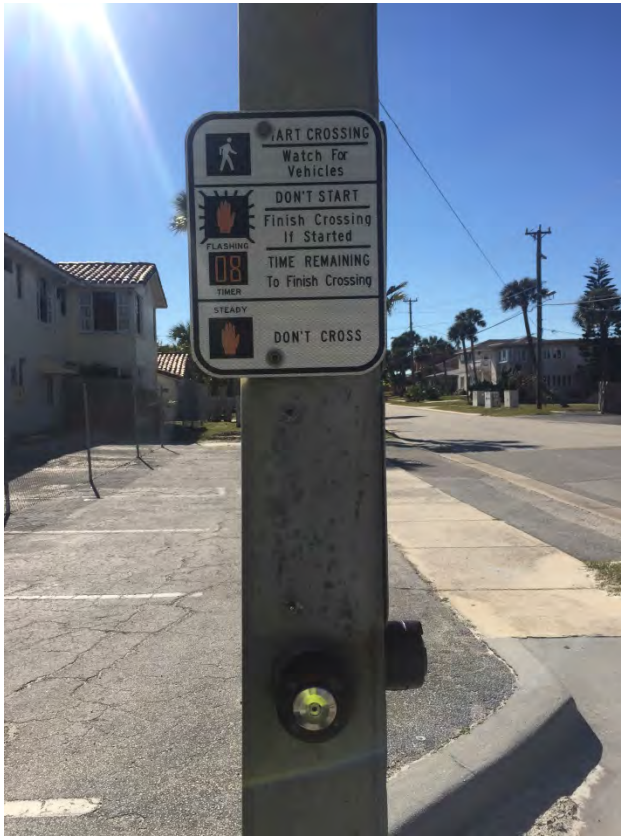
Figure 68

- The span wire pole in the southwest corner is missing a pedestrian push button sign indicating to push the button to cross Atlantic Avenue (shown in **Figure 68**).
- The push button and push button signage on the span wire pole located on the northwest corner is not on the same side of pole as depicted in **Figure 69**.
- Parts of the detectable warning surface on the southeast corner are missing (**Figure 70**).

In the short-term, consider replacing the missing push button sign on the pole in the southwest corner and moving the push button signage on the northwest corner to be on the same side as the push button. Also, consider replacing the detectable warning surfaces at the intersection, consistent with the newer surfaces along the corridor (as illustrated in **Issue #3: Detectable Warning Surfaces**).
