# SR/CR A1A PEDESTRIAN SAFETY & MOBILITY STUDY

## PEDESTRIAN / BICYCLE SAFETY REVIEW

Focus Area D / SR A1A from Plaza Boulevard to Rockefeller Drive (Daytona Beach/Ormond Beach)

October 2016

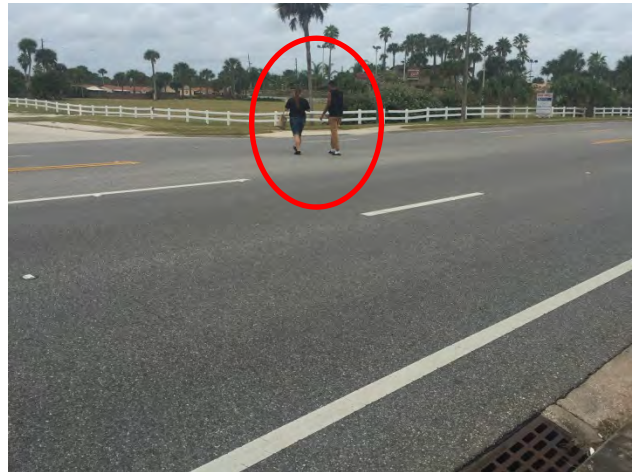
Figure 5

A 12-foot center two-way left-turn lane (TWLTL) is provided along SR A1A from Milsap Road to Rockefeller Drive (illustrated in **Figure 4**). The center TWLTL ends approximately 0.35 miles north of the study limits (Rockefeller Drive) and changes back to a four-lane divided cross section. The center TWLTL is an area of potential conflict between pedestrians/bicyclist and vehicles as pedestrians were observed using the center TWLTL as a refuge to cross SR A1A as shown in **Figure 5**. Conflicts arise when drivers utilize the center TWLTL while pedestrians or bicyclists are using it as a crossing refuge.

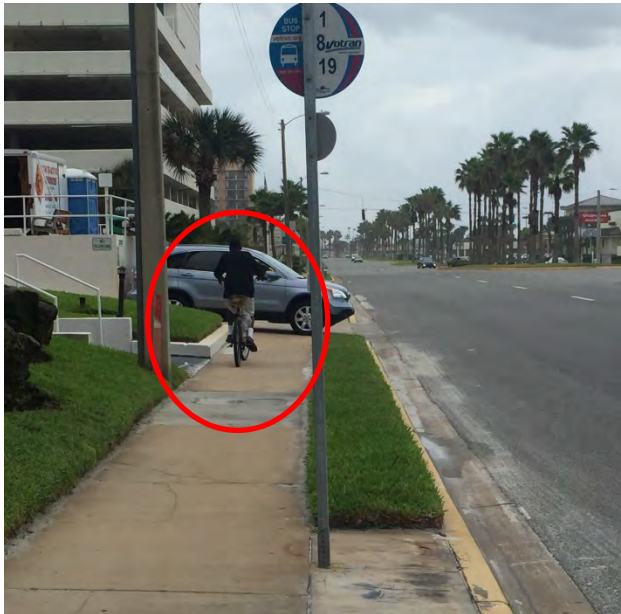
Figure 6

Half of the bicycle crashes involved bicyclists riding along the sidewalk and against the flow of traffic (example shown in **Figure 6** and **Figure 8**). In the field, some bicyclists were observed riding along the roadway, but most bicyclists were observed riding along the sidewalks. Examples of the observed bicycle activity are illustrated in **Figure 6** through **Figure 9**. As described in **Issue #1: Four-Lane Divided Section** and **Issue #2: Five-Lane Undivided Section**, marked bicycle lanes are not provided in either cross section. The bicycle crash history and observations from the field suggest that bicyclists prefer riding on the sidewalks rather than in the roadway alongside vehicles traveling around 35 mph.

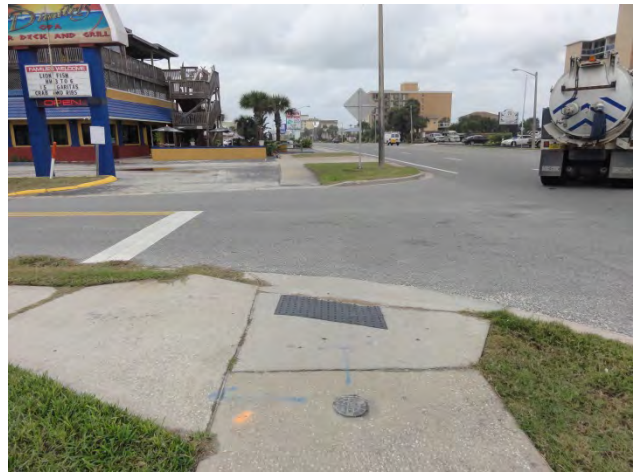
Figure 11

Marked crosswalks are not included along any of the minor street approaches at the unsignalized intersections throughout the corridor (see **Figure 10** and **Figure 11**). This was observed along both sides of the study corridor.

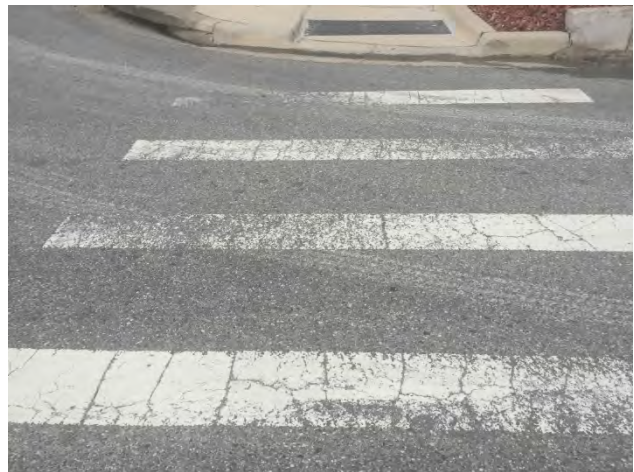
Figure 13

Crosswalk markings at the three signalized intersections are beginning to wear (illustrated in **Figure 12** and **Figure 13**).

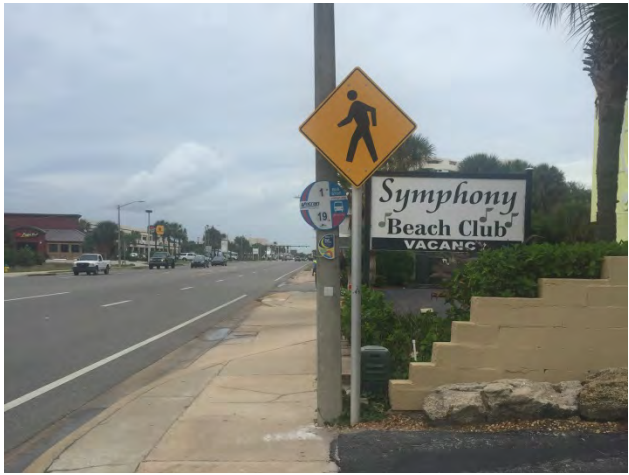
Figure 14

The study review team observed a lack of consistency between the pedestrian crossing signage in use along the study corridor. Pedestrian crossing signage with the standard yellow background (shown in **Figure 14**) was observed as well as signage with the fluorescent yellow-green background (illustrated in **Figure 15**). Section 2C.50 of the *Manual on Uniform Traffic Control Device (MUTCD)* provides guidance stating when a fluorescent yellow-green background is used, a systematic approach featuring one background color within a zone or area should be used. The mixing of standard yellow and fluorescent yellow-green backgrounds within a selected site area should be avoided.

Consider replacing the standard yellow background pedestrian warning signs with those having the fluorescent yellow-green background to provide consistent signage along the study limits. This will provide a consistent message to roadway users alerting them that pedestrians are crossing in the area. The following summarizes the locations and number of the standard yellow background pedestrian signage to be replaced:

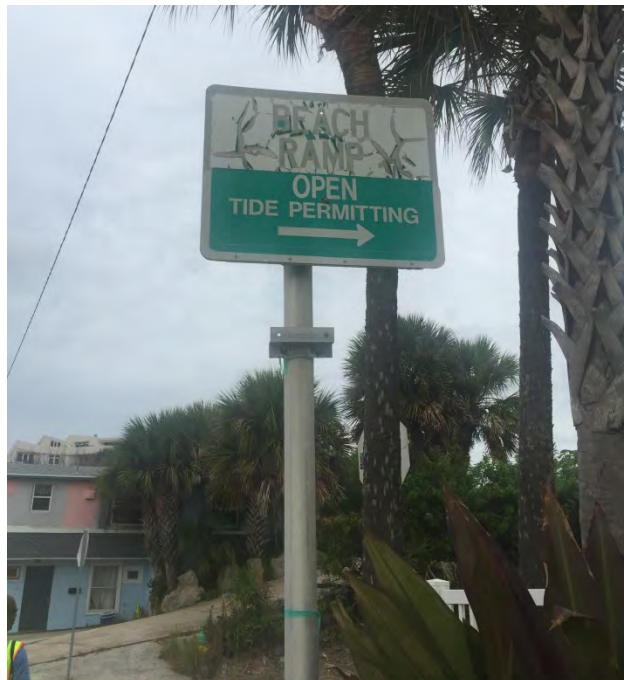
Figure 28

There is beach access signage along the corridor (example shown in **Figure 28**); however, the signage is often contradictory to the conditions. For example, the signage indicates that the beach ramp is open, but the beach access is gated off to vehicular traffic.

Consider installing new beach access signage for pedestrians/drivers as the existing signage is showing wear and does not display accurate information to the roadway users. Consider prioritizing the implementation of pedestrian facilities at strategic beach access locations. Emphasis on installing sidewalks at the beach locations with signalized or marked crosswalks across SR A1A could be considered. Locations with off beach parking nearby should also be emphasized as beach patrons will park their vehicles at an off beach parking lot before accessing the beach. Also consider pedestrian level lighting at the beach access locations.

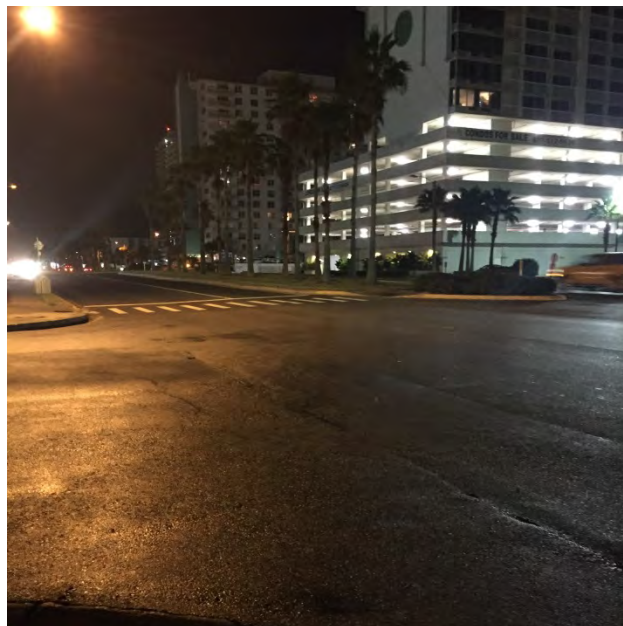
**Figure 39****Description of Issue:**

Shutting off lights or using the barrier shields negatively impact the lighting conditions for the roadway users. Reducing the light can make it difficult for drivers to see pedestrians or bicyclists at night,

especially those wearing dark clothing. **Figure 39** illustrates the lighting levels the safety team observed. The safety study team observed the roadway lighting conditions at night and had the following observations:

- Consider upgrading lighting at the signalized intersections to meet the requirements of section 7.3 in Volume 1 of the FDOT Plans Preparation Manual (PPM). This may require the existing lighting to be replaced.

- Replace or turn on all the lights on the corridor after the turtle nesting season ends.
- Consider conducting field measurements of existing lighting levels to evaluate lighting uniformity levels and add lighting where necessary. Consider light poles on the east side that are angled westerly away from the beach. These light poles cast their light to the west and illuminate the roadway as needed. The light bulb is not seen by the turtles due to the angle and orientation of the light fixture.

- As a long-term consideration, consider upgrading to an adaptive roadway lighting system along the corridor. Lighting levels could be programmed to be reduced during the sea turtle nesting season and increased to normal levels outside of the nesting season.

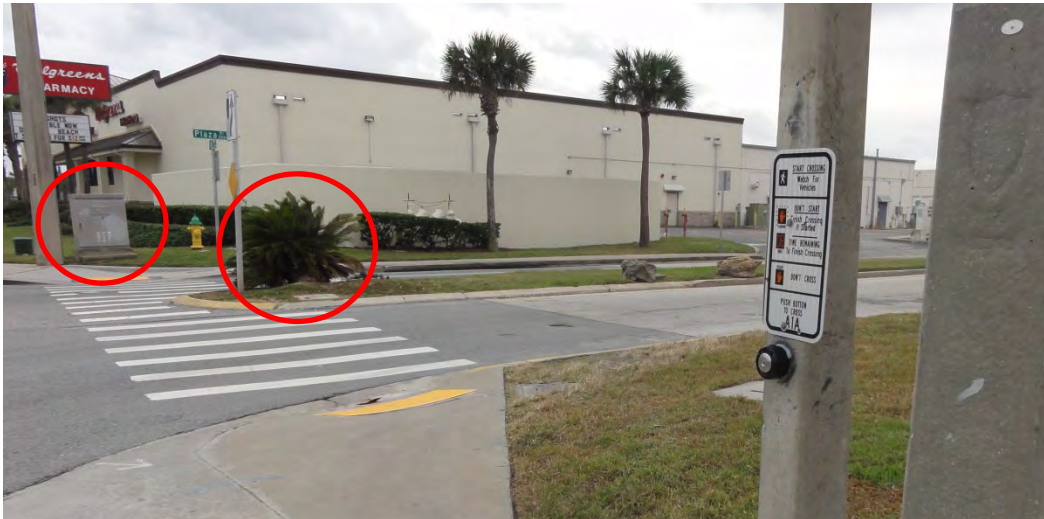
There is a bush in the median of the eastbound approach restricting sight distance looking northbound. In addition to the bush, there is a signal controller cabinet on the southwest corner restricting a driver's ability to see a pedestrian standing on the corner waiting to cross the south leg of the intersection.

Consider removing the bush to allow for adequate sight distance. Consider installing a Turning Vehicles Yield to Pedestrians sign (R10-15) on the span wire for the eastbound approach.

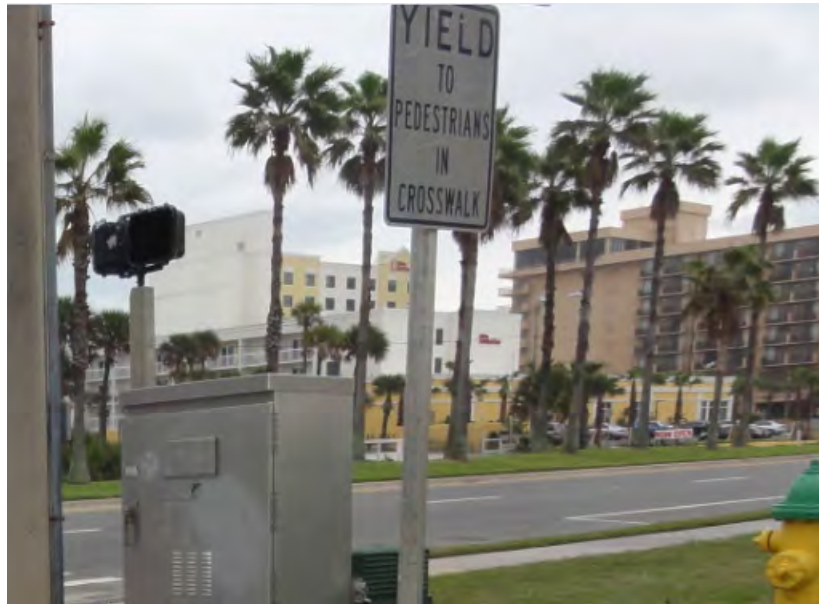
**Figure 40****Description of Issue:**

The existing Yield to Pedestrians in Crosswalk signage is cracking and has limited retro-reflectivity. The sign is shown in **Figure 40**.

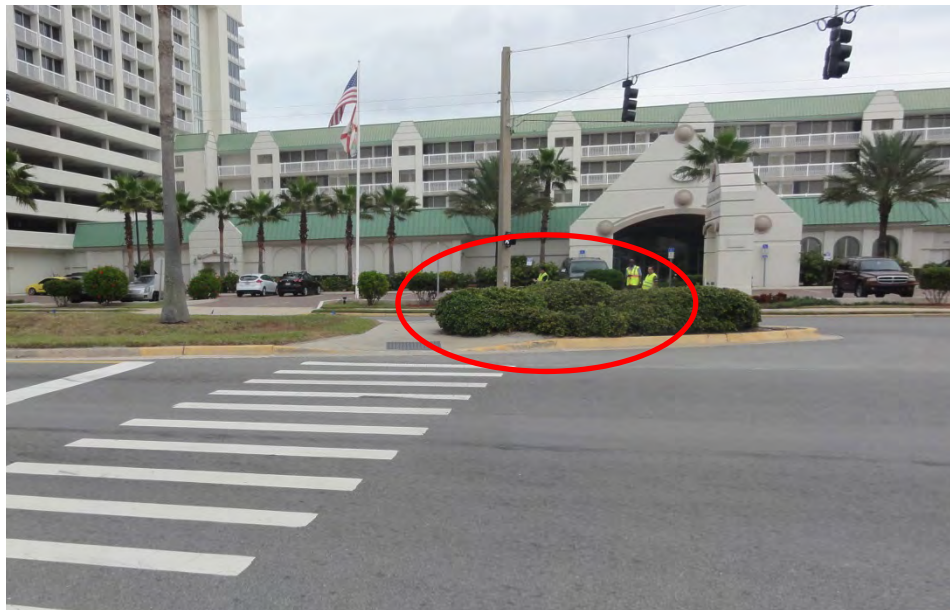
**Figure 41****Description of Issue:**

The landscaping in the center median of the southbound approach is encroaching into the pedestrian refuge island restricting the effective refuge width (illustrated in **Figure 41**).

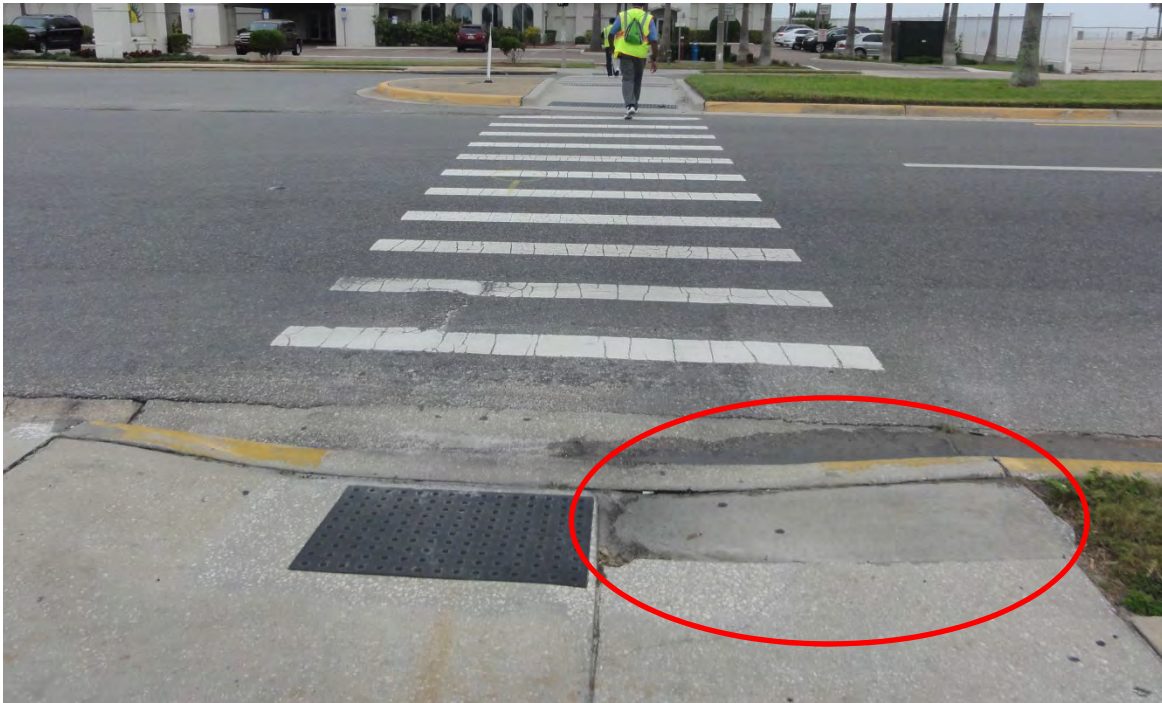
**Figure 42****Description of Issue:**

The curb ramp on the southwest corner of the intersection (shown in **Figure 42**) is uneven and could present difficulty for a wheelchair bound pedestrian to traverse and could also present a trip hazard. The depressed portion of the ramp is also missing a detectable warning surface.

Consider patching the curb ramp to remove the potential trip hazard by providing a level surface, and install a detectable warning surface.

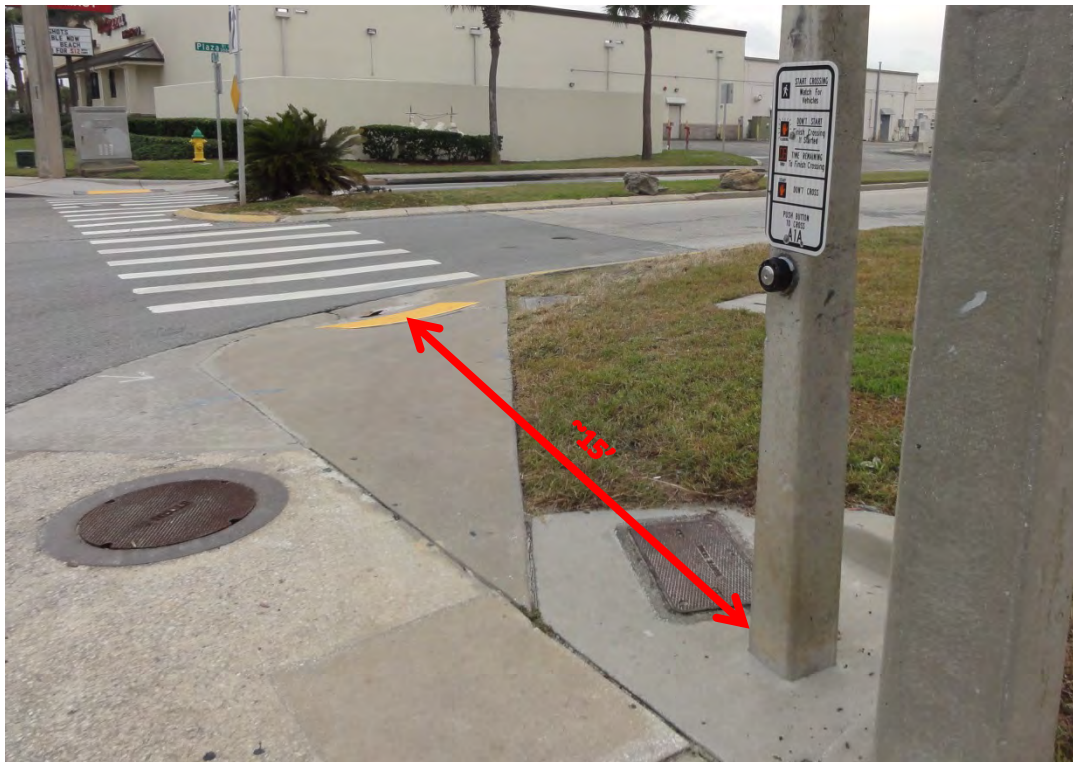
**Figure 43****Description of Issue:**

The pedestrian push button on the northwest corner of the intersection is greater than the 10' maximum distance to the curb ramp (**Figure 43**), as defined in section 4E.08 of the 2009 *MUTCD*.

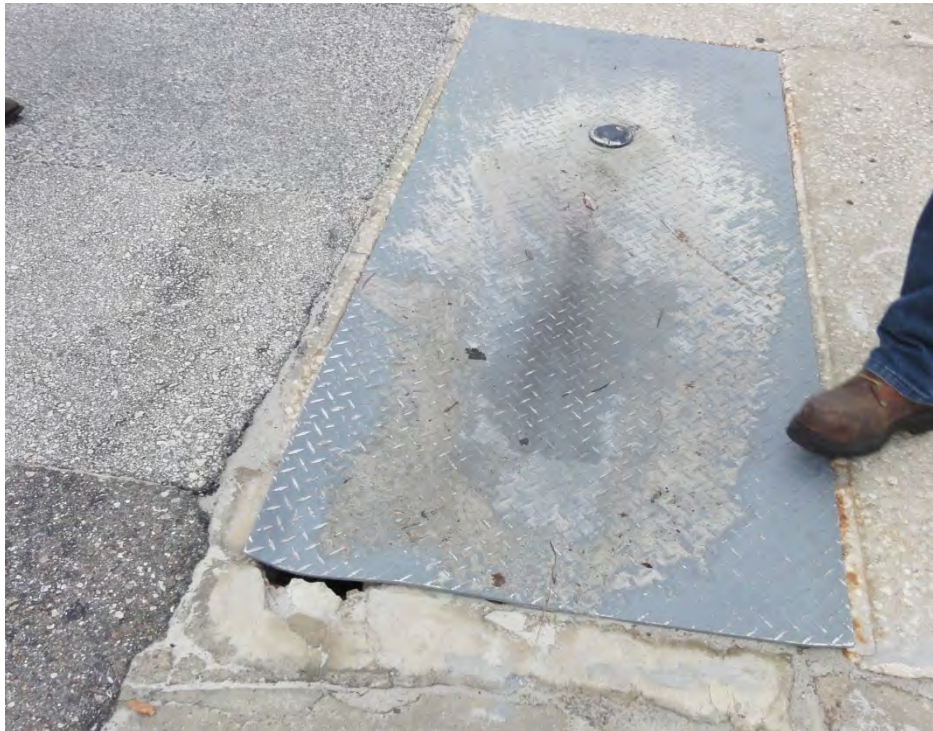
**Figure 44**

As shown in **Figure 44**, the safety review team encountered a water meter cover in the middle of the west side sidewalk. The metal cover is not flush with the sidewalk and could pose as a trip hazard.

Consider patching the concrete sidewalk and/or replacing the cover so that the two surfaces are flush.

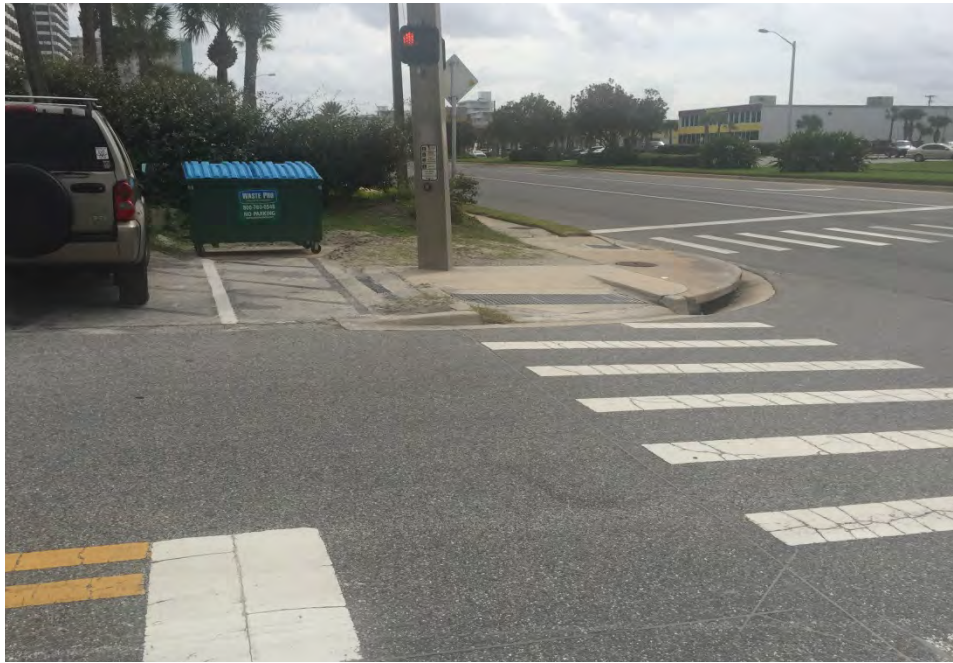
**Figure 45****Description of Issue:**

The existing landscaping and the signal strain pole on the southeast corner restrict the available sight distance for a vehicle attempting a westbound right-turn (**Figure 45**). Vehicles have to pull past the stop bar and into the crosswalk to see past the pole and landscaping.

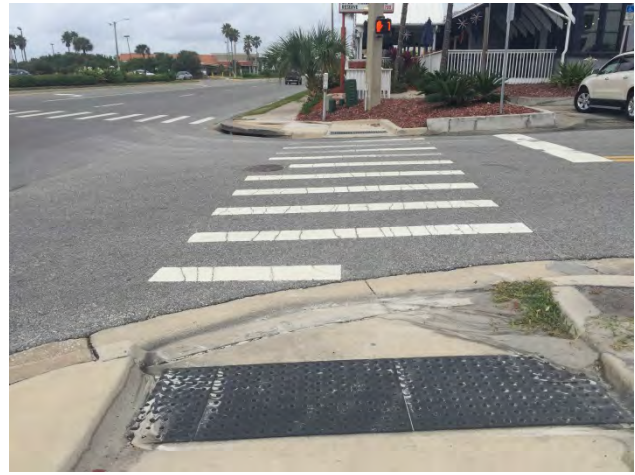
**Figure 47****Description of Issue:**

Sand and debris have built up on the detectable warning surfaces located on the northeast and southeast corners of the intersection (**Figure 46** and **Figure 47**, respectively).

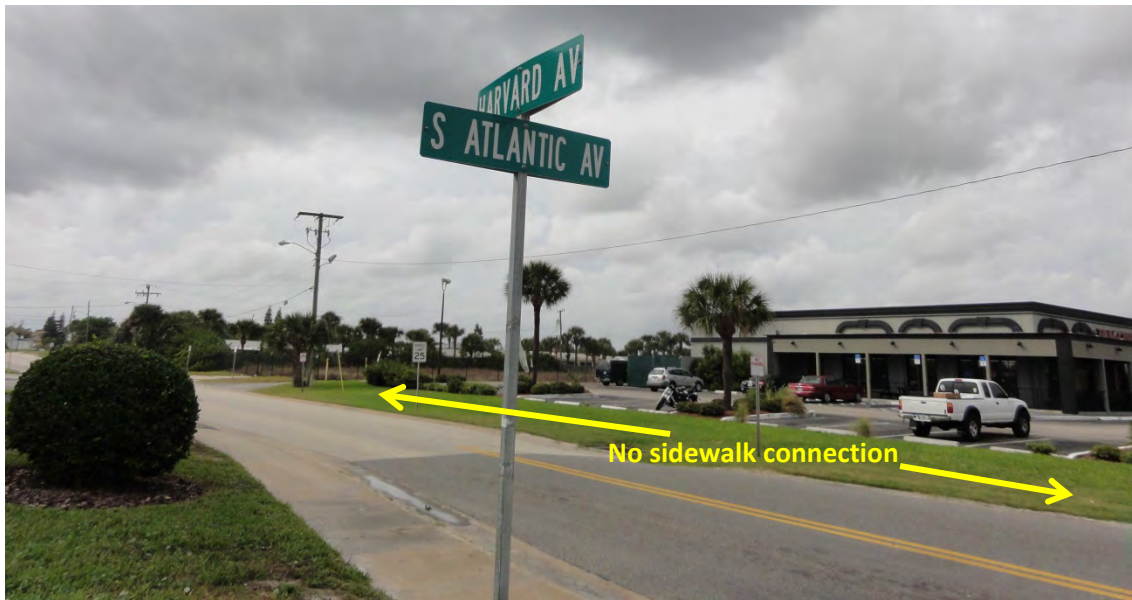
**Figure 48****Description of Issue:**

There are marked crosswalks to and from the northwest corner of the intersection. However, there is no sidewalk connection on the north side of Harvard Drive to connect to the existing curb ramp and western sidewalk (shown in **Figure 48**).

Harvard Drive Intersection	22	Sidewalk Connectivity	Consider constructing a sidewalk on the north side Harvard Drive to facilitate pedestrian connectivity to the sidewalks along SR A1A and the beach access on the east side of the intersection. This could be considered in addition to the basic ADA upgrades and APS implementation as part of the future intersection upgrade from strain wire to mast arms.
Harvard Drive to Cardinal Drive	23	Mid-Block Crossing at Andy Romano Beachfront Park	The following could be considered at this location to address the yield compliance and lighting issues observed: <ul style="list-style-type: none"> <li>• Consider installing an active warning device, such as Rapid Rectangular Flashing Beacons (RRFB), at the crosswalk. RRFBs may also be installed on the advance crosswalk warning signs per FHWA's interim approval memorandum.</li> <li>• Install lighting on the crosswalk's west side and in the refuge island.</li> </ul>

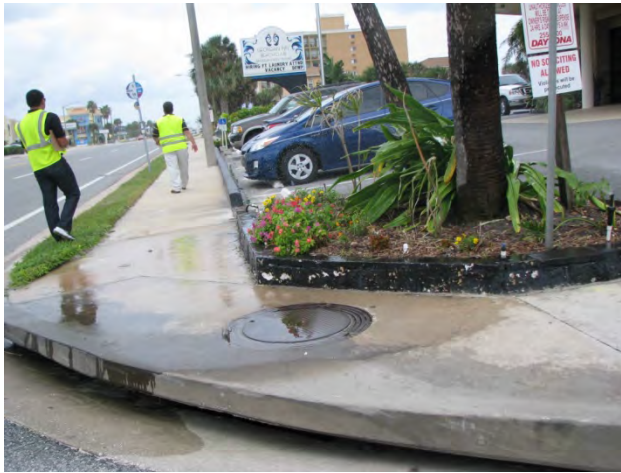
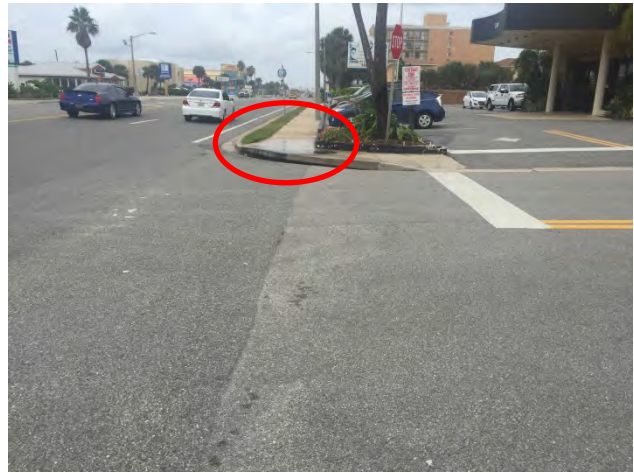
A sprinkler was observed watering the sidewalk on the northeast corner of the Milsap Road intersection as shown in **Figure 51** and **Figure 52**. Pedestrians or bicyclists have to walk on the landscape buffer strip to avoid slipping on the sidewalk.

Harvard Drive to Cardinal Drive	24	Sidewalk Hazard	Coordinate with the property owner to adjust the sprinkler head so that it is not directed at the sidewalk.
Benjamin Drive Intersection	25	Intersection Sight Distance	Consider trimming the landscaping back and consider conducting a sight distance evaluation to determine the available sight distance at the intersection.
Wren Road	26	Missing Stop Sign and Detectable Warning Surface	Consider installing a stop sign (R1-1) on the eastbound approach with appropriate street name signage. Consider replacing the detectable warning surface on the southwest corner of the intersection.
Cardinal Drive Intersection	28	Intersection Sight Distance	Consider trimming the landscaping back and consider conducting a sight distance evaluation to determine the available sight distance at the intersection. If adequate sight distance cannot be provided due to the strain pole, consider installing a No Turn on Red sign (R10-11 or R10-11a) to restrict right-turns on red. This could be effective until mast arms and signal upgrades are implemented at this location.

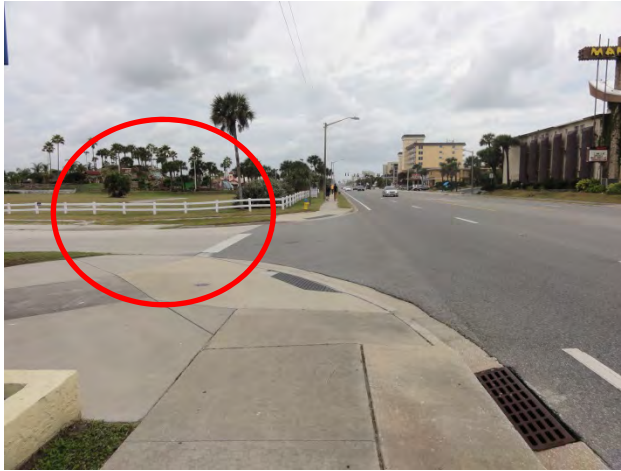
**Figure 54**

No stop sign or street name signage is provided along the eastbound approach at the intersection of Wren Road. This is illustrated in **Figure 54**. Part of the detectable warning surface on the southwest corner shown in **Figure 55** is missing.

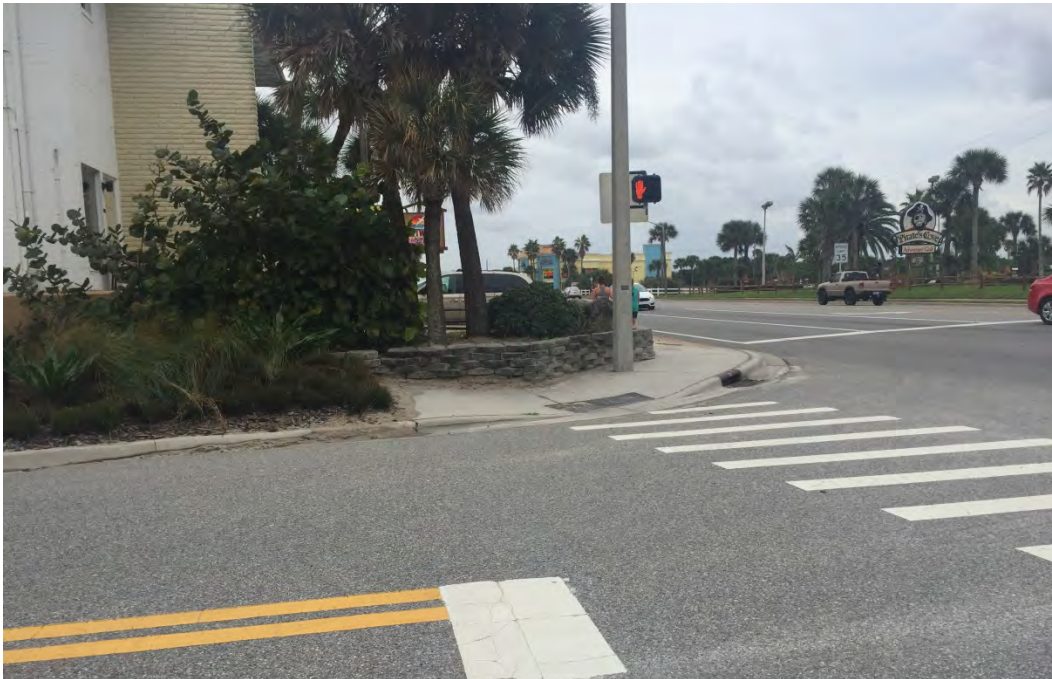
**Figure 60****Description of Issue:**

The existing landscaping and the signal strain pole on the southeast corner restrict the available sight distance for a vehicle attempting a westbound right-turn (**Figure 60**). Vehicles have to pull past the stop bar and into the crosswalk to see past the pole and landscaping.

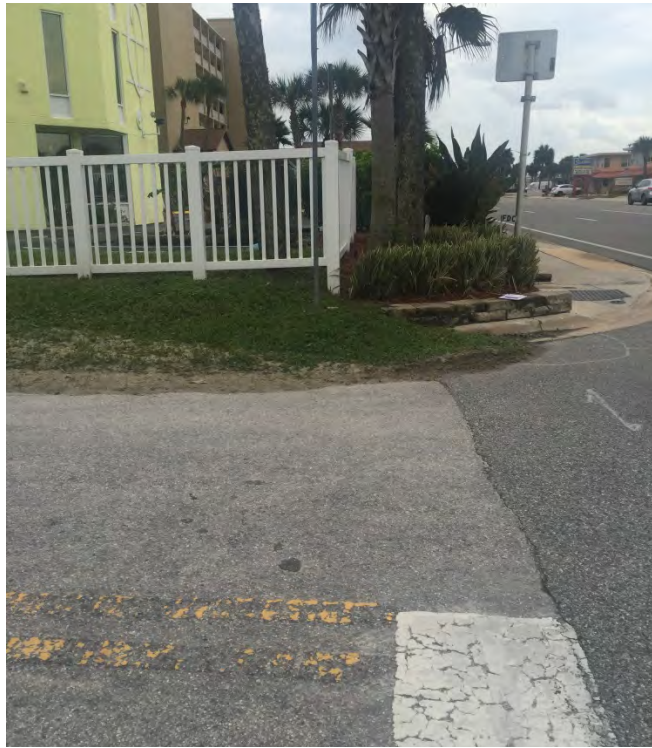
**Figure 66****Description of Issue:**

The existing hedges on the northwest corner restrict the available sight distance for eastbound vehicles and landscaping on the southeast corner (shown in **Figure 66**) restricts the available sight distance for westbound vehicles. Vehicles have to pull past the stop bar and into the effective crossing area used by pedestrians and bicyclists (no marked crosswalk present) to see past the landscaping.

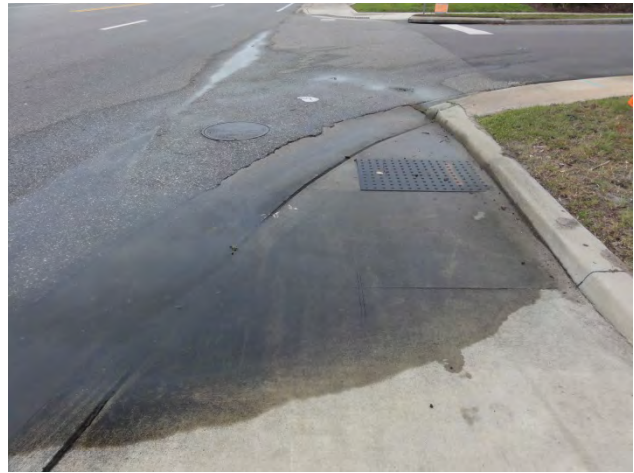
**Figure 68****Description of Issue:**

Water ponds onto the curb ramp and detectable warning surface on the north side of the eastbound River Beach Drive approach (northwest corner of the River Beach Drive intersection). This issue is displayed in **Figure 67** and **Figure 68**. This poses an issue to pedestrians, bicyclists, and vehicles as they cross the approach or make a southbound right-turn maneuver. There is a curb inlet around the corner, directly adjacent to the curb ramp; however, it appears that not all of the water is flowing to the inlet.

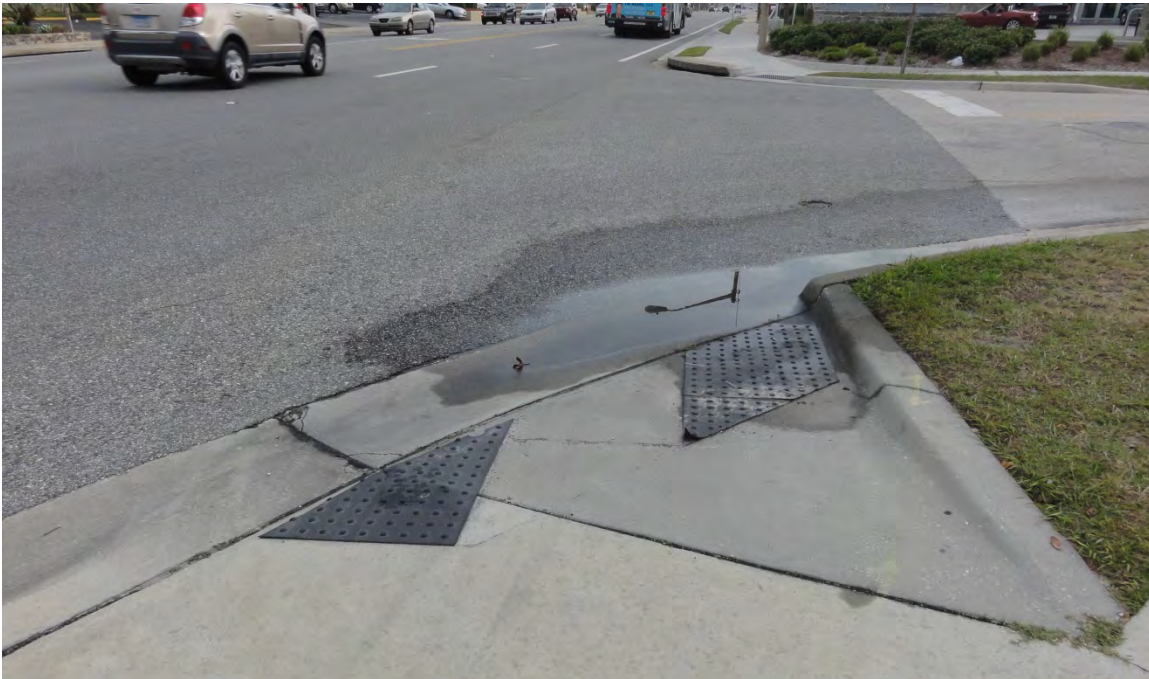
**Figure 75****Description of Issue:**

Part of the detectable warning surface on the northwest corner shown in **Figure 75** is missing.
