# SR/CR A1A PEDESTRIAN SAFETY & MOBILITY STUDY

## PEDESTRIAN / BICYCLE SAFETY REVIEW

Focus Area E / Sandcastle Drive to Holland Road (Ormond Beach/Ormond-by-the-Sea)

## **Pedestrian/Bicycle Safety Review Report for Focus Area E: SR A1A from Sandcastle Drive to Holland Road (Ormond Beach/Ormond-by-the-Sea)**

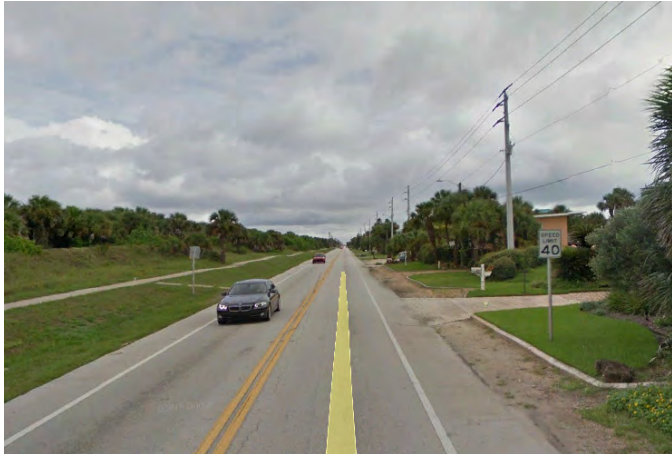
Figure 2

Posted speed limit within the study corridor is 40 MPH, but 35 MPH approximately one mile south near Neptune Avenue (see **Figure 2**). The land uses (retail, service, schools, and parking on the west and residential, hotel, and parks on the east) within the study corridor contribute to greater bicycle and pedestrian traffic as compared to the segments south of Neptune Avenue (residential on the east and limited uses on the west); however, the increased posted speed does not inform the motorist of this type of community character.

- Near Term
  - Reduce width of the roadway section for traffic calming benefits
    - For parcels with the ability to facilitate onsite circulation of parking maneuvers, consider working with the private property owner to install wheel stops or curbing to direct motorists to access SR A1A via defined driveway locations only.
    - Consider pedestrian refuge islands or spot medians where feasible.

- Long Term
  - Implement complete streets strategies such as curbing, bioswales, repurposing wide shoulder areas to improve parking areas with wide driveways, implement buffered bike lanes.

If these treatments are effective in reducing vehicle speeds, consider a speed study to assess if the posted speeds can be reduced to 35 MPH and speed feedback devices can be used to increase driver awareness of their travel speed.

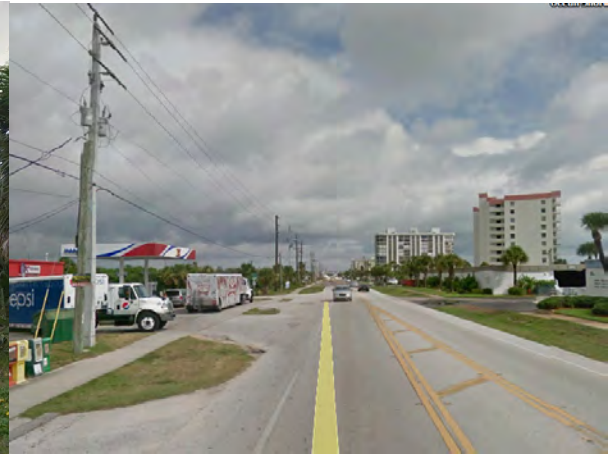
Figure 3

In addition to the higher posted speed limits, the corridor widens from a two-lane cross section to a three-lane cross section (see **Figure 3**). The additional roadway pavement and the wider right-of-way to accommodate it contribute to higher motorist speeds.

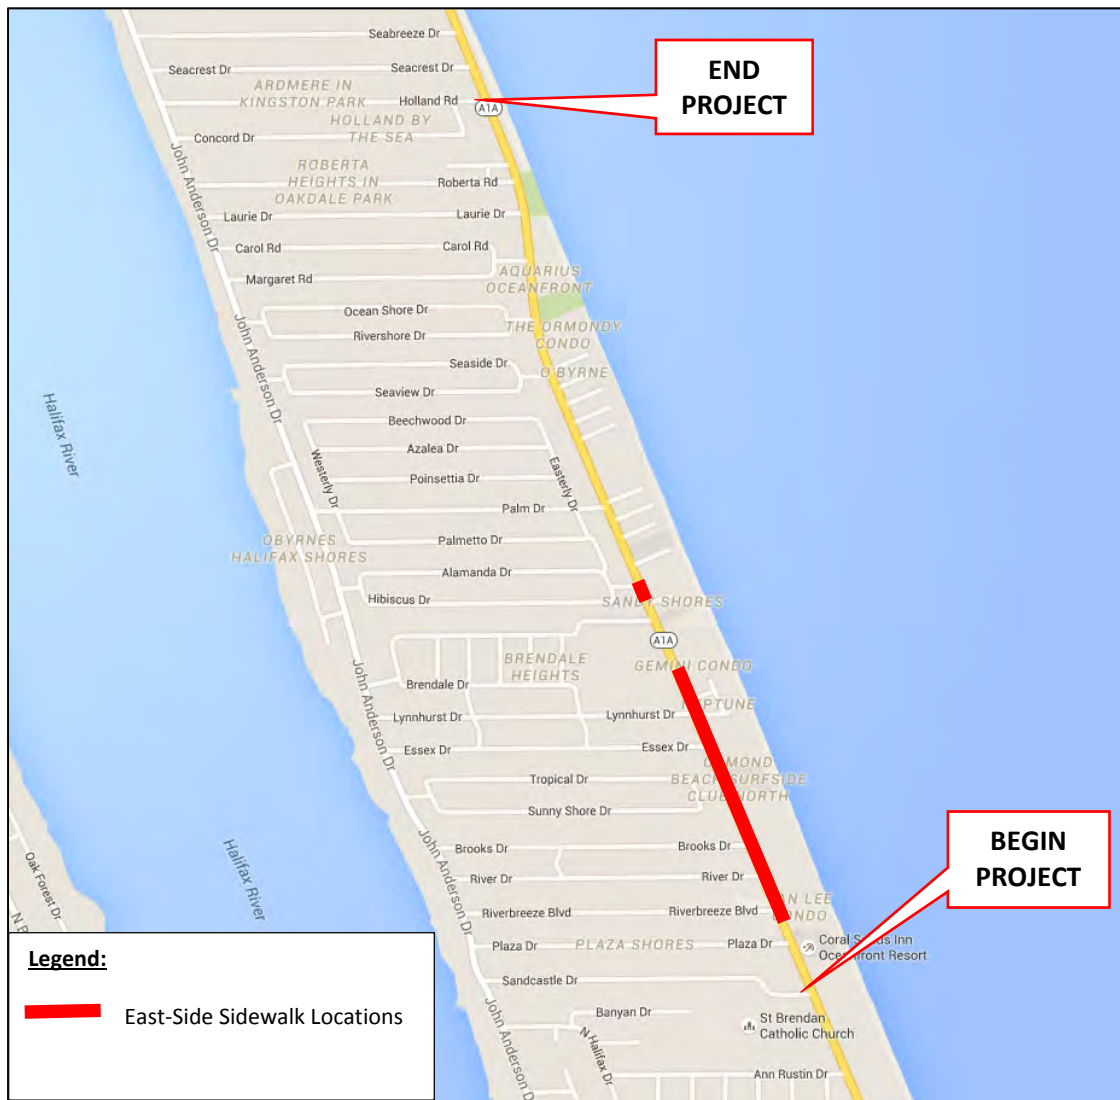
Figure 4

Sidewalks are present along the entire length of the corridor on the west side. Sidewalks are only present on the east side of SR A1A in the areas noted in **Figure 4**.

**Near Term:** Consider providing sidewalk, as properties redevelop, on the east side of SR A1A to fill in the gaps.

**Long Term:** Consider providing sidewalk on the east side of SR A1A to fill in the gaps as part of a complete streets project or other construction effort.

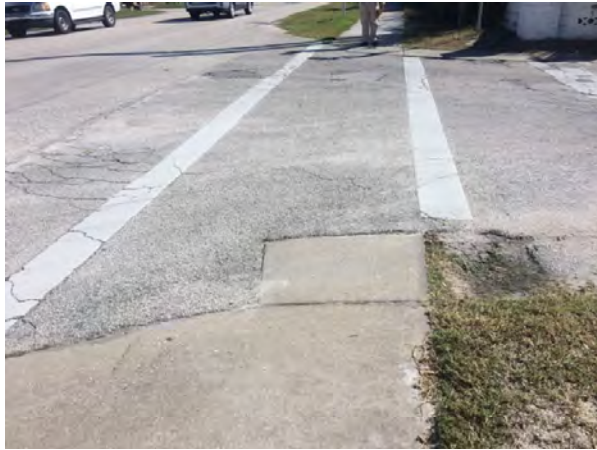
**Figure 5**

Along the corridor, the study team observed the detectable warning surfaces to be missing, covered, or in disrepair at multiple crosswalks at minor street intersections as illustrated in **Figure 5**. At some of the mid-block crossings, the study team noted no paved landing areas as illustrated in **Figure 6**.

Consider installing detectable warning surfaces where missing at signalized/unsignalized intersections and crosswalks per the FDOT Design Standard Index 304. Consider constructing a landing pad with detectable warning surfaces at the mid-block locations where no landing pad is present.

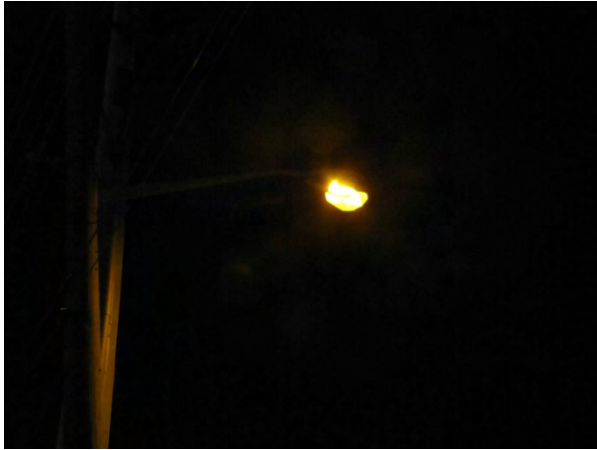
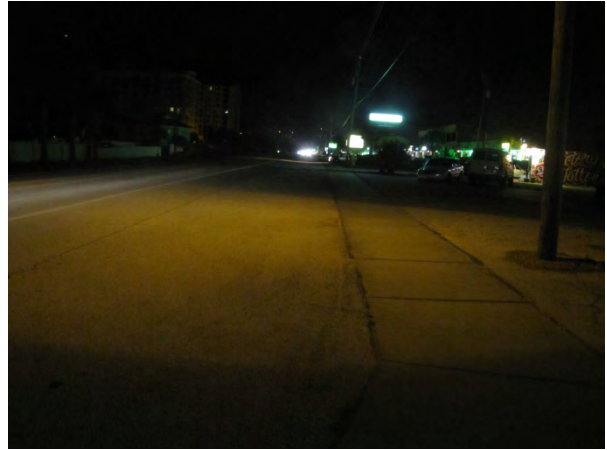
The study team observed poor roadway lighting in areas along the corridor. Some of the street lighting was fitted with amber lenses and/or shields which limit ambient light within the roadway and pedestrian environment. The study team also observed lighting on poles along the west side of SR A1A.

Shutting off lights or using the barrier shields negatively impact the lighting conditions for the roadway users. Reducing the light can make it difficult for drivers to see pedestrians or bicyclists at night, especially those wearing dark clothing. **Figure 8** illustrates the lighting levels the safety team observed. The safety study team observed the roadway lighting conditions at night and had the following observations:

- Inconsistent lighting levels along the corridor
- Some of the street lights were either off or not working properly
- Shields cause street light to only illuminate half of the roadway.
- Intersection and ambient lighting helped illuminate the roadway at some locations

- Consider upgrading lighting at the signalized intersections to meet the requirements of section 7.3.2.2 in Volume 1 of the FDOT Plans Preparation Manual (PPM). This may require the existing lighting to be replaced.
- Consider conducting field measurements of existing lighting levels to evaluate lighting

uniformity levels and add lighting where necessary. Consider light poles on the east side that are angled westerly away from the beach. These light poles cast their light to the west and illuminate the roadway as needed. The light bulb is not seen by the turtles due to the angle and orientation of the light fixture.

- Consider implementing a lighting plan for the time the sea turtle nesting season is not active as roadway lighting levels should not be reduced at this time.
- Consider conducting a lighting justification study along unlit portions of the corridor to determine if additional lighting is justified.
- Consider implementation of pedestrian-level lighting, with less visibility from the beach, to supplement areas where street lighting is not able to provide adequate illumination.
- As a long-term consideration, upgrade to an adaptive roadway lighting system along the corridor. Lighting levels could be programmed to be reduced during the sea turtle nesting season and increased to normal levels outside of the nesting season. This could be coupled with replacing the current high pressure sodium lighting with LED lighting.

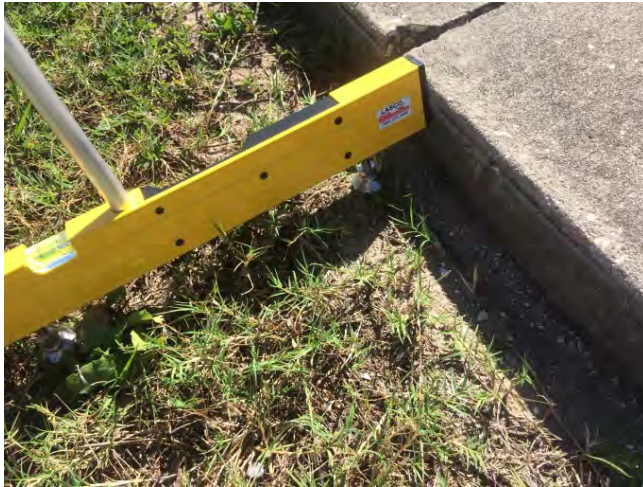
**Figure 9**

Numerous drop-off hazards were observed adjacent to sidewalks presenting tripping hazards to pedestrians and overturning hazards to wheelchair users.

Consider filling areas with soil adjacent to sidewalks to remove drop-off hazard. At locations where drainage inlets are present as displayed in **Figure 10**, consider constructing sloped concrete off the edge of the sidewalk, meeting ADA guidance, to reduce the risk of a maintenance problem with loose soil entering the drainage inlet.

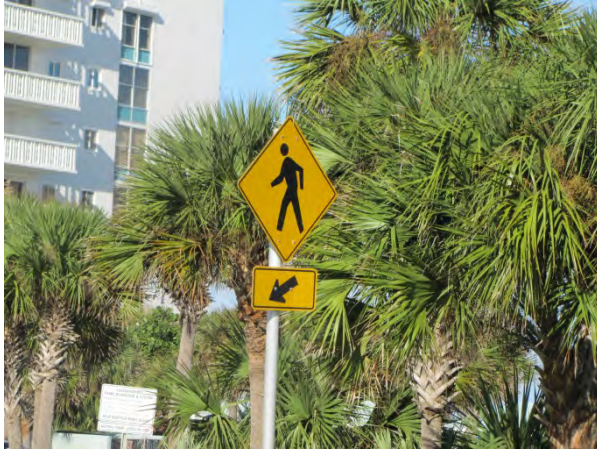
**Figure 11**

Pedestrian crosswalk signage material is not consistent throughout the corridor. Some signs have the yellow-orange coloration illustrated within **Figure 11**. Other crosswalk signage uses the newer high-visibility yellow-green coloration illustrated within **Figure 12**. The retro-reflectivity levels of the two types of sign coatings described above is very different, which could contribute to greater compliance at the crosswalks with higher retro-reflectivity levels at night and less compliance at the crosswalks with lower retro-reflectivity levels.

During next signage update or resurfacing project, consider replacing all crosswalk signage with signs using high-visibility, high retro-reflectivity coatings (Type 11 sheeting).

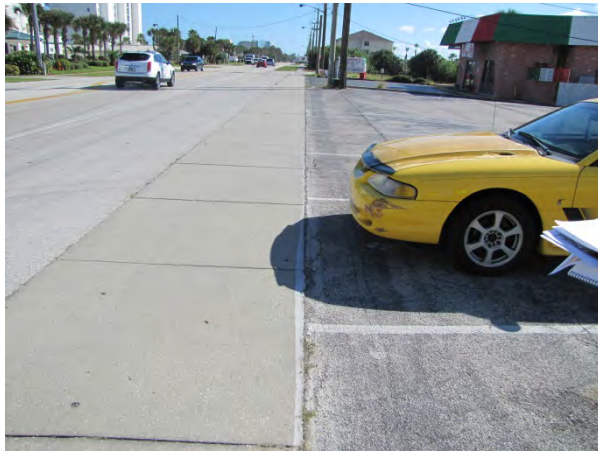
Figure 13

As illustrated in **Figure 13** and **Figure 14**, multiple parking areas to commercial properties do not have defined driveways and allow access to their parking spaces for the entire width of the parcel. This issue introduces numerous unexpected conflict points for bicyclists and pedestrians to negotiate. Some sites do not have sufficient set-backs to allow for onsite circulation for parking maneuvers. The study team identified multiple locations where parked vehicles in these areas encroached onto sidewalk facilities as illustrated in **Figure 15**.

For parcels with the ability to facilitate onsite circulation of parking maneuvers, consider working with the private property owner to install wheel stops or curbing to direct motorists to access SR A1A via defined driveway locations only.

For parcels without the ability to facilitate onsite circulation of parking maneuvers, consider relocating parking to areas with better parking access and circulation.

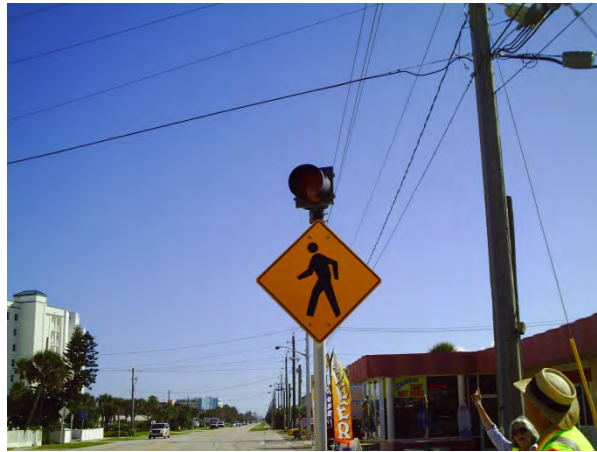
**Figure 16**

Flashing beacon at Brooks Drive facing north is not functional and is located approximately 150 feet upstream (see **Figure 17**) of its crosswalk on SR A1A leading to motorist's confusion about where to expect pedestrian crossings.

Repair flashing beacon and consider relocating the sign as a maintenance improvement.

If the sign cannot be relocated, the following near-term improvements could be considered at this location:

- Consider an active warning device, such as Rapid Rectangular Flashing Beacons (RRFB), at the crosswalk. RRFBs may also be used on the advance crosswalk signs per FHWA's interim approval memorandum.
- Provide a median refuge island with a minimum length of 90 feet and minimum four-foot wide pedestrian access route for pedestrians in the TWLTL.
- Install lighting on each side of the crosswalk.
  - Directional lighting oriented towards the crosswalk could be provided; or
  - LED lighting could turn on when the RRFB is activated and flashing and could turn off when the flashers stop.
- Restripe the crosswalk with Special Emphasis Crosswalk markings consistent with sheet 10 of the FDOT Design Index 17346.

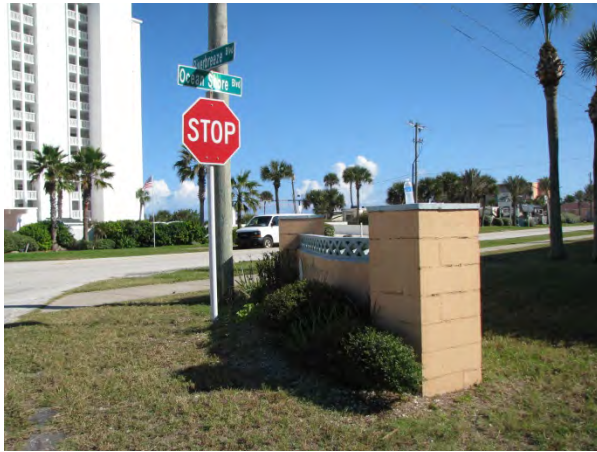
**Figure 18**

Decorative walls block motorist's view of pedestrians and bicyclists at Riverbreeze Boulevard and Plaza Drive. Traditional sight triangles used at intersections are typically measured from the vehicle path of the intersecting roadway.

Consider working with the property owners to relocate or remove the decorative walls to improve intersection sight distance between eastbound vehicles and pedestrians/bicyclists on the sidewalk.

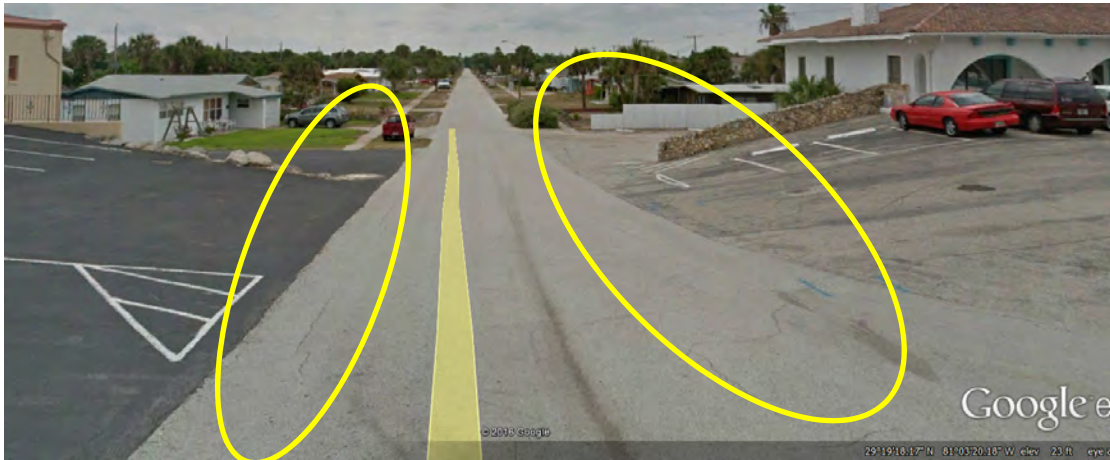
**Figure 20**

Sidewalks are provided on both sides of Essex Drive, but do not connect to the sidewalks along SR A1A.

Consider installing sidewalks or designating a clear pedestrian access route (PAR) compliant with the PROWAG.

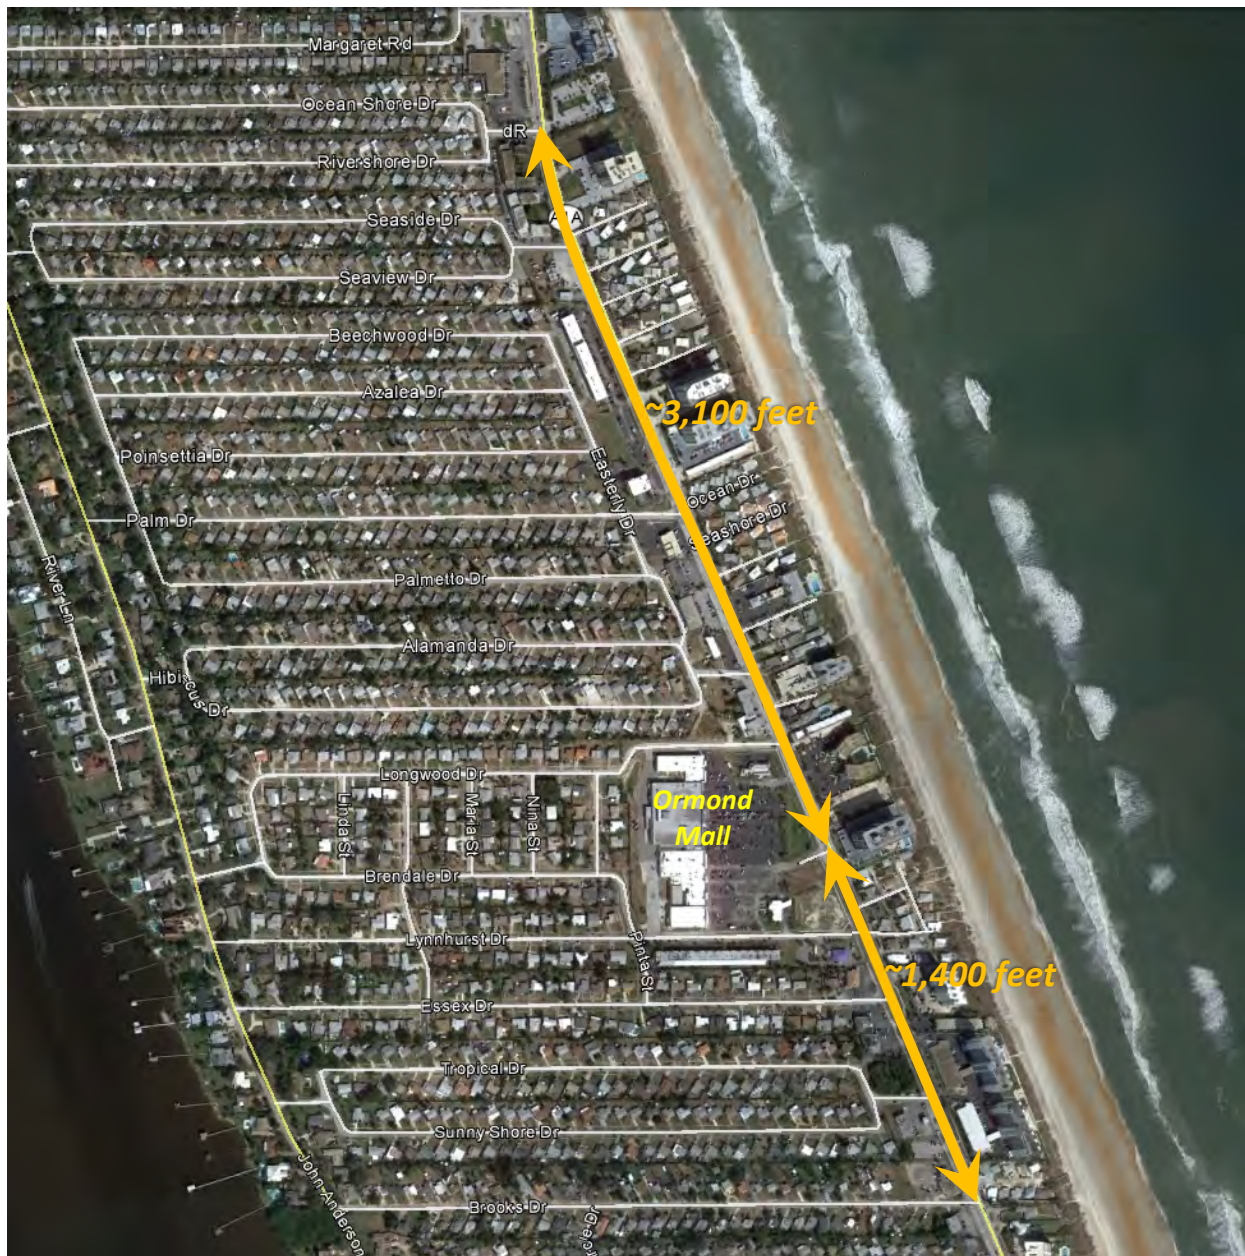
**Figure 21****Description of Issue:**

There are no marked mid-block crosswalks between Brooks Drive and the Ormond Mall signal; a distance of approximately 1,400 feet as depicted in Figure 21. Continuing further north, the next marked crosswalk to the north of Ormond Mall traffic signal is located approximately 3,100 feet north. Without the provision of marked crosswalks at regular intervals, pedestrians cross SR A1A wherever it is convenient or desirable and they tend to utilize the center TWLTL.

As illustrated in **Figure 22**, consider providing the following on the north side of the Essex Drive intersection, between Hibiscus Drive and Sandy Beach Drive, and the north side of the Palm Drive intersection:

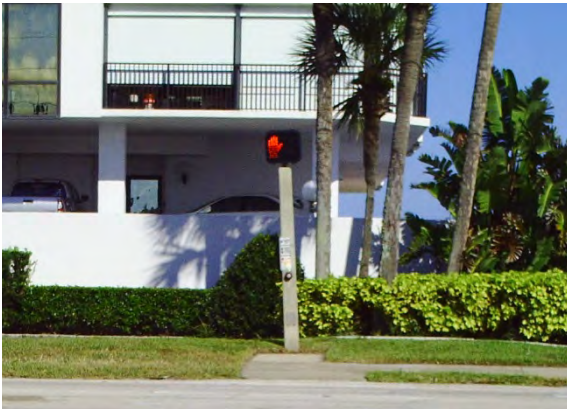
**Figure 23**

The field review observed the countdown pedestrian signals on the southeast (**Figure 23**) and northwest (**Figure 24**) corner of the intersection are not functioning properly. The walk indication is properly illuminated; however, the countdown numbers did not illuminate when crossing eastbound on the south leg.

Dispatch a signal technician to review if all pedestrian countdown signals are working properly.

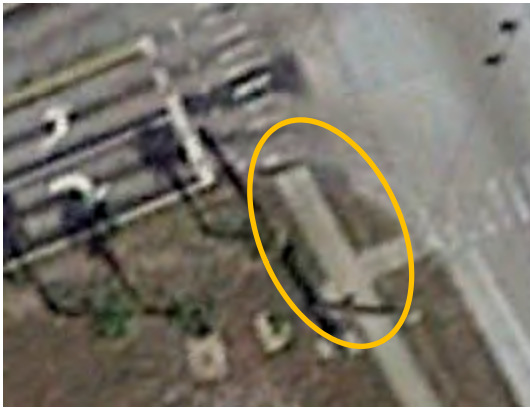
**Figure 25**

The pedestrian push button in the southwest corner (**Figure 25**) is located on the strain pole more than 15 feet from the curb ramp. The maximum allowable distance as defined in section 4E.08 of the 2009 MUTCD is 10 feet.

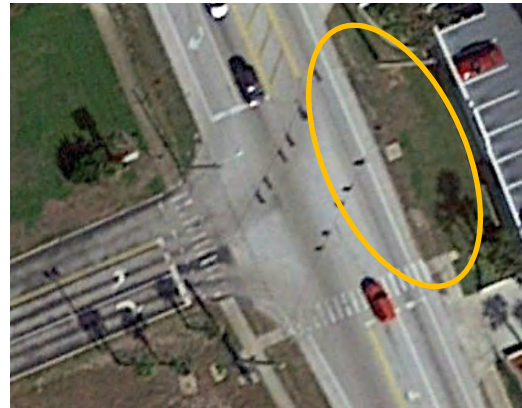
**Figure 26**

The grass on the east side of the intersection (**Figure 26**) has been worn by pedestrian foot traffic. Additionally, no crosswalk is present on the north leg of the intersection as shown in **Figure 27**.

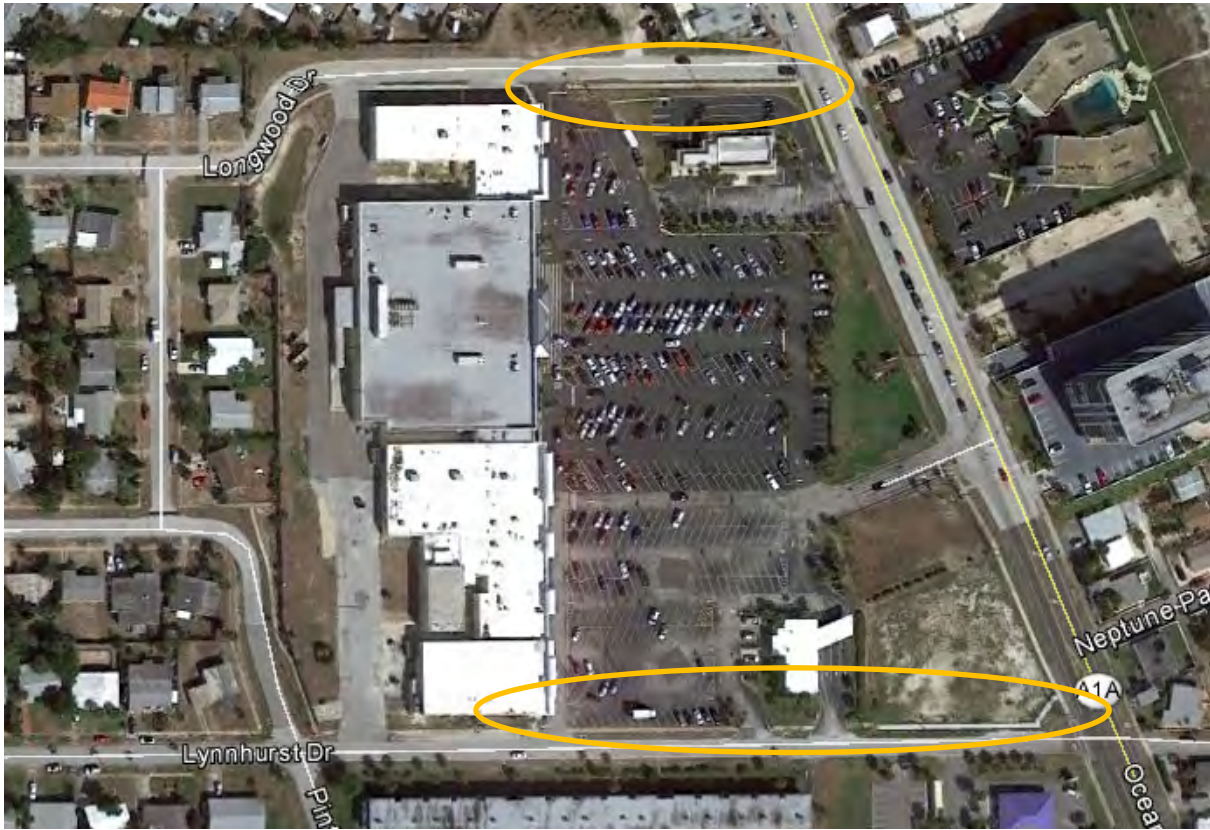
**Figure 29****Description of Issue:**

At the Ormond Mall, pedestrian access from SR A1A is only provided on the north and south sides of the site via Longwood Drive and Lynnhurst Drive, respectively (see **Figure 29**). Pedestrians crossing SR A1A at the Ormond Mall traffic signal do not have a pedestrian walkway to access the site.

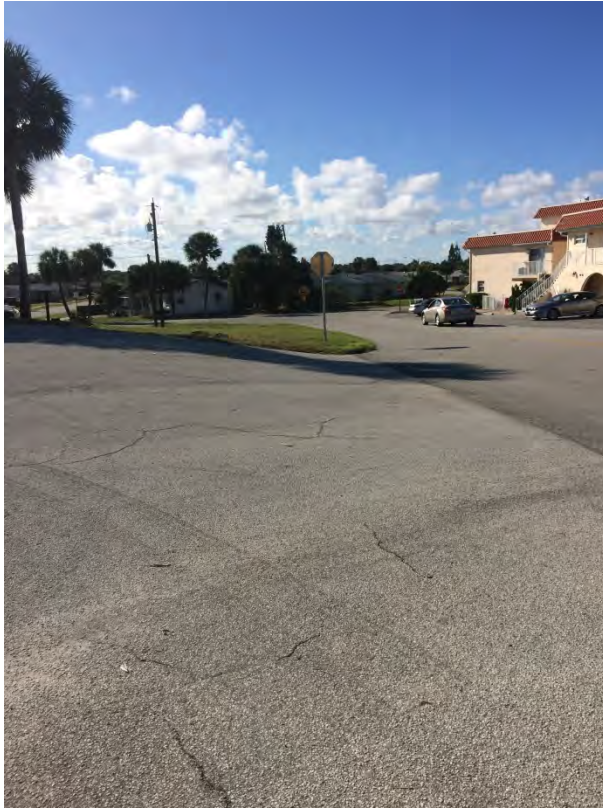
**Figure 35**

The southwest corner of Seaside Drive and SR A1A no clear definition of driveways, roadway edge, or parking areas. Additionally, the STOP sign on the eastbound approach is located approximately 50 feet from the intersection which may lead to motorists traveling eastbound on Seaside Drive yielding to parking lot traffic.
