SR/CR A1A PEDESTRIAN SAFETY & MOBILITY STUDY

PEDESTRIAN / BICYCLE SAFETY REVIEW

Focus Area F / Kathy Drive to Wisteria Drive (Ormond-By-The-Sea)

Pedestrian/Bicycle Safety Review Report for SR A1A from Kathy Drive to Wisteria Drive (Ormond-by-the-Sea)

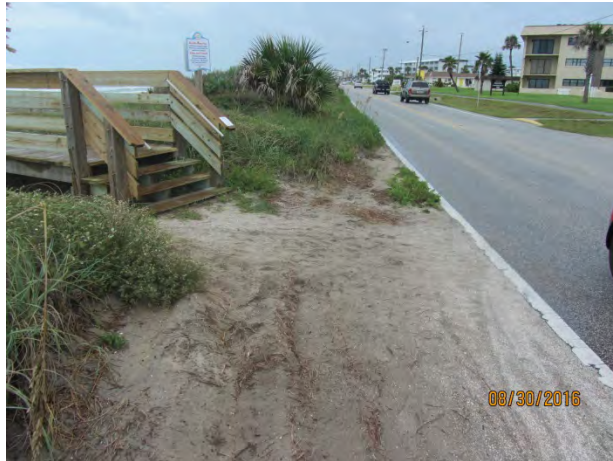
Figure 2

The study team observed a lack of formal bicycle facilities along SR A1A within the project limits. On the east side of the roadway nearest the dune, no shoulder is present except at beach access points (**Figure 2**). The study team observed buildup of sand at these locations, which may not be suitable for bicycles to traverse.

The team discussed the consideration for widening SR A1A to install buffered bicycle lanes. Due to potential impacts to the dunes and the fact that the eight-foot sidewalk on the west side of SR A1A is designated as part of the Florida Shared-Use Nonmotorized (SUN) Trail network, buffered bicycle lanes were not suggested for this section of SR A1A.

In lieu of buffered bicycle lanes, consider reconstructing the sidewalk on the west side of the roadway to be a 10'-12' wide shared-use path as a long term improvement. With the relatively high speeds (posted speed limit of 45 MPH), the study team observed most bicyclists utilizing the sidewalk. In order to accommodate the bicycle and pedestrian traffic in the area, a wider shared-use path would serve both of those non-automobile modes. To help illuminate pedestrians/bicyclists utilizing the path, low level bollards with lights could be installed along the length of the study area, or at a minimum at unsignalized intersections. These low level bollard lights could be designed so they cannot be seen from the beach, thus reducing the risk of turtles being drawn to the roadway. Because the current sidewalk is approximately 5' to 30' from the edge of pavement, at unsignalized intersections the path can be brought closer to SR A1A so turning vehicles can better see pedestrians crossing the side street.

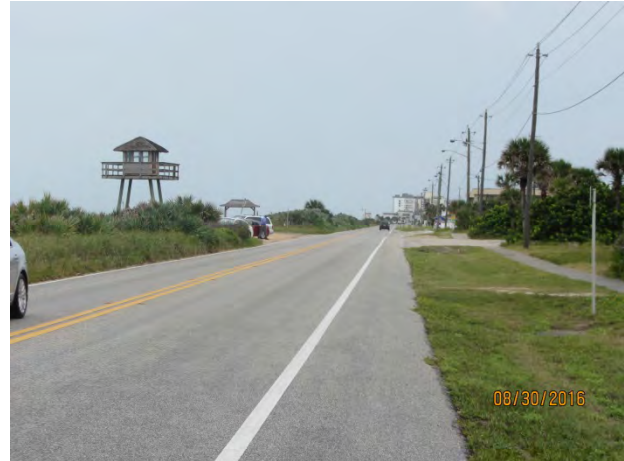
Figure 3

On the west side of the roadway, an approximate 4'-5' shoulder is present along the length of the study limits (**Figure 3**). The study team observed bicyclists riding off the roadway either on the sidewalk or within paved driveways on the west side of SR A1A (**Figure 4**). Two bicycle crashes occurred during the crash analysis period with one bicyclist crossing SR A1A and one being struck at a driveway while traveling on the sidewalk against the flow of traffic.

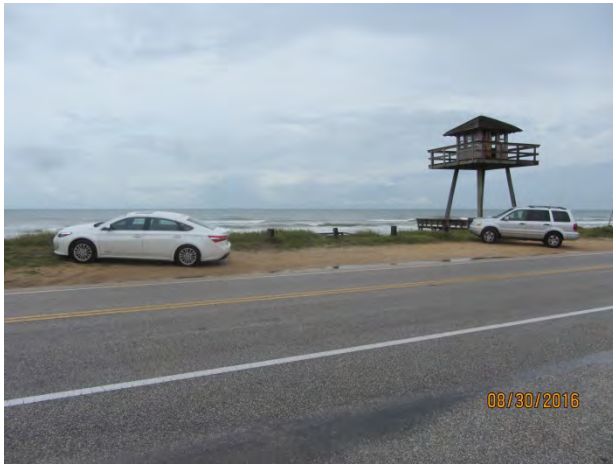
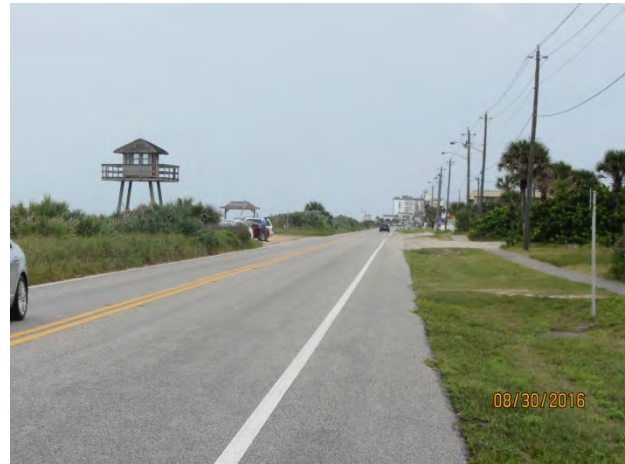
Currently there are no designated beach parking lots along the study corridor, but there is a location near Spanish Waters Drive where beach patrons can park along the east side of SR A1A. Beach patrons park in the designated area (shown in **Figure 5** and **Figure 6**) or park along the west side of SR A1A in areas not having parking restrictions. This leads to beachgoers parking at random locations along the corridor and creates variability in pedestrian crossing locations along SR A1A.

Consider converting the vacant parcel on the northwest corner of SR A1A and Spanish Waters Drive to a beach access parking lot (**Figure 7**). As discussed later in **Issue #3: Mid-Block Crossings**, a mid-block crossing is suggested at this location to accommodate pedestrians crossing SR A1A to the beach access point. This mid-block crossing could be constructed in conjunction with the beach parking lot in order to concentrate pedestrian crossings at a specific location. If an off-street beach parking area is constructed, consider installing NO PARKING (R8-3a) signs along the west side of SR A1A to encourage beachgoers to park in the designated beach parking area.

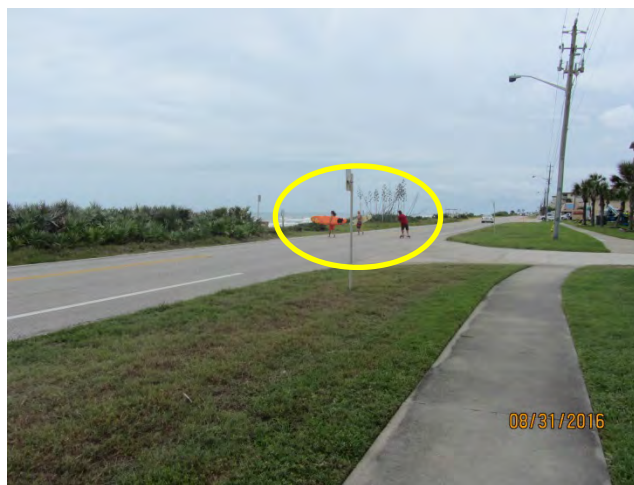
**Figure 10****Description of Issue:**

In addition to numerous private beach access points, three public beach access points are located along the study corridor at Kathy Drive, Ocean Breeze Circle, and Sunrise Avenue. The Kathy Drive and Ocean Breeze Circle locations are shown in **Figure 8** and **Figure 9**, respectively. Four of the five pedestrian crashes occurred with a pedestrian crossing SR A1A at or near a beach access point with one occurring near Kathy Drive, one near Berkeley Road, and two near Wisteria Drive. Even though the roadway is only two lanes wide, the 45 MPH speed limit may make it difficult for pedestrians to judge gaps when attempting to cross the roadway (**Figure 10**).

The study team discussed potential crosswalk locations along the corridor and considered evaluating the following locations for new crosswalks or improvements to existing features:

- Sunrise Avenue;
- Kathy Drive;
- Spanish Waters Drive (consider if the vacant parcel on the northwest corner is converted to be a beach parking area); and
- Ocean Breeze Circle (existing crosswalk).

The team discussed a tiered approach to mid-block crossing implementation:

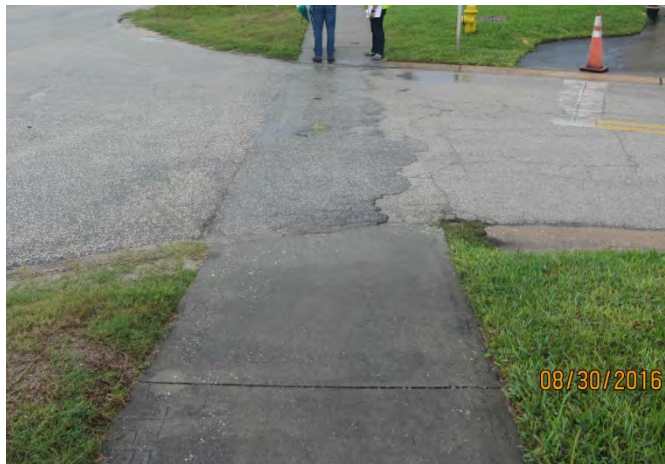
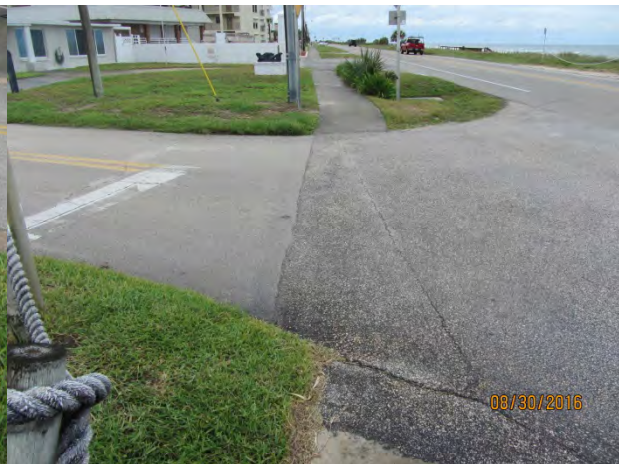
Along the corridor, the unsignalized minor street approaches did not include marked crosswalks or detectable warning surfaces (**Figure 11** and **Figure 12**). The study team also noted faded stop bars and double yellow striping on minor street approaches along the corridor (**Figure 13**).

Consider emphasizing the pedestrian realm across minor stop-controlled intersection approaches by adding crosswalk markings (standard or special emphasis to be determined on a case-by-case basis) as shown on sheet 12 of FDOT Design Standard Index 17346.

Consider installing detectable warning surfaces at public roadway, minor street intersections (i.e. non-driveways) along the corridor per FDOT Design Standard Index 304. Also consider restriping minor street stop bars and double yellow lines as shown on sheet 7 of FDOT Design Standard Index 17346 to emphasize where the vehicle needs to stop before making their turning movement.

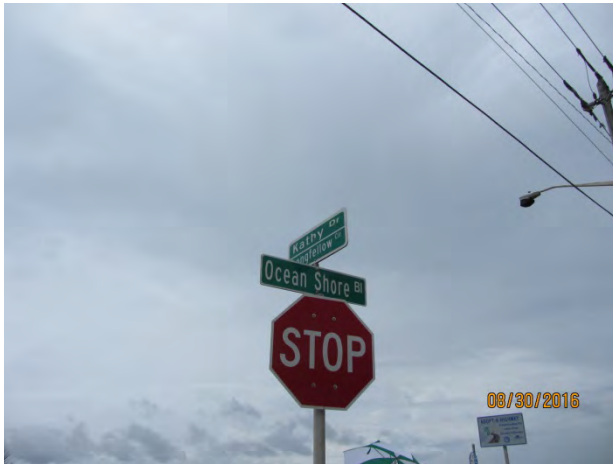
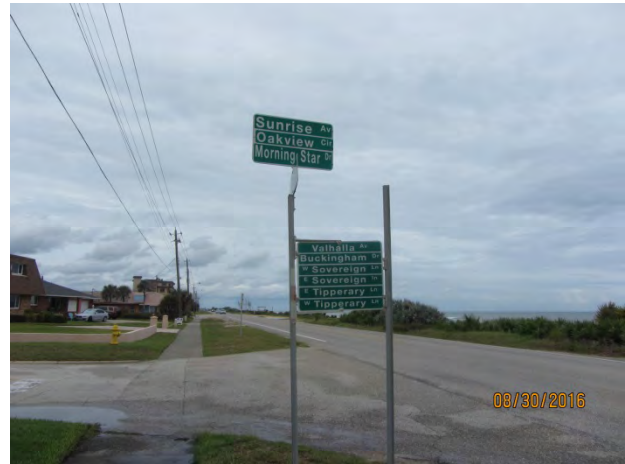
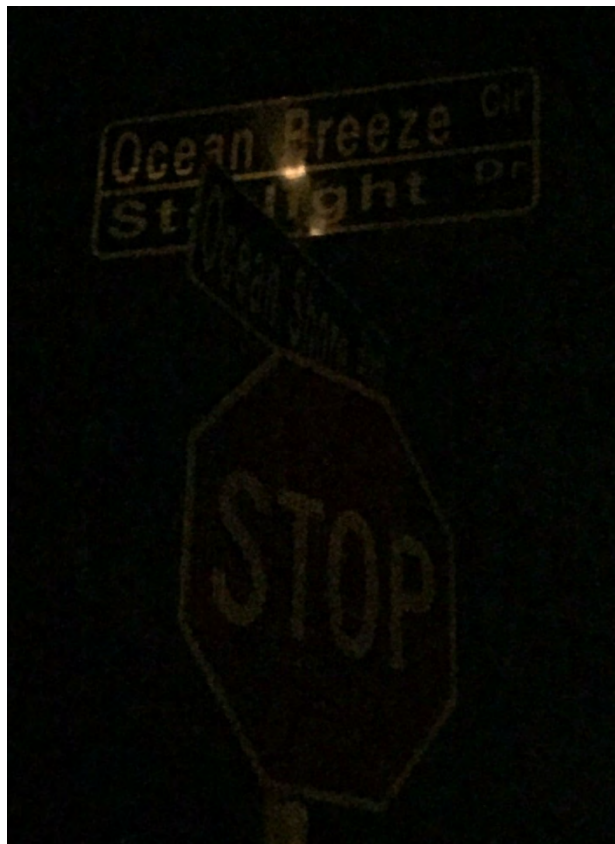
The street signs along the corridor had a varying letter heights, multiple street names listed, and lacked retro reflectivity, as displayed in **Figure 14**, **Figure 15**, and **Figure 16**. At Sunrise Avenue (**Figure 15**), street signage is provided for nine different streets. This is difficult for drivers to read and can be a

distraction. Conflicts may occur at night if a vehicle is driving slowly trying to find a specific street and a following vehicle gets impatient and decides to pass them. If a pedestrian is attempting to cross the roadway at the same time, the passing driver may not see the pedestrian causing a pedestrian related crash.

In the near term, consider replacing street name signage (**D3-1**) with new retro-reflective signs using applicable font size following the guidance provided in section 2D-43 of the 2009 *Manual on Uniform Traffic Control Devices (MUTCD)*. Table 2D-2 specifies 6" letter height on post mounted street signs at intersections along two-lane roadways. The excess signage at the Sunrise Avenue intersection should be removed to only show the street connecting to SR A1A (Sunrise Avenue).

Also in the near term consider a signage study/plan for the study corridor to evaluate the amount of signage, applicability, retro-reflectivity, and location along the study corridor. This signage study/plan should include replacing the older signs with signs meeting current standards.

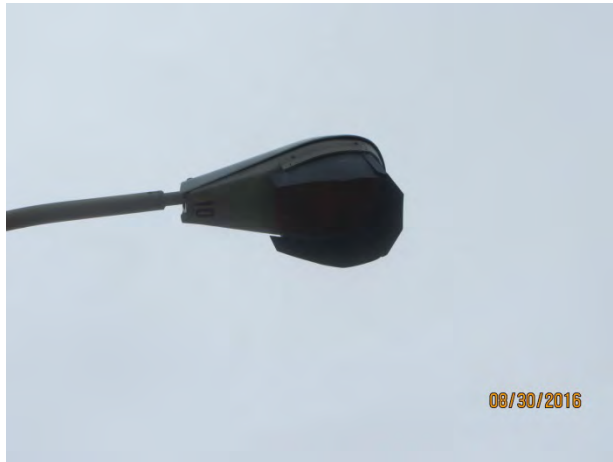
Figure 17

The beach along the study corridor is a destination for sea turtle nesting. The sea turtle nesting season is from May 1 to October 31. **Figure 17** displays 270 degree turtle shielding on an overhead light to minimize light emittance. The reduced lighting conditions can make it difficult for drivers to see pedestrians or bicyclists at night, especially those wearing dark clothing. **Figure 18** illustrates the lighting

- Consider conducting field measurements of existing lighting levels to evaluate lighting uniformity levels and add lighting where necessary. Consider light poles on the east side that are angled westerly away from the beach. These light poles cast their light to the west and illuminate the roadway as needed. The light bulb is not seen by the turtles due to the angle and orientation of the light fixture.

- Consider implementing a lighting plan for the time the sea turtle nesting season is not active as roadway lighting levels should not be reduced at this time.

- Consider conducting a lighting justification study along unlit portions of the corridor to determine if additional lighting is justified.
- Consider implementation of pedestrian-level lighting, with less visibility from the beach, to supplement areas where street lighting is not able to provide adequate illumination as discussed in **Issue #1: Lack of Bicycle Facilities**.

- As a long-term consideration, upgrade to an adaptive roadway lighting system along the corridor. Lighting levels could be programmed to be reduced during the sea turtle nesting season and increased to normal levels outside of the nesting season. This could be coupled with replacing the current high pressure sodium lighting with LED lighting.

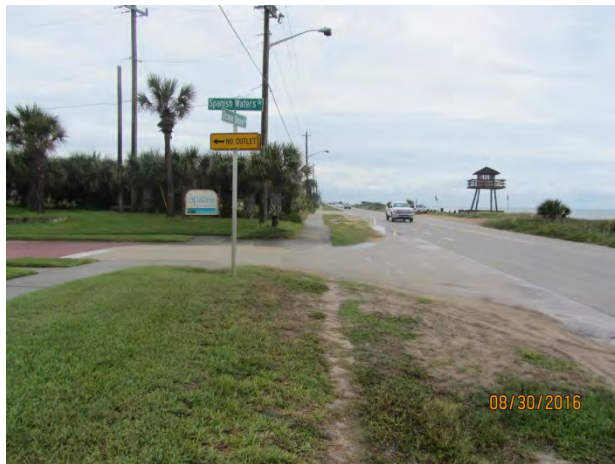
Figure 20

The study team observed the stop bars at the minor streets to be set back 20' to 25' from the edge of the travel lane, as displayed on **Figure 20**. The stop bar is set back due to the location of the sidewalk which creates sight distance issues for vehicles turning from the minor street. The sight distance was observed to be restricted by landscaping along SR A1A. Because the sight distance is restricted, vehicles were seen driving through the stop bar and stopping near the roadway often on the unmarked crosswalk (**Figure 21**). This creates a conflict with pedestrians and bicyclists who may be attempting to cross the minor street as a vehicle is pulling out to make a turn onto SR A1A.

Consider moving the stop bars to be the minimum of 4' away from the marked crosswalks discussed in **Issue #4: Minor Street Intersections**, per sheet 7 of FDOT Design Standard Index 17346. A curb and gutter could also be constructed along the radius return of the intersections and the sidewalk could be moved closer to SR A1A. This allows both the sidewalk and crosswalk to be moved closer to SR A1A, potentially reducing some of the existing sight distance issues.

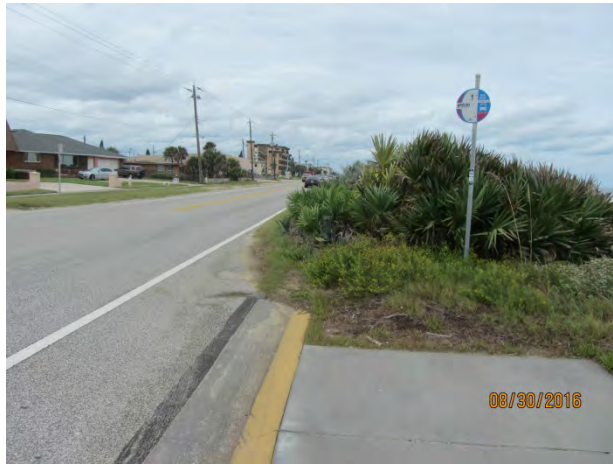
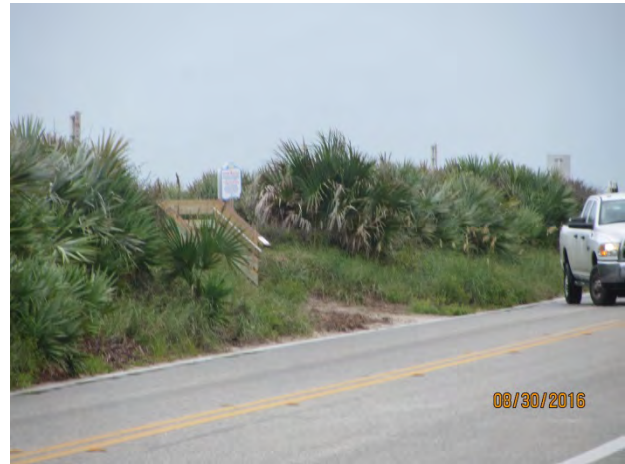
There were several locations along the east side of the corridor having high hedges and bushes encroaching onto the shoulder/travel lane. This was especially apparent at the entrances to beach access points (shown in **Figure 22** and **Figure 23**). It is very difficult for drivers to see pedestrians standing on the side of the road when they are attempting to cross from the east side to the west side (leaving the beach access point). The study team also observed that as a pedestrian, the landscaping restricted sight distance along SR A1A. This creates a potential hazard for beach patrons leaving the beach access points.

Coordinate with FDOT maintenance to trim the obstructions and encourage regular landscape maintenance.

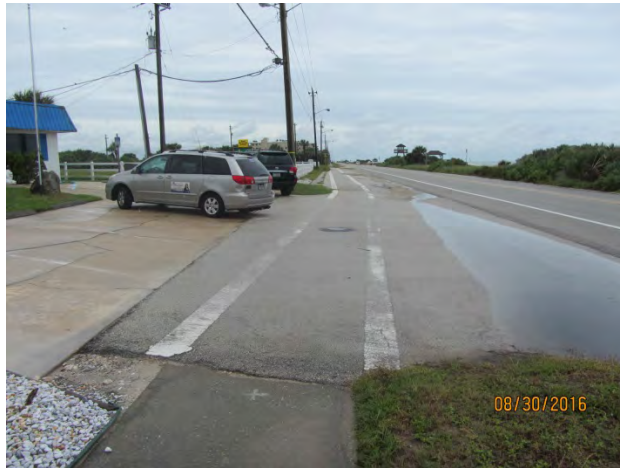
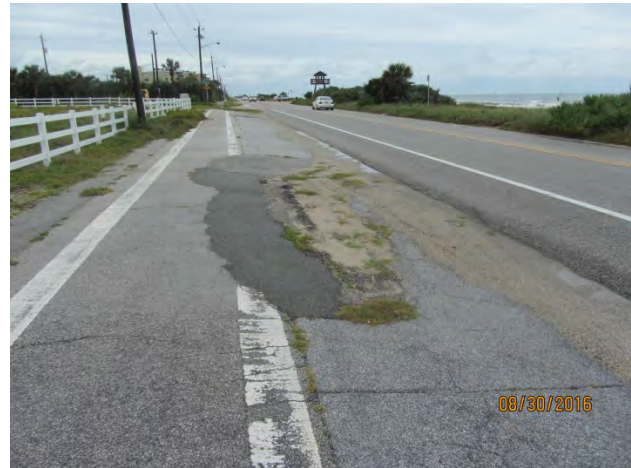
The study team observed a striped sidewalk area on the west side of SR A1A between Kathy Drive and Spanish Waters Drive, as displayed in **Figure 24** and **Figure 25**. The pavement markings are beginning to fade and in some cases are no longer present due to some patch work. As shown in **Figure 26**, the markings terminate on the southeast corner of the intersection of Spanish Waters Drive and SR A1A. A paved surface is provided adjacent to the asphalt, but a worn trail through the grass was observed. This worn trail is directly across from the sidewalk on the northwest corner of the intersection.

In the near term, consider restriping the pavement markings delineating the sidewalk. Consider adding new sidewalk in the worn trail area to create a more direct route to the sidewalk in the northwest corner.

As a long term improvement, consider removing the existing asphalt surface to create a shared-use path consistent with the suggestion included in **Issue #1: Lack of Bicycle Facilities**. In addition, consideration could be given to providing a curb and gutter at the edge of the sidewalk or shared-use path as a long-term improvement. The adjacent pavement area between the curb and gutter and southbound travel lane could be utilized as parallel parking with several parking stalls.

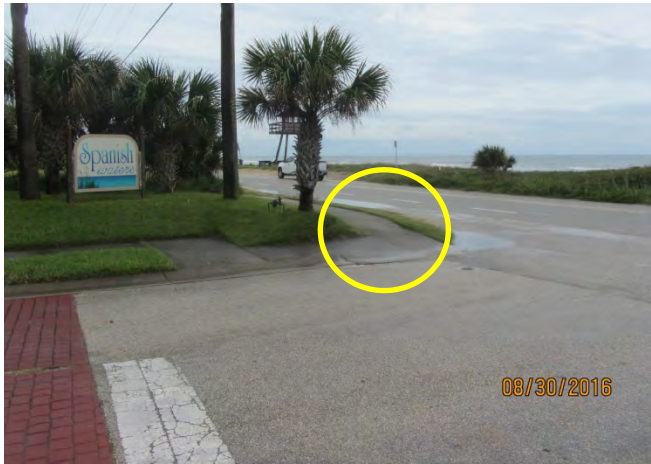
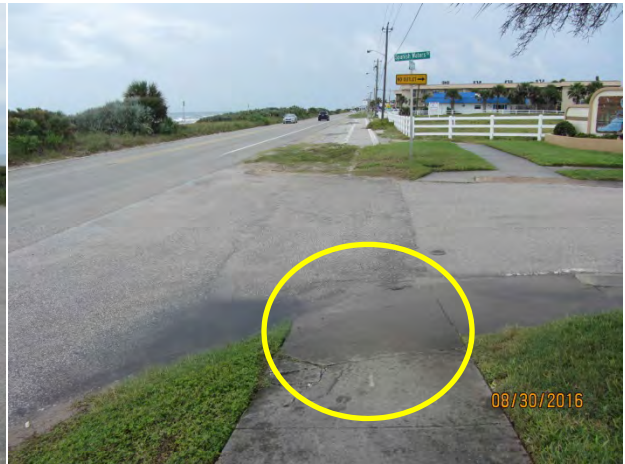
When walking along the corridor, the study team observed a steep curb ramp on the northwest corner of Spanish Waters Drive, as illustrated in **Figure 27** and **Figure 28**. The sidewalk slope exceeds the American's with Disabilities Act (ADA) maximum slope threshold of 1:12 and people using a wheelchair may have difficulty traversing the sidewalk at this location.

Consider reconstructing the curb ramp on the northwest corner to meet ADA standards. This should be done in conjunction with potential sidewalk improvements included in **Issue #9: Sidewalk Enhancements** or potential curb and gutter improvements as part of **Issue #7: Minor Street Sight Distance**.

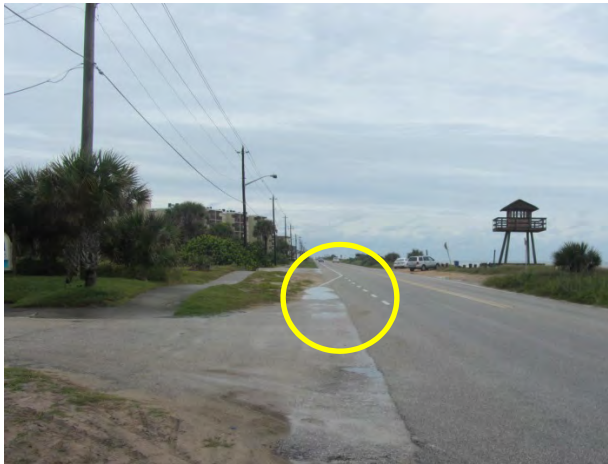
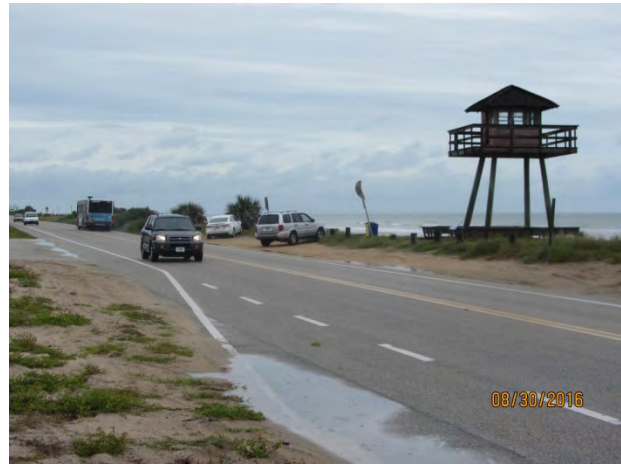
Figure 29 and **Figure 30** illustrate excess pavement just north of the Spanish Waters Drive intersection. This excess pavement is striped to serve as a deceleration taper for southbound right-turning vehicles. The pavement markings create a potential conflict area for bicyclists riding on the shoulder and vehicles attempting to make a southbound right-turn maneuver at the intersection.

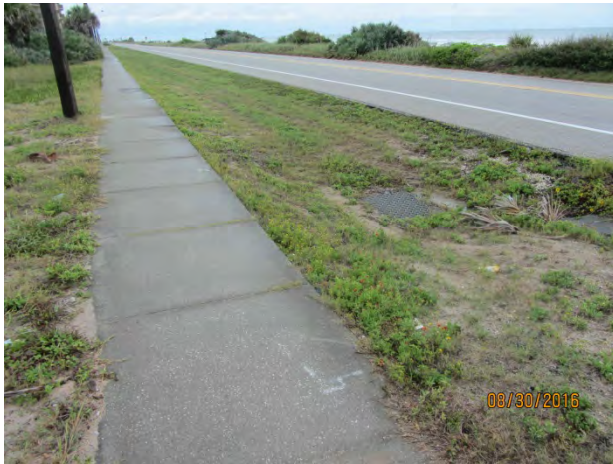
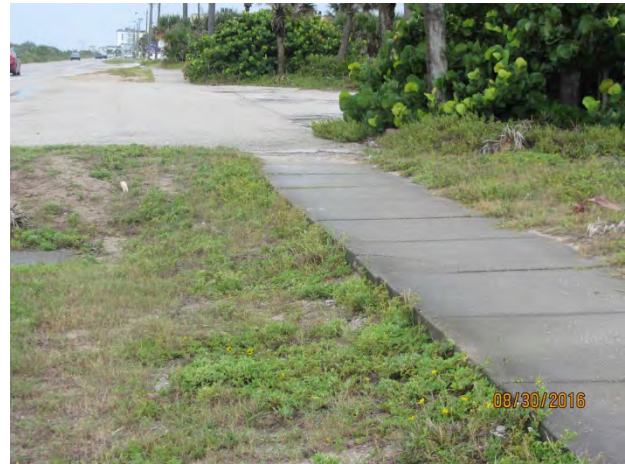
The study team observed an exposed drainage inlet between the sidewalk and the southbound travel lane. There is a drop off from the edge of the sidewalk to the bottom of the drainage inlet structure as displayed in **Figure 31** and **Figure 32**. This creates a potential hazard for pedestrians or bicyclist to fall into the structure.

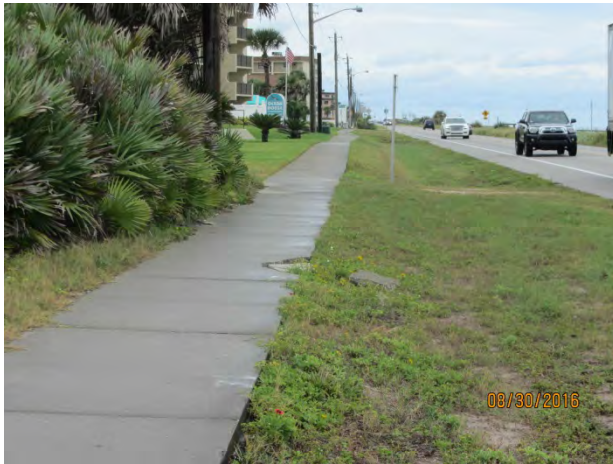
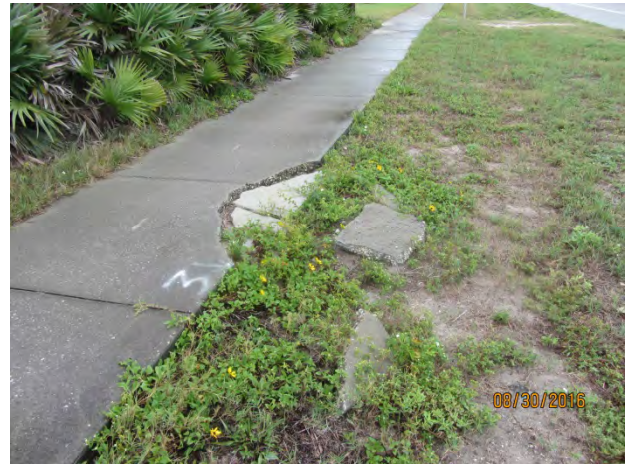
The study team observed a section of broken sidewalk approximately 500 feet north of the Spanish Waters Drive intersection. The sidewalk appears to have been fixed once, but has broken again (shown in **Figure 33** and **Figure 34**). The broken sidewalk presents a potential trip hazard for sidewalk users and restricts the effective width of the sidewalk.

Consider reconstructing the sidewalk panels to replace the broken sidewalk and remove the potential trip hazard.

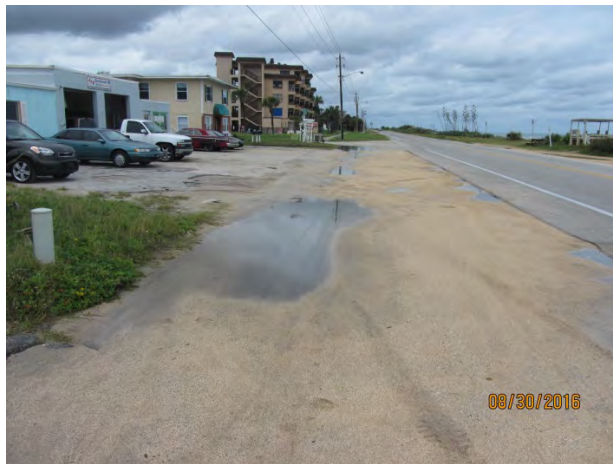
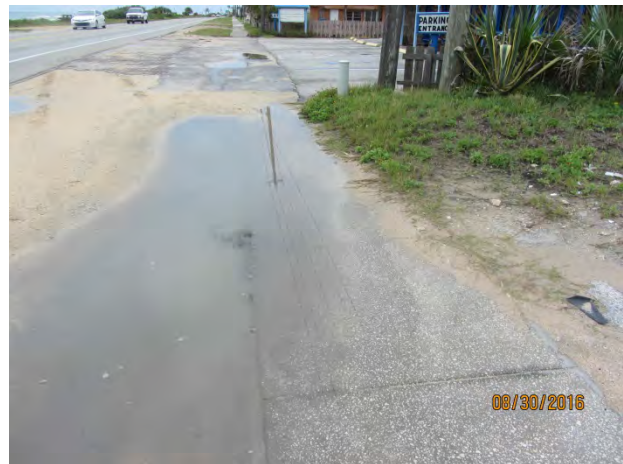
The study team observed water ponding along the sidewalk on the west side of SR A1A between Sunrise Avenue and Briggs Avenue. Examples of the issue are illustrated in **Figure 42** and **Figure 43**. This poses an issue to pedestrians and bicyclists traveling along the sidewalk where they are forced to go around the water closer to the travel lanes.

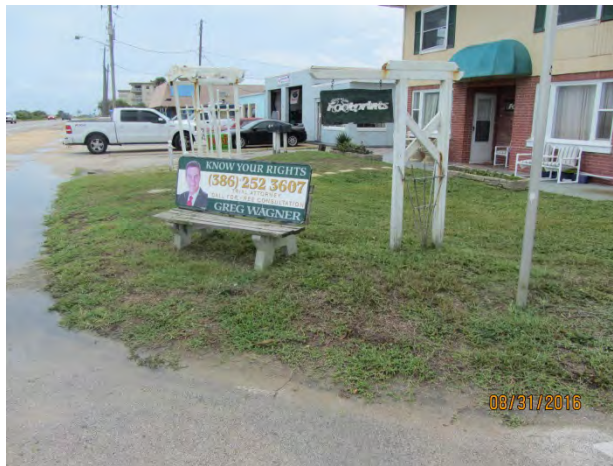
Figure 44

The study team observed a transit stop bench on the southwest corner of the intersection of Briggs Avenue (**Figure 44**). Votran has recently upgraded the transit facilities along the study corridor and the new bus stop is located on the northwest corner of the intersection (**Figure 45**). Transit riders wishing to sit on the bench while waiting for the bus are not waiting at the actual transit stop and could be overlooked by the bus driver.

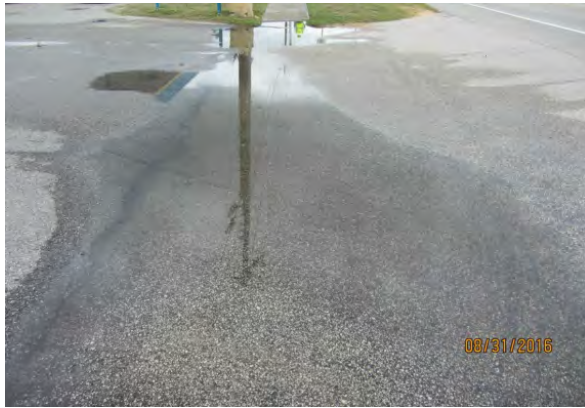
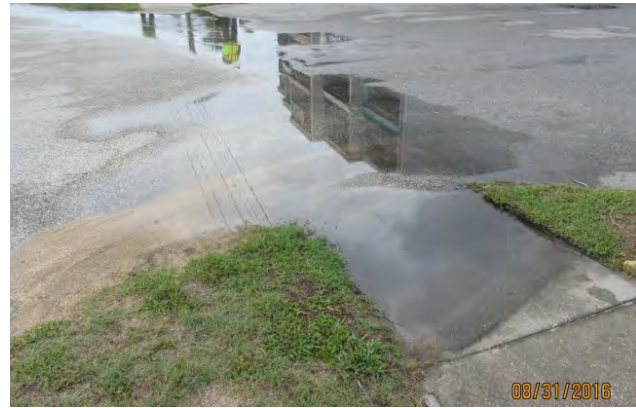
The driveway to the gas station is relatively wide (approximately 50 feet) as illustrated in **Figure 46** and **Figure 47**. The concrete sidewalk ends at the edges of the driveway and is replaced by the asphalt driveway. Because the sidewalk ends, there is not a distinct delineation between the driveway and where the sidewalk should be. Vehicles were observed pulling out of the driveway and stopping prior to traveling on SR A1A but not stopping where the sidewalk was located. This creates a conflict with non-motorists traveling along the driveway.

The study team also observed water ponding along the length of the driveway. The extent of the water ponding is illustrated in **Figure 46** and **Figure 47**. Currently this section of the asphalt driveway is the low point. This poses an issue to pedestrians and bicyclists traveling along the sidewalk where they are forced to go around the pools closer to the travel lanes or within the gas station parking lot.
