SR/CR A1A PEDESTRIAN SAFETY & MOBILITY STUDY

PEDESTRIAN / BICYCLE SAFETY REVIEW

Focus Area G / S 23rd Street to S 11th Street and at the Beverly Beach Camptown RV Resort (Flagler Beach)

Project Title: Focus Area G Pedestrian/Bicycle Safety Field Review

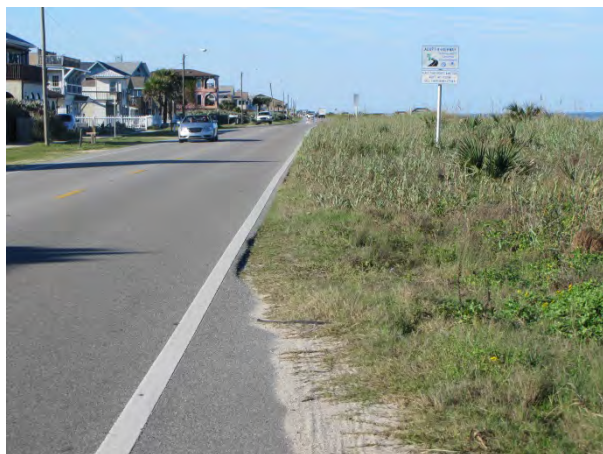
Figure 3

The study team observed a lack of formal bicycle facilities along SR A1A within the project limits. On the east side of the roadway nearest the dune, no shoulder is present except at beach access points (**Figure 3**). On the west side of the roadway, an approximate 4'-5' shoulder is present along the length of the study limits (**Figure 4**). The study team observed bicyclists riding off the roadway either on the sidewalk or within paved parking areas on the west side of SR A1A (**Figure 5**). The sidewalk on the west side was found to be no wider than 8'. Two bicycle crashes occurred between northbound traveling vehicles and bicycles riding in the northbound lane, where no shoulder or bicycle lane is present.

In the near term, consider reconstructing the sidewalk on the west side of the roadway to be a 10'-12' multi-use path. With the relatively high speeds (posted speed limit of 45 MPH), the study team observed most bicyclists utilizing the sidewalk. In order to accommodate the bicycle and pedestrian traffic in the

area, a wider multi-use path would serve both of those non-automobile modes. To help illuminate pedestrians/bicyclists utilizing the path, low level bollards with lights could be installed along the length of the study area, or at a minimum at unsignalized intersections. These low level bollard lights could be designed so they cannot be seen from the beach, thus reducing the risk of turtles being drawn to the roadway. Because the current sidewalk is approximately 5' to 20' from the edge of pavement, at unsignalized intersections the path can be brought closer to SR A1A so turning vehicles can better see pedestrians crossing the side street.

As a longer term suggestion, consider widening SR A1A to install buffered bicycle lanes. The group discussed the need to have facilities both on-street and off street to accommodate all types of bicyclists. For this suggestion, the eastern pavement line would remain in its current location (so the dune is not impacted) and SR A1A could be widened to the west by approximately 10' (7' for the northbound bicycle lane and an extra 3' for the southbound bicycle lane, because a 4' shoulder is already present). Because most of the existing buffer between the roadway and sidewalk (or multi-use path if the near term suggestion is constructed) would be utilized for new pavement, a curb and gutter cross section should be considered so a vertical obstruction is added between the roadway and pedestrian walking area.

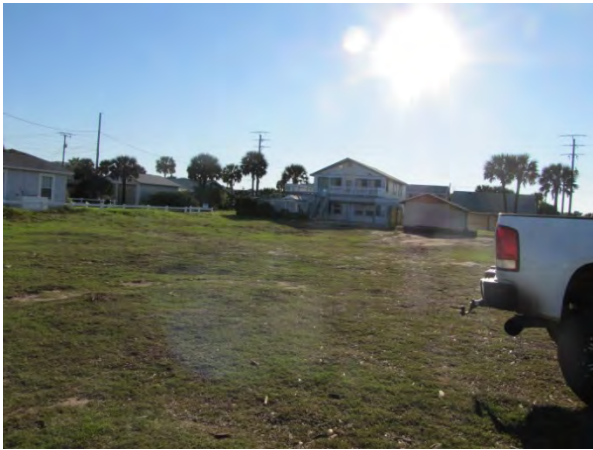
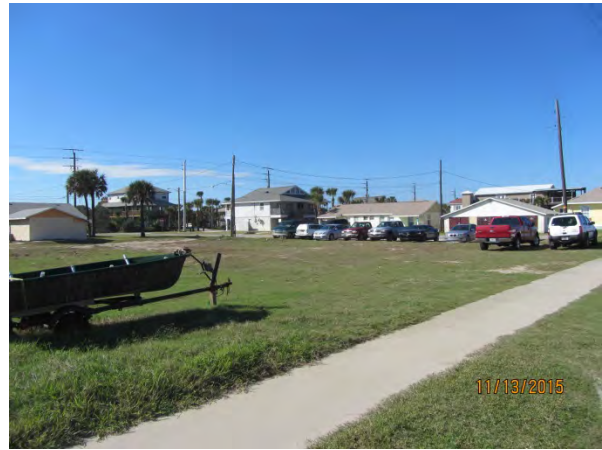
Currently there are no designated beach parking lots along the study corridor and beachgoers need to either park in vacant lots (**Figure 6** and **Figure 7**) or park along the west side of SR A1A in areas not having parking restrictions. This leads to beachgoers parking anywhere along the corridor and creates variability in locations where pedestrians cross SR A1A to get to the beach.

Consider converting the vacant parcel on the southwest corner of SR A1A and 19th Street South to a beach access parking lot (**Figure 8**). As discussed in **Issue #3: Mid-Block Crossings**, a mid-block crossing is suggested at 19th Street to accommodate pedestrians crossing SR A1A to the beach access point. This mid-block crossing could be constructed in conjunction with the beach parking lot in order to concentrate pedestrian crossings at a specific location. The vacant parcels on the corners of 17th Street (**Figure 8**) and 13th Street could also be considered for beach parking areas. A mid-block crossing is suggested at 13th Street as discussed in **Issue #3: Mid-Block Crossings**.

If off street beach parking areas are constructed, consider installing NO PARKING (R8-3a) signs along the west side of SR A1A to encourage beachgoers to park in the designated beach parking areas.

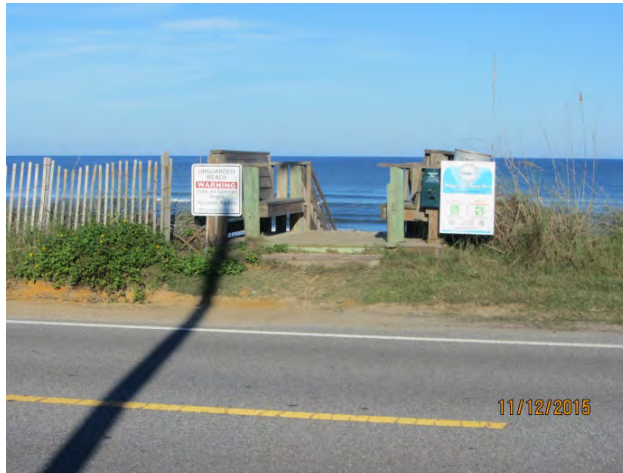
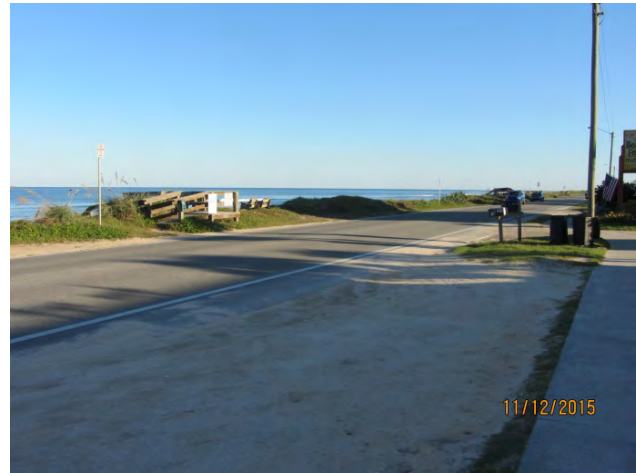
In addition to numerous private beach access points, thirteen public beach access points are located along the study corridor (**Figure 9** and **Figure 10**). Five of the six pedestrian crashes occurred with a pedestrian crossing SR A1A at or near a beach access point, with two occurring at 16th Street (one being fatal) and one each occurring at 17th Street, 13th Street, and 11th Street. Even though the roadway is only two lanes wide, the 45 MPH speed limit makes it difficult for pedestrians to judge gaps when trying to cross the roadway (**Figure 11**).

Consider constructing mid-block crossings at 16th Street and 13th Street. A mid-block crossing should also be considered at 19th Street if the vacant parcel on the southwest corner is converted to be a beach parking area. The following details considerations for the mid-block crossings:

- Conduct a mid-block crossing study per Section 3.8 of the FDOT *Traffic Engineering Manual (TEM)* to evaluate if a crosswalk is warranted based upon existing demands.

- Install an active warning device, such as Rapid Rectangular Flashing Beacons (RRFB), at the crosswalk. Due to the high speed of the roadway, RRFBs should also be considered on advanced crosswalk signs per FHWA's interim approval memorandum.

- Provide a median refuge island with a minimum length of 90 feet for pedestrians.
 - The roadway would have to be widened to fit the refuge island between the northbound and southbound lanes but this impact could be minimized by reducing the travel lanes to be 11' wide. By constructing a raised refuge island, traffic calming may be a positive byproduct, as discussed further in **Issue #7: Vehicular Speed**.

- Install lighting on the crosswalk's east side.
 - Directional lighting oriented towards the crosswalk could be provided; or
 - LED lighting could turn on when the RRFB is activated and flashing and could turn off when the flashers stop.

- Stripe the crosswalk with special emphasis crosswalk markings consistent with sheet 10 of the FDOT Design Index 17346.
- Reconstruct the beach access walkover to have a 90 degree bend in the ramp similar to what is displayed in **Figure 12**. While the figure displays the 90 degree bend facing north, it would be preferred to construct the bend facing south so the pedestrian can better see northbound oncoming traffic. With the bend in the beach access ramp, the risk of a child or inattentive adult walking out onto SR A1A when coming from the beach is reduced.

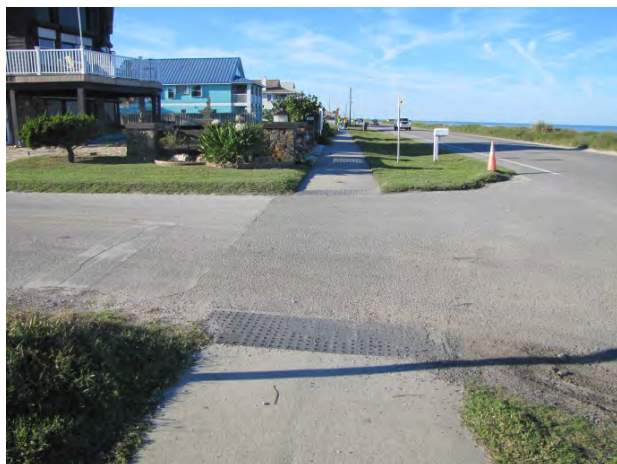
Figure 13

Along the corridor, the unsignalized minor street approaches did not include marked crosswalks and most of the detectable warning surfaces were in disrepair (**Figure 13**). The study team also observed detectable warning surfaces were angled with the curve of the curb return leading to wear from vehicles off tracking onto the warning surface/sidewalk (**Figure 14**). The study team also noted faded stop bars and double yellow striping along the minor street approaches along the corridor (**Figure 15**).

As a maintenance-type suggestion, consider emphasizing the pedestrian realm across minor stop-controlled intersection approaches by adding crosswalk markings (standard or special emphasis to be determined on a case-by-case basis) as shown on sheet 9 of FDOT Design Standard Index 17346. Consider replacing/installing detectable warning surfaces at minor street intersections along the corridor per FDOT Design Standard Index 304. When replacing the detectable warning surfaces, consider

installing them perpendicular to the sidewalk instead of at an angle so they are less impacted by right turning vehicles. Also consider restriping minor street stop bars and double yellow lines as shown on sheets 2 and 4 of FDOT Design Standard Index 17346 to emphasize where the vehicle needs to stop before making their turning movement.

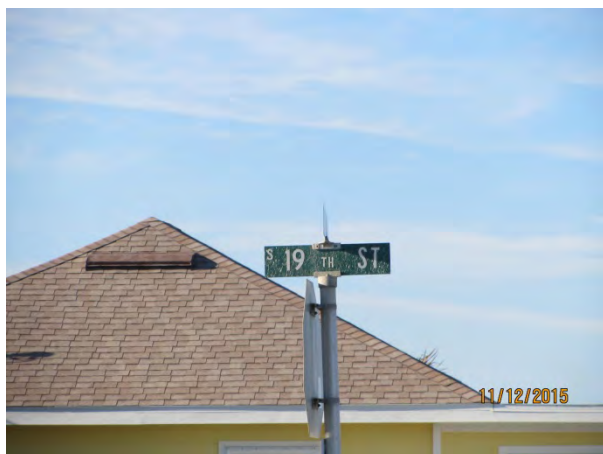
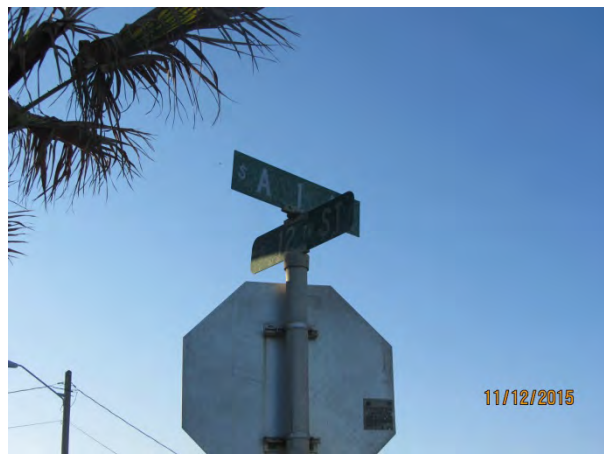
The street signs along the corridor were faded/worn, had a letter height of approximately 4", and lacked retro reflectivity, as displayed in **Figure 16** and **Figure 17**. Conflicts may occur at night if a vehicle is driving slowly trying to find a specific street and a following vehicle gets impatient and decides to pass them. If a pedestrian is attempting to cross the roadway at the same time, the passing driver may not see the pedestrian causing a pedestrian related crash.

In the near term, consider replacing street name signage (**D3-1**) with new retro-reflective signs using applicable font size following the guidance provided in section 2D-43 of the 2009 *Manual on Uniform Traffic Control Devices (MUTCD)*. Table 2D-2 specifies 6" letter height on post mounted street signs at intersections along two-lane roadways. The street signs closer to SR 100 were recently upgraded to have 6" letter height with a decorative border so consider replacing the street signs along the study corridor with the same signage type for consistency.

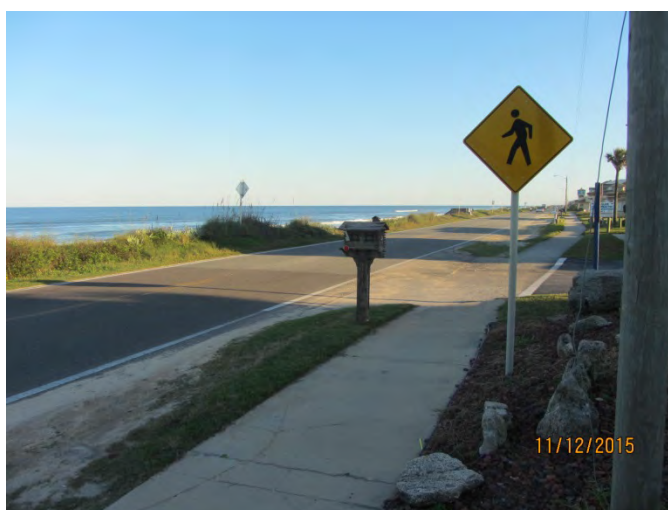
Figure 18

The study team also observed numerous signs along the corridor, both in the number of signs along the corridor and the applicability/location of some of the signs. For example, **Figure 18** displays a pedestrian warning sign near a private beach access with little pedestrian crossing volume while other public beach access points have no warning signs.

Also during the next resurfacing project, a signage study/plan for the study corridor to evaluate the amount of signage, applicability, retro-reflectivity, and location along the study corridor. This signage study/plan should include replacing the older signs with signs meeting current standards.

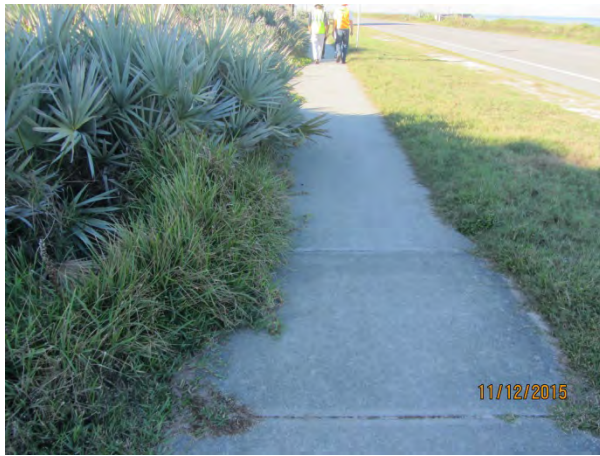
**Figure 19**

Along a majority of the corridor, the sidewalk was observed as having walkability issues due to encroachment from grass/shrubbery (**Figure 19**) or sand partially covering the walking area (**Figure 20**). Vacant parcels along the corridor were the primary locations where grass/shrubbery was encroaching on the sidewalk because no one owned the property to maintain the landscaping.

Consider regular sidewalk maintenance (sweeping debris/sand) along the corridor. The maintenance may be scheduled (once every one or two weeks, etc.) or may be performed after a heavy rain event.

In lieu of regular sidewalk maintenance by a local jurisdiction, local businesses along the corridor could apply for the FDOT Adopt-A-Highway program. According to the website (found at <http://www.dot.state.fl.us/statemaintenanceoffice/aah.shtm>), volunteers would “enter into a two-year agreement with DOT, during which they agree to conduct litter removal at regularly scheduled intervals. Many miles of highway are adopted statewide by various organizations, allowing civic-minded people to make a difference in their communities. This eases the load of DOT work crews, enabling them to devote more time to other road maintenance and special highway projects.”

In addition to the program, the volunteers could also trim the grass/shrubbery within the right-of-way and removing sand from the sidewalk.

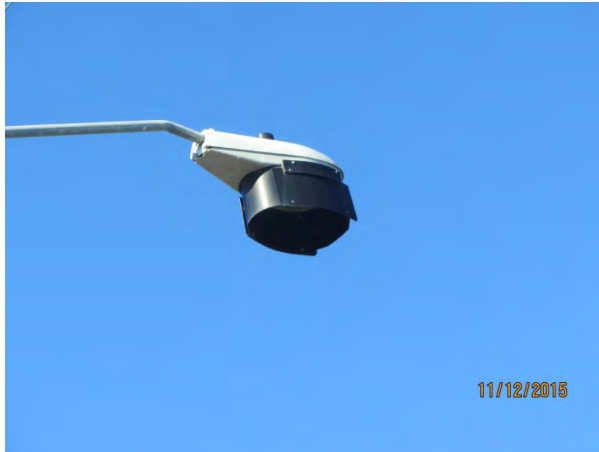
Flagler Beach is a destination for sea turtle nesting. The sea turtle nesting season is from May 1 to October 31. **Figure 21** displays 360 degree turtle shielding on an overhead light to minimize light emittance. Members of the study team also confirmed that during turtle season, the overhead lights along the corridor are turned off. Shutting off lights or using the turtle shields negatively impact the lighting conditions for the roadway users. Reducing the light can make it difficult for drivers to see pedestrians or bicyclists at night, especially those wearing dark clothing. **Figure 22** illustrates the lighting levels the safety team observed during the night field review. **Figure 23** displays the lighting from an overhead light that has 360 degree turtle shielding it is very concentrated just below the light. The safety study team observed the roadway lighting conditions and had the following observations:

- Replace the lights on the corridor that are burnt out.
- Consider conducting field measurements of existing lighting levels to evaluate lighting uniformity levels and add lighting where necessary. Consider light poles on the east side that are angled westerly away from the beach. These light poles cast their light to the west and illuminate the roadway as needed. The light bulb is not seen by the turtles due to the angle and orientation of the light fixture.

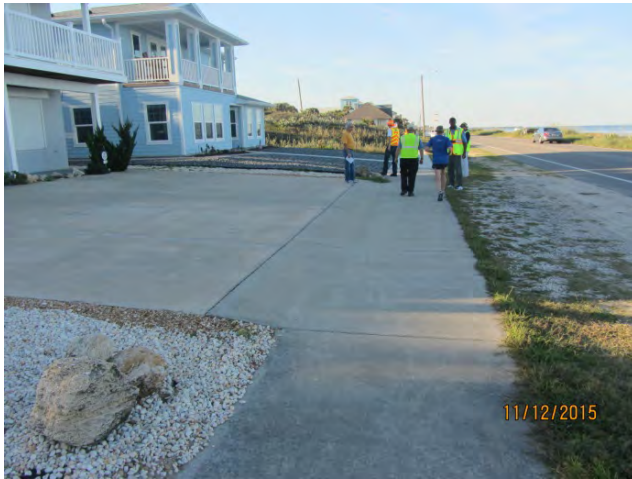
**Figure 24**

Many residential properties along the west side of the corridor had paved driveways but no formal driveway connection onto SR A1A, as displayed in **Figure 24**. Some properties did not have a paved driveway but the study team observed missing grass where it looked like vehicles had consistently turned from SR A1A, driven over the sidewalk, and parked on a property (**Figure 25**). In situations like these, a vehicle turning from SR A1A may not see a pedestrian or bicycle on the sidewalk. Also vehicles backing out from these properties will have a tough time seeing pedestrians or bicyclists on the sidewalk. In addition to the vehicular/non-motorist conflict, the vehicles driving over the unpaved portion of the driveway will track dirt, sand, and other debris onto the sidewalk.

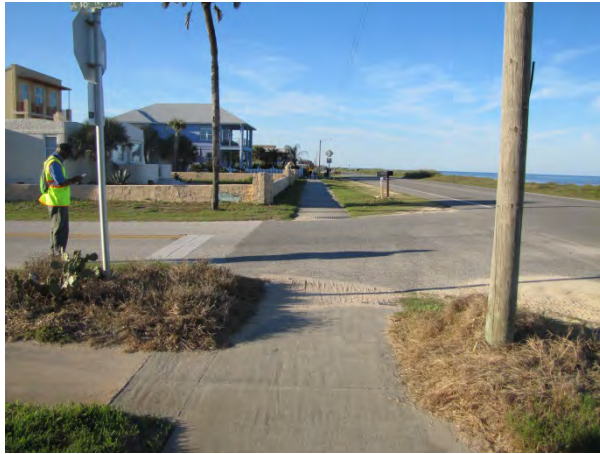
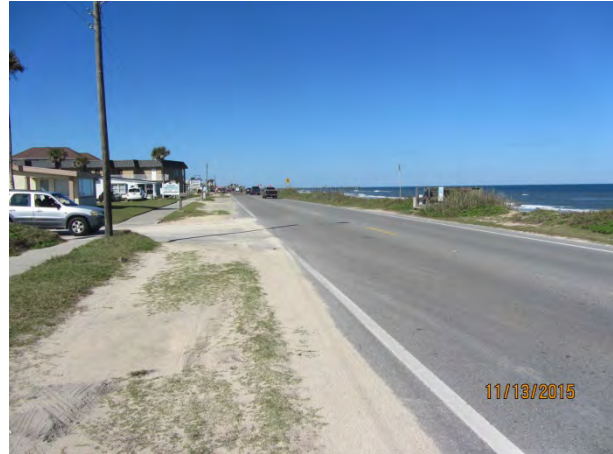
The study team observed the stop bars at the minor streets to be set back 20'-25' from the edge of the travel lane, as displayed on **Figure 26** and **Figure 27**. The stop bar is set back due to the location of the sidewalk but this creates sight distance issues for vehicles turning from the minor street. The sight distance was observed to be restricted by walls along properties and by areas where vehicles are allowed to park on the west side of SR A1A. Because the sight distance is restricted, vehicles were seen driving through the stop bar and stopping near the roadway often on the unmarked crosswalk. This creates a conflict with pedestrians and bicyclists who may be attempting to cross the minor street as a vehicle is pulling out to make a turn onto SR A1A.

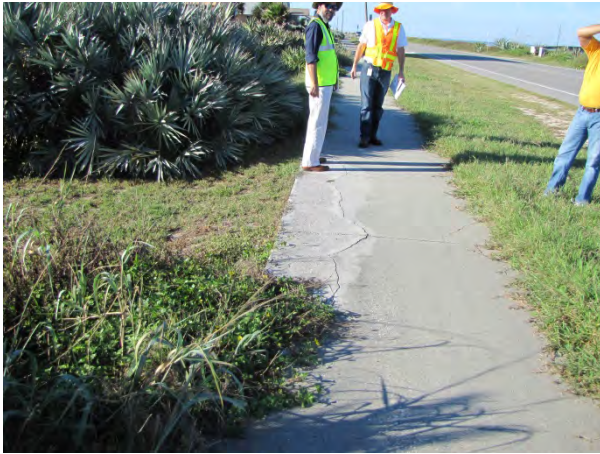
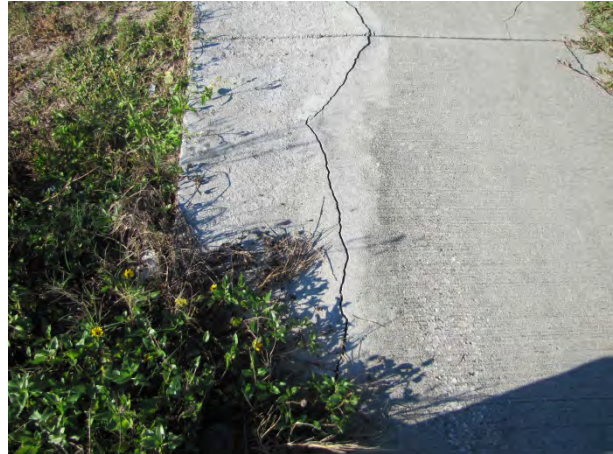
The study team observed broken sidewalk just south of 22nd Street, as displayed in **Figure 28** and **Figure 29**. The broken sidewalk does not present a usable pedestrian walking surface in this section.

Consider reconstructing the sidewalk panels south of 22nd Street to replace the broken sidewalk and create a walkable pedestrian access route.

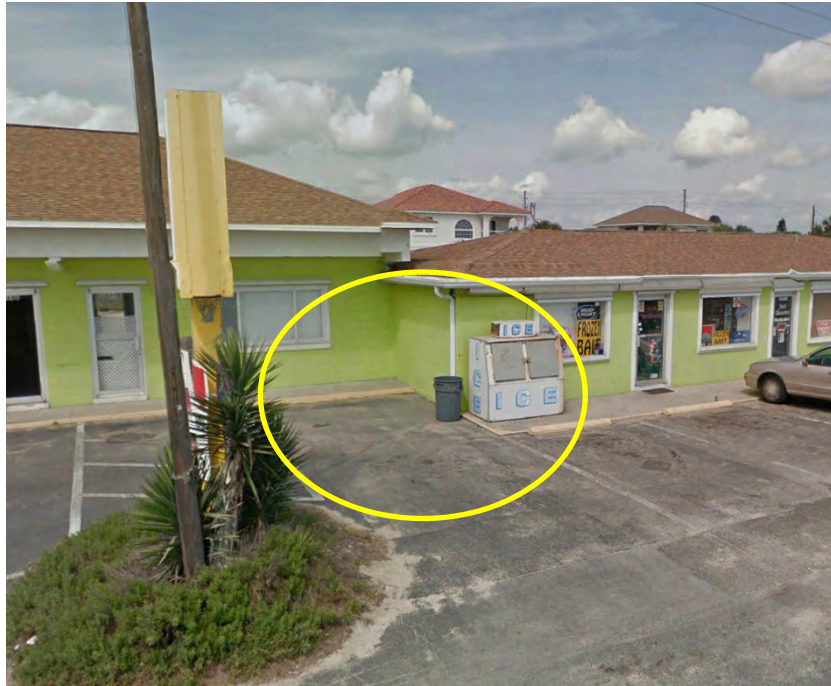
Figure 35

Concrete sidewalk is already located in front of the Pope Plaza buildings between the building face and the perpendicular parking stalls. While this sidewalk may be constructed on private property, consider working with the property owner to expand this sidewalk to be 6'-8' wide and connect to the sidewalk being considered in front of the Oceanside Bar. The two buildings in the Pope Plaza are offset, so a sidewalk connection would need to be made between the southernmost and the northernmost buildings as displayed in **Figure 35**.

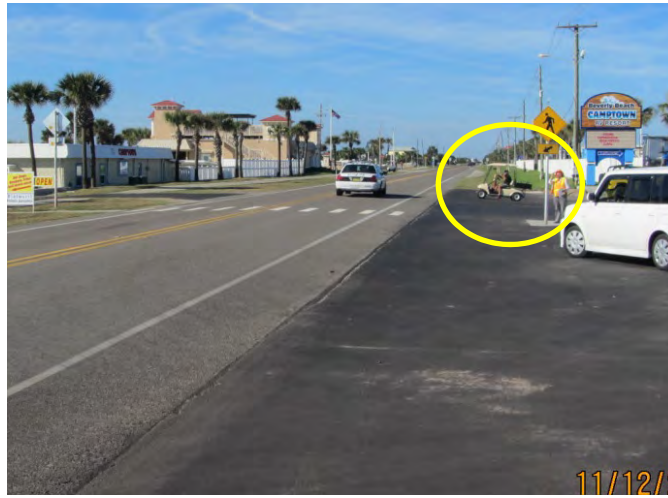
Figure 43

Golf carts were observed crossing from the west side of Beverly Beach, where the mobile homes and RV parking is located, to the east side of Beverly Beach, where the RV park grocery store and beach is located. In talking with the mayor of Beverly Beach, he noted this is a common occurrence because residents and guests do not want to drive their cars across the roadway (**Figure 43**). Golf carts are not “street legal” thus are not legally permitted to cross SR A1A in Beverly Beach.
