Reed Canal Park Bridge Replacement Feasibility Study

City of South Daytona

Prepared For: River to Sea TPO Prepared By: RS&H, Inc.

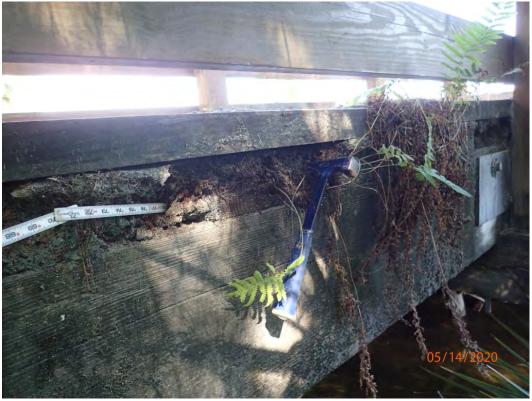
CS2 (1140) = The right ends of transverse timbers have areas of moderate decay and moderate vegetation growth, that can be probed up to 1ft. deep. Refer to Photo 1. (200SF) REPATR

Photo 1: Element 31: Outer ends of transverse timber deck are wet, soft, and decayed.

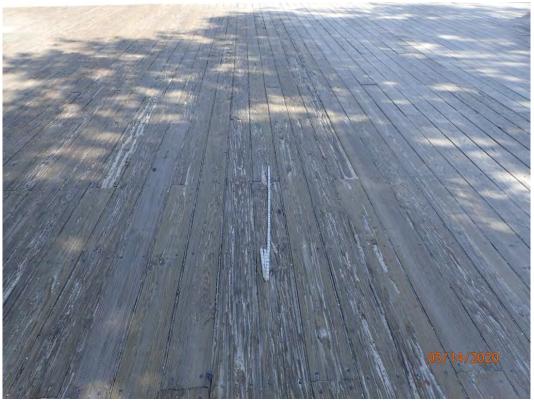
CS2 (3230) = The longitudinal timber (running boards) are weathered and checked and the nails are beginning to back out. Refer to Photo 2. (2036SF) REPAIR.

Photo 2: Element 31: Showing weathered and checked timber running boards.

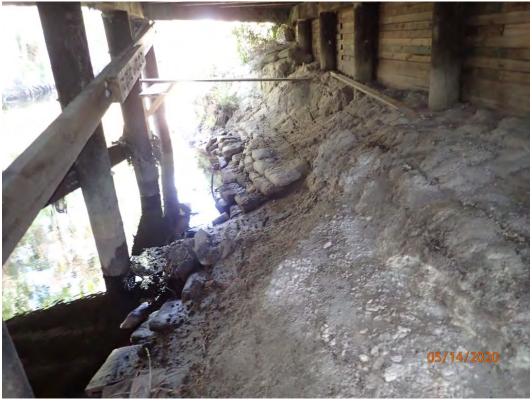
The cement rip rap bags placed along the north and south channel banks are displaced due to the channel bank erosion. Refer to Photo 3. REPAIR

Photo 3: Element 8290: Showing channel bank erosion and displaced rip rap bags.

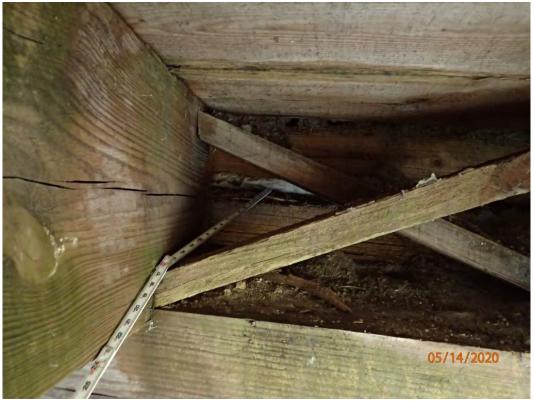
Photo 4: Element 8476: Showing fill migration and decay at Abutment 1 backwall.

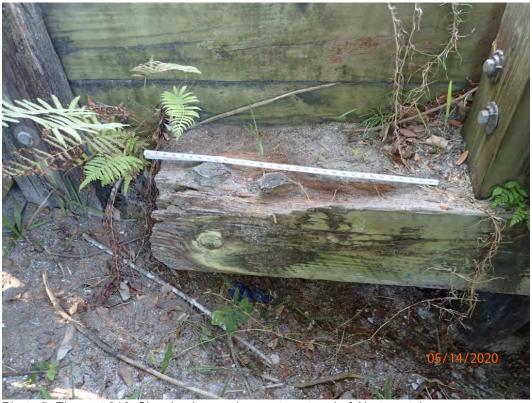
Photo 5: Element 216: Showing heavy decay at east end of Abutment 1 cap.

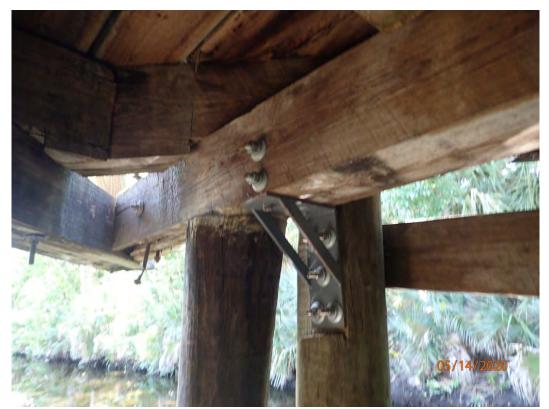
Photo 6: Element 228: Pile 4-7 bracing.

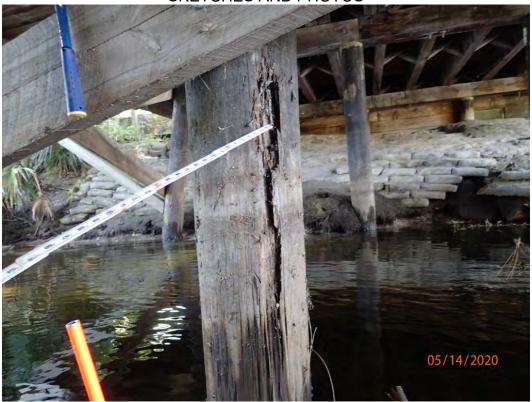
Photo 7: Element 228: Showing heavy decay at Pile 3-3.

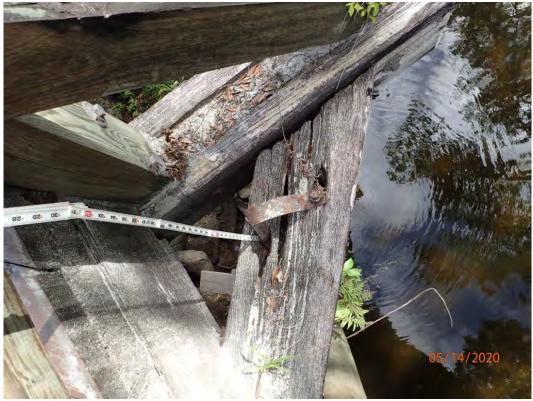
Photo 8: Element 235: Showing heavy decay at Bent 4 cap and horizontal brace.

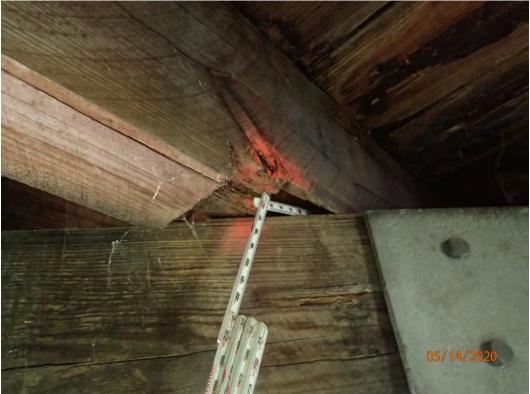
Photo 9: Element 111: Showing decay at timber stringer 4-19.
