# **SR/CR A1A PEDESTRIAN SAFETY & MOBILITY STUDY** PEDESTRIAN / BICYCLE SAFETY REVIEW Focus Area I / 19th Road to Apache Drive (Flagler County)

## Pedestrian/Bicycle Safety Review Report for SR A1A from 19<sup>th</sup> Road to Apache Drive (Flagler County)

Section Number: 73030000 (SR A1A) Mile Post: 13.095 to 14.771 Flagler County

## Project Title: Focus Area I Pedestrian/Bicycle Safety Field Review

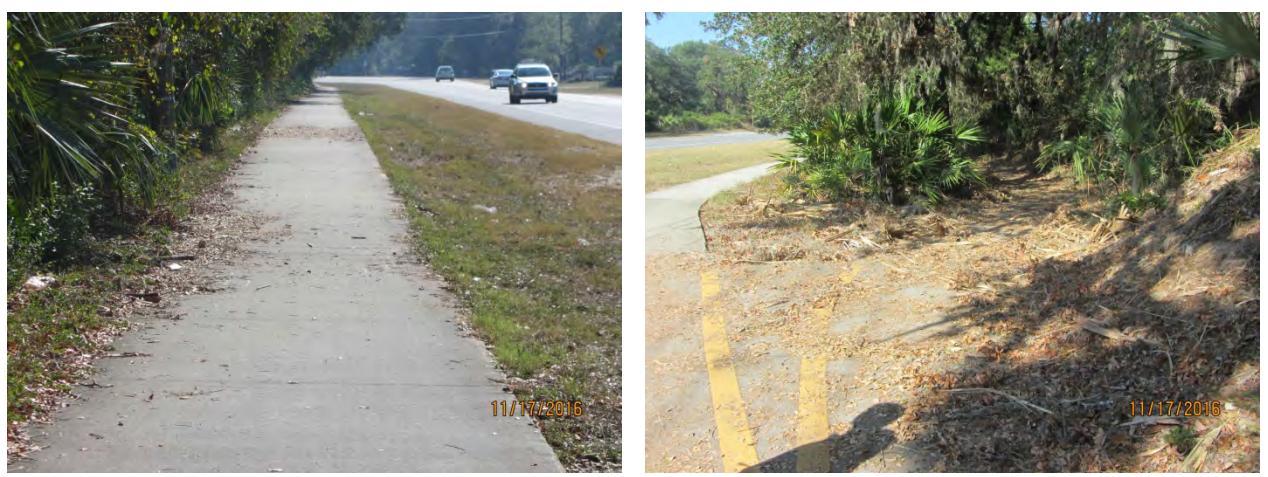
Debris covers the following sections of the sidewalk/shared-use path within the study section:

- 19<sup>th</sup> Road to Hammock Community Church (Figure 2); and
- Shared use path north of 16<sup>th</sup> Road to south of Flagler Fire & Rescue (**Figure 3**).

As a maintenance-type improvement, consider dispatching a maintenance crew to remove the debris on the sidewalk/shared-use path.

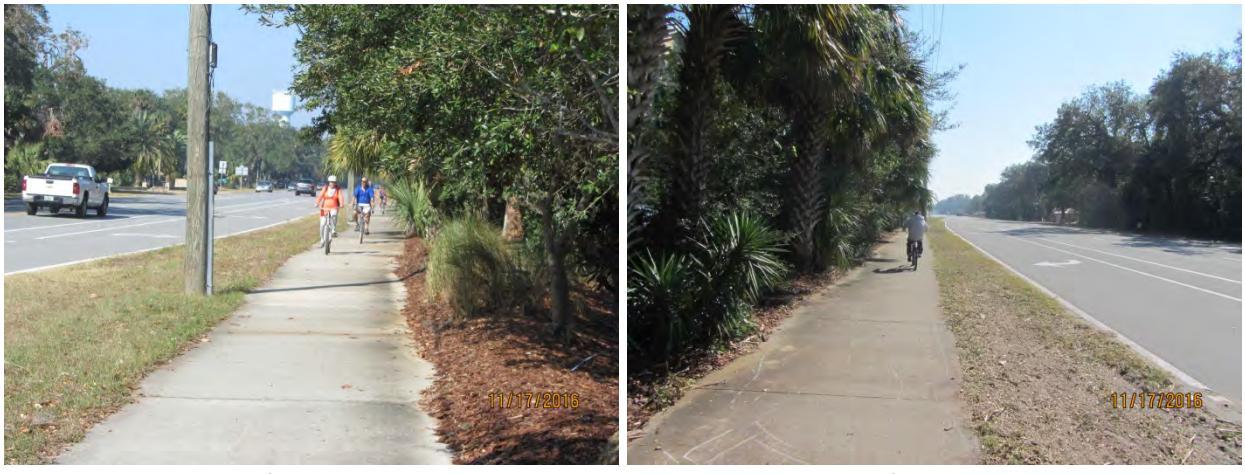
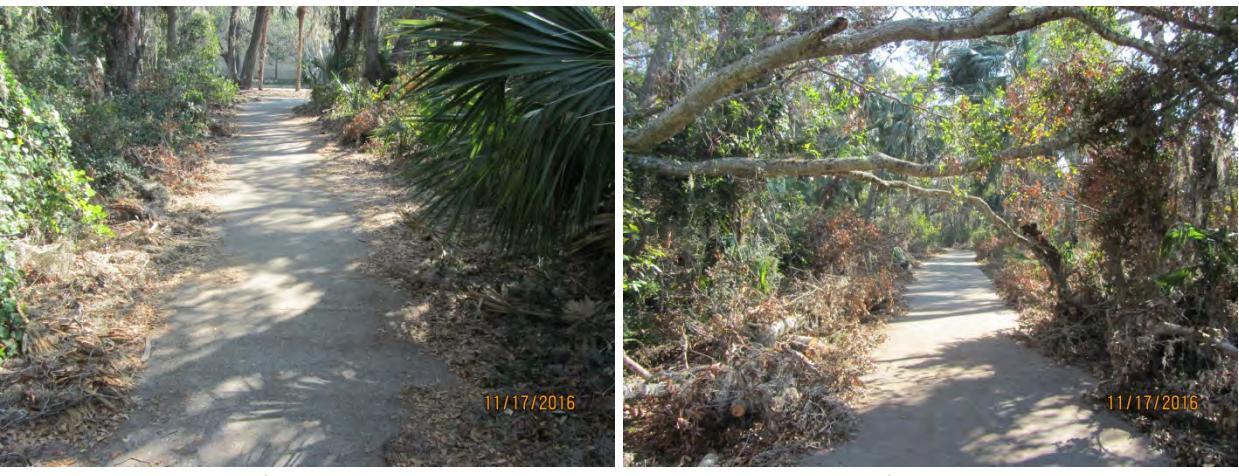
Vegetation, landscaping, and overhanging trees were observed to be encroaching onto the sidewalk/shared-use path along the following sections:

- 19<sup>th</sup> Road to SunTrust driveway;
- SunTrust driveway to 16<sup>th</sup> Road (Figure 4);
- 16<sup>th</sup> Road to south of Flagler Fire & Rescue (Figure 5 and Figure 6); and
- North of Adult & Community Education center to south of Malacompra Road (Figure 7).

As a maintenance-type improvement, consider dispatching a maintenance crew to trim vegetation so it is not encroaching on the sidewalk/shared-use path and prune overhanging trees to provide an eight-foot vertical clearance. Also, consider clearing the trees that have fallen onto the sidewalk/shared-use path.

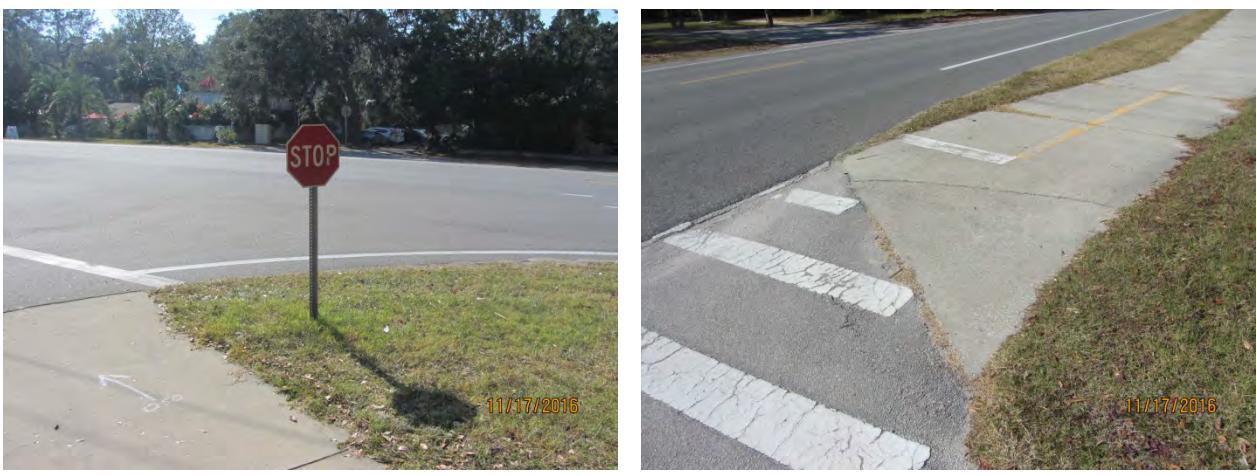
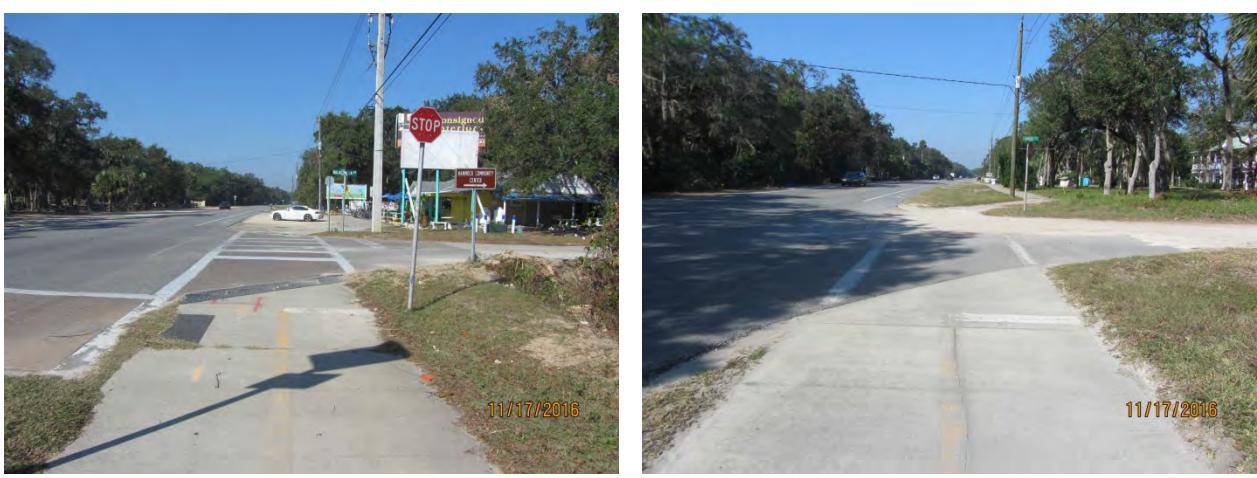
The shared-use path from 16<sup>th</sup> Road north to Apache Drive has inconsistent signage/markings at the crossing locations with driveways and stop-controlled minor streets. In some locations, just a stop bar is present, whereas in other locations only a stop sign is present. Specific locations with inconsistent signs and/or markings are as follows:

- 16<sup>th</sup> Road (Figure 8);
- Driveways at the Adult & Community Education Center (Figure 9);
- Malacompra Road (Figure 10); and
- Apache Drive (Figure 11).

According to Florida Statute 316.130(7), motorists are required to stop or yield to pedestrians in crosswalks, which would include trail crossings. As stated in the American Association of State Highway and Transportation Official's (AASHTO) Guide for the Development of Bicycle Facilities, 4<sup>th</sup> Edition,

"attempts to require bicyclists to yield or stop at each cross street driveway are inappropriate and typically not effective" (p. 5-8). The Guide also notes, "Installing unwarranted or unrealistically restrictive controls on path approaches in an attempt to 'protect' path users can result in path users disregarding the signs and other traffic control devices at the intersection. This can lead to a loss of respect for traffic control at more critical locations" (p. 5-34).

As a maintenance-type improvement, consider dispatching a maintenance crew to replace the stop signs/bars with yield signs/markings at unsignalized intersections and driveways (where appropriate). The yield signs/markings will help inform bicyclists they are approaching an intersection and should be cautious of vehicles turning to/from the minor street that may not see them.

In addition to the yield signage/markings for the trail, consider installing trail crossing warning signs (W11-15) and plaques (W11-15P) that would draw the motorist's attention to the presence of pedestrians or bicycles on the shared use path.

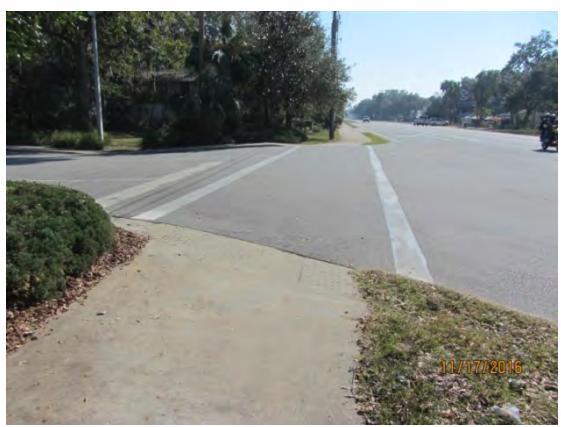
Figure 12

The study team observed crosswalks at minor streets and driveways were faded. Certain driveways have crosswalk markings for pedestrians, such as the SunTrust and Publix driveway in **Figure 12**, while other driveways do not have markings. Specific locations with faded crosswalk markings are below:

- SunTrust driveway (Figure 12);
- 16<sup>th</sup> Road (**Figure 13**);
- Driveways at the Adult & Community Education Center (Figure 14);
- Malacompra Road (Figure 15); and
- Apache Drive.

As a maintenance-type improvement, consider restriping the current crosswalk markings at unsignalized intersections (standard or special emphasis determined on a case-by-case basis) as shown on sheet 12 of FDOT Design Standard Index 17346 to provide consistency along the corridor. To emphasize the pedestrian realm at frequently used driveways, consider striping standard crosswalk markings as shown on sheet 12 of FDOT Design Standard Index 17346.

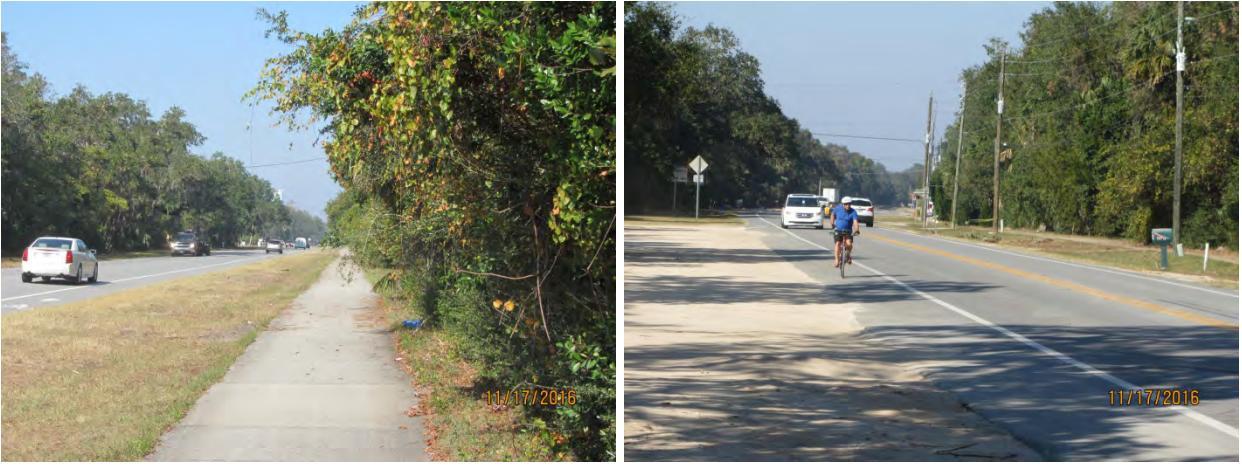
Figure 16

During the field review, the team observed vehicles driving on the raised audible pavement markings, disregarding their purpose to warn drivers about driving on the shoulder. **Figure 16** and **Figure 17** show drivers driving close/on the line, one near a bicyclist while he was utilizing the shoulder bicycle facility.

As a near-term improvement, consider implementing ground-in rumble strips or profiled thermoplastic to more effectively alert drivers when they are crossing into the shoulder.

If rumble strips are utilized, consider repaving the shoulders and adding pavement to create space for the strips and provide a homogenous surface for bicyclists. If the shoulder is repaved, consider adding enough pavement to provide a 7' buffered bicycle lane.

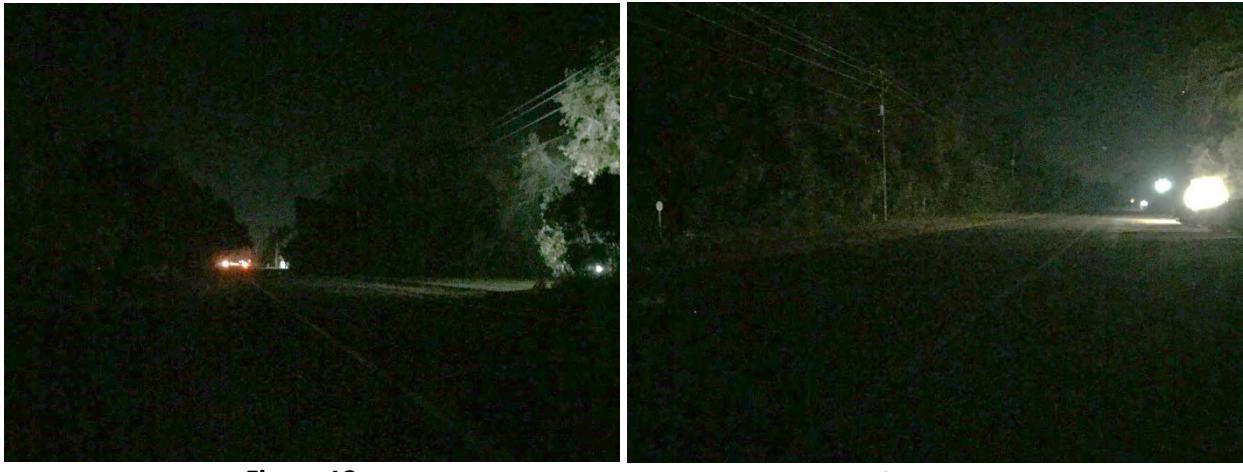
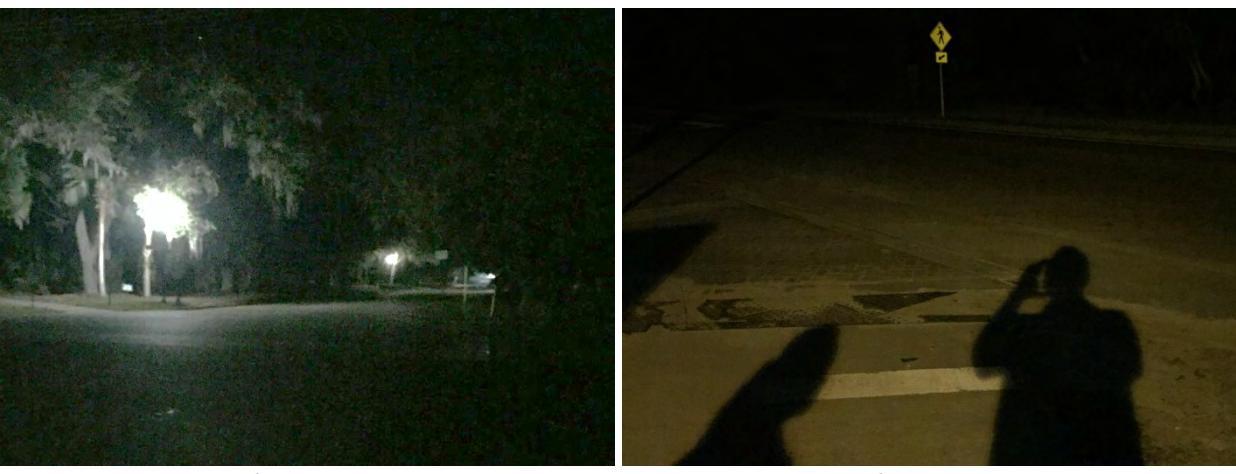
With the exception of roadway lighting along the north side of 16<sup>th</sup> Road E (**Figure 20**), no roadway lighting is present along the study corridor. Two of the three crashes (67 percent) occurred in dark lighting conditions, with both resulting in a fatality.

Consider conducting a lighting justification study along unlit portions of the corridor to determine if additional lighting is justified. Also, consider implementation of pedestrian-level lighting to supplement areas where roadway lighting is not able to provide adequate illumination along the shared-use path between 16<sup>th</sup> Road and Malacompra Road.

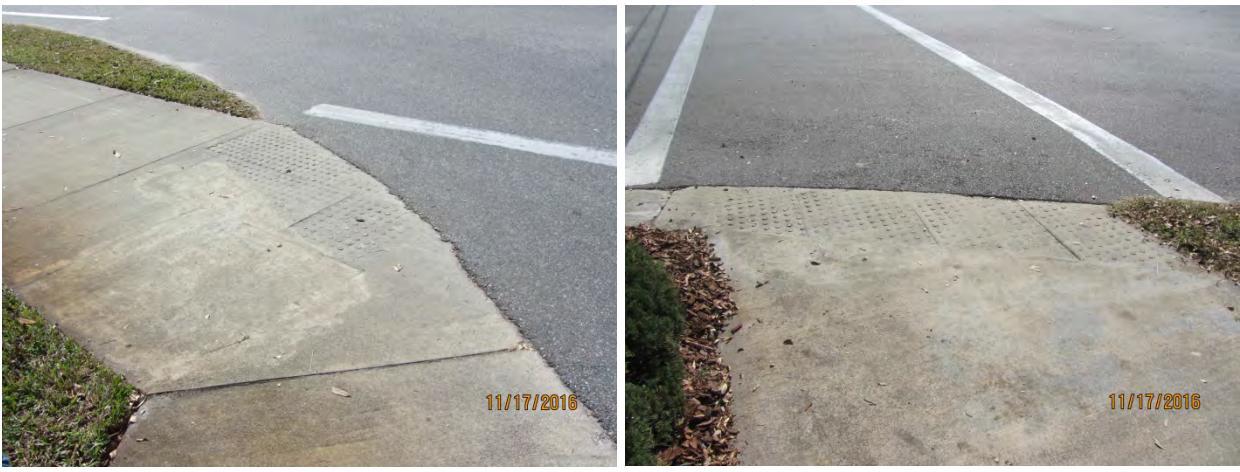
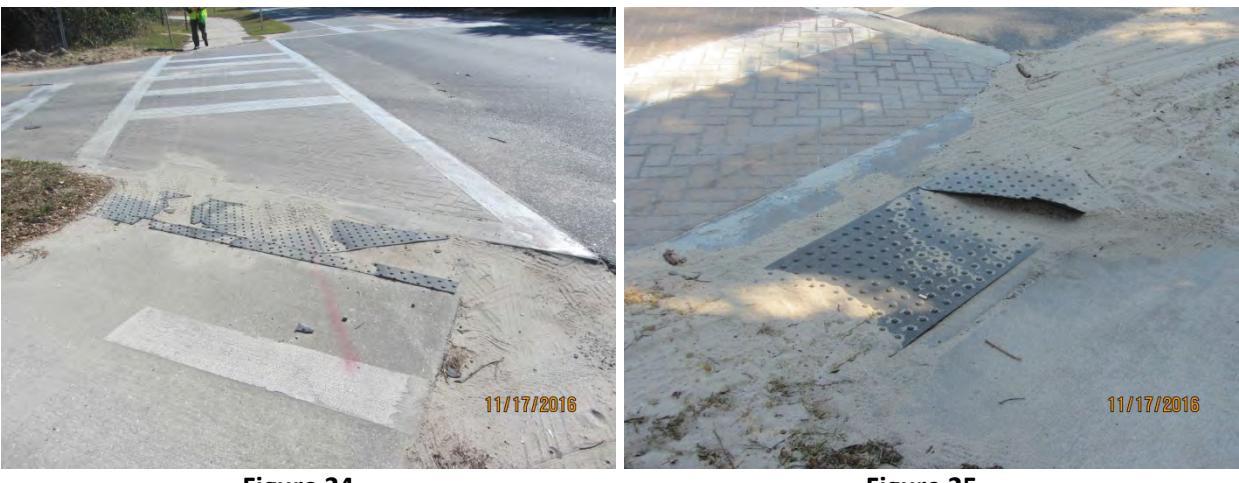
The detectable warning surfaces at certain intersections are concrete-stamped, as displayed in Figure 22 and Figure 23, or destroyed as shown in Figure 24 and Figure 25.

As a maintenance-type improvement, consider dispatching a maintenance crew to install new detectable warning surfaces per FDOT Design Standard Index 304.

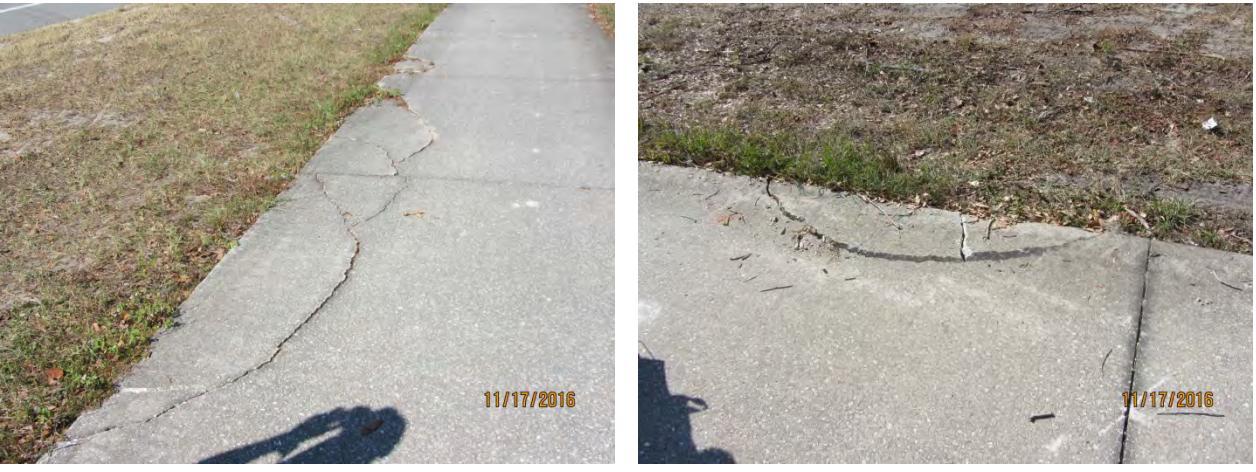
Figure 26

Sections of the concrete sidewalk between 19<sup>th</sup> Road and 18<sup>th</sup> Road are cracked and/or broken (**Figure 26** and **Figure 27**) creating a possible tripping hazard for pedestrians.

As a maintenance-type improvement, consider dispatching a maintenance crew to reconstruct the damaged concrete panels.

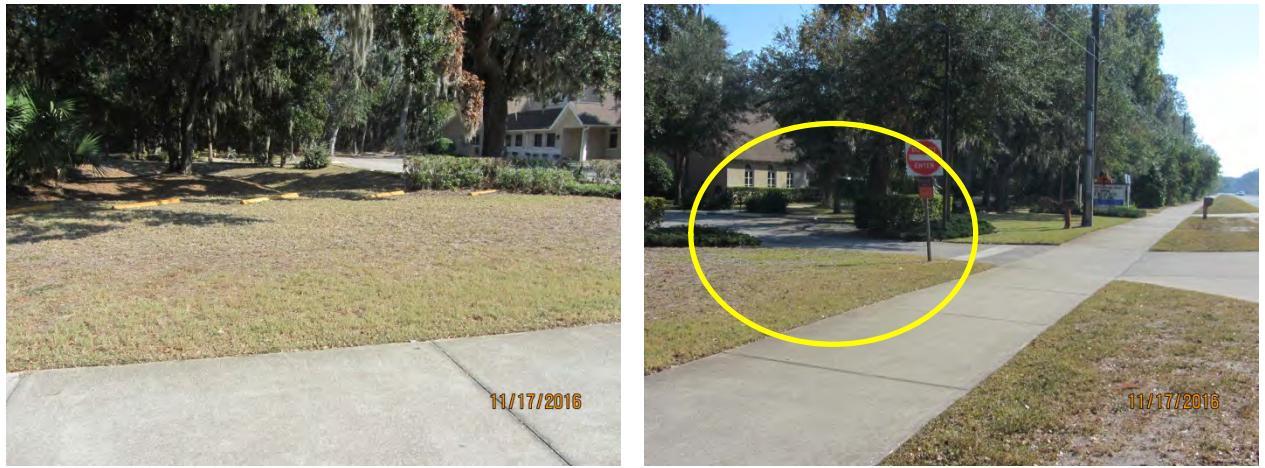
Hammock Community Church has created parking spaces in their lawn adjacent to the sidewalk (Figure 28). Vehicles can access this parking via the exit driveway, prior to the DO NOT ENTER sign (Figure 29), or from the roadway over the grass shoulder and sidewalk. A vehicle traversing the sidewalk is a safety issue for pedestrians that may be using the path while also causing cracks in the concrete panels because they are not designed to support the weight of a vehicle.

As a near-term improvement, consider coordinating with Hammock Community Church to remove the parking or to create another on-site access point to the parking area. This would eliminate the need for vehicles to traverse the sidewalk to access the parking area.

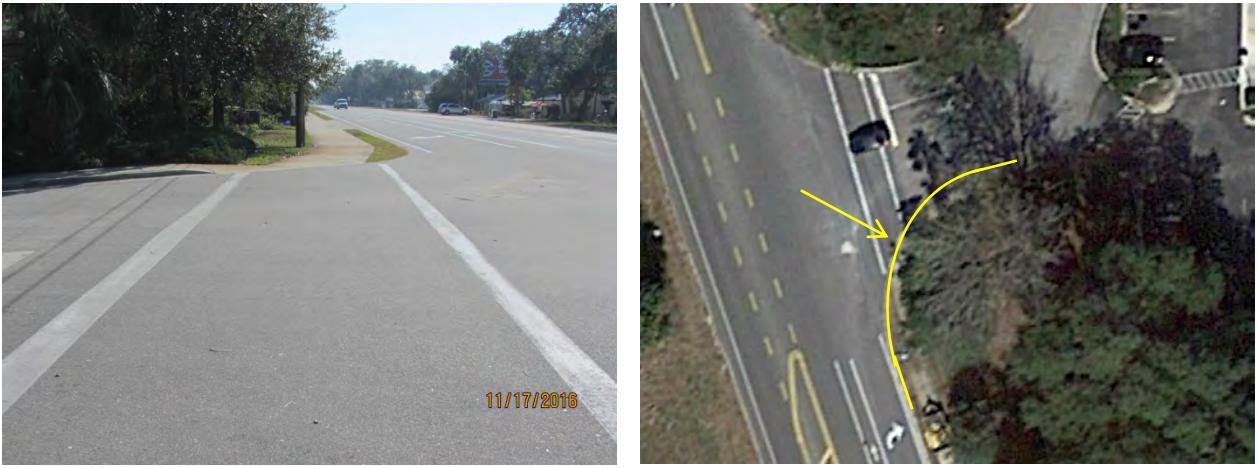
The southeast corner of the SunTrust driveway (Figure 30) has a large curb return radius (Figure 31), which enables drivers to make northbound right-turn movements at higher rates of speed. Vehicles that are traveling faster may not see pedestrians/bicyclists utilizing the crosswalk, thus creating a conflict.

As a near-term improvement, consider reconstructing the southeast corner curb return radius based on FDOT Standard Index 515 so the driveway throat width is reduced.

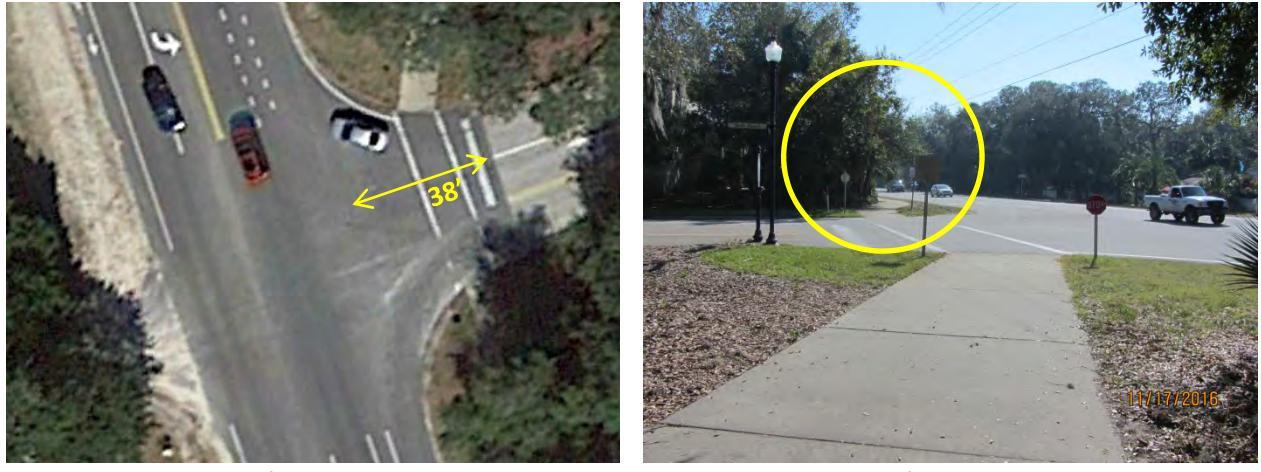
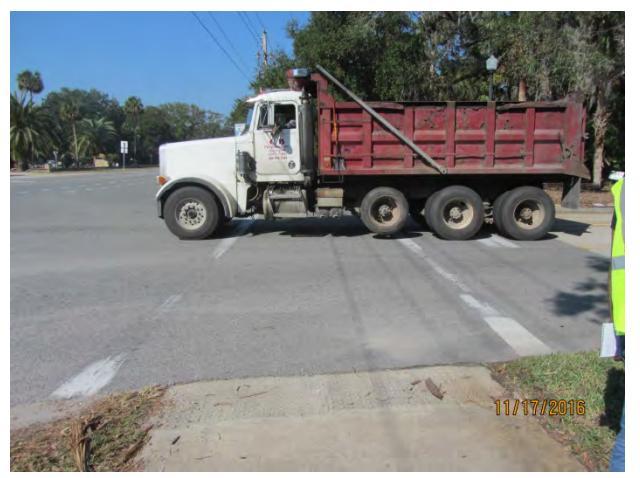
The existing stop bar is located approximately 38' from the edge of pavement along SR A1A (**Figure 32**) due to the setback distance of the crosswalk. In combination with the vegetation along the path (**Figure 33**), intersection sight distance is limited for westbound drivers departing 16<sup>th</sup> Road. **Figure 34** displays a dump truck that had to stop over the crosswalk in order to obtain the sight distance needed to turn onto SR A1A.

As a near-term improvement, consider realigning the sidewalk/shared-use path closer to the roadway and restriping the crosswalk as discussed in **Issue #4: Unsignalized Intersection and Driveway Crosswalk Markings**. In doing so, the stop bar could be brought closer to the roadway thus increasing sight distance. When reconstructing the sidewalk south of 16<sup>th</sup> Road, widen from 8' to 10' so the sidewalk to shared-use path transition takes place south of 16<sup>th</sup> Road instead of at the crosswalk for the intersection.

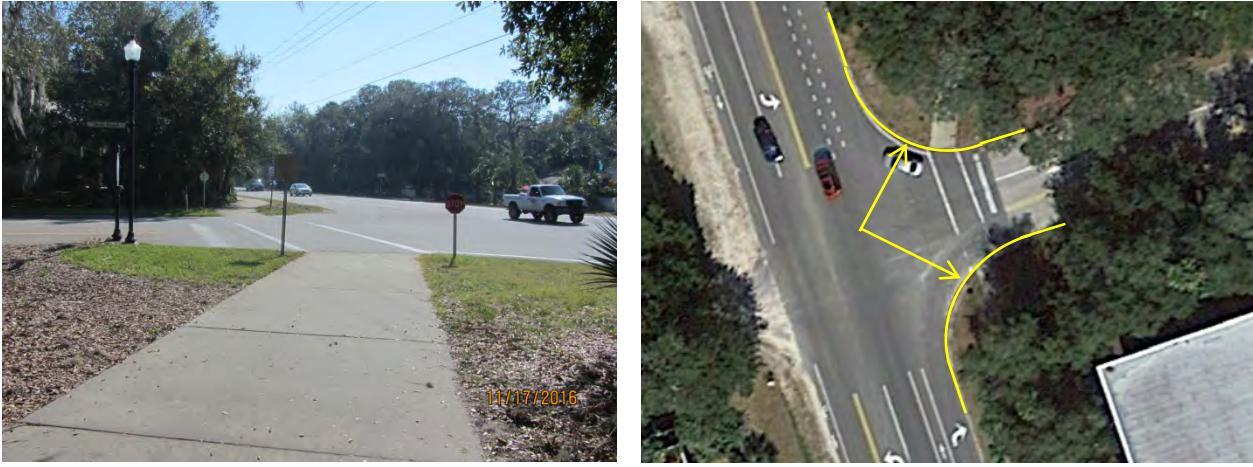
The northeast and southeast corners at 16<sup>th</sup> Road (**Figure 35**) have large curb return radii (**Figure 36**), which enables drivers to make northbound and westbound right turn movements at higher rates of speed. Vehicles that are traveling faster may not see pedestrians/bicyclists utilizing the crosswalk, thus creating a conflict.

As a near-term improvement, consider reconstructing the northeast and southeast corner curb return radius based on FDOT Standard Index 515 so the driveway throat width is reduced.

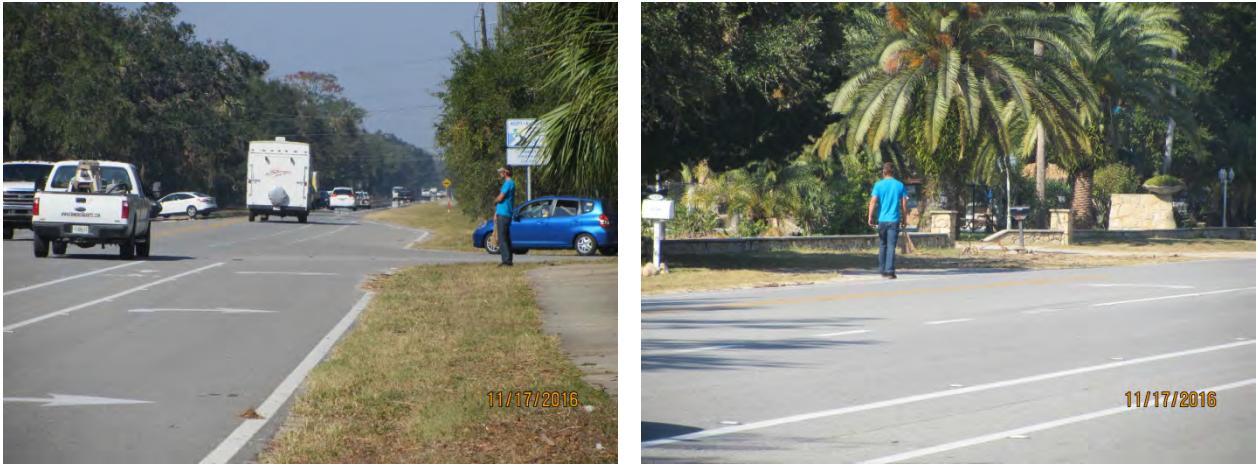
Figure 37

The existing intersection traffic control is two-way stop for 16<sup>th</sup> Road with crosswalk markings on the east leg, as discussed in **Issue #11: Intersection Sight Distance**. During the daytime field review, the study team observed a pedestrian crossing SR A1A westbound at 16<sup>th</sup> Road (**Figure 37** and **Figure 38**), in addition to steady vehicular traffic turning from 16<sup>th</sup> Road E. 16<sup>th</sup> Road E provides resort and beach access, as well as access to Publix, attracting motorists, pedestrians, and bicyclists.

As a near-term improvement, consider conducting a signal warrant evaluation at this intersection. If the intersection warrants a signal and a signal is constructed, consider installing crosswalks and pedestrian features on the north and south legs to provide crossings across SR A1A for pedestrians and bicyclists.

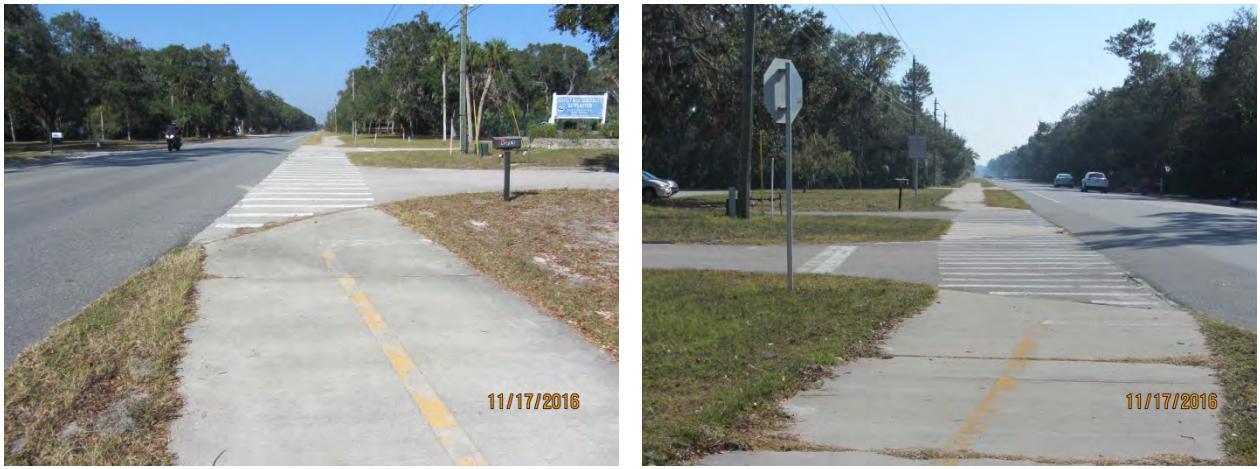
The existing crosswalks at the Adult & Community Education Center driveways are adjacent to the edge of pavement without any buffer (**Figure 39** and **Figure 40**) creating an uncomfortable walking/cycling experience for a non-motorist on the shared-use path.

As a near-term improvement, consider realigning the crosswalk to the east and providing a 5' landscape buffer between the crosswalk and roadway if right-of-way is available.

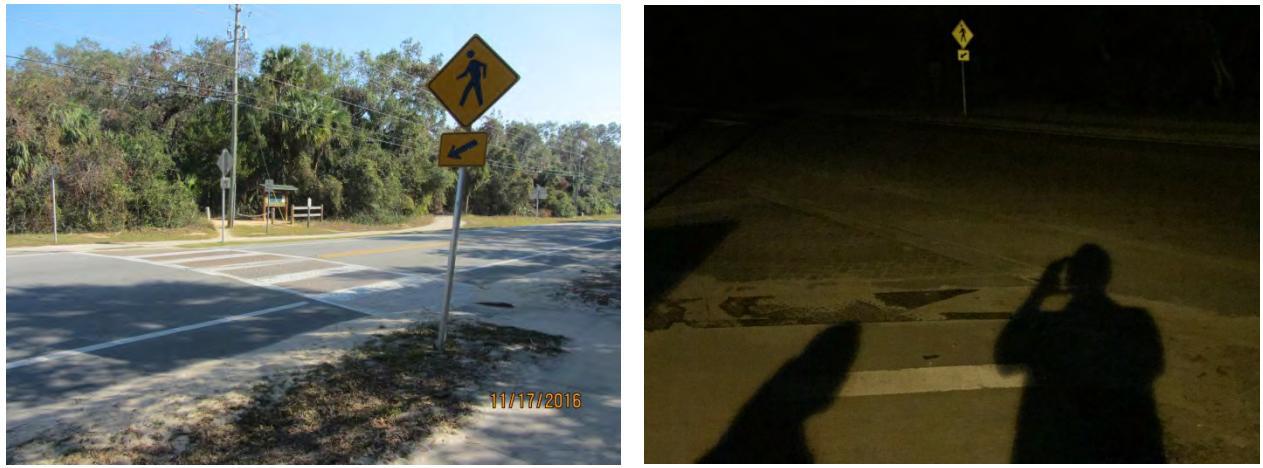
Figure 41

The pedestrian warning signs along SR A1A for the crosswalk markings at Malacompra Road (Figure 41) have limited retro-reflectivity. This is primarily an issue during non-daytime hours because no roadway lighting is present along the corridor to illuminate the crosswalks (Figure 42).

As a maintenance-type improvement, consider dispatching a maintenance crew to replace the existing signs (W11-2) and plaques (W16-7P) to enhance their visibility. Due to the lack of roadway lighting near the crossing, consider replacing the standard yellow background with those having the fluorescent yellow-green background with Type 11 sheeting.

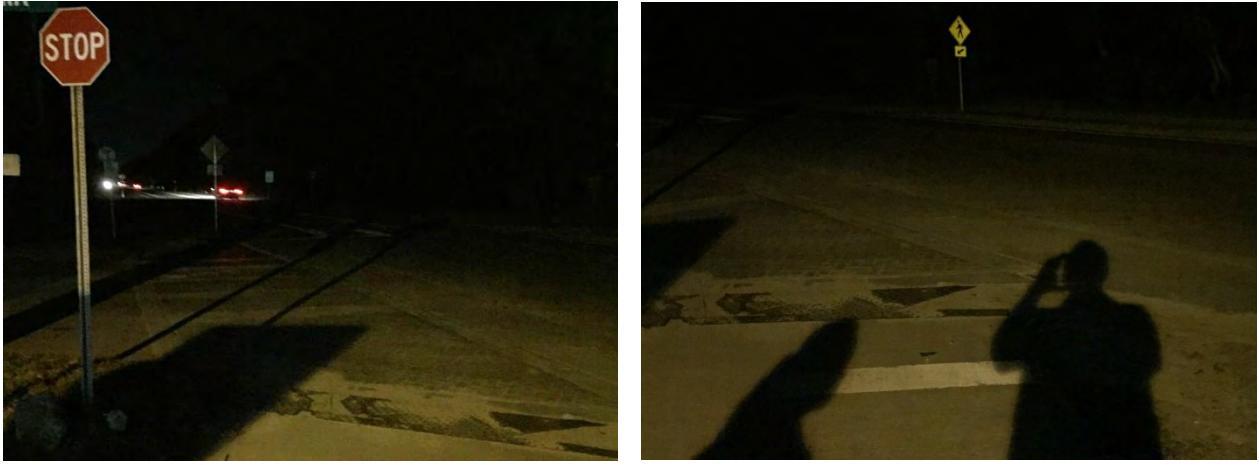
The intersection of SR A1A and Malacompra Road has special emphasis crosswalk markings on the east and south legs which are visible during the daytime but are difficult to see at night (**Figure 43** and **Figure 44**), even with ambient lighting.

As a long-term improvement, consider one of the following options to enhance the lighting at this intersection:

- 1. Implement pedestrian activated overhead lighting to illuminate crosswalks. When a pedestrian approaches the crosswalk, he/she can push a button to activate the lighting which will help alert drivers of a pedestrian utilizing the crosswalk. The lighting would then turn off once the pedestrian has crossed the roadway, based on the MUTCD walking speed of 3.5 feet/second.
- 2. Install in-pavement lighting along the crosswalk bars, either LED-powered discs or activated lights that can be activated when a pedestrian pushes a button to cross the roadway. These in-pavement lights would also help alert drivers to pedestrians in the crosswalk.
