# **Pedestrian Study**

Qualitative Assessment  
Pedestrian Volume Count

**SR A1A at 3rd Street South (Flagler Beach Pier)**

FLAGLER COUNTY  
SECTION 73030  
MP 3.890 to MP 3.942

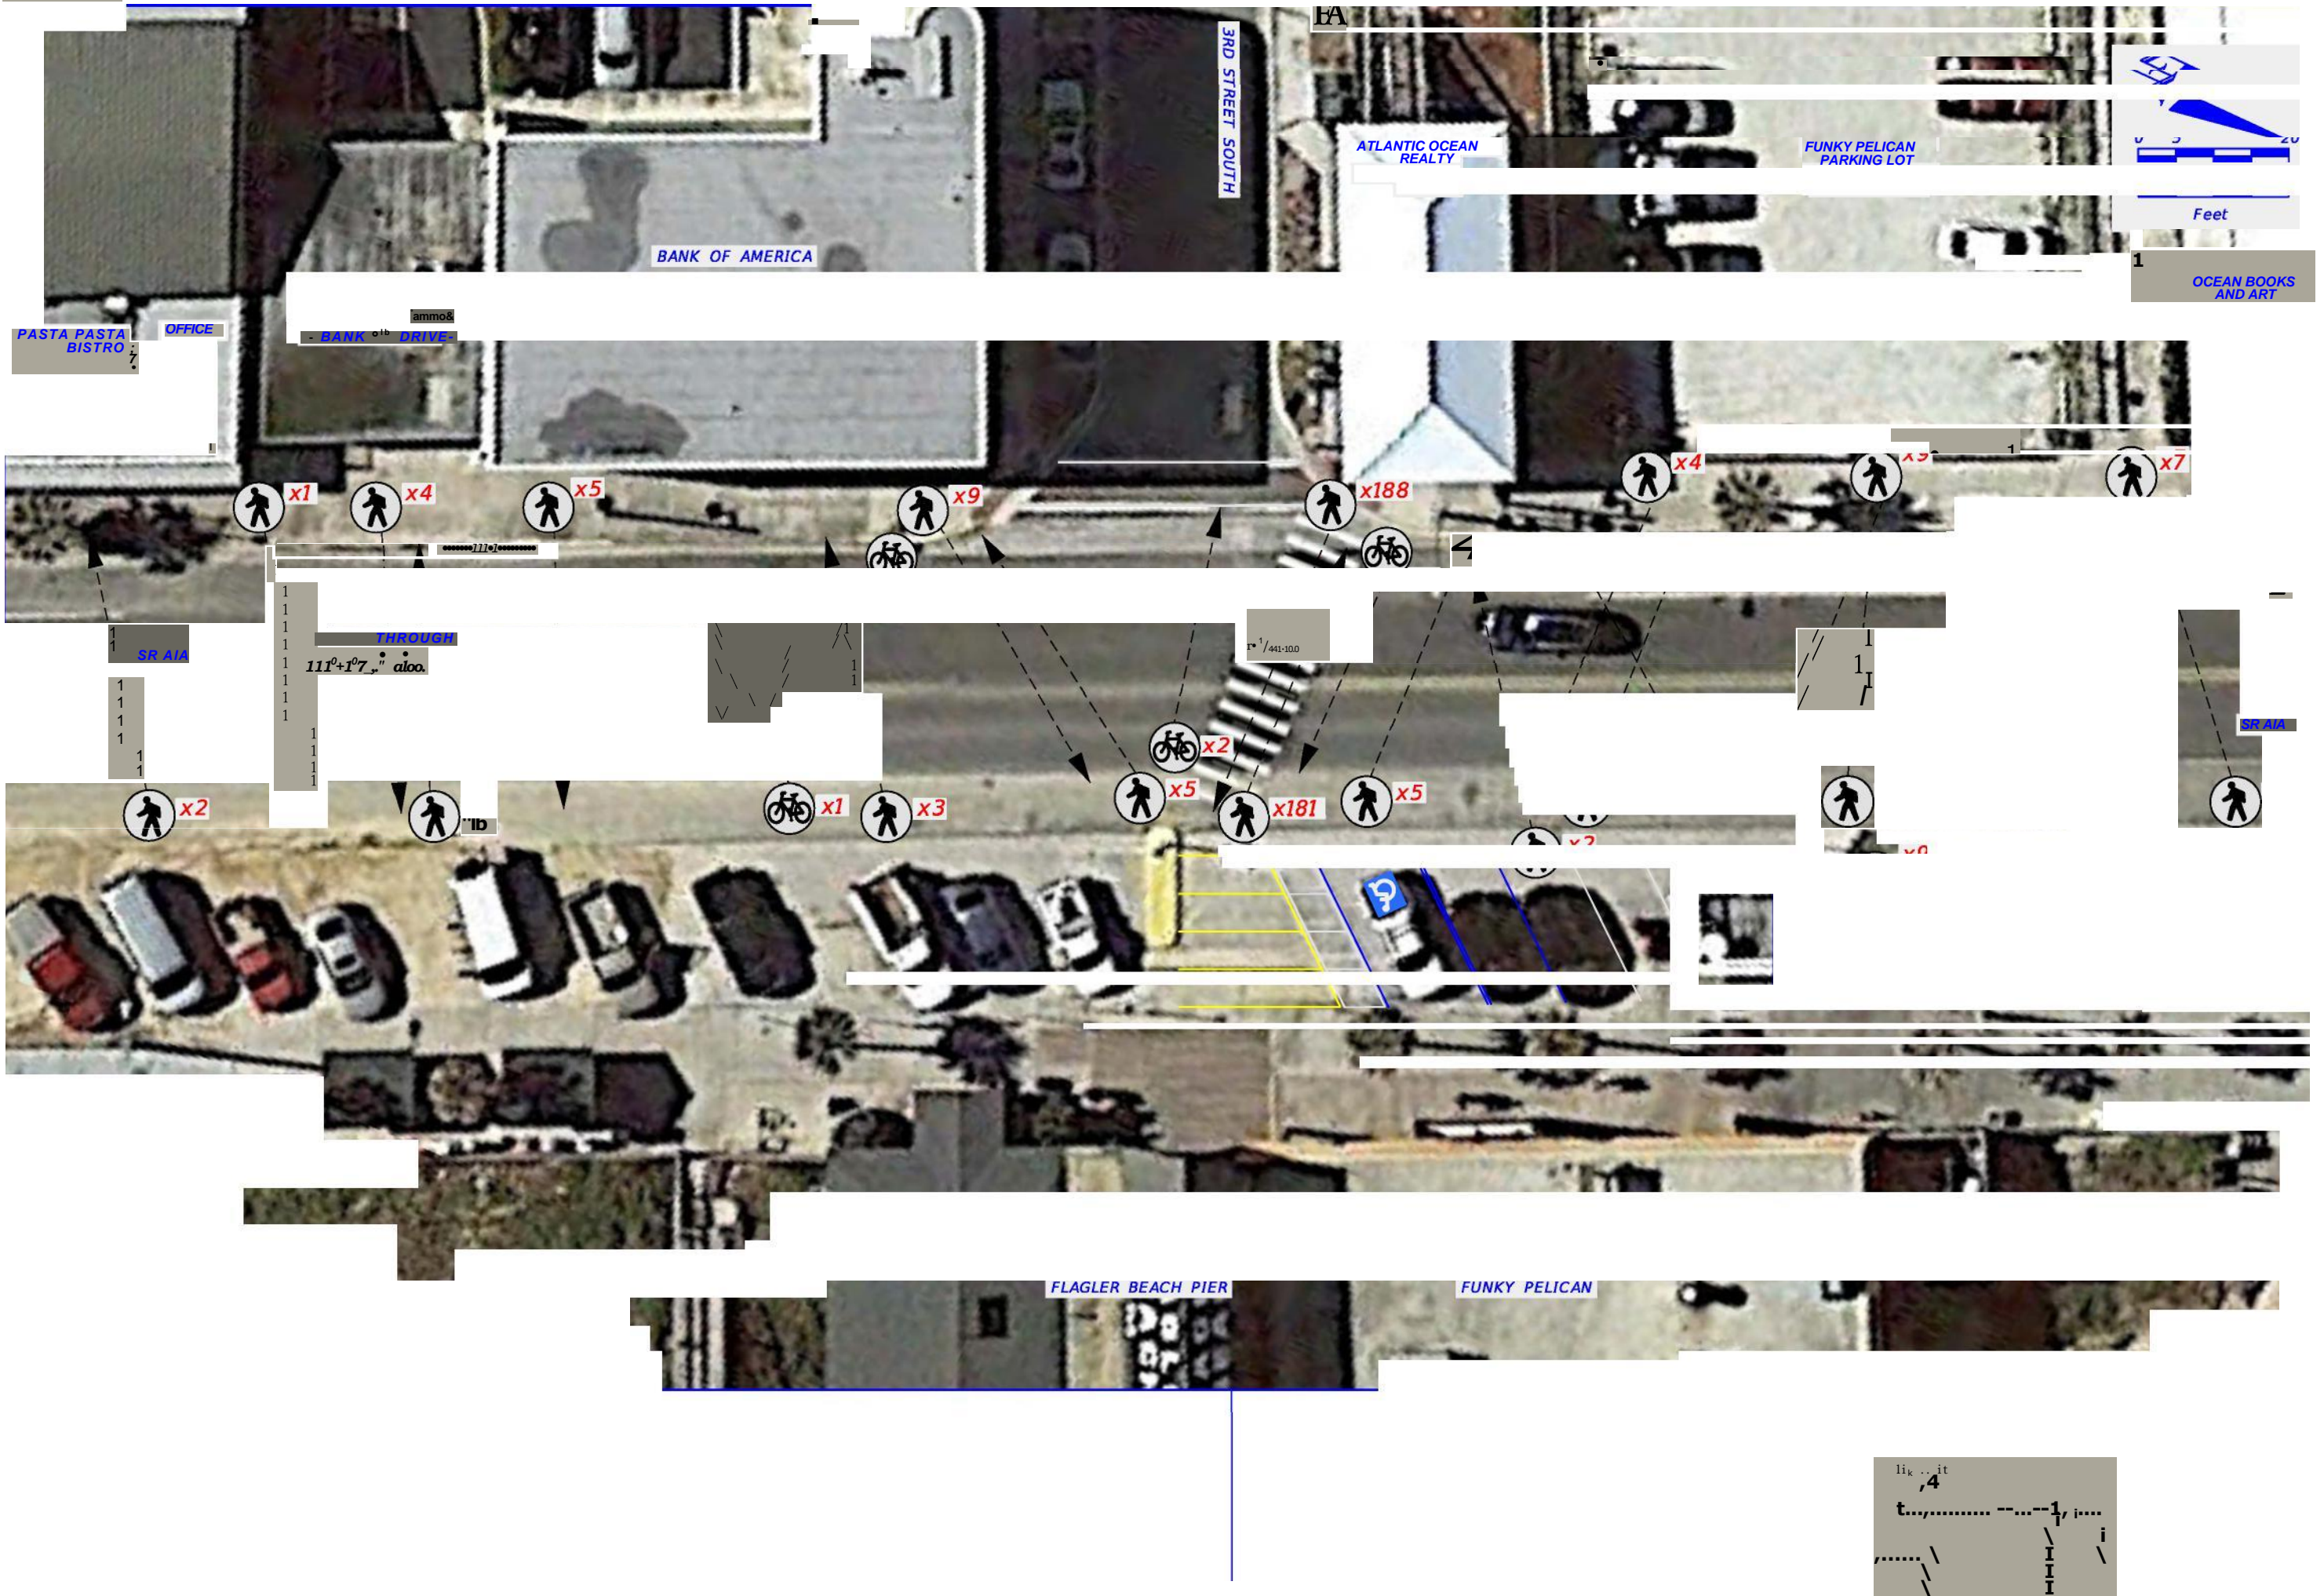
A four-hour pedestrian/bicycle count summary is included in the appendix of the report. The pedestrian/bicycle crossing locations are shown in detail in Figure 2.

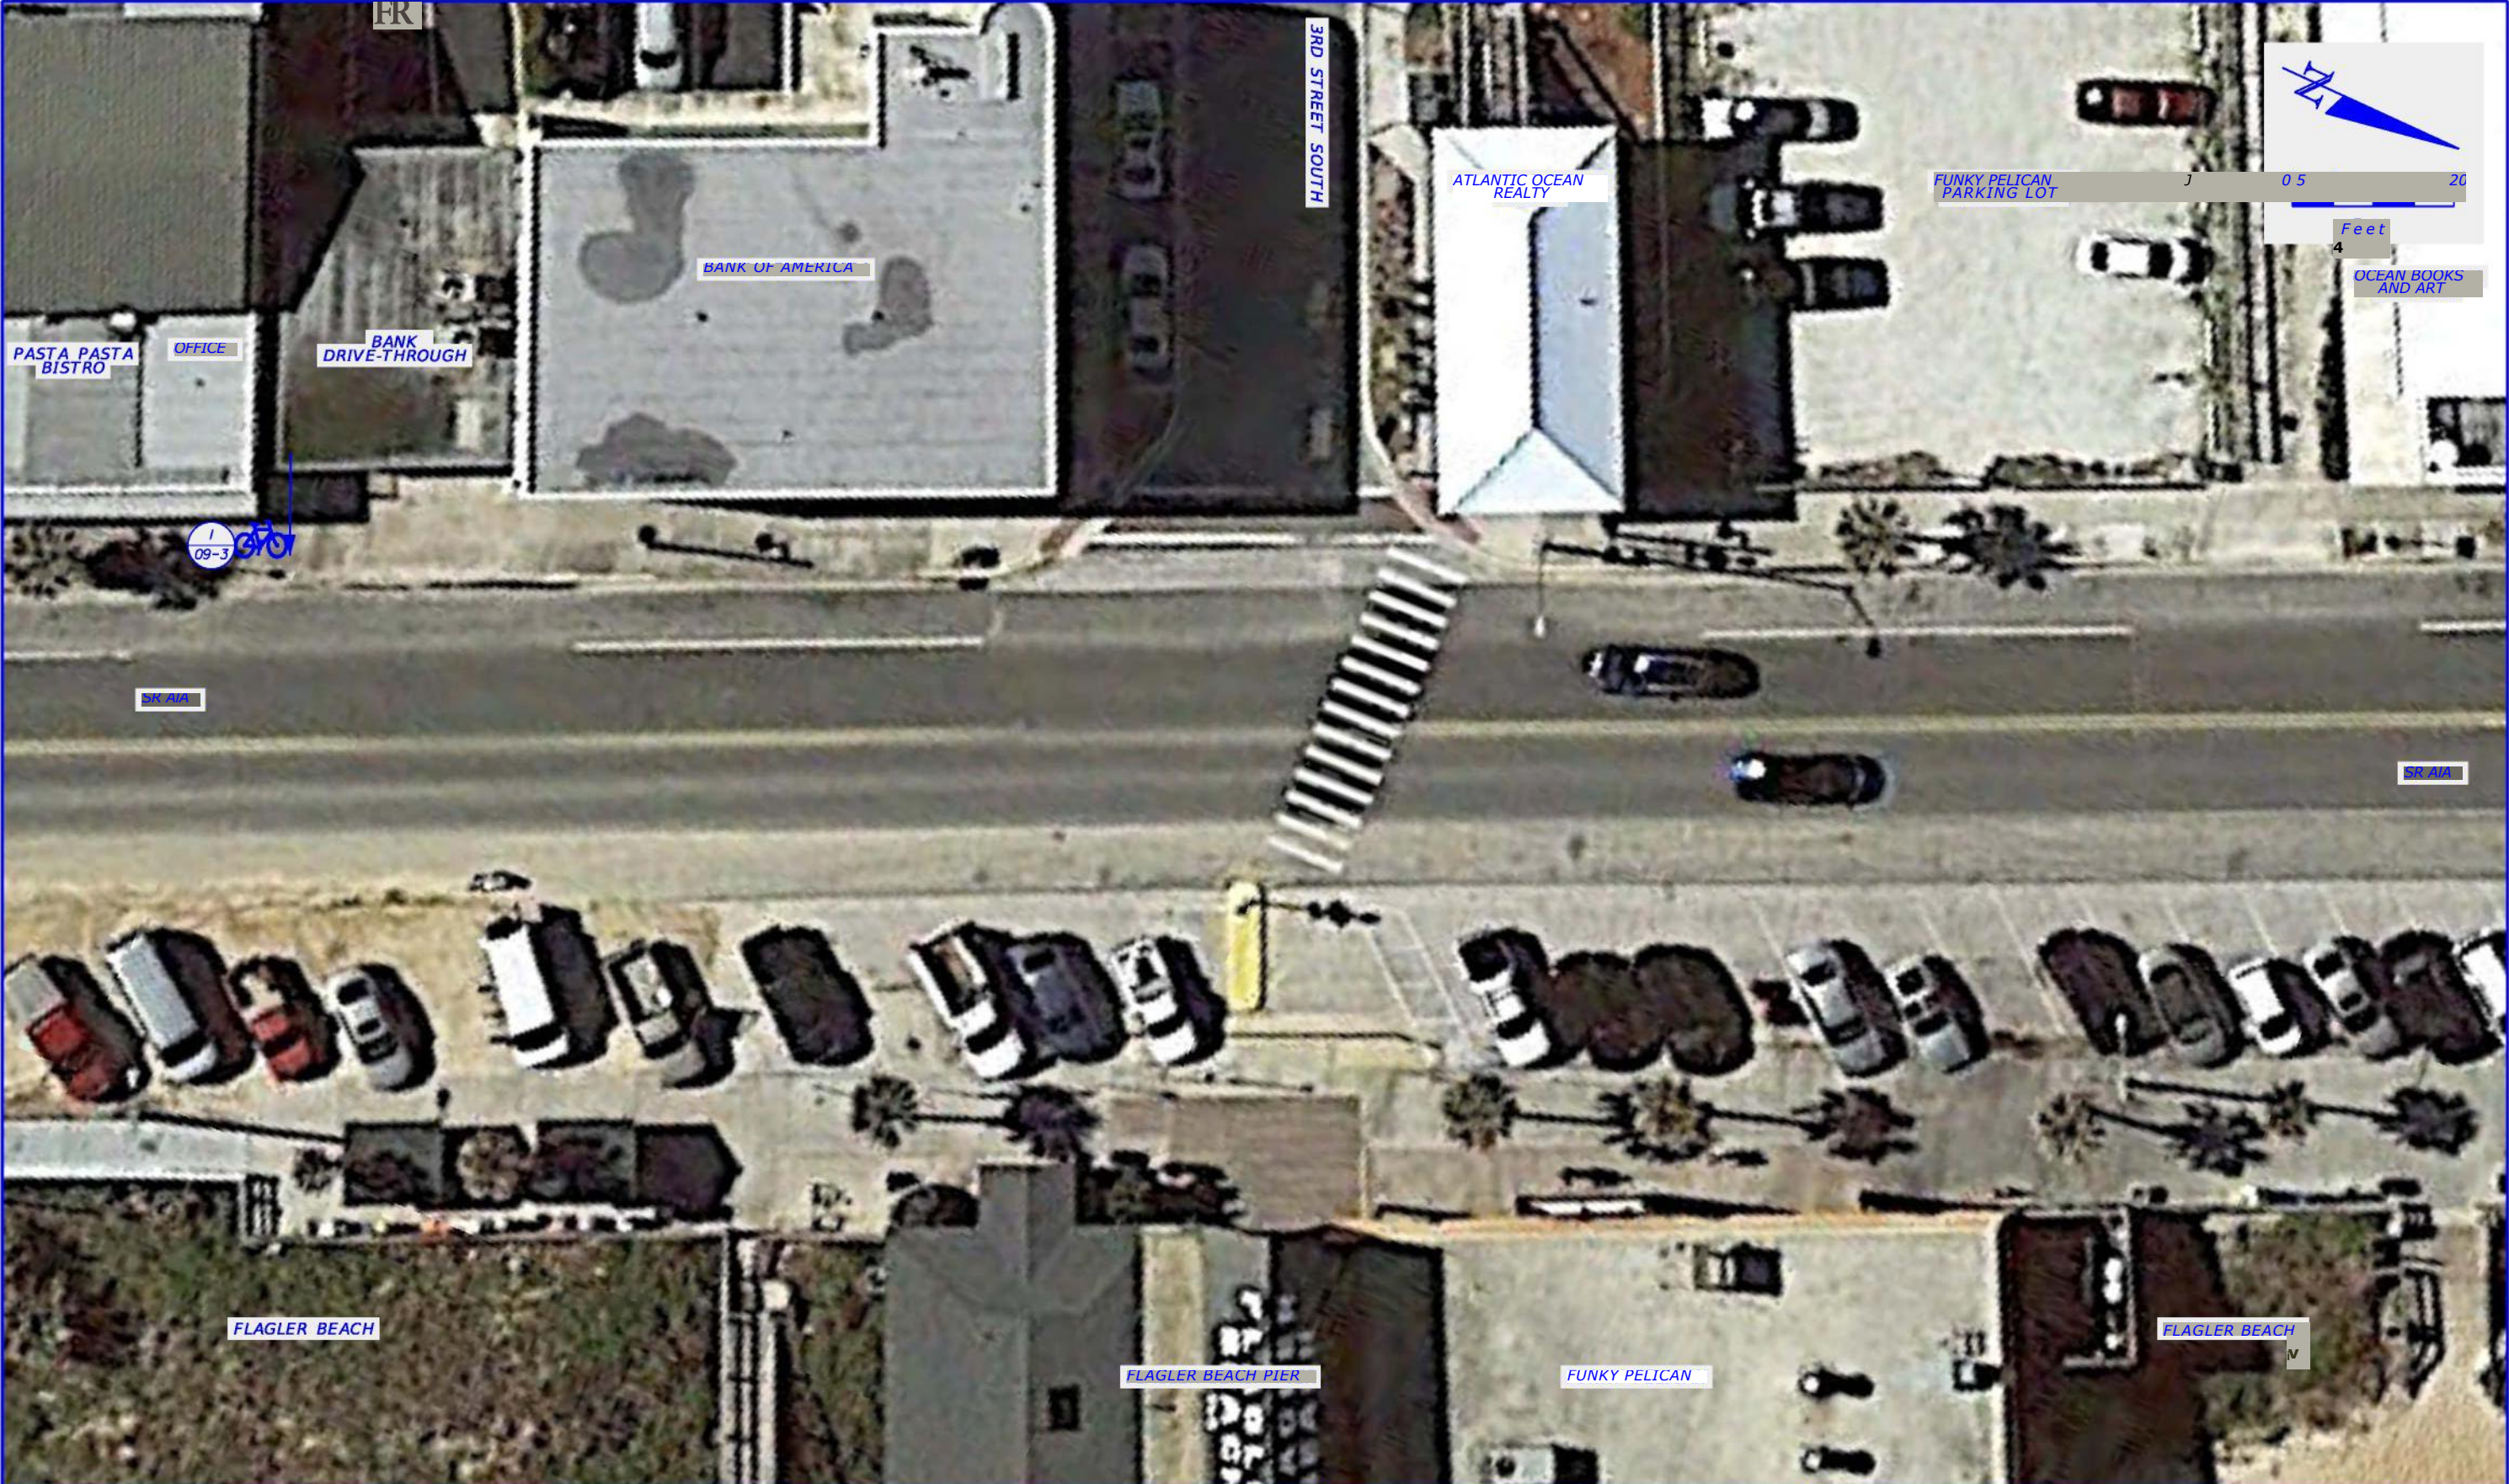
A review of FDOT Collision Analysis Reporting System (CARS) and Signal Four Analytics data found one reported bicycle-related collision within the study limits during the five year period ending December 2013. The crash occurred when a northbound bicyclist, riding on the sidewalk, struck the side of a vehicle exiting the bank drive-through. The collision resulted in one injury and occurred during the day on a dry roadway.

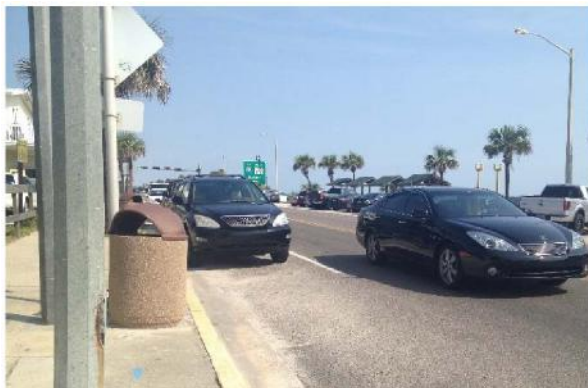
Eastbound sight line to southbound A1A from curb ramp

- Vehicles parked within the on-street parking were observed to restrict the line of sight for eastbound pedestrians entering the crosswalk and southbound motorists approaching the crosswalk. Eastbound pedestrians do not achieve an adequate line of sight until they have entered approximately 10 feet into the crosswalk. Per Plans Preparation Manual Chapter 8, adequate sight distance shall be provided for both the pedestrian and motorists per PPM Table 2.7.1, Minimum Stopping Sight Distance. Per Table 2.7.1, the minimum stopping sight distance for a 30 mph speed limit is 200 feet. The existing southbound stopping sight distance from the curb is estimated to be 80 feet due to on-street parking. Sight distance can be improved via the construction of a curb bulb-out on the northwest corner of the intersection. The bulb-out will also provide a traffic calming feature on southbound SR A1A approaching the crosswalk. Consideration was given to re-aligning the crosswalk to be perpendicular to SR A1A; however, it is likely that pedestrians would still cross at a diagonal to the pier, as this is the primary destination for pedestrians.

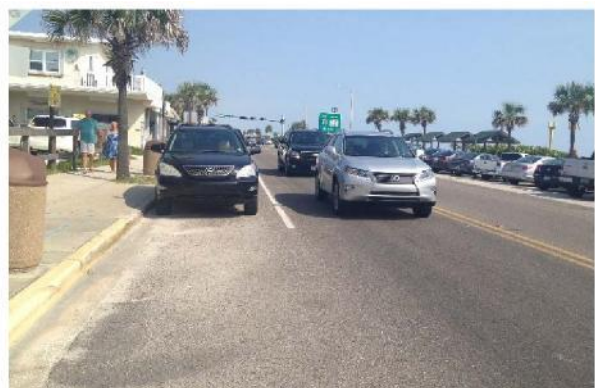
Eastbound sight line to southbound A1A from crosswalk

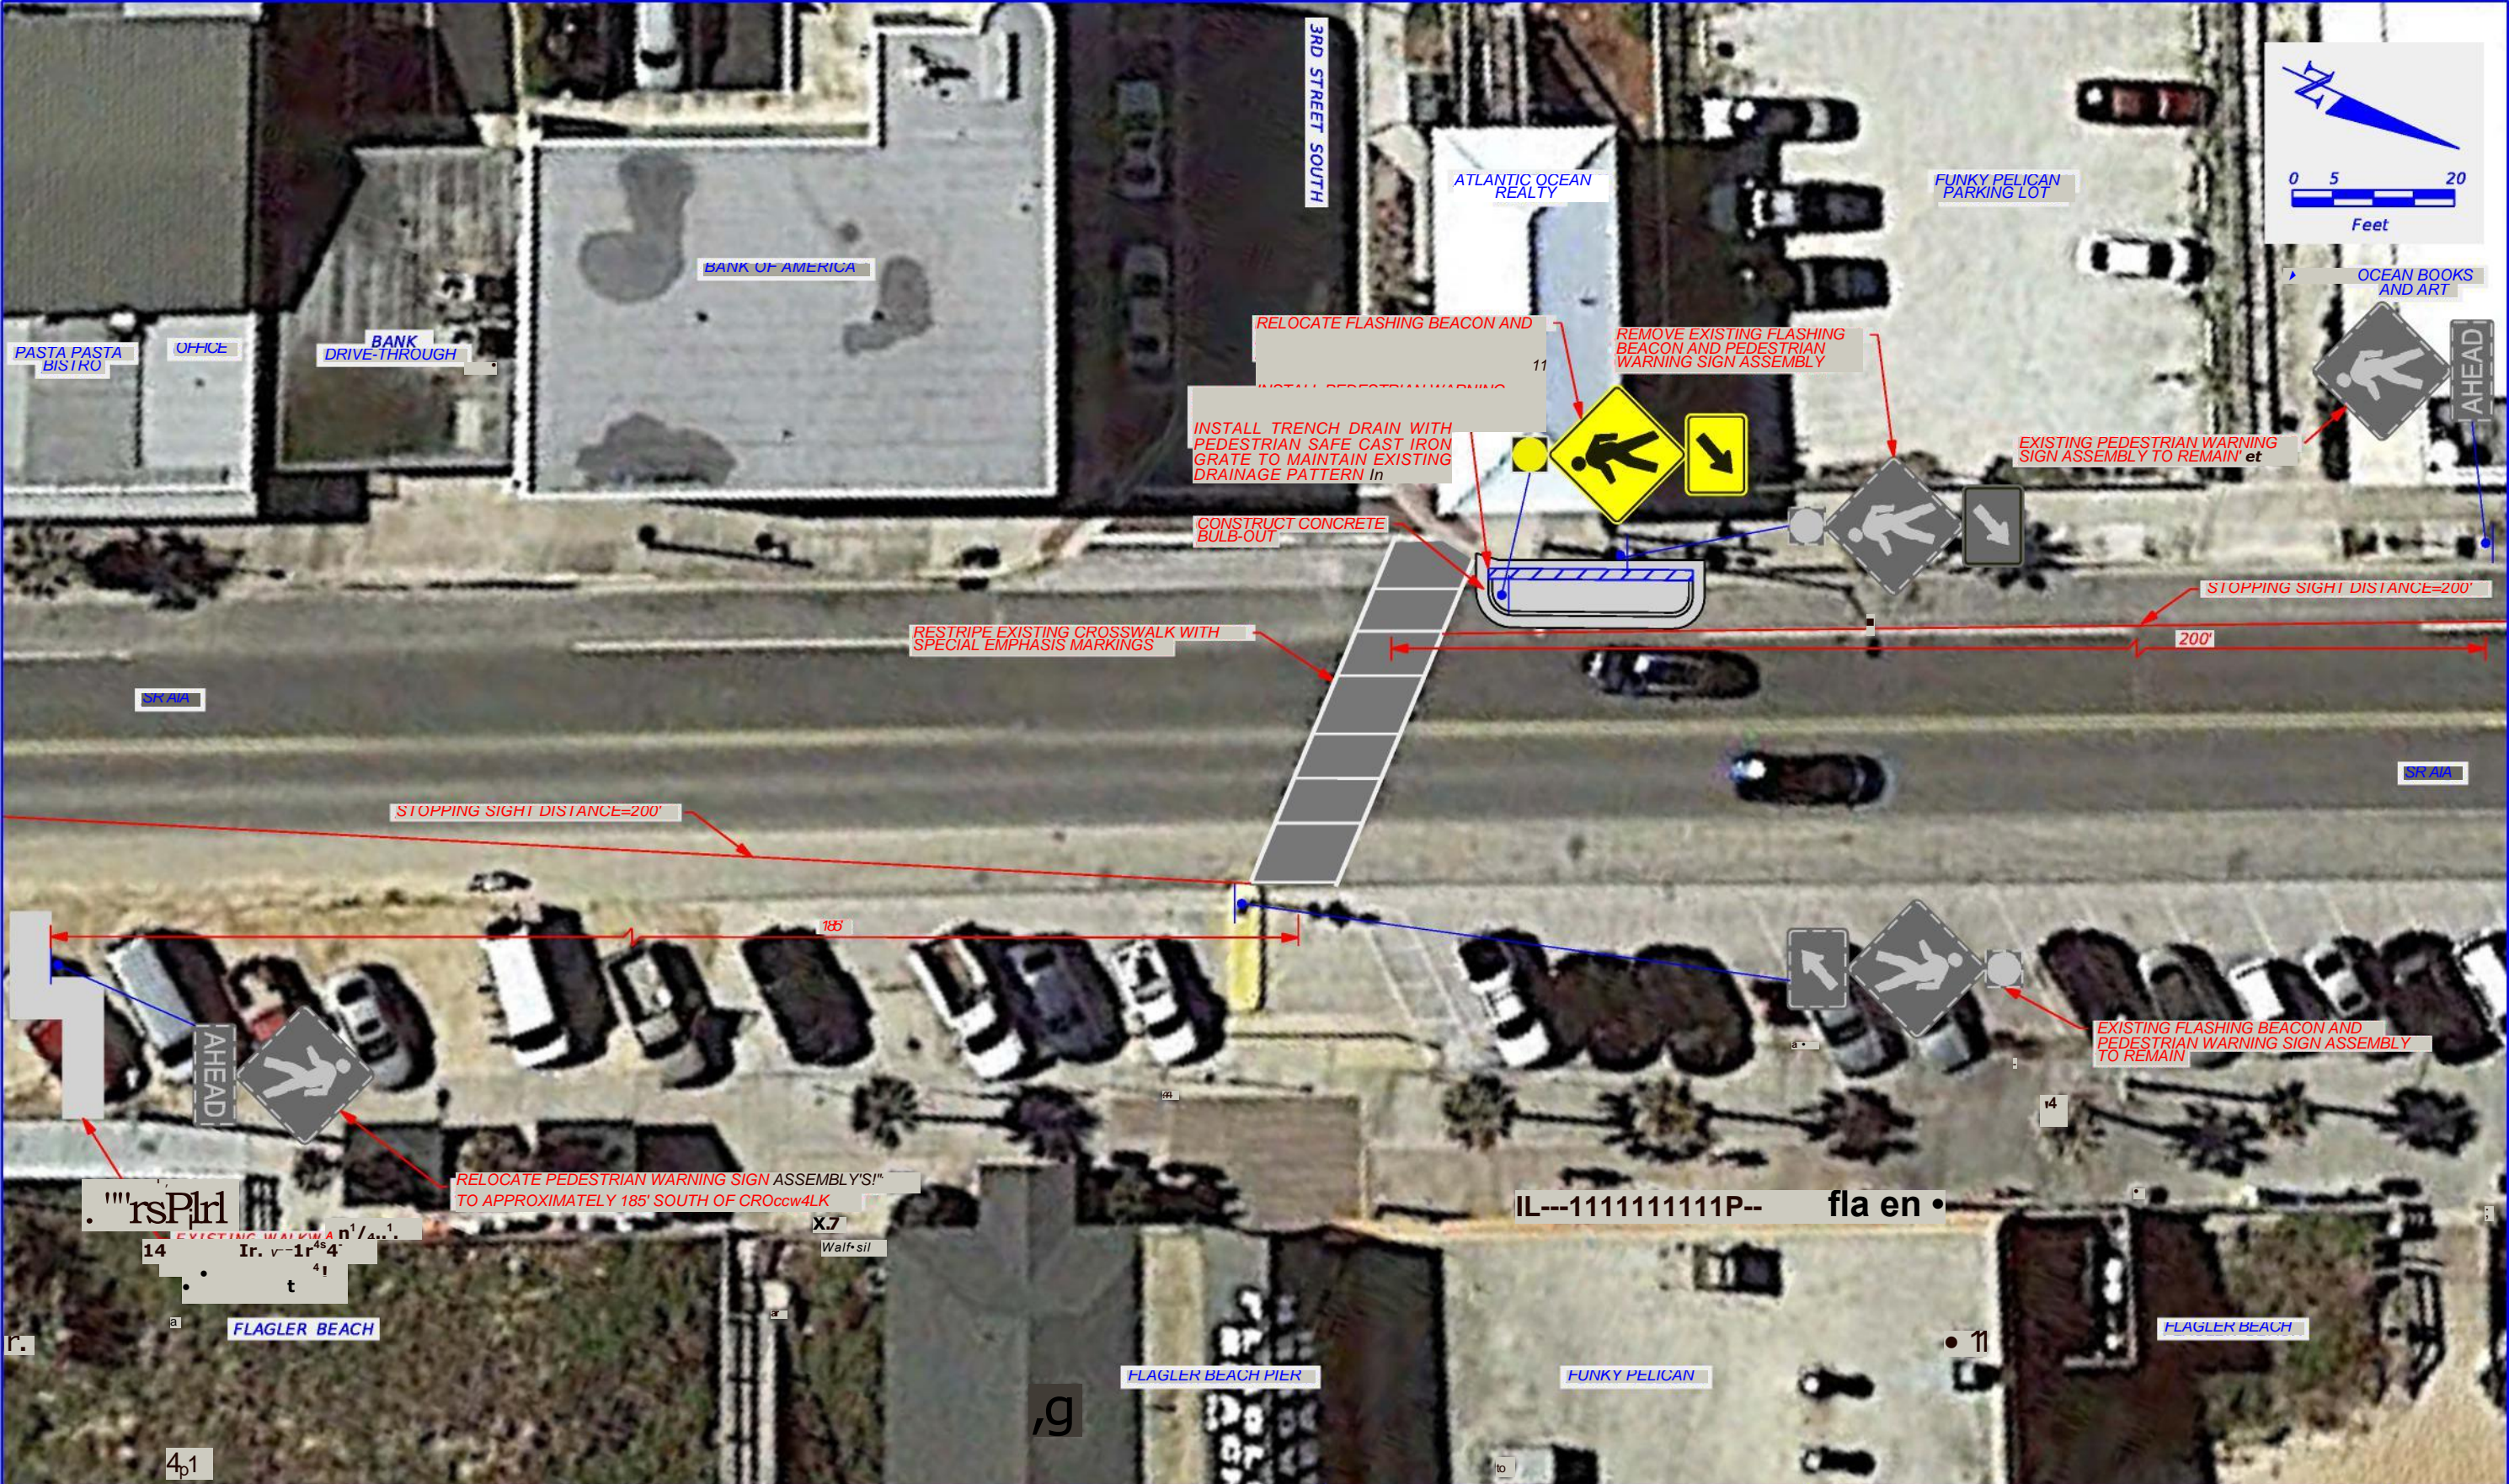
A conceptual improvement diagram has been developed to further depict the recommended improvements and is included on the following page.

1. Construct a curb bulb-out on the northwest corner of the intersection.
  - a. Install a trench drain with a pedestrian safe cast iron grate between the existing curb line and the proposed curb bulb-out to maintain existing drainage.

2. Re-stripe existing crosswalk with special emphasis markings per Index 17346.
3. Relocate the northbound advance pedestrian warning sign assembly.
4. Remove the existing southbound pedestrian warning sign assembly and install a new sign assembly in the proposed bulb out. Relocate the southbound yellow flashing beacon to the proposed pedestrian warning sign assembly.

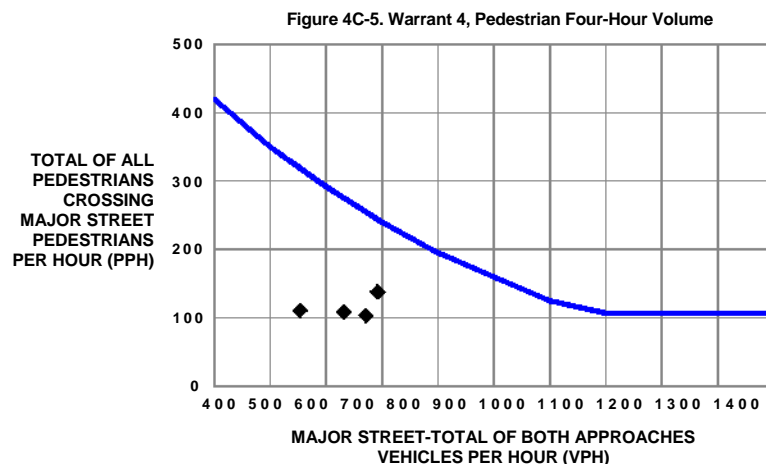
\*Note: 107 pph applies as the lower threshold volume

If Condition 1 is satisfied and any four points lie above the appropriate line, then the warrant is satisfied.

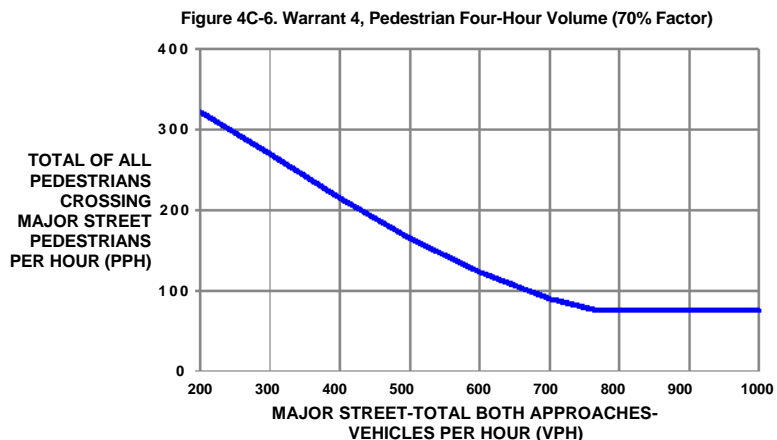
\*Note: 75 pph applies as lower threshold volume.

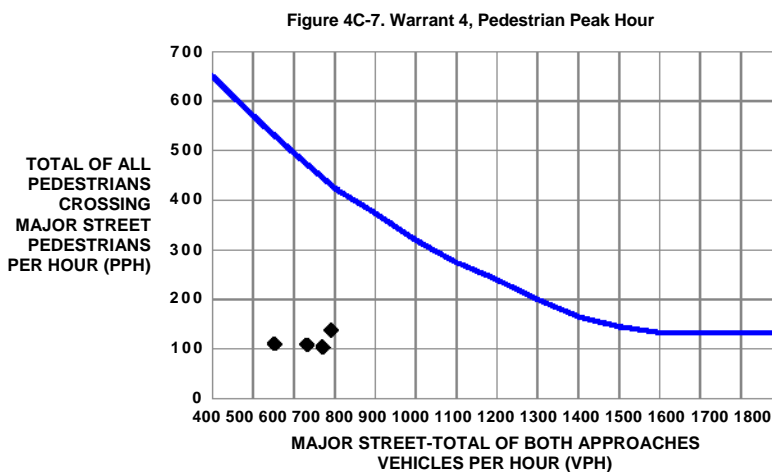
\*Note: 133 pph applies as the lower threshold volume

If Condition 1 is satisfied and any of the plotted points lie above the appropriate line, then the warrant is satisfied.

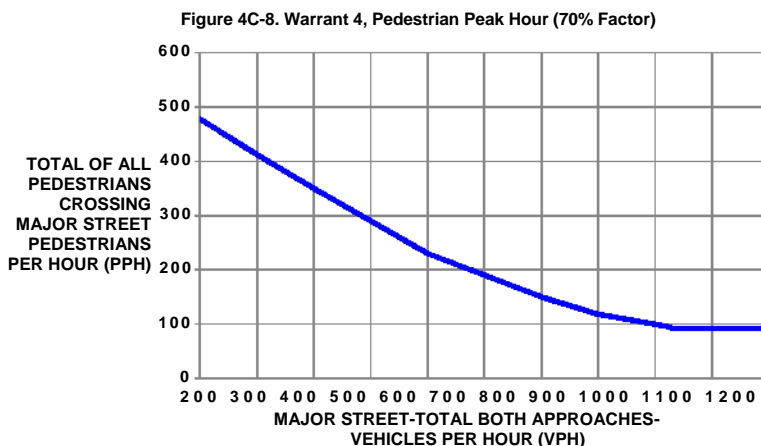
\*Note: 93 pph applies as lower threshold volume.
