COMPOSITE STUDY

Big Tree Road and Golfview Boulevard / Graham Street
South Daytona, Volusia County

January 2012
Revised April 2012

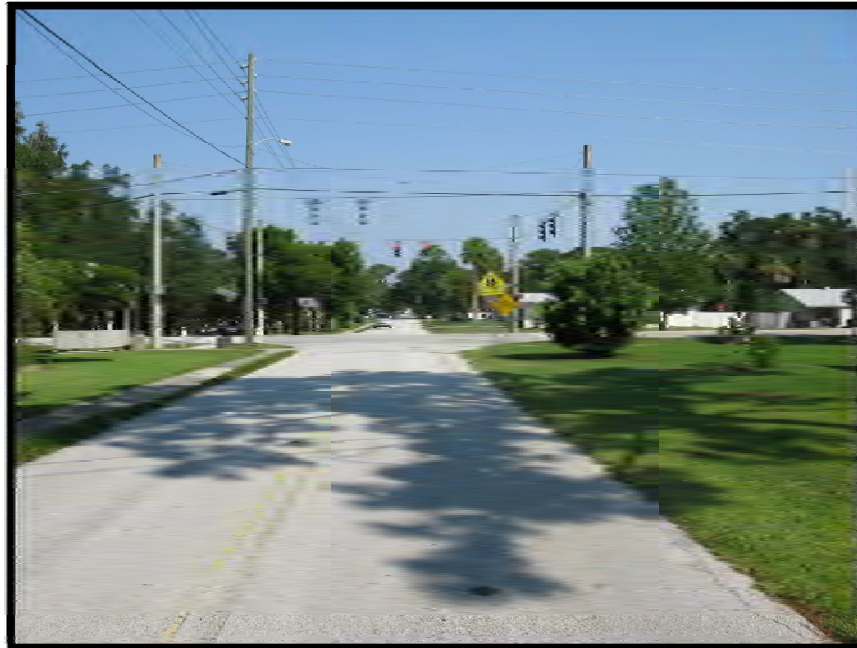
Figure 3
Photograph of Northbound Approach
(Looking Toward Intersection)
Graham Street at Big Tree Road

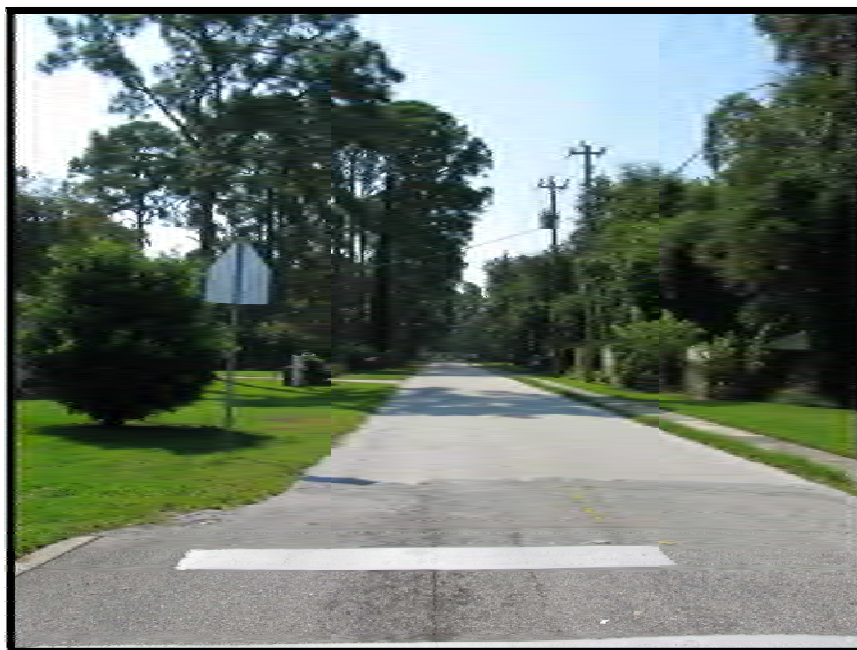
Figure 4
Photograph of Northbound Approach
(Looking Away from Intersection)
Graham Street at Big Tree Road

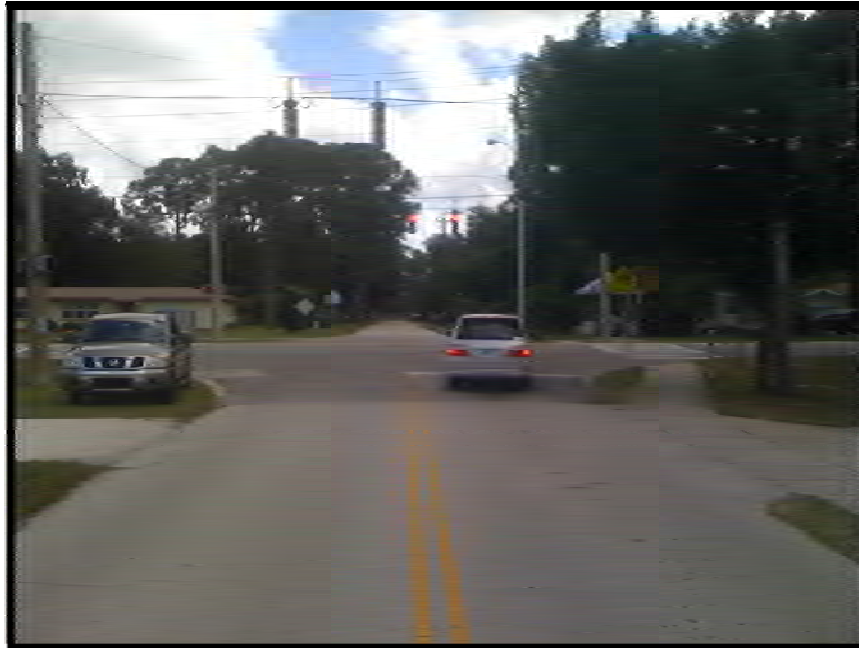
Figure 5
Photograph of Southbound Approach
(Looking Toward Intersection)
Golfview Boulevard at Big Tree Road

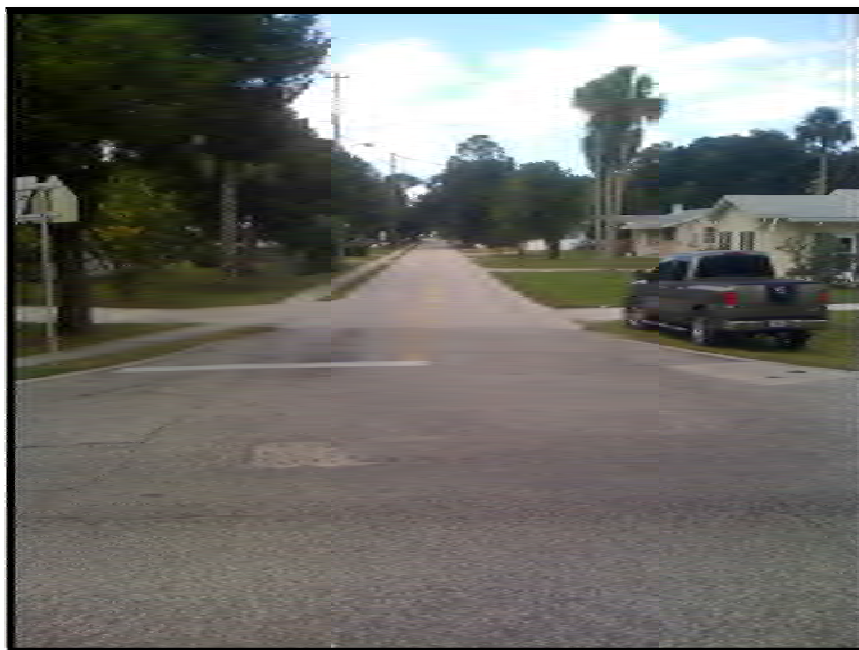
Figure 6
Photograph of Southbound Approach
(Looking Away from Intersection)
Golfview Boulevard at Big Tree Road

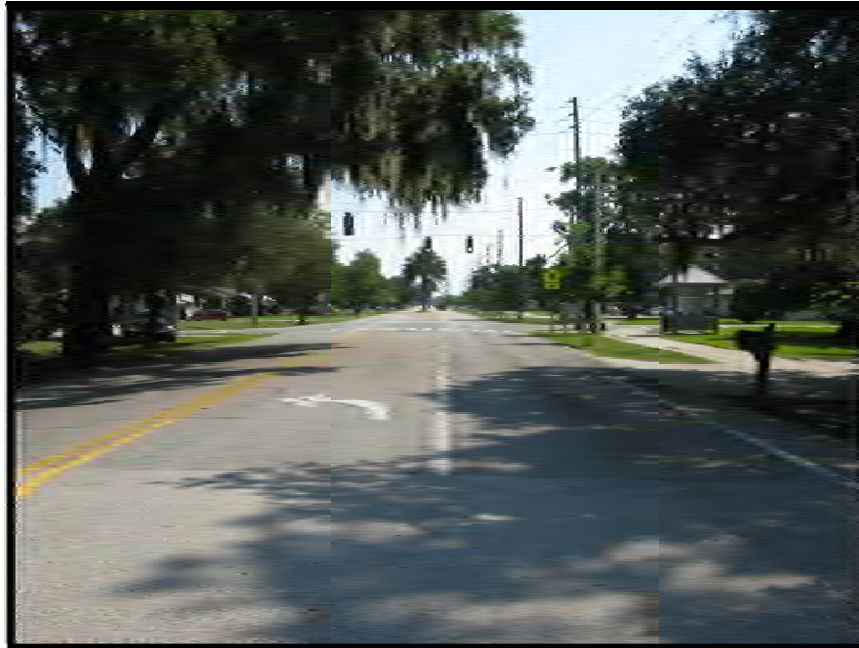
Figure 7
Photograph of Eastbound Approach
(Looking Toward Intersection)
Big Tree Road at Golfview Street / Graham Street

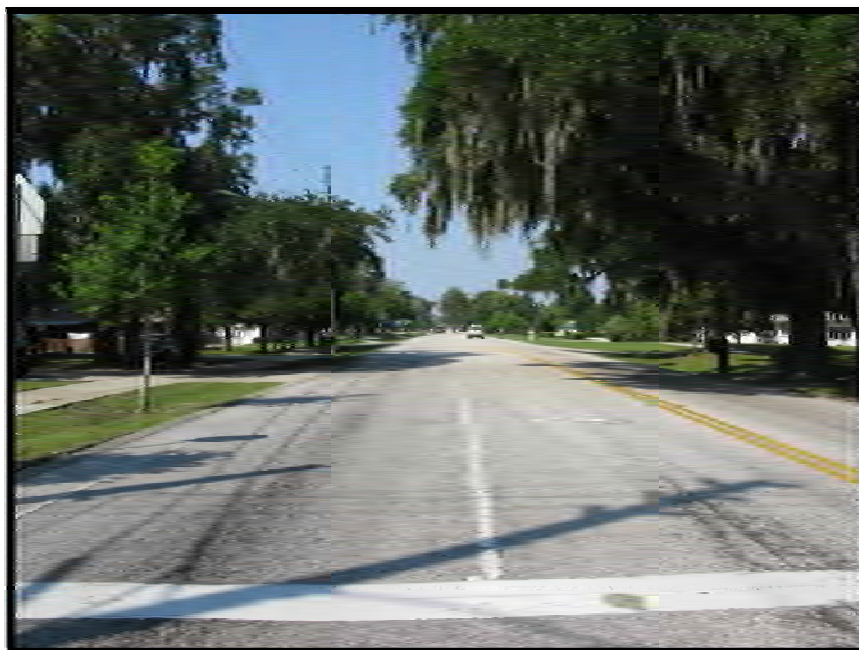
Figure 8
Photograph of Eastbound Approach
(Looking Away from Intersection)
Big Tree Road at Golfview Street / Graham Street

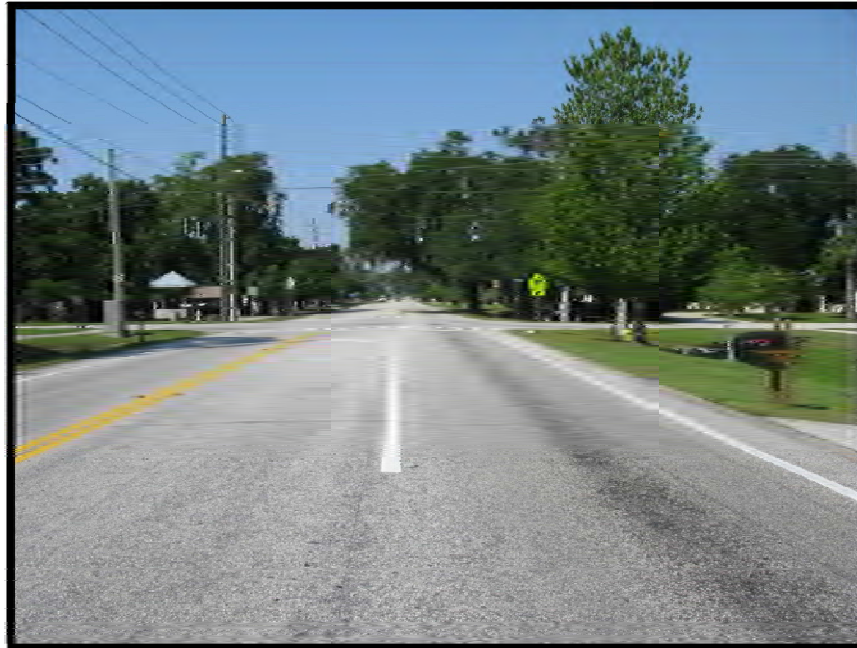
Figure 9
Photograph of Westbound Approach
(Looking Toward Intersection)
Big Tree Road at Golfview Street / Graham Street

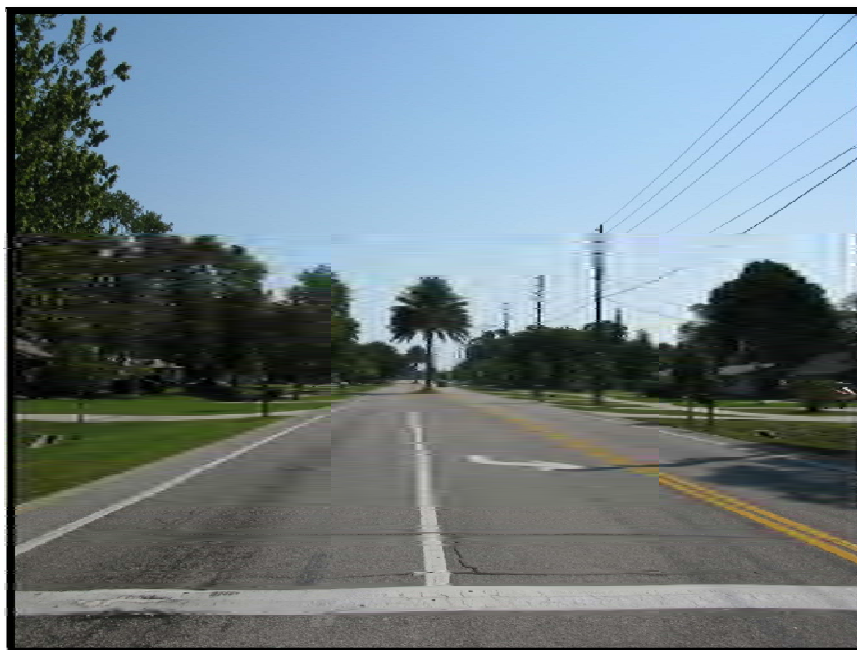
Figure 10
Photograph of Westbound Approach
(Looking Away from Intersection)
Big Tree Road at Golfview Street / Graham Street
