Bicycle and Pedestrian School Safety Review Study: Assessment & Implementation Report

Ormond Beach Middle School

**Volusia County Transportation Planning Organization
Bicycle and Pedestrian School Safety Review Study**

**Assessment & Implementation
Report
Ormond Beach Middle School
Ormond Beach, FL**

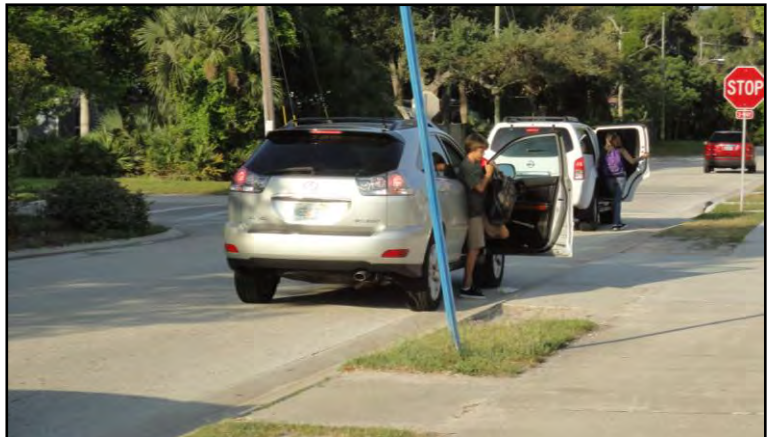
- Parents dropping off and picking up students on both sides of Domicillio Avenue, sometimes in the travel lane and not utilizing the parent loop.
- The intersection of Domicillio Avenue and Northbrook Drive is congested in the morning and afternoon with all bus loop traffic and the majority of the parent loop traffic travelling through this intersection. Some drivers tend to rush through this intersection, not looking for students who may be crossing. Staff members are also present at this intersection to allow for greater awareness and visibility of students.

Illustration 2: Parents dropping off students in the travel lanes on Domicillio Avenue

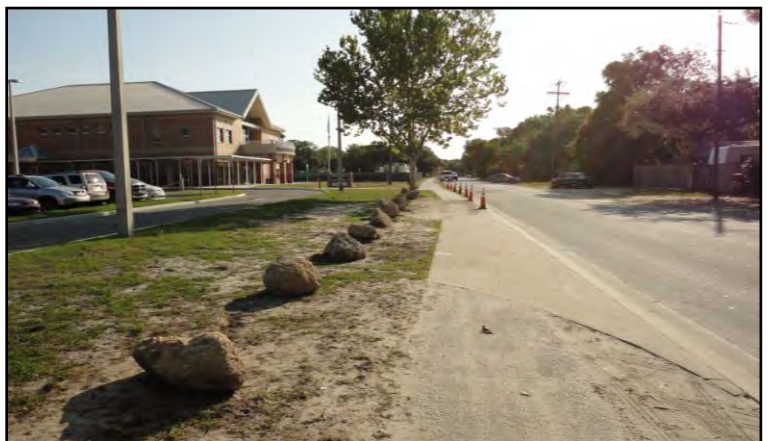
Illustration 3: Cones and decorative rock set up along Domicillio Ave., west of Ridgewood Ave. to discourage parents from parking or dropping off students in this location

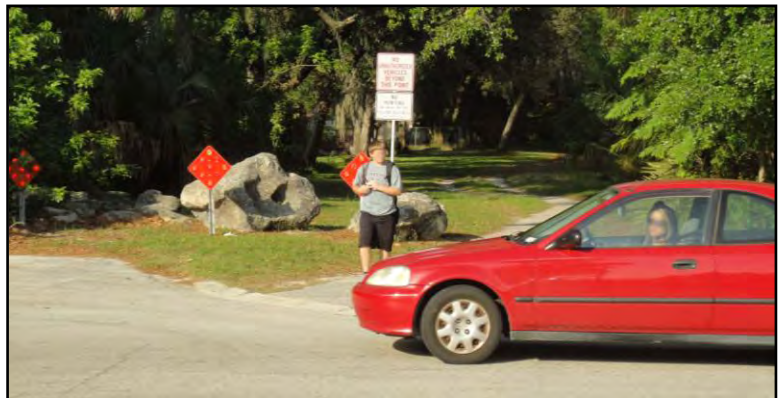
Illustration 4: Parent dropping off students on the sidewalk along Domicillio Avenue

Recommendations: The parent loop location will change as the construction of the school progresses, which may make its utilization more convenient. The school should continue to send information to the parents regarding the proper procedures and importance of utilizing the parent loop for dropping off their students.

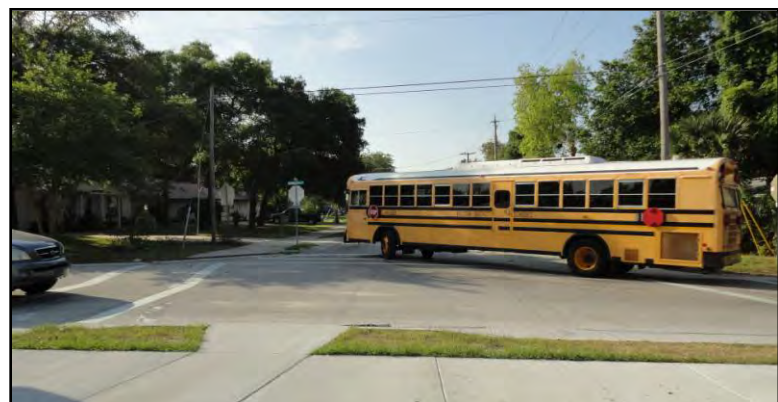
Observation: The current location of the bus loop off Northbrook Drive requires buses to travel through the intersection of Ridgewood Ave./Domicillio Dr. and Domicillio Ave./Northbrook Dr. The buses do not have the proper turning radii at these locations to make these turns without encroaching into the oncoming lanes.

Illustration 6: Insufficient turning radius for the school bus at the intersection of Ridgewood Ave. and Domicillio Dr.

Recommendations: When the bus loop is relocated to Domicillio Avenue this conflict should be eliminated.

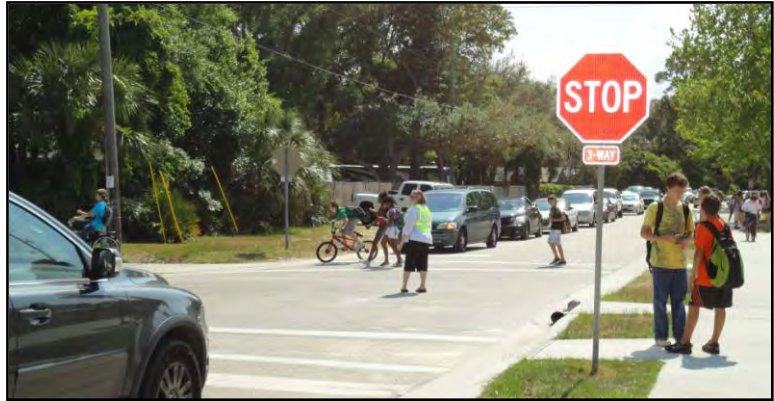
Observation: The intersection of Domicillio Avenue and Ridgewood Avenue is heavily congested following afternoon dismissal with vehicles traveling on the roadway to and from the parent and bus loops, parents stopping on Domicillio Avenue to pick-up students and students crossing the street at this location.

Illustration 7: Intersection of Domicillio Avenue and Ridgewood Avenue following afternoon dismissal

Recommendation: It is recommended that the existing crosswalks be converted to special emphasis crosswalks at this location and “In-Street Ped Crossing” signs R1-6c per Chapter 7 of the manual on Uniform Traffic Control should be installed. for greater visibility of the crosswalk. Additionally, it is recommended that parents be discouraged from picking students up along the street. To the greatest extent possible, staff should direct students to the parent pick-up loop to wait to be picked-up. Parents should be continued to be notified to utilize the parent loop to pick-up their students. Further, it is recommended that the school continue to utilize staff trained by the Ormond Beach Police Department to assist with the safe crossing of students at this intersection.

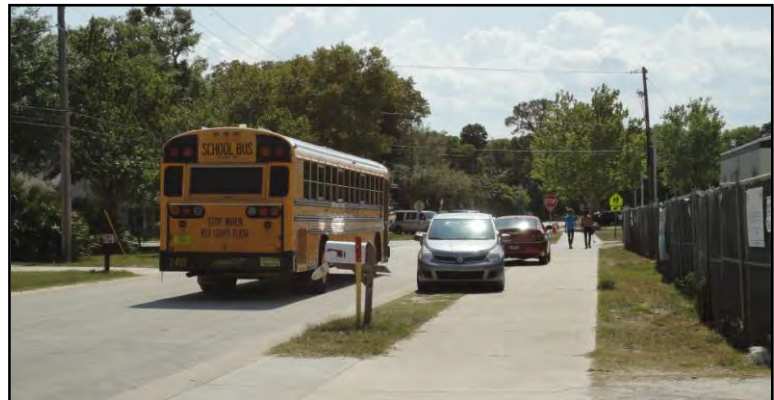
Illustration 8: Parents waiting on sidewalk along Domicillio Avenue prior to afternoon dismissal

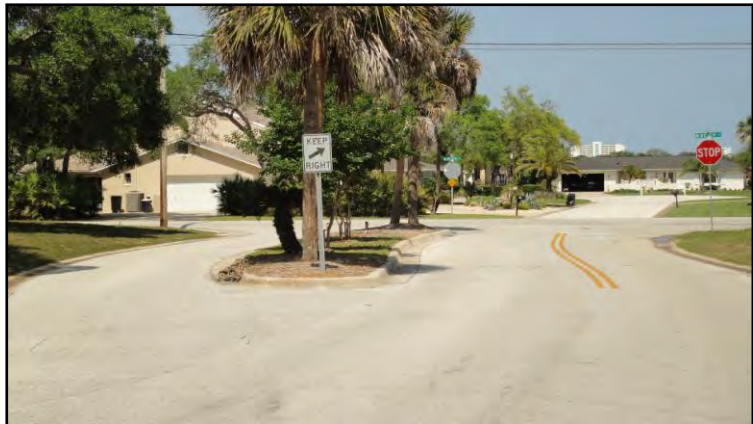
Observation: At the intersection of Northbrook Drive and Beach Street, there are two westbound lanes, one on each side of the median and one eastbound lane. This roadway geometry may cause confusion to drivers.

Illustration 11: Intersection of Northbrook Drive and Beach Street, looking east.

Recommendation: It is recommended that the City of Ormond Beach investigate this intersection and convert the operation of the intersection to two eastbound lanes on the south side of the median and one westbound lane on the north side of the median.

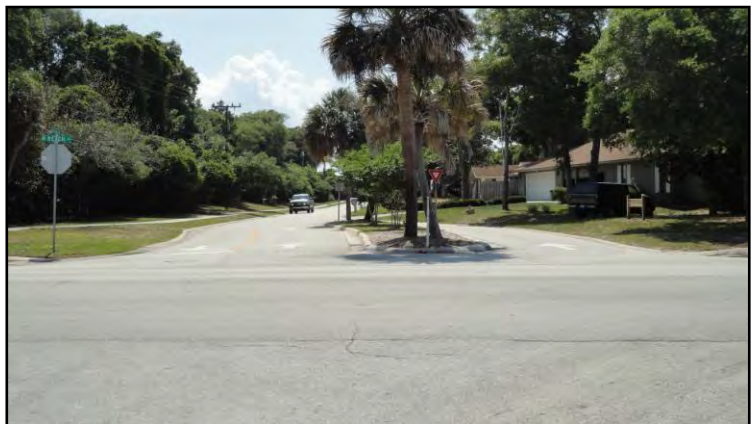
Illustration 12: Intersection of Northbrook Drive and Beach Street, looking west.

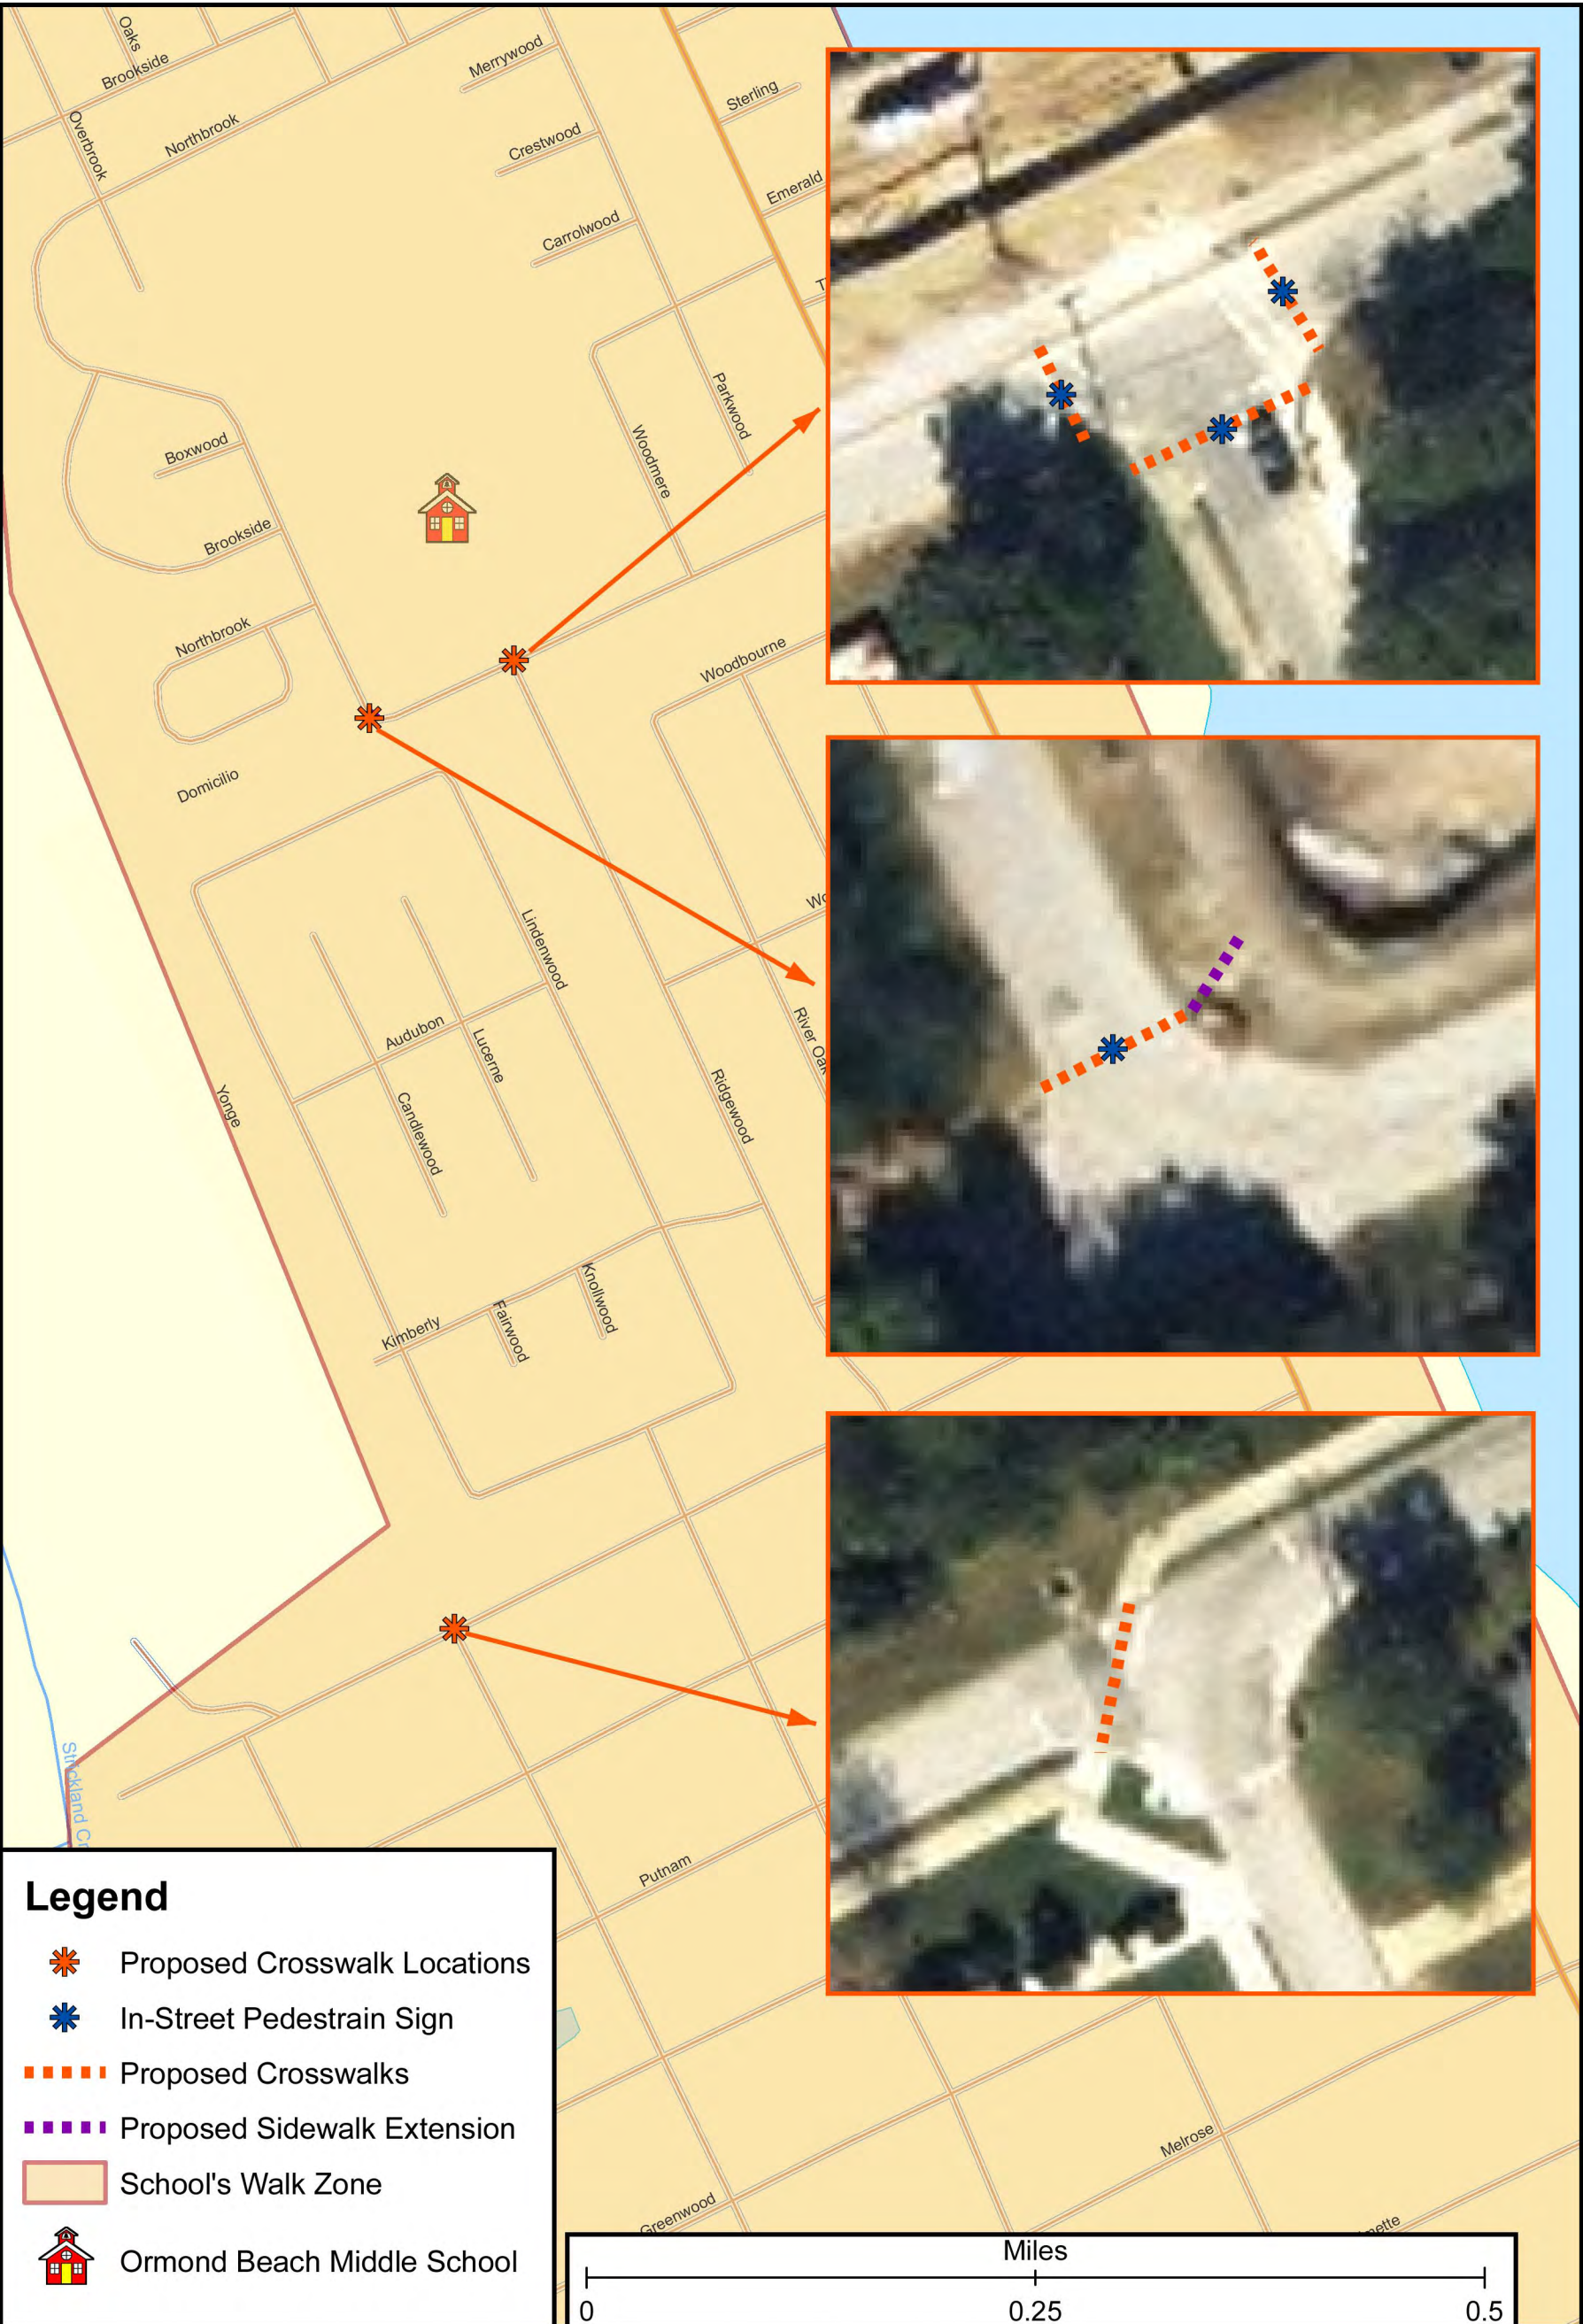
<p>Ormond Beach Middle School Bicycle and Pedestrian School Safety Review Study Ormond Beach, FL</p>		
<p>Recommended Improvements</p>	<p>Figure: 5</p>

- ✱ Proposed Crosswalk Locations
- ✱ In-Street Pedestrian Sign
- Proposed Crosswalks
- Proposed Sidewalk Extension
- Yellow shaded area School's Walk Zone
- Red house icon Ormond Beach Middle School

Table 5 summarizes all recommendations that have been made within this report. These recommendations and existing conditions are also illustrated on Figure 4. It should be noted that Volusia County has identified \$1,000,000 for the purpose of constructing sidewalks at not-yet determined locations in its 2010/2011-2014/2015 Transportation Improvement Program. Therefore, it is recommended that the City of Ormond Beach and the County collaborate to implement the recommendations of highest priority.

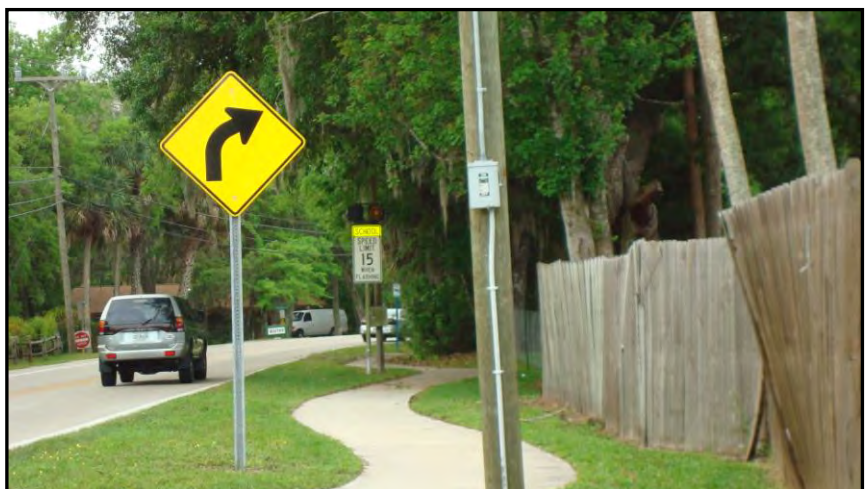
School flashing beacons (Illustration 11) also play an important role in safety. Flashing beacons alert drivers that they are entering a school zone and indicate that the displayed speed limit is in effect. It was observed that school flashing beacons can be

Illustration 11: Flashing beacon traffic signal control

operated manually or can be pre-set to turn off/on during pre-programmed timeframes. Manually run school flashing beacons are usually operated by school crossing guards, who are primarily assigned to cross elementary school students. Unfortunately, this does not address the needs of middle school students.

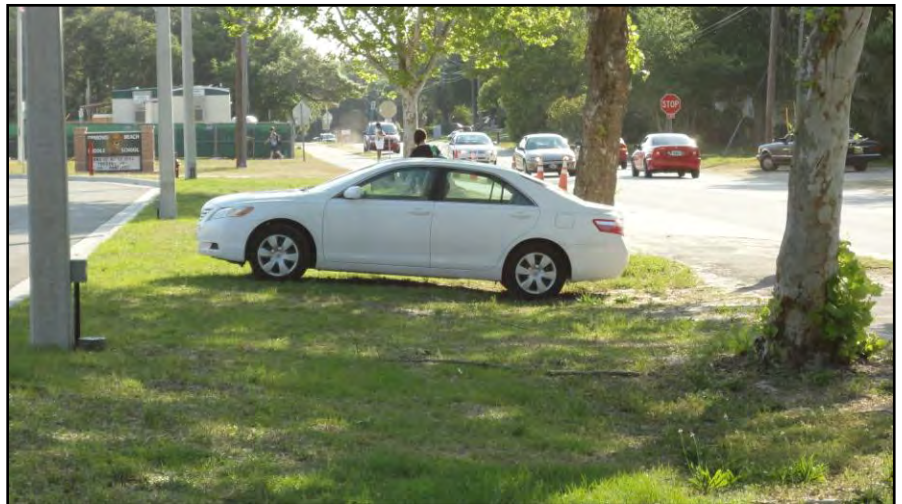
Regulations are not always followed by adults dropping off/picking up students. Motorists were observed to park in No Parking areas and make prohibited vehicular movements, including U-turns. Some motorists were observed to be speeding within the reduced-speed zone.

Illustration 12: Parent parking in no parking area prior to afternoon dismissal

- Parents should receive flyers or recorded messages on a school-wide basis to inform them of the proper drop-off/pick-up procedures. Strict enforcement of these procedures should eventually deter parents from practicing unsafe drop-off/pick-up actions.

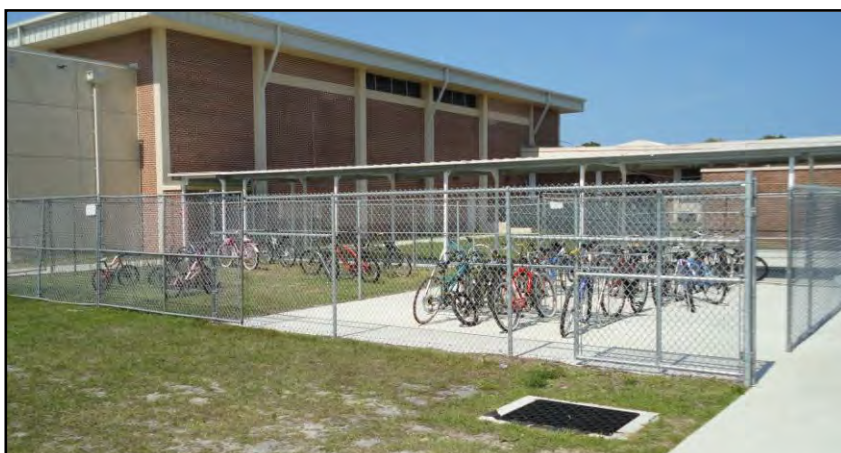
Illustration 13: secure bicycle racks provided at the school
