SR/CR A1A PEDESTRIAN SAFETY & MOBILITY STUDY

PEDESTRIAN / BICYCLE SAFETY REVIEW

Focus Area H / 9th Street S to 13th Street N

Pedestrian/Bicycle Safety Review Report for SR A1A from 9th Street S to 13th Street N (Flagler Beach)

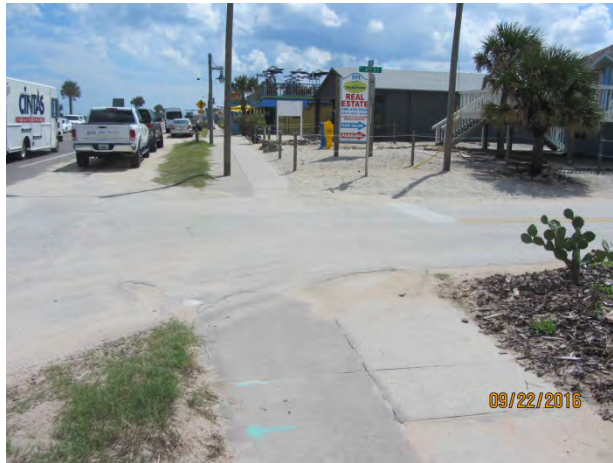
Figure 2

Along the corridor, north of 6th Street N, the unsignalized minor street approaches do not include marked crosswalks and do not include detectable warning surfaces (**Figure 2**). The study team also noted some stop bars were beginning to wear along some of the minor street approaches along the corridor (**Figure 3**). Some of the minor street intersections did have crosswalk markings; however, some were also beginning to fade (**Figure 3**).

As a maintenance-type suggestion, consider emphasizing the pedestrian realm across minor stop-controlled intersection approaches by adding or restriping crosswalk markings (standard or special emphasis to be determined on a case-by-case basis) as shown on sheet 12 of FDOT Design Standard Index 17346.

Consider installing detectable warning surfaces at minor street intersections along the corridor per FDOT Design Standard Index 304.

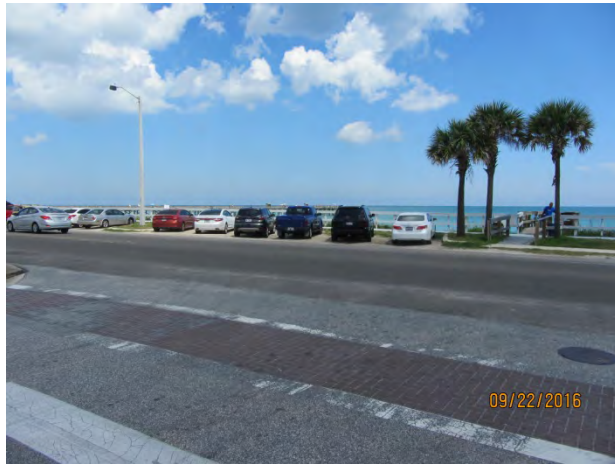
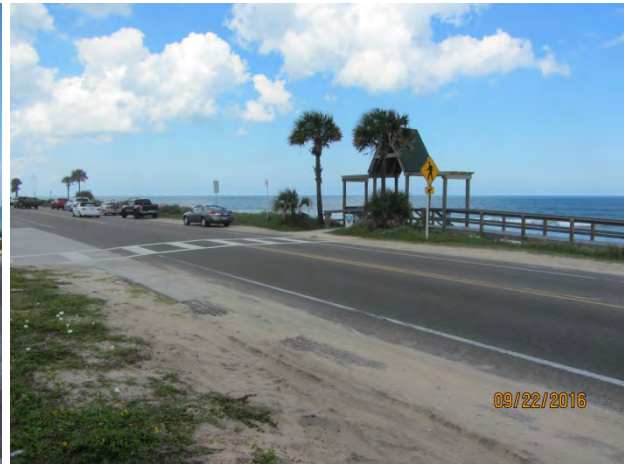
There are different types of beach parking along the study corridor and parking is offered on both the east and west sides of SR A1A in most locations. Angle parking is provided between 8th Street S and SR 100 (as illustrated in **Figure 4**) and parallel parking is provided north of SR 100 (as shown in **Figure 5**). The parking to the south of SR 100 is primarily angle parking, but parking spaces are not defined. The study team also observed higher utilization of the parking spaces on the east side (beach side) of SR A1A compared to the utilization of the parking spaces on the west side of the roadway.

As a near-term improvement, consider converting the parking areas along the east side of SR A1A south of SR 100 to lattice style parking areas. The lattice style parking area has been implemented on adjacent city roads with an example provided in **Figure 8**. Implementing this parking area style along the corridor would reduce the risk of bicyclists dropping off into the sand. This also provides a more consistent and level parking area for beach patrons. Providing the lattice style parking area would provide better drainage than paving over the sand with impervious asphalt or concrete.

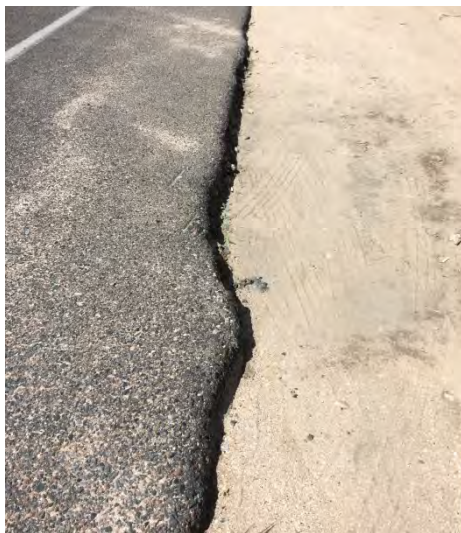
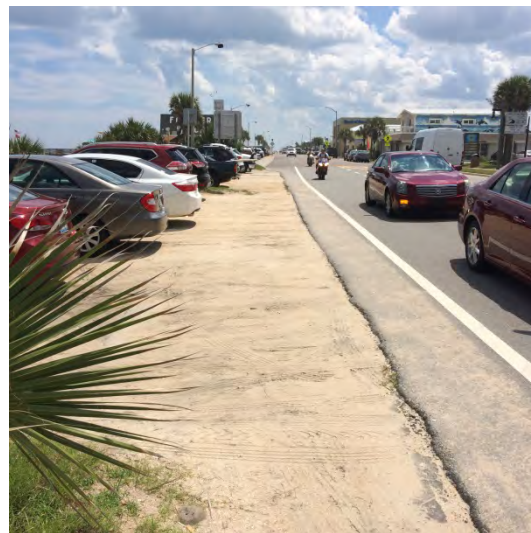
Along the east side of SR A1A, drop offs were observed between the sand parking areas and the shoulder (see **Figure 6** and **Figure 7**). This poses a hazard for bicyclists traveling in the shoulder. Vehicles were observed “bottoming out” on the drop off. This also serves as a distraction for drivers as they may be focused on maneuvering their vehicles onto the roadway without paying attention to potential bicyclists or pedestrians walking in the parking area or traveling along the shoulder.

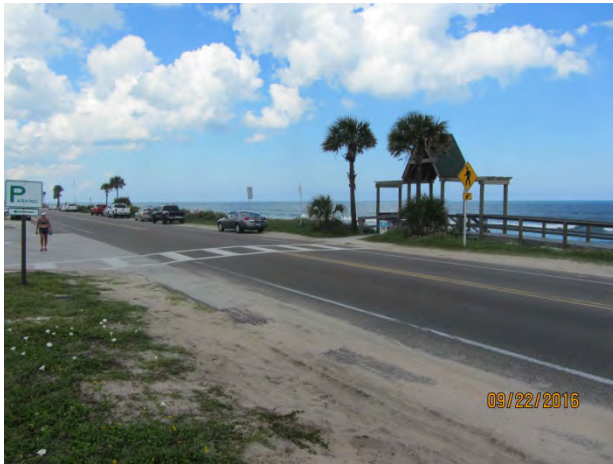
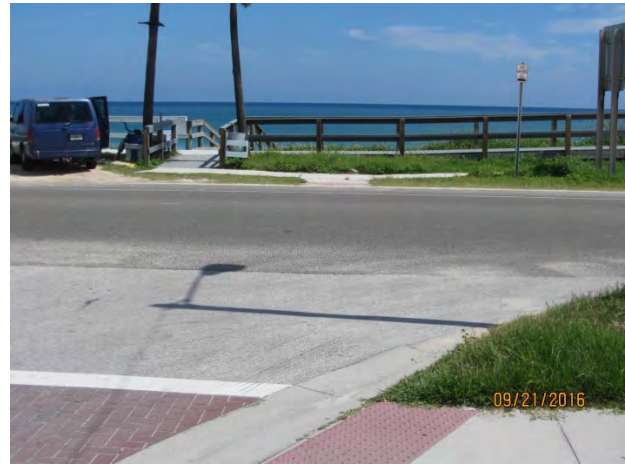
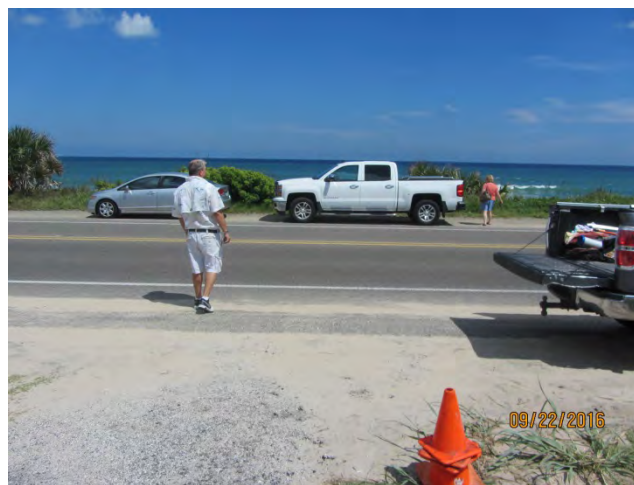
There are several beach accesses along the study corridor. At some of the access points, a marked crosswalk is provided to facilitate non-motorists across SR A1A (**Figure 9**). An example of dune crossover without a marked crosswalk is provided in **Figure 10**. Three of the seven pedestrian/bicyclist crashes occurred with a pedestrian/bicyclist crossing SR A1A at or near a beach access point. Even though the roadway is only two lanes wide, the relatively high traffic volumes during peak beach times makes it difficult for pedestrians to judge gaps when trying to cross the roadway (**Figure 11**).

The study team discussed crosswalk locations along the corridor and considered evaluating the following locations for new crosswalks or maintenance-type improvements to existing crossings:

- 8th Street S (existing crosswalk)
 - Consider adding advanced pedestrian warning signage (W11-2 and W16-9P) along the northbound and southbound approaches to the crossing.
- 6th Street S or 5th Street S (new crosswalk)
- 4th Street N (existing crosswalk)
 - Consider relocation of the southbound pedestrian warning sign to the southwest corner as it is currently blocked by a business sign.
 - Consider adding advanced pedestrian warning signage (W11-2 and W16-9P) along the northbound approach to the crossing.

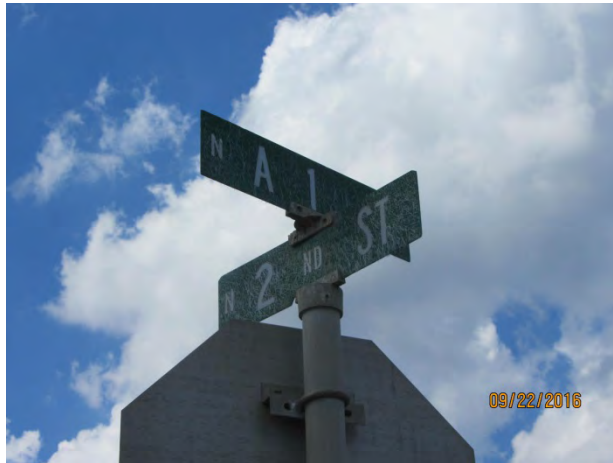
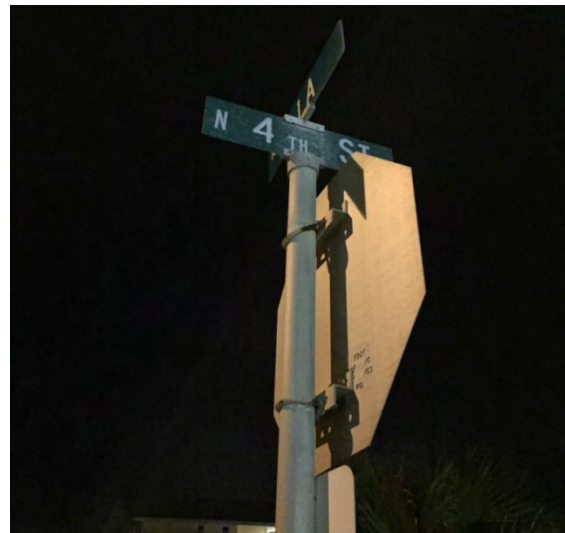
The street signs along the corridor to the north of SR 100 were beginning to fade and crack, had a varying letter height, and lacked retro reflectivity, as displayed in **Figure 12** and **Figure 13**. Differences in street name sizes and lack of retro-reflectivity may impact the driver or non-motorist expectancy. Conflicts may occur at night if a vehicle is driving slowly trying to find a specific street and a following vehicle gets impatient and decides to pass them. If a pedestrian is attempting to cross the roadway at the same time, the passing driver may not see the pedestrian causing a pedestrian related crash.

The City indicated they are working towards replacing the street signs with 9" lettering within the City limits. Consider coordinating with the City to prioritize replacing old and faded signs with new street name signage (**D3-1**). Also, in the near-term, consider a signage study/plan for the study corridor to evaluate the amount of signage, applicability, retro-reflectivity, and location along the study corridor. This signage study/plan should include replacing the older signs with signs meeting current standards.

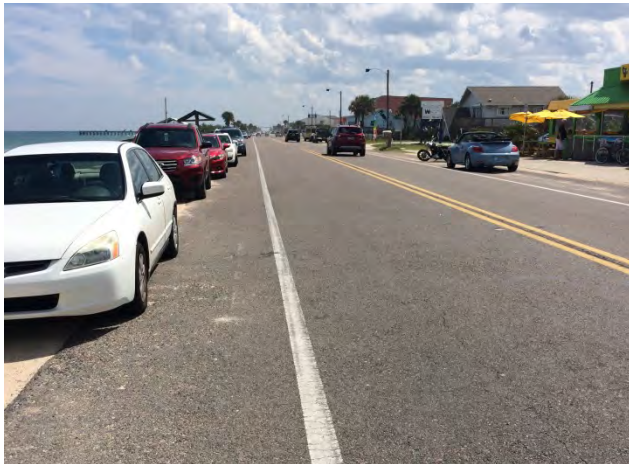
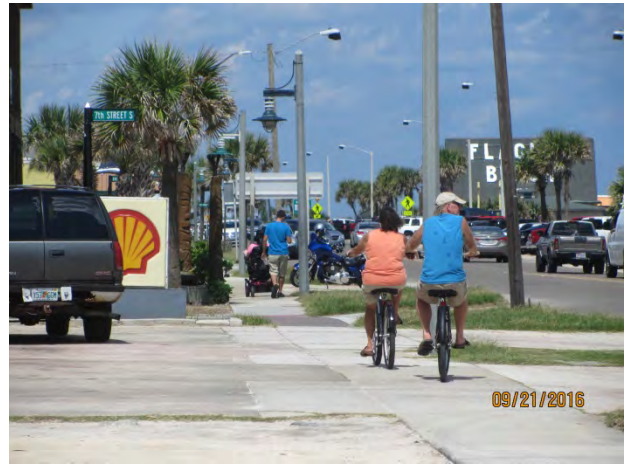
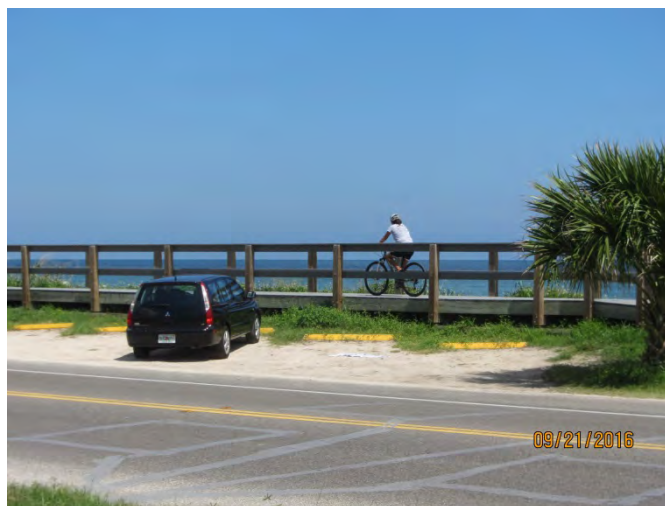
The study team observed a lack of formal bicycle facilities along SR A1A within the project limits. In some locations along the east side of the roadway, there is a paved shoulder; however, the effective width varies as sand and parked vehicles use part of the shoulder (see **Figure 14**). On the west side of the roadway, an approximate 4'-5' shoulder is present along the length of the study limits. The study team observed bicyclists riding off the roadway either on the sidewalk (**Figure 15**) or along the boardwalk on the east side of SR A1A (**Figure 16**). Three bicycle crashes occurred during the crash analysis period with one bicyclist crossing SR A1A and two traveling on the sidewalk against the flow of traffic being struck at driveways/minor street intersections.

The team discussed installing bicycle lanes along SR A1A. The parking spaces along the west side of SR A1A are less utilized and could provide opportunity for bicycle lanes without the need to widen SR A1A.

The City would be in support of removing some parking spots along the west side of the roadway to add bicycle lanes. In the near-term, consider conducting a study to evaluate the feasibility of removing parking spaces and implementing Complete Streets-type enhancements along the corridor.

The sidewalk on the west side of SR A1A is part of the Florida Shared-Use, Nonmotorized (SUN) Trail network. As a long-term improvement, consider reconstructing the sidewalk on the west side of the roadway to be a 10'-12' wide shared-use path. As noted previously, the lack of bicycle facilities along the study corridor encourages a lot of bicyclists to utilize the sidewalk. In order to accommodate both the bicycle and pedestrian traffic in the area, a wider shared-use path would serve both of those modes.

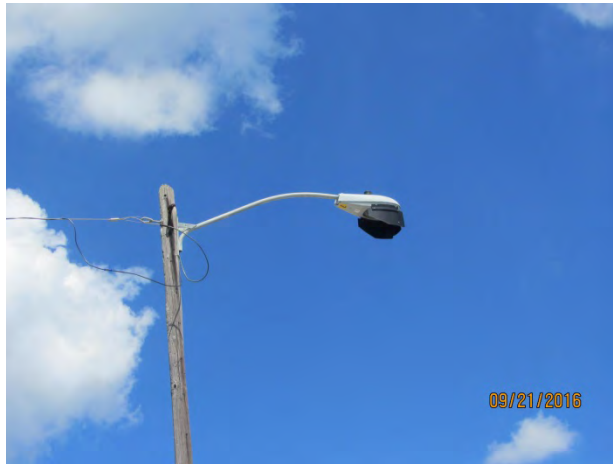
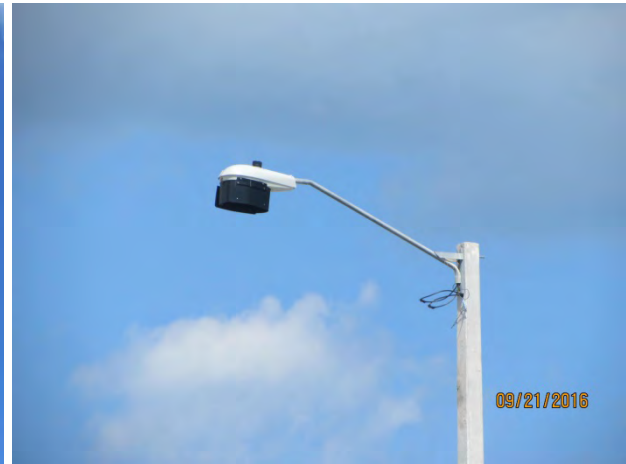
Flagler Beach is a destination for sea turtle nesting. The sea turtle nesting season is from May 1 to October 31. **Figure 17** and **Figure 18** show examples of 360 degree turtle shielding on overhead lights on both sides of the roadway to minimize light emittance. The reduced lighting conditions can make it difficult for drivers to see pedestrians or bicyclists at night, especially those wearing dark clothing. **Figure 19** illustrates the lighting levels the study team observed during the nighttime review. The lone nighttime crash occurred in June during turtle season.

- As a maintenance-type consideration, consider reviewing the pedestrian-level lighting fixtures along the corridor and replace any burnt out bulbs and reconnect any hanging covers.
- Consider conducting field measurements of existing lighting levels to evaluate lighting uniformity levels and add lighting where necessary. Consider implementing a lighting plan for the time the sea turtle nesting season is not active as roadway lighting levels should not be reduced at this time.
- As a long-term consideration, consider upgrading to an adaptive roadway lighting system along the corridor. Lighting levels could be programmed to be reduced during the sea turtle nesting season and increased to normal levels outside of the nesting season. This could be coupled with replacing the current high pressure sodium lighting with LED lighting.

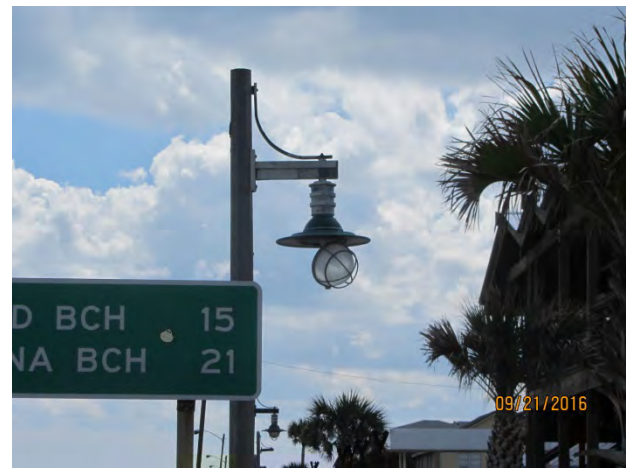
Figure 20

Pedestrian-level lighting is present along the west side of the corridor. The study team noticed some of the pedestrian lighting needs maintenance. **Figure 20** shows an example of a pedestrian-level light cover hanging from the light fixture. This poses a risk for pedestrians or bicyclists walking/riding underneath the light fixture.

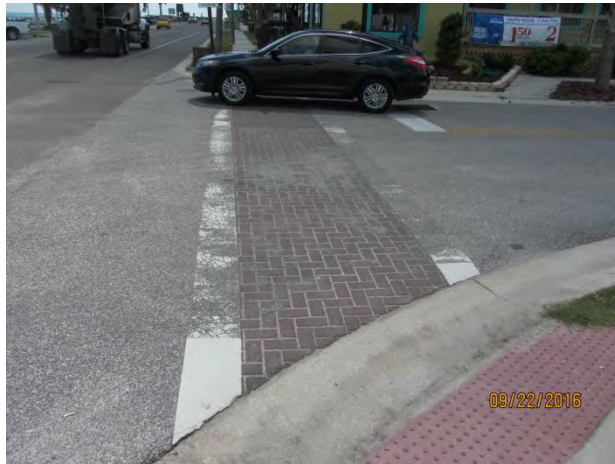
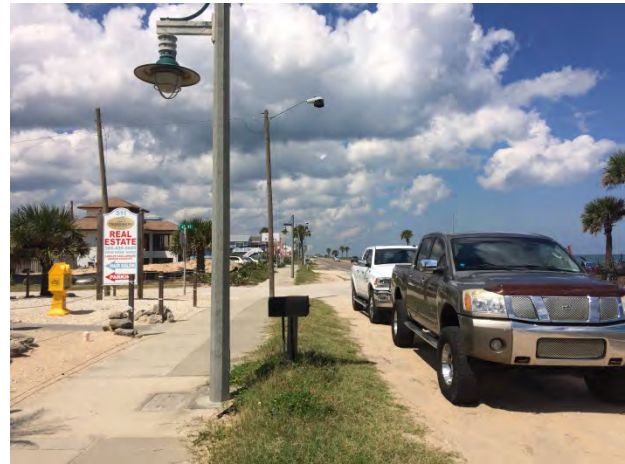
The study team observed the stop bars at the minor streets to be set back 10'-20' from the edge of the travel lane, as displayed on **Figure 21**. The stop bar is set back due to the location of the sidewalk but this creates sight distance issues for vehicles turning from the minor street. The sight distance was observed to be restricted by a variety of things such as buildings (restaurant on the southwest corner of 5th Street S shown in **Figure 21**), business signs, or on-street parking along SR A1A (**Figure 22**). Because the sight distance is restricted, vehicles were seen driving through the stop bar and stopping near the roadway across either the marked or unmarked crosswalk. This creates a conflict with pedestrians and bicyclists who may be attempting to cross the minor street as a vehicle is turning onto SR A1A.

Consider moving the stop bars to be the minimum of 4' away from the marked crosswalks discussed in **Issue #1: Minor Street Intersections**, per sheet 7 of FDOT Design Standard Index 17346. Another consideration is to conduct a sight distance study along the corridor to evaluate whether on-street parking spaces are restricting sight distance. Removal of select parking spaces along the west side of SR A1A in conjunction with the considerations of **Issue #5: Lack of Bicycle Facilities** could help alleviate sight distance issues.

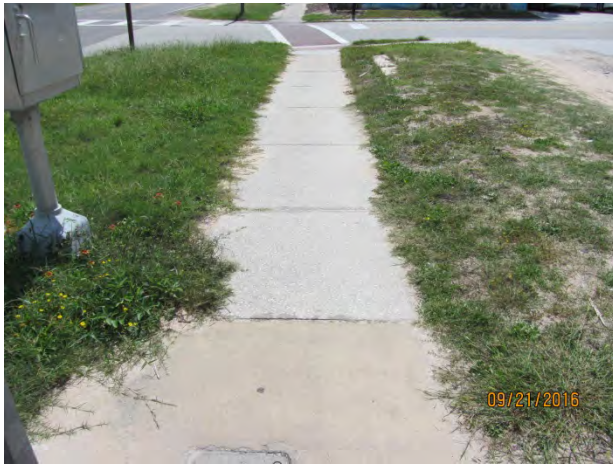
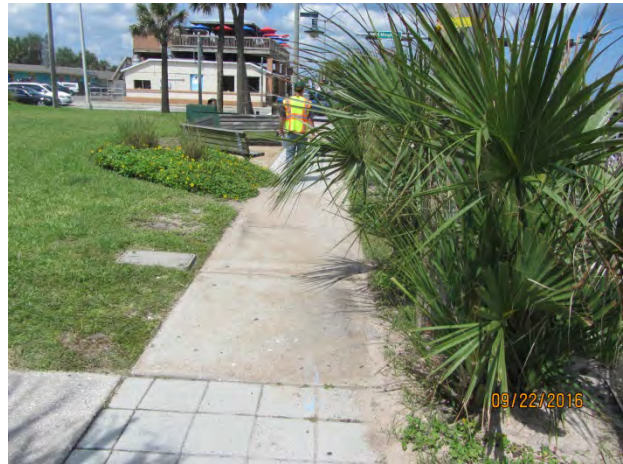
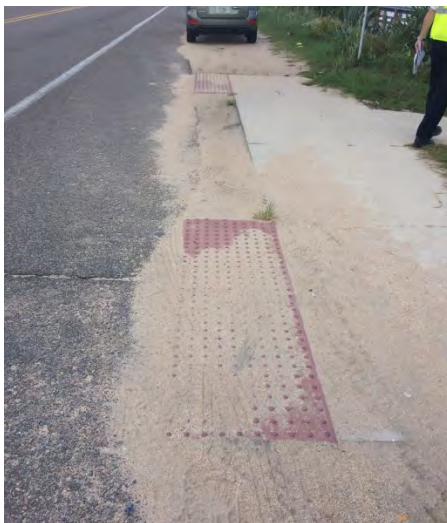
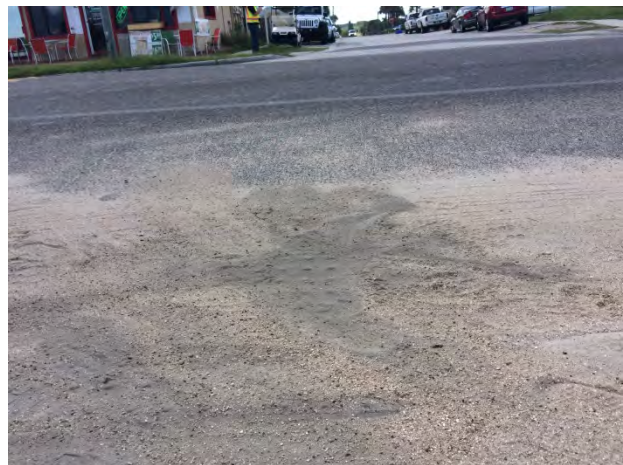
There were several locations along both sides of the corridor where landscaping encroaches onto the sidewalk (**Figure 23** and **Figure 24**) or where sand has built up onto the sidewalk or detectable warning surfaces (**Figure 25** and **Figure 26**). This was especially apparent just north of 8th Street N, just south of SR 100, and for the curb ramps coming from the boardwalk at 2nd Street N. The landscaping restricts the effective width of the sidewalk and the sand build up creates a trip hazard and reduces the effectiveness of the detectable warning surfaces to visually impaired users.

Consider coordinating with FDOT to trim the obstructions and encourage better sidewalk and landscape maintenance along the entire length of the study corridor. Consider creating a routine maintenance schedule to remove sand from the sidewalks and pedestrian warning surfaces.

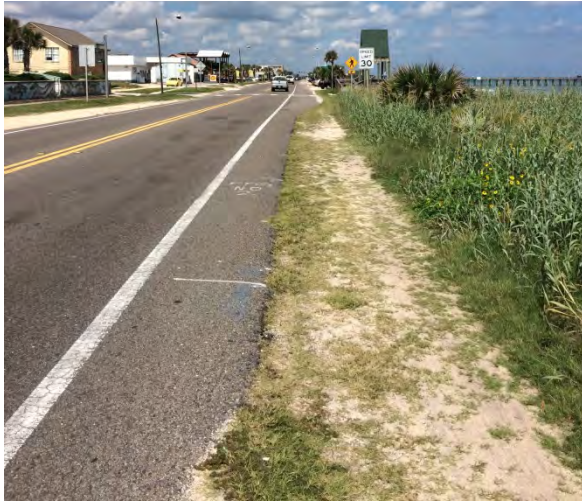
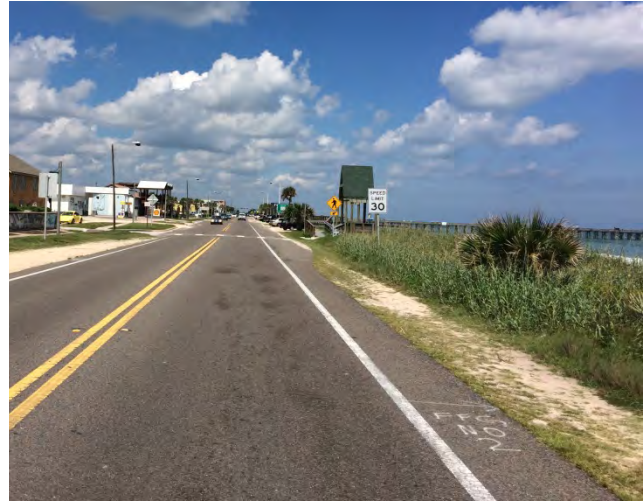
The study team noted the shoulder width along the east side of the roadway is approximately 3 feet wide between 9th Street S and 8th Street S. As shown in **Figure 27** and **Figure 28**, the shoulder widens to 5 feet approximately 75' south of 8th Street S. Most bicycle riders do not feel comfortable riding alongside traffic within a 3-foot wide shoulder. Instead, bicyclists may be inclined to take part of the lane, potentially causing vehicular drivers to become impatient and attempt to make unsafe passing maneuvers.

In the near-term, consider widening the shoulder to provide a consistent width for bicyclists. In the long-term, consider bicycle lanes or a shared-use path as introduced in **Issue #5: Lack of Bicycle Facilities**.

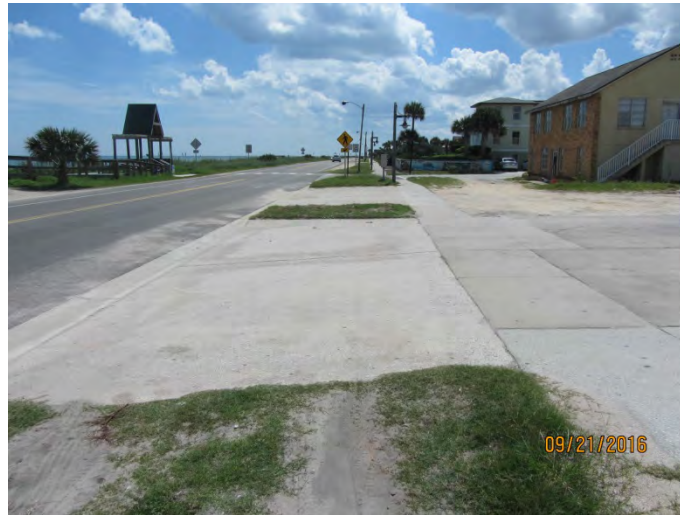
Figure 29

The gas station on the southwest corner of 7th Street S has four driveway accesses (three along SR A1A and one along 7th Street S). These driveways are relatively wide (**Figure 29**) and create a large conflict area between non-motorists using the sidewalk and vehicles turning into and out of the driveway. Vehicles were observed stopping on the sidewalk prior to turning onto SR A1A.

Consider driveway reconstruction during the roadway's next 3R project to reduce the driveway widths down to the 36' maximum per FDOT Standard Index 515. Also as part of this future 3R project, consider eliminating/consolidating unused driveways for the gas station.

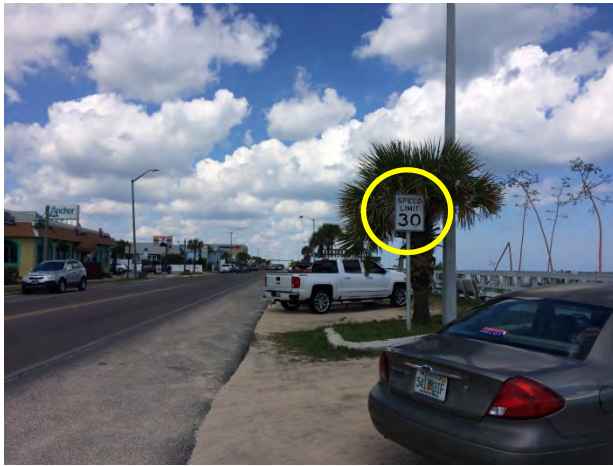
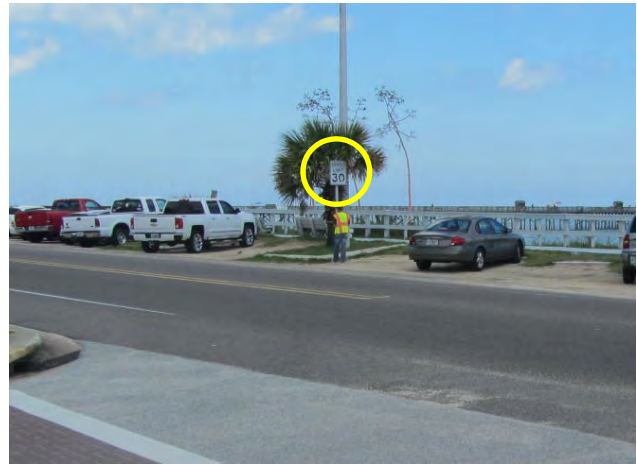
Figure 30 and **Figure 31** illustrate a 30 MPH speed limit sign on the east side of SR A1A between 6th Street S and 5th Street S. The signage is obstructed by a palm tree.

As a maintenance-type treatment, consider coordinating with FDOT or the City to trim the tree so the sign is visible to motorists.

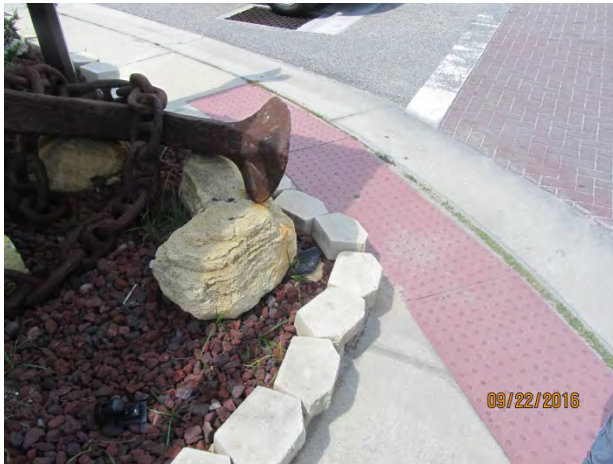
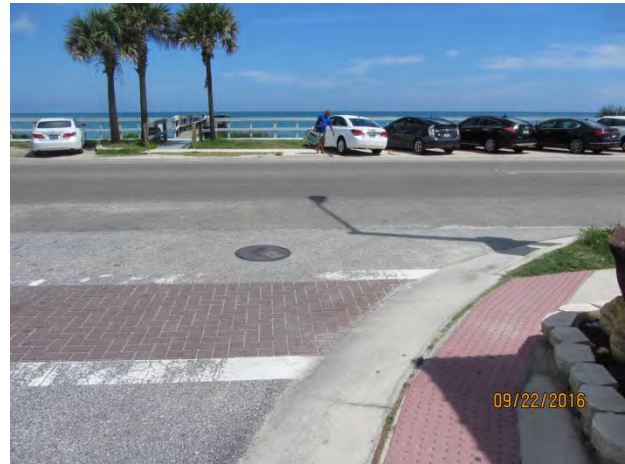
During the review, the study team observed concrete landscaping blocks encroaching into the sidewalk and curb ramp on the southwest corner of 5th Street S. These landscaping features restrict the no turning space at the top of the ramp as displayed in **Figure 32** and **Figure 33**. A person in a wheelchair would not be able to travel around this corner while staying on the sidewalk/pedestrian warning surface and would have to navigate themselves into the roadway or gutter.

Consider reviewing right-of-way (ROW) on this corner and if applicable, coordinate with the property owner to relocate the landscaping features within their (ROW). This could help provide adequate sidewalk and curb ramp widths so non-motorists aren't forced to travel into the roadway and/or gutter.

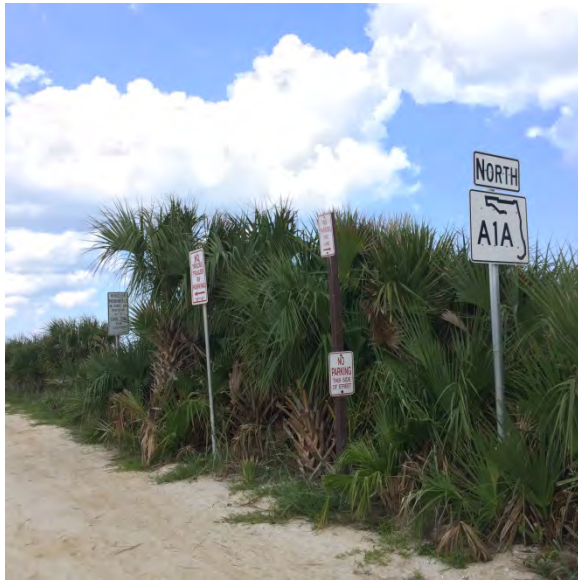
Figure 34

Parking is restricted on the northeast corner of the SR A1A/SR 100 intersection as illustrated in **Figure 34** and is intended for emergency vehicles. City staff indicated that beach patrons still park in this area.

Consider formalizing the emergency vehicle area by paving an asphalt surface and applying yellow striping. Also, consider increased enforcement of the emergency vehicle parking area to dissuade the general public from parking or unloading their vehicles at this location.

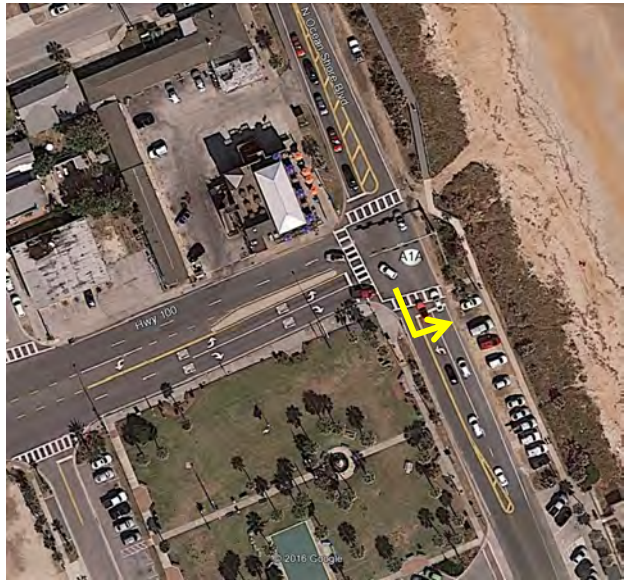
Figure 35

Parking is allowed southeast of the intersection; however, the study team observed southbound vehicles stopping along SR A1A to wait for a gap to turn left into the parking spaces (**Figure 35**). This creates not only an operational issue at the intersection, but also creates a conflict with bicyclists riding in the northbound direction on the shoulder.

As a near-term improvement, consider removing some of the parking spots southeast of the intersection. If removal of beach parking is not desired, consider constructing a raised median extending south of SR 100 to restrict the southbound left-turn movements into the beach parking spaces.

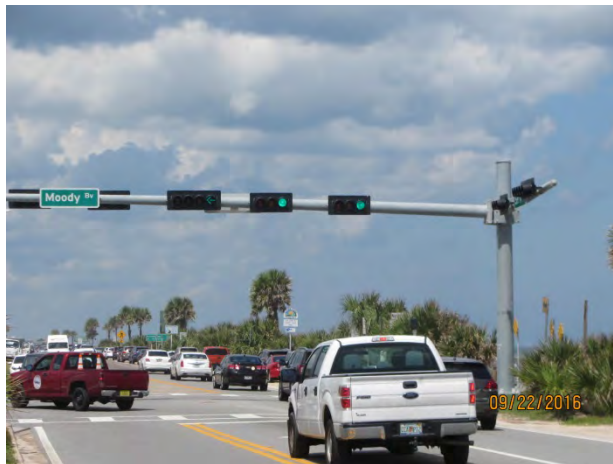
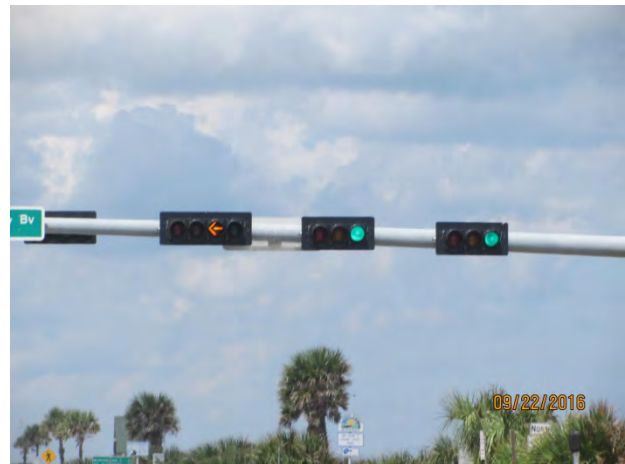
Three of the seven (43 percent) pedestrian crashes along the study corridor occurred at the intersection of SR A1A and SR 100. All three crashes occurred within the crosswalk (two on the west leg and one on the north leg) and involved left-turning vehicles. As shown in **Figure 36** and **Figure 37**, the northbound left-turn signal phasing is protected/permitted phasing. During the permitted northbound left-turn phase the pedestrian walk phase is active for the west leg crosswalk and vehicles must yield to pedestrians in the crosswalk.

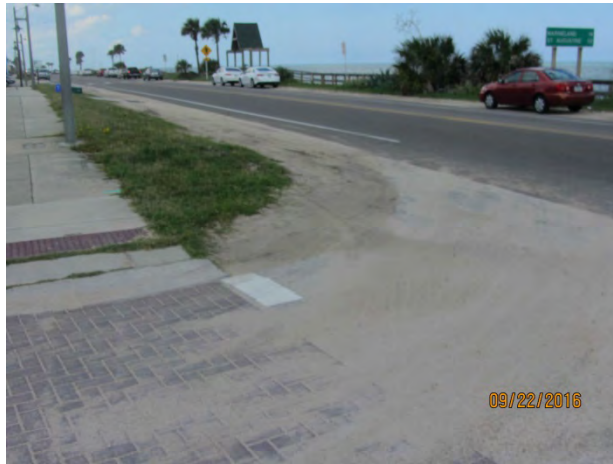
Figure 41

The intersection turning radii on the northwest and southwest corners from 4th Street N to 13th Street N are flush with the roadway. As shown in **Figure 41** and **Figure 42**, sand and debris is tracked onto the crosswalks and detectable warning surfaces because of this. The lack of curb and gutter has also allowed for pooling of water onto the sidewalk, forcing non-motorists to walk or bike through or around the puddles (**Figure 43**).

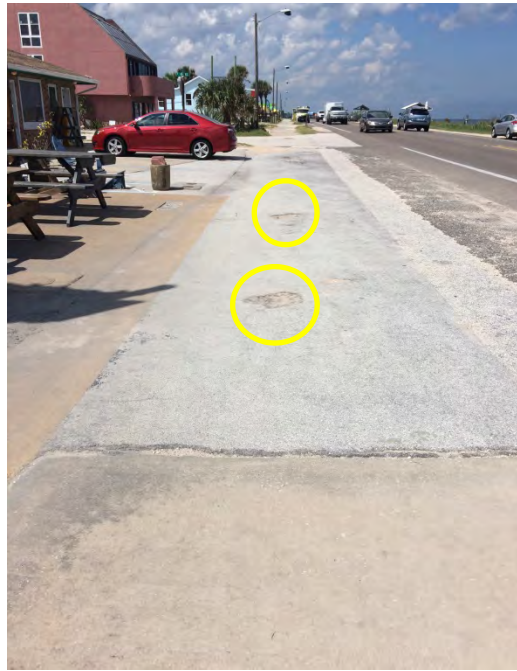
Figure 44

Approximately 100 feet south of 9th Street N the sidewalk transitions from concrete to asphalt. There are several potholes within this stretch of asphalt sidewalk as illustrated in **Figure 44**. These create a potential trip hazard for non-motorists using the sidewalk.

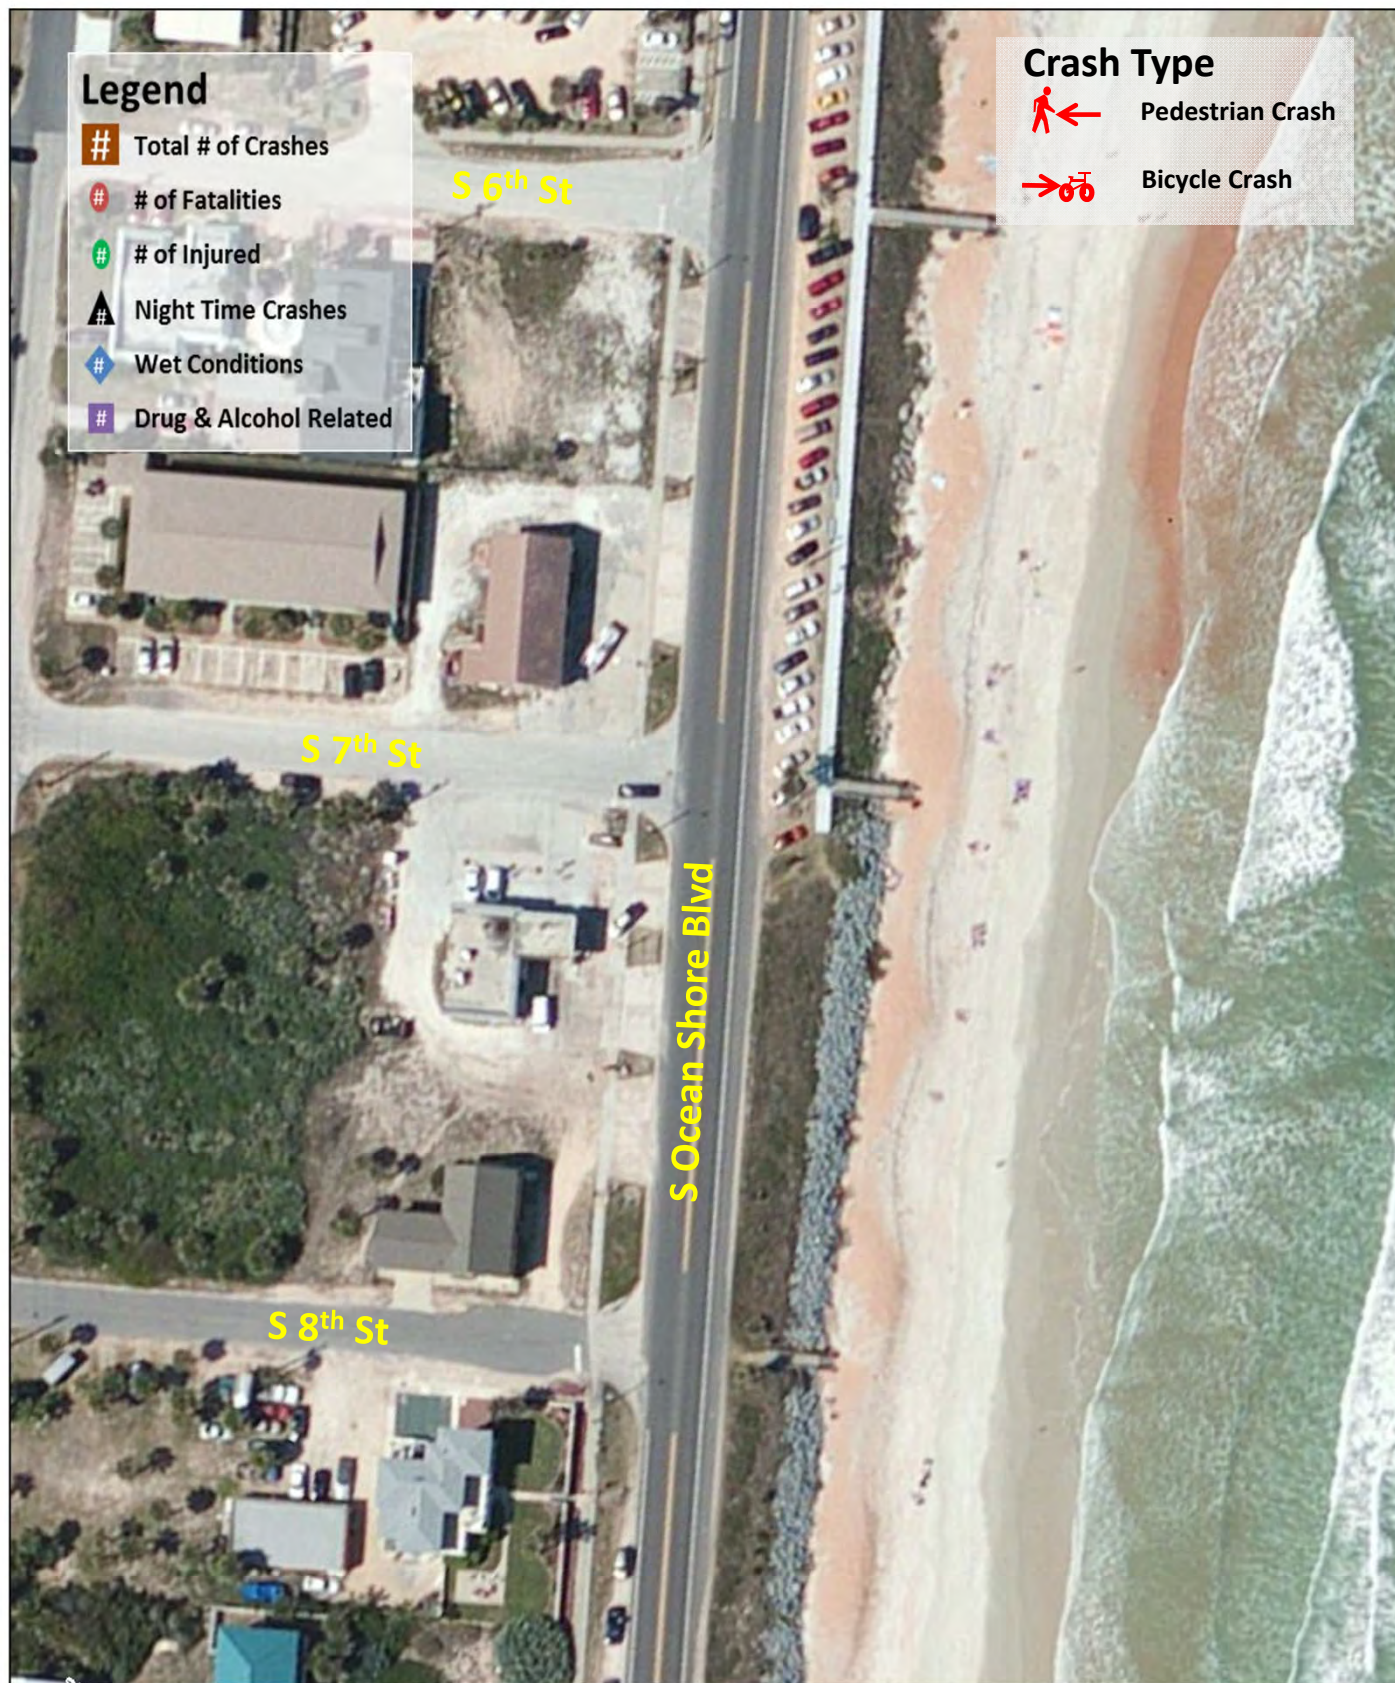
Figure
1

SR/CR A1A Pedestrian Safety & Mobility Study
Collision Diagram (2009 – 2014)
Location H: S 9th St. to S 6th St.

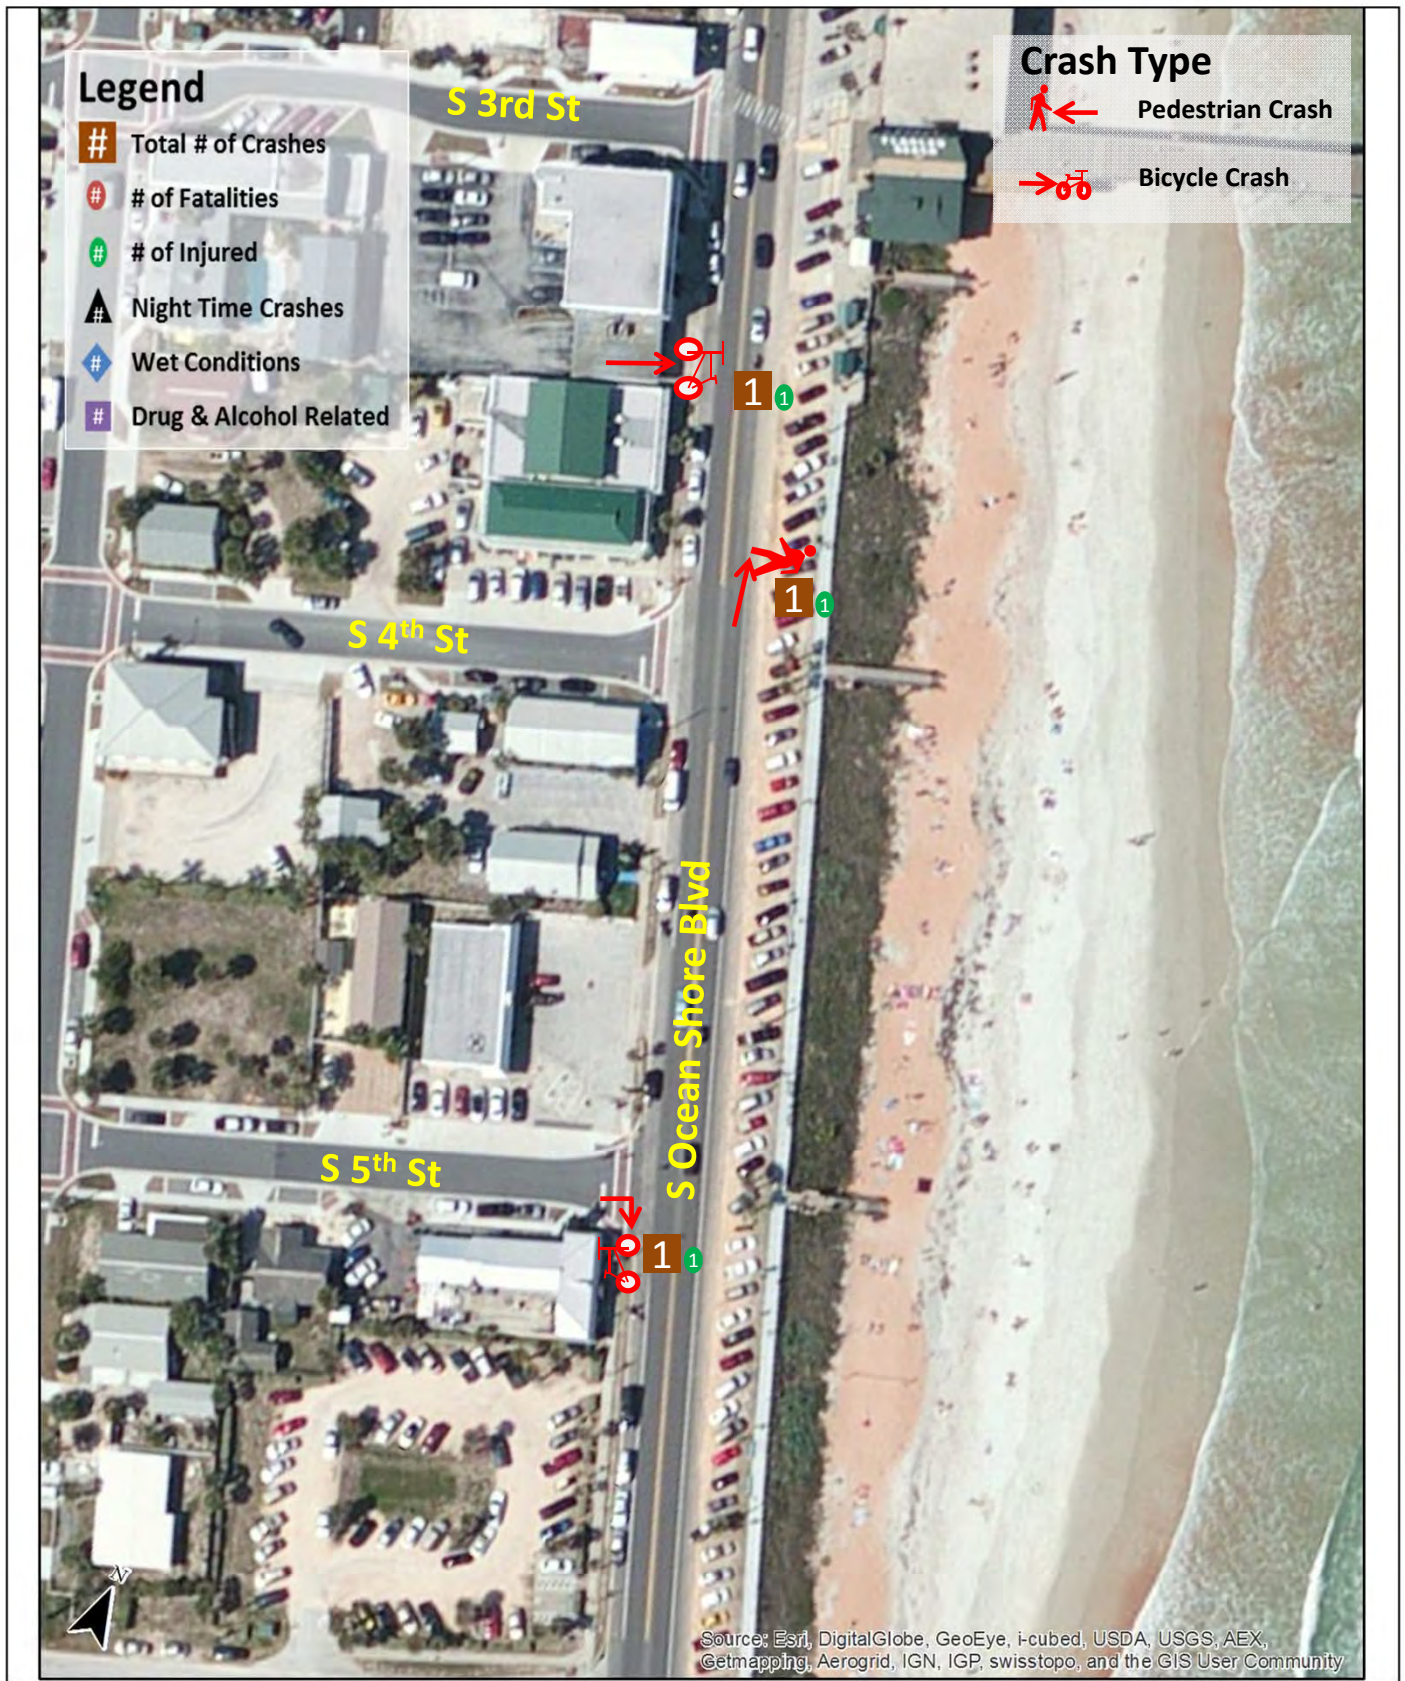
Figure
2

SR/CR A1A Pedestrian Safety & Mobility Study
Collision Diagram (2009 – 2014)
Location H: S 6th St. to S 3rd St.

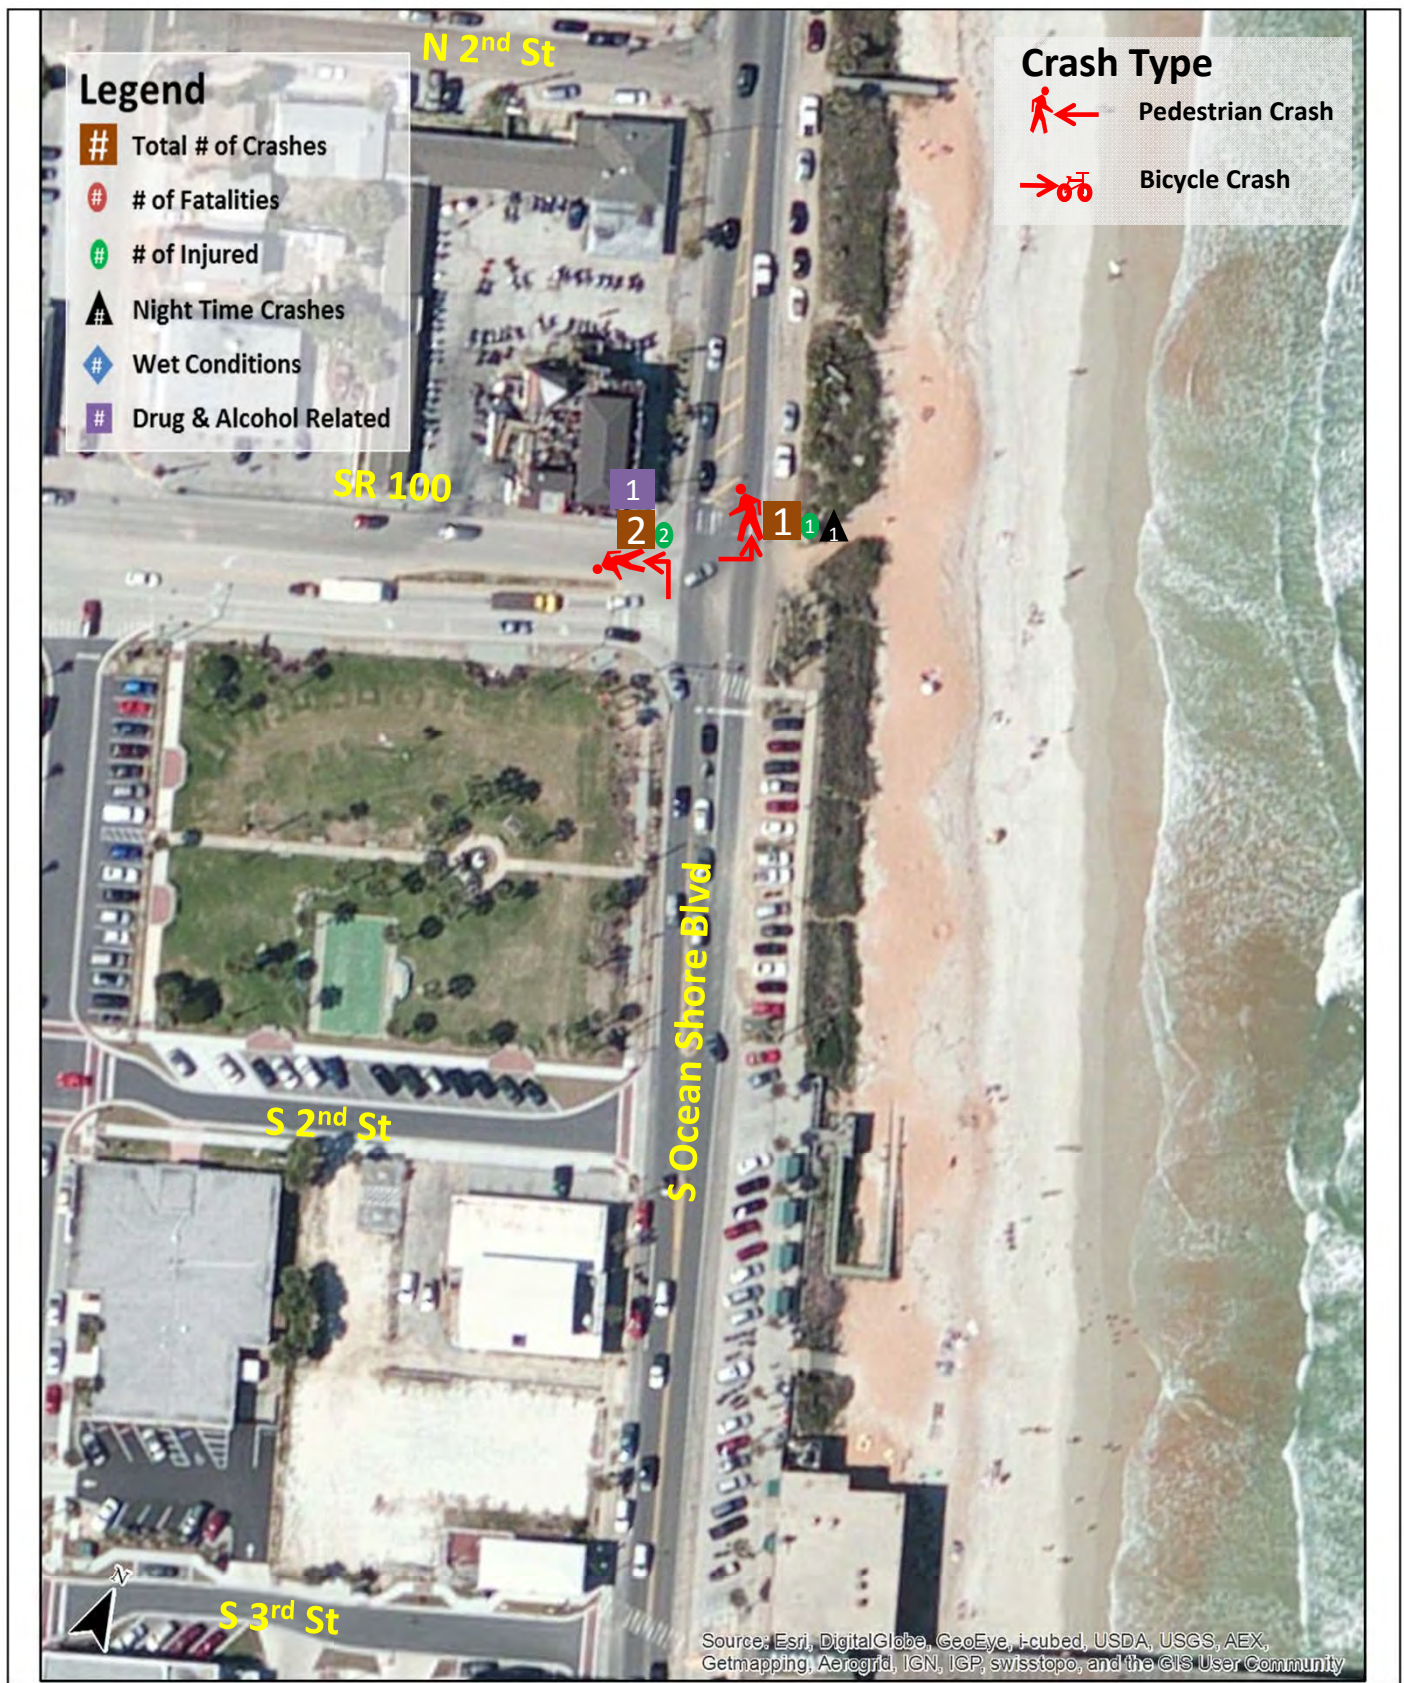
Figure
3

SR/CR A1A Pedestrian Safety & Mobility Study
Collision Diagram (2009 – 2014)
Location H: S 3rd St. to N 2nd St.
