SR/CR A1A PEDESTRIAN SAFETY & MOBILITY STUDY

PEDESTRIAN / BICYCLE SAFETY REVIEW

Focus Area H / 9th Street S to 13th Street N

Pedestrian/Bicycle Safety Review Report for SR A1A from 9th Street S to 13th Street N (Flagler Beach)

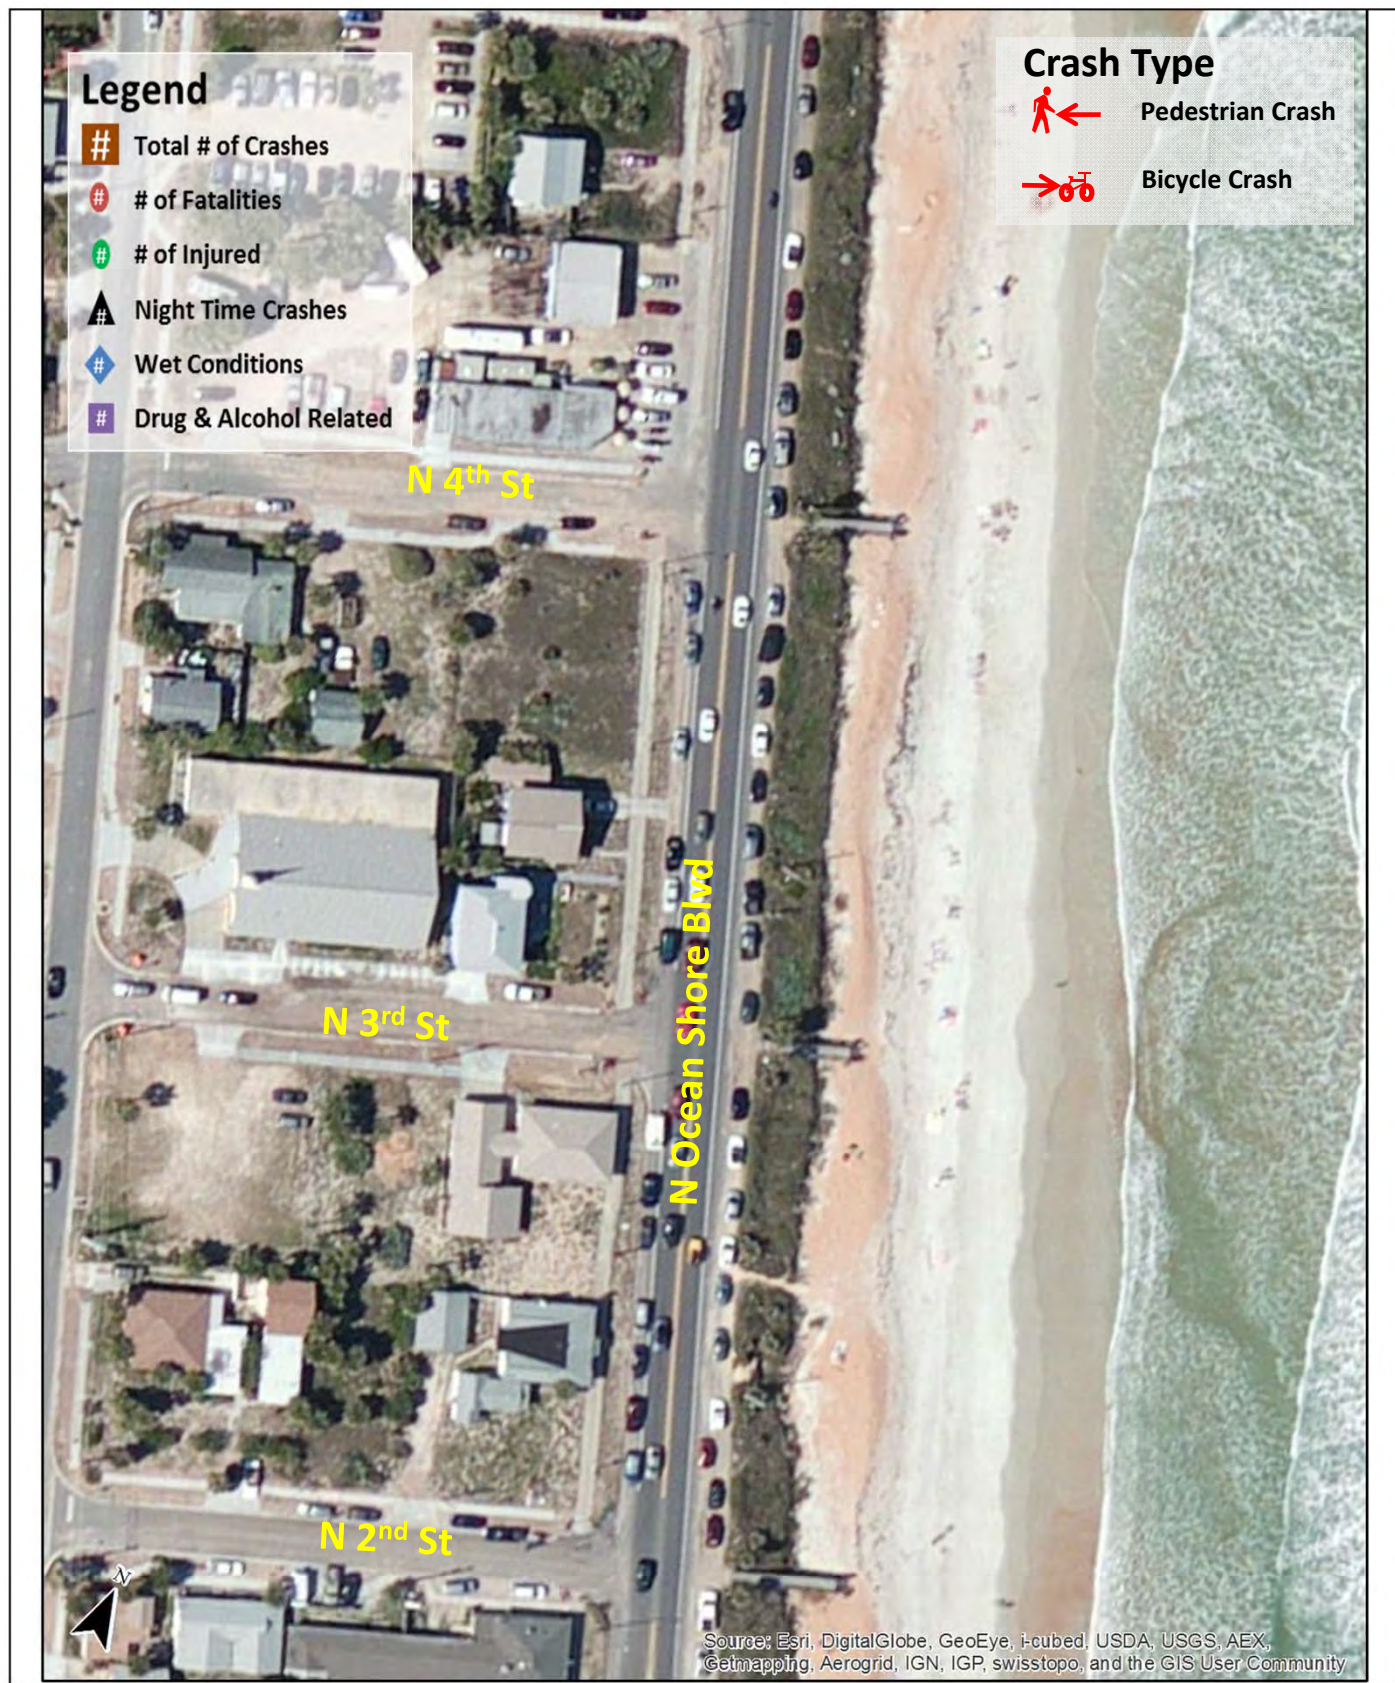
Figure
4

SR/CR A1A Pedestrian Safety & Mobility Study
Collision Diagram (2009 – 2014)
Location H: to N 2nd St. to N 4th St.

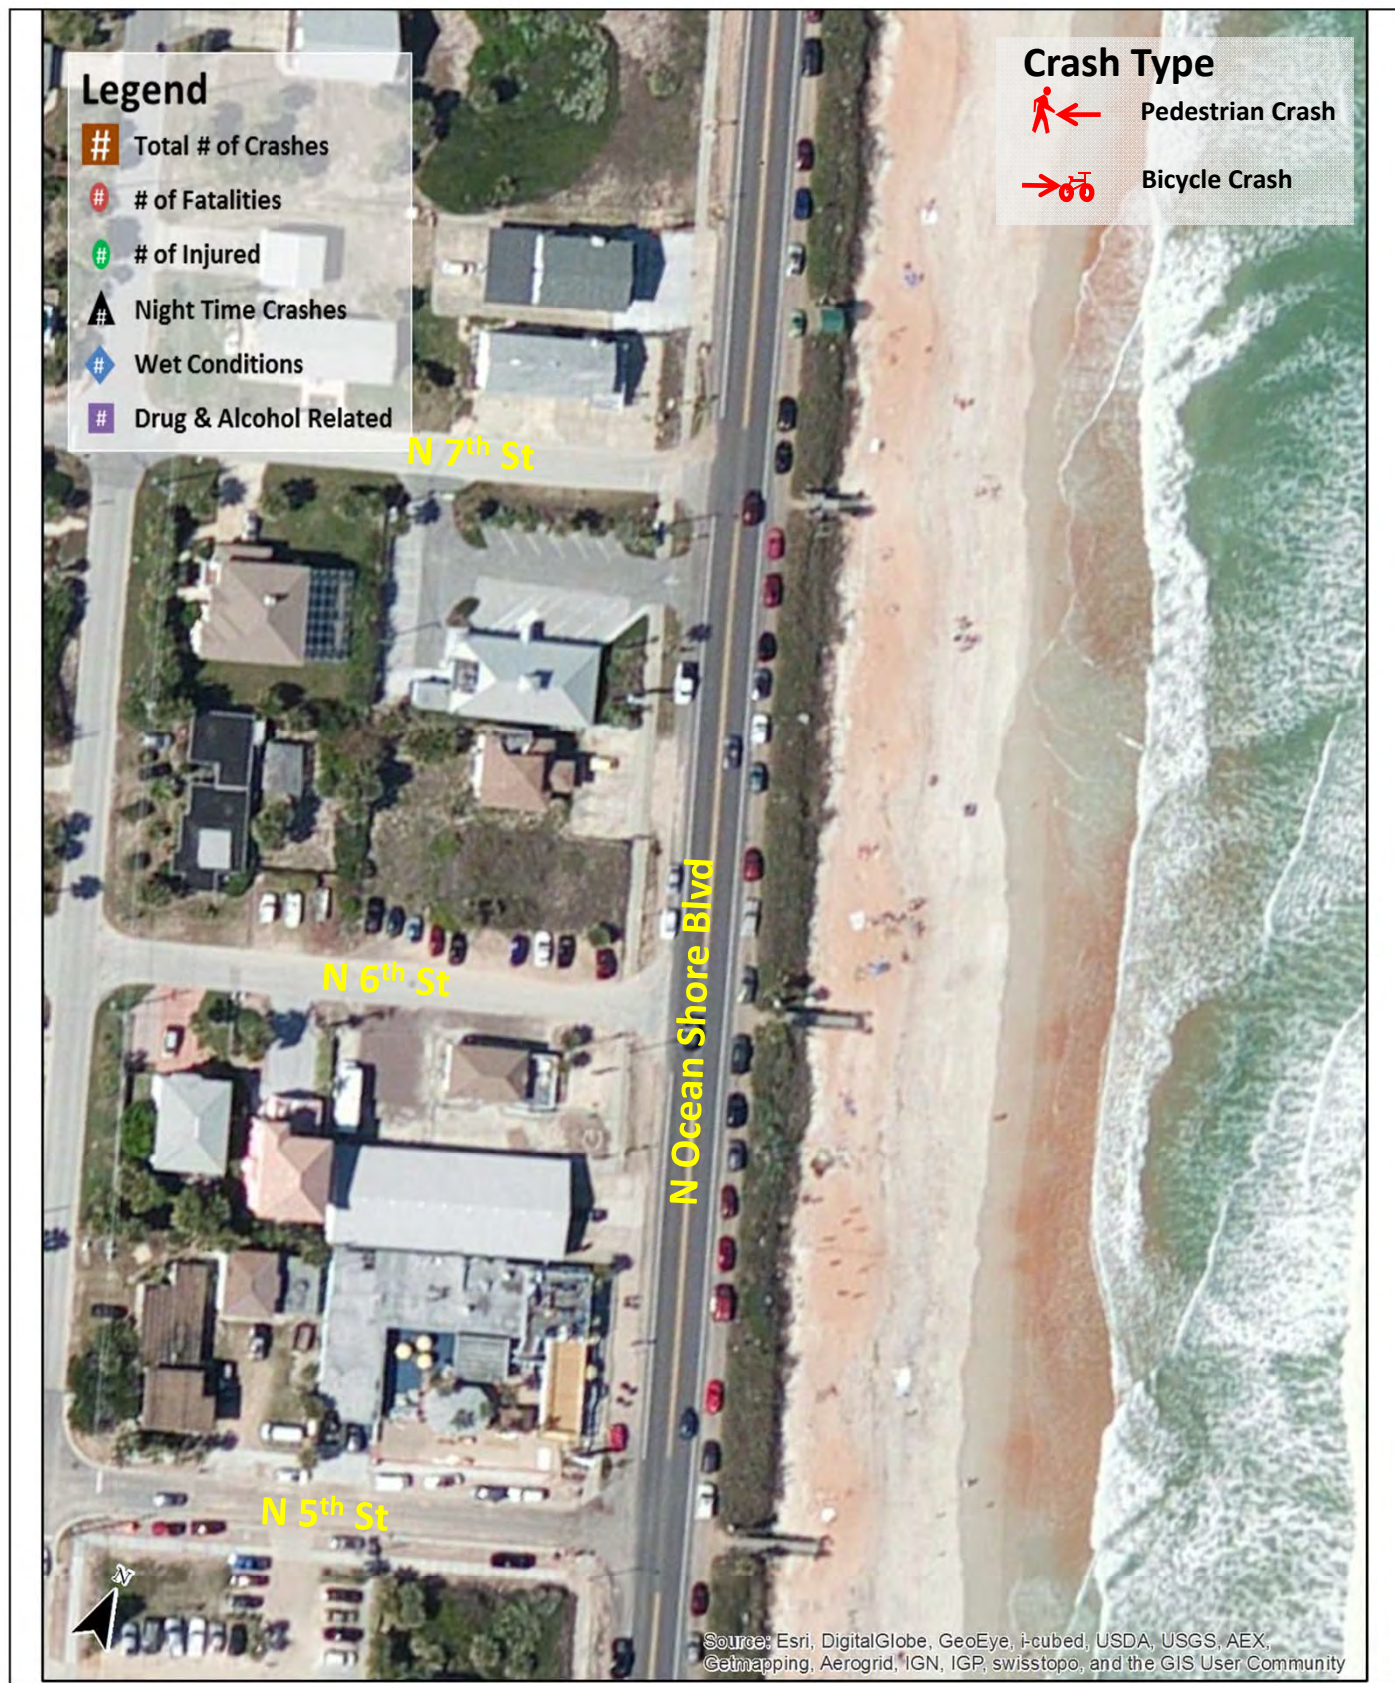
Figure
5

SR/CR A1A Pedestrian Safety & Mobility Study
Collision Diagram (2009 – 2014)
Location H: N 4th St. to N 7th St.

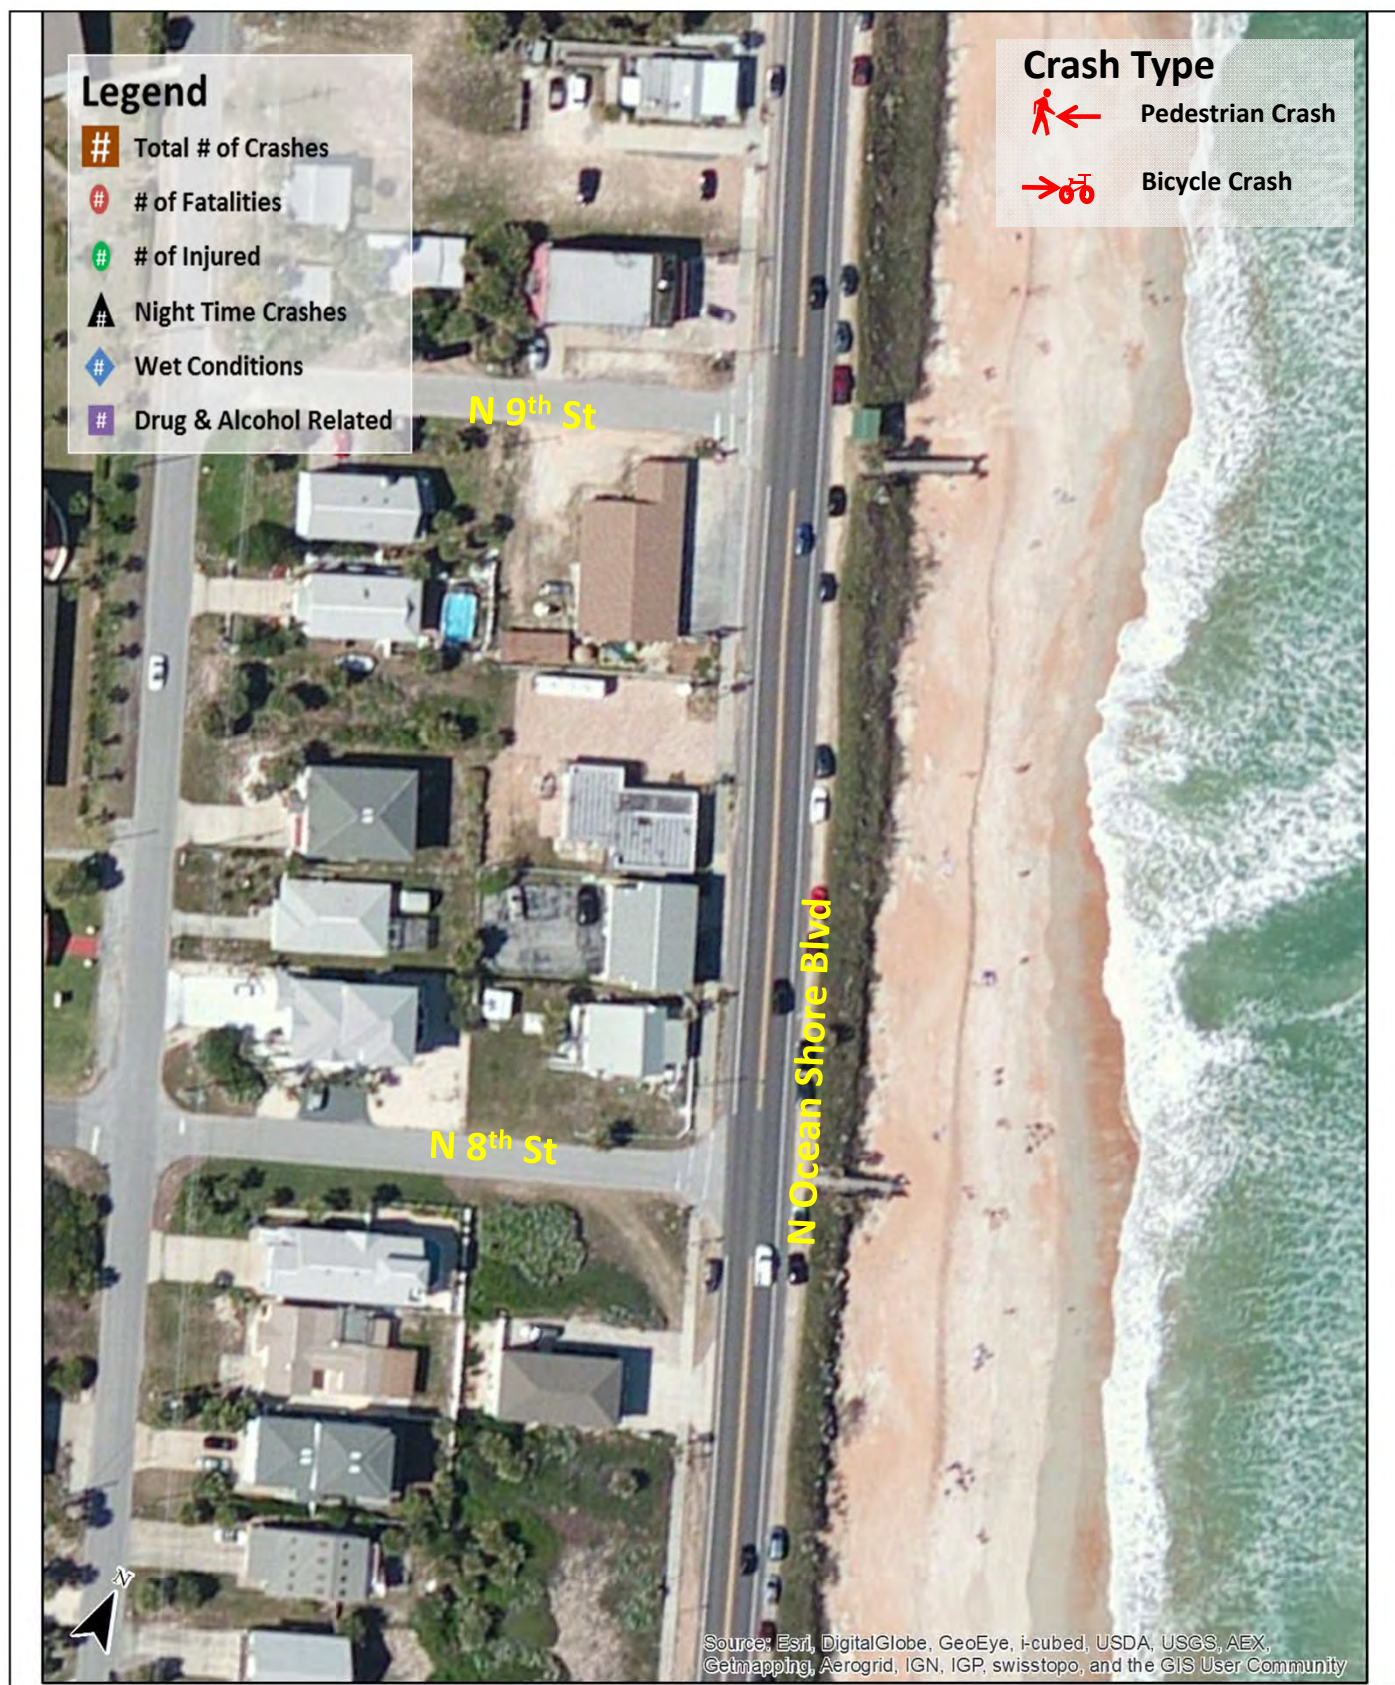
Figure
6

SR/CR A1A Pedestrian Safety & Mobility Study
Collision Diagram (2009 – 2014)
Location H: N 7th St. to N 9th St.

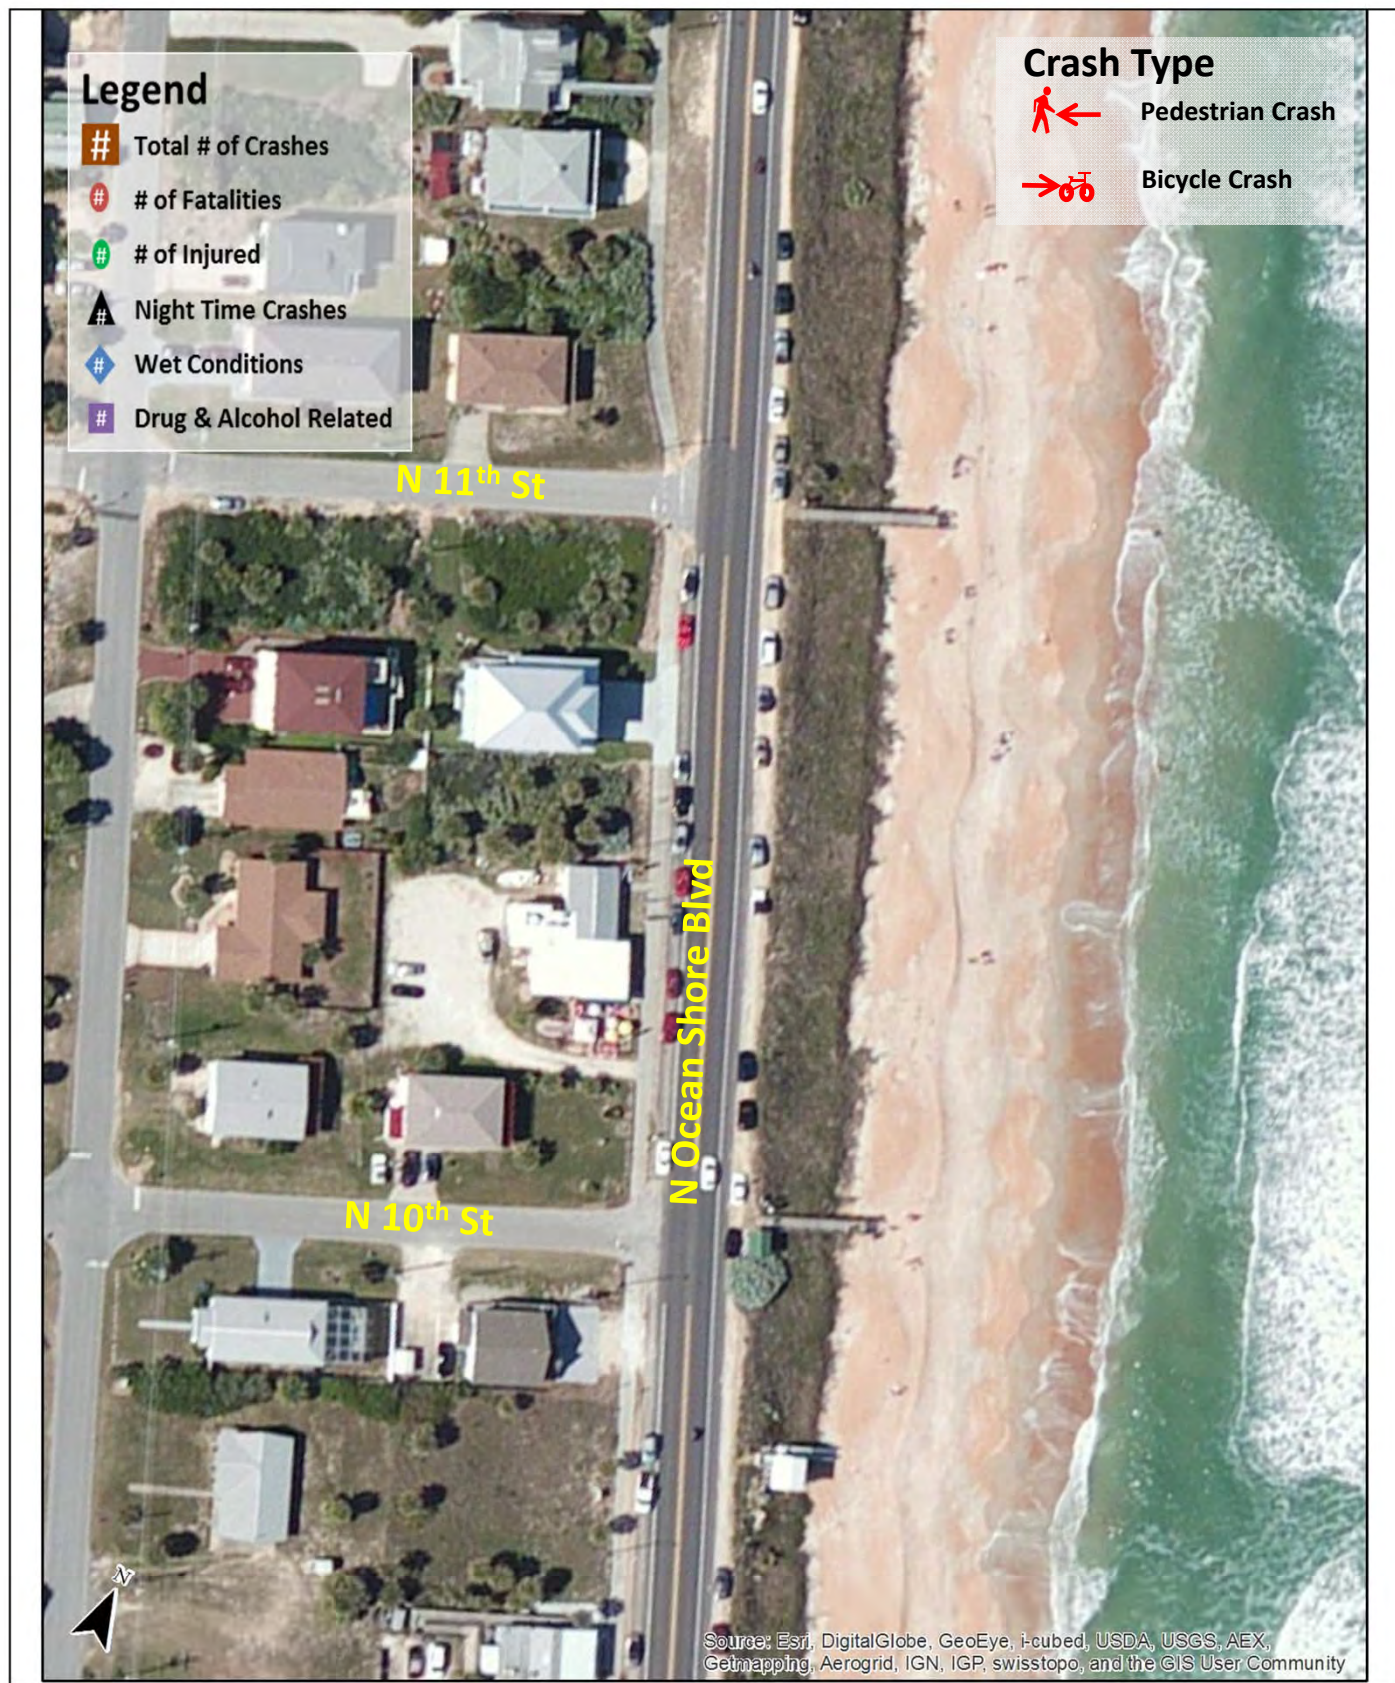
Figure

SR/CR A1A Pedestrian Safety & Mobility Study
Collision Diagram (2009 – 2014)
Location H: N 9th St. to N 11th St.
