Pedestrian Crosswalk Research Study

Identifying Innovative & Feasible
Pedestrian Crosswalk Technologies for
Two Study Corridors in Volusia County

GMB Engineers & Planners, Inc

For
S Atlantic Avenue from Dunlawton Avenue to Beach Street
&
CR A1A from E 6th Avenue to Canaveral National Seashore Entrance

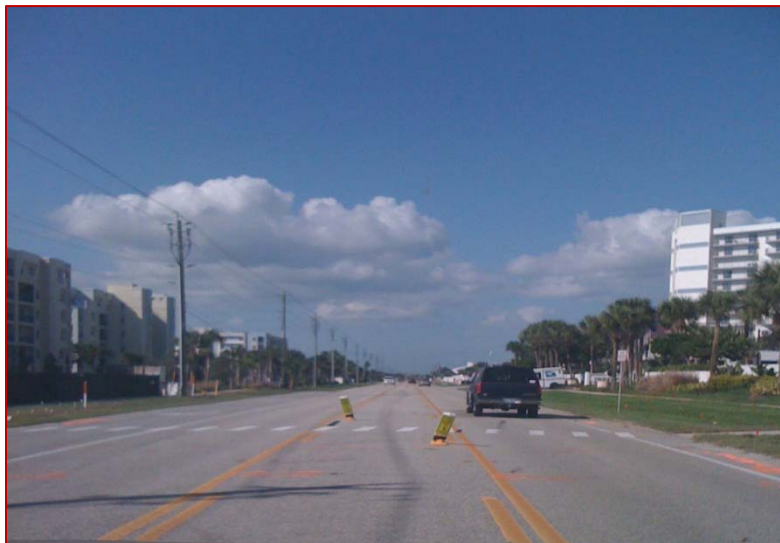
Figure 3: Picture of In-Street Pedestrian Crosswalk Signs

MUTCD R1-6 In-Street Pedestrian Crosswalk Signs are intended for use at uncontrolled (unsignalized) crosswalks to remind drivers of laws regarding pedestrians' right-of-way. The legend "State Law" may be shown on the top of the sign if applicable.

This technology is currently used in both the study areas. However, the size and number of signs used at an individual location are the two areas where improvements could be considered to improve the effectiveness of these signs. For instance, instead of one sign, a group of at-least three signs could be used to improve the effectiveness. The size of the sign could be increased for better visibility. Refer to the MUTCD – 2009 Edition and Section 3.8 of the Topic No. 750-000-005 on selection guidance and additional information on this treatment.

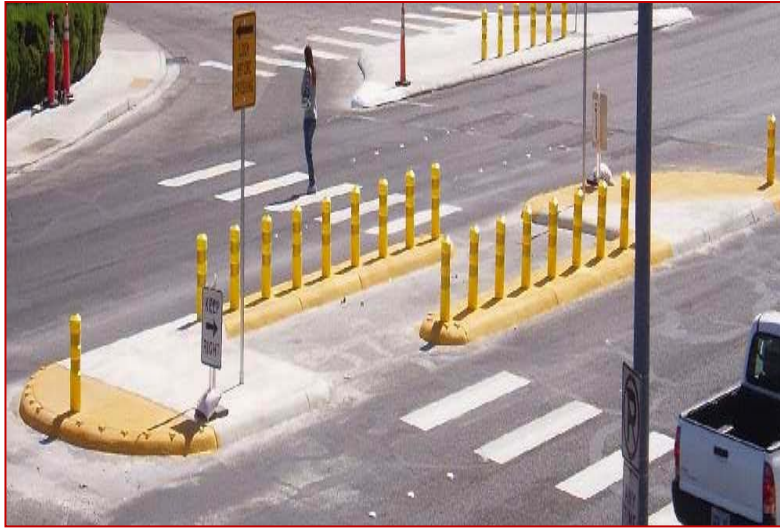
Figure 6: Picture of Danish Offset and Median Refuge Island Combination

A Danish offset is an offset at the middle of a multilane crossing that provides refuge for pedestrians in terms of physical separation from traffic and ensures they are facing the traffic before crossing the second half of the roadway.

The offset is a type of channelization that encourages pedestrians to turn and walk parallel to the traffic they are crossing.

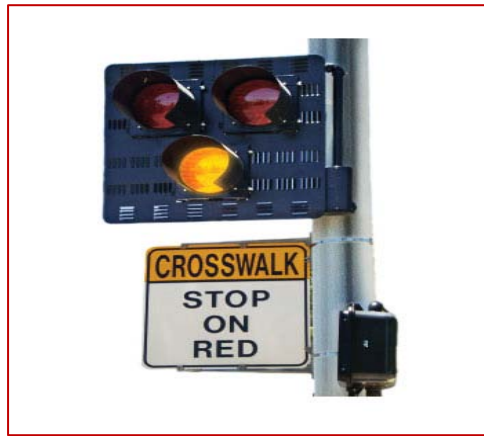
Figure 14: Picture of HAWK Beacon (source: 4)

HAWK beacons could be installed on roadside poles and mast arms and remains dark until a pedestrian activates the system by pressing a pushbutton. Once the system is activated, a sequence of amber and red beacon lights provides a bright warning to motorists.

The system also provides a Pedestrian Signal Head and could be used as mid-block pedestrian signal.
