# PEDESTRIAN AND BICYCLE SAFETY STUDY

Dayton Beach Shores, Volusia County

RIVER TO SEA TRANSPORTATION PLANNING ORGANIZATION

July 2015

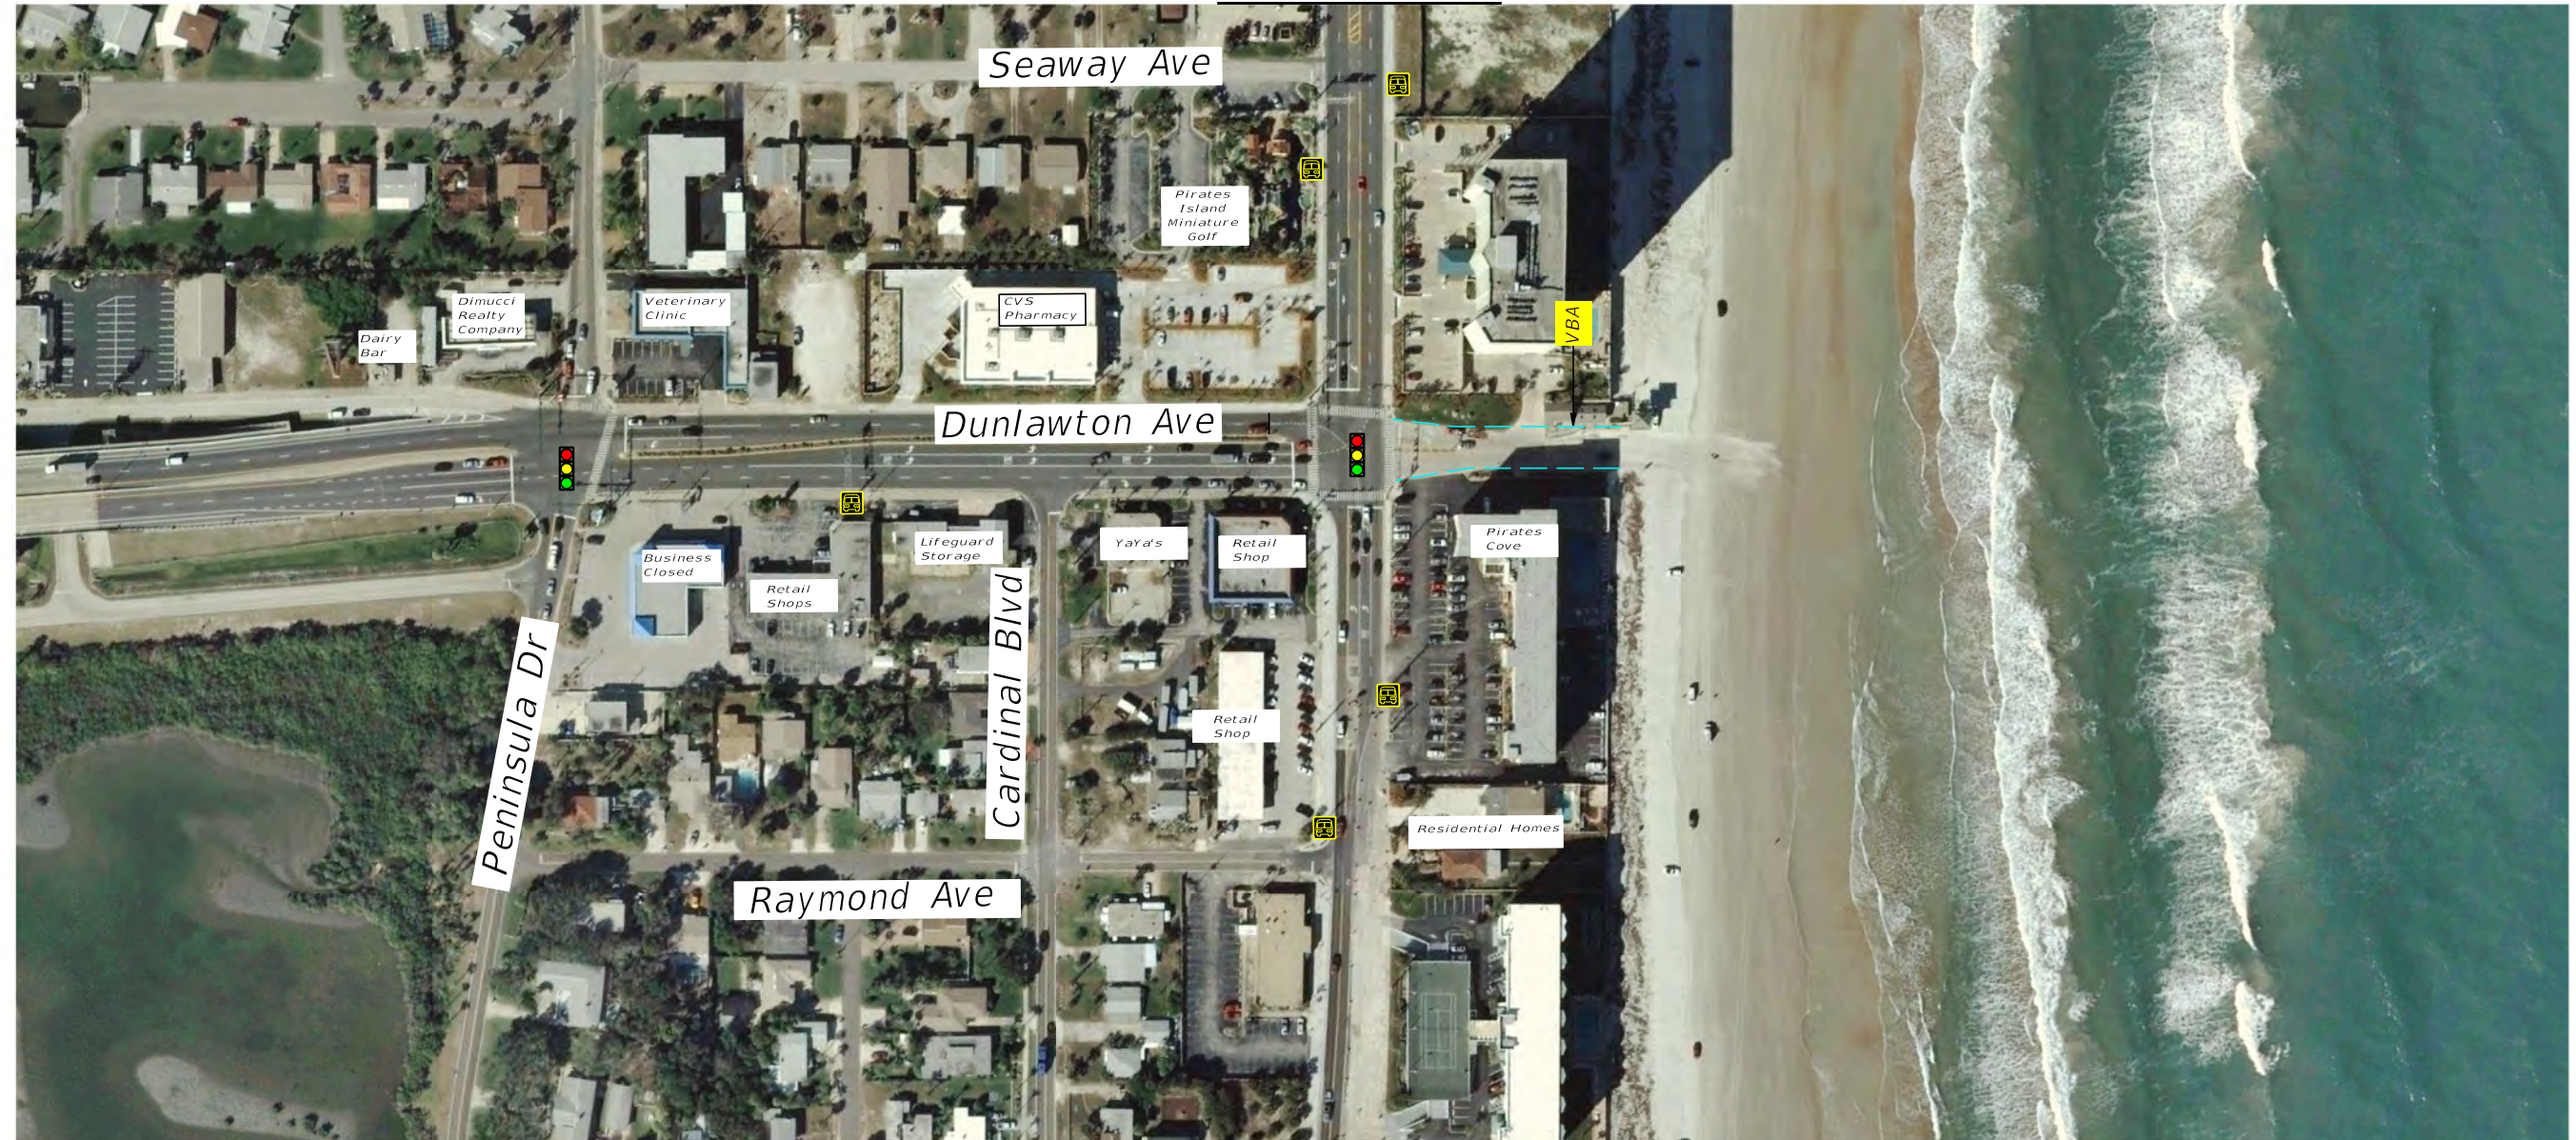
FIGURE 2 (PAGE 1 OF 5)  
EXISTING CONDITIONS

**Figure 2** shows the existing conditions along the study corridor.

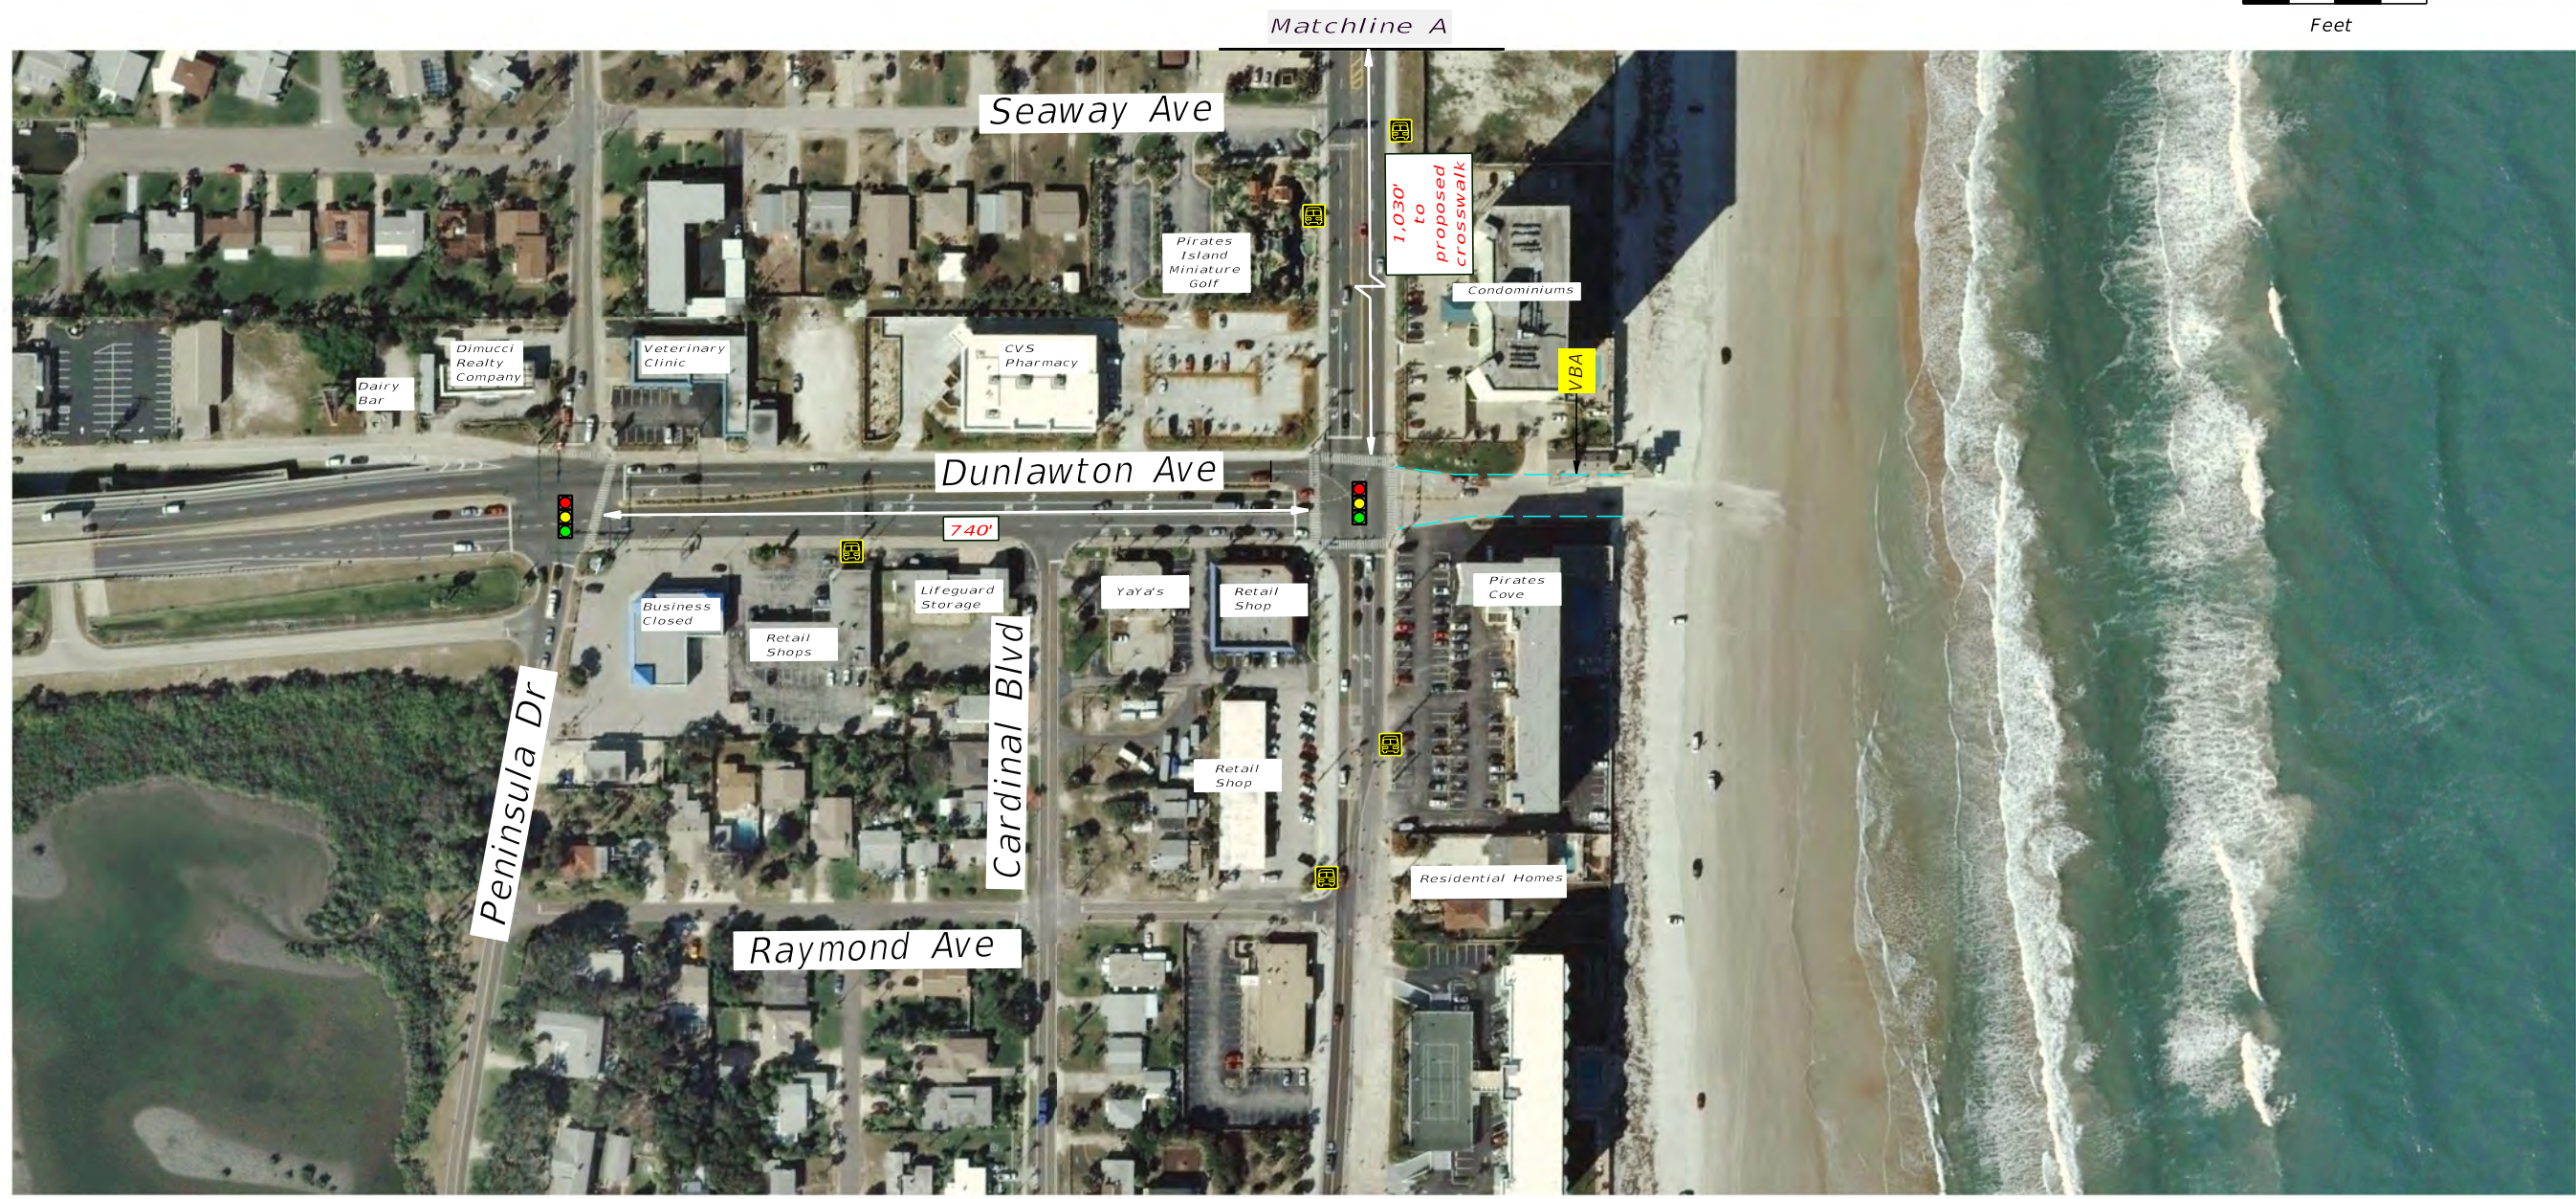
An aerial photograph showing the study corridor, crossing locations and distances in between crossing locations or signals is depicted in **Figure 3**.

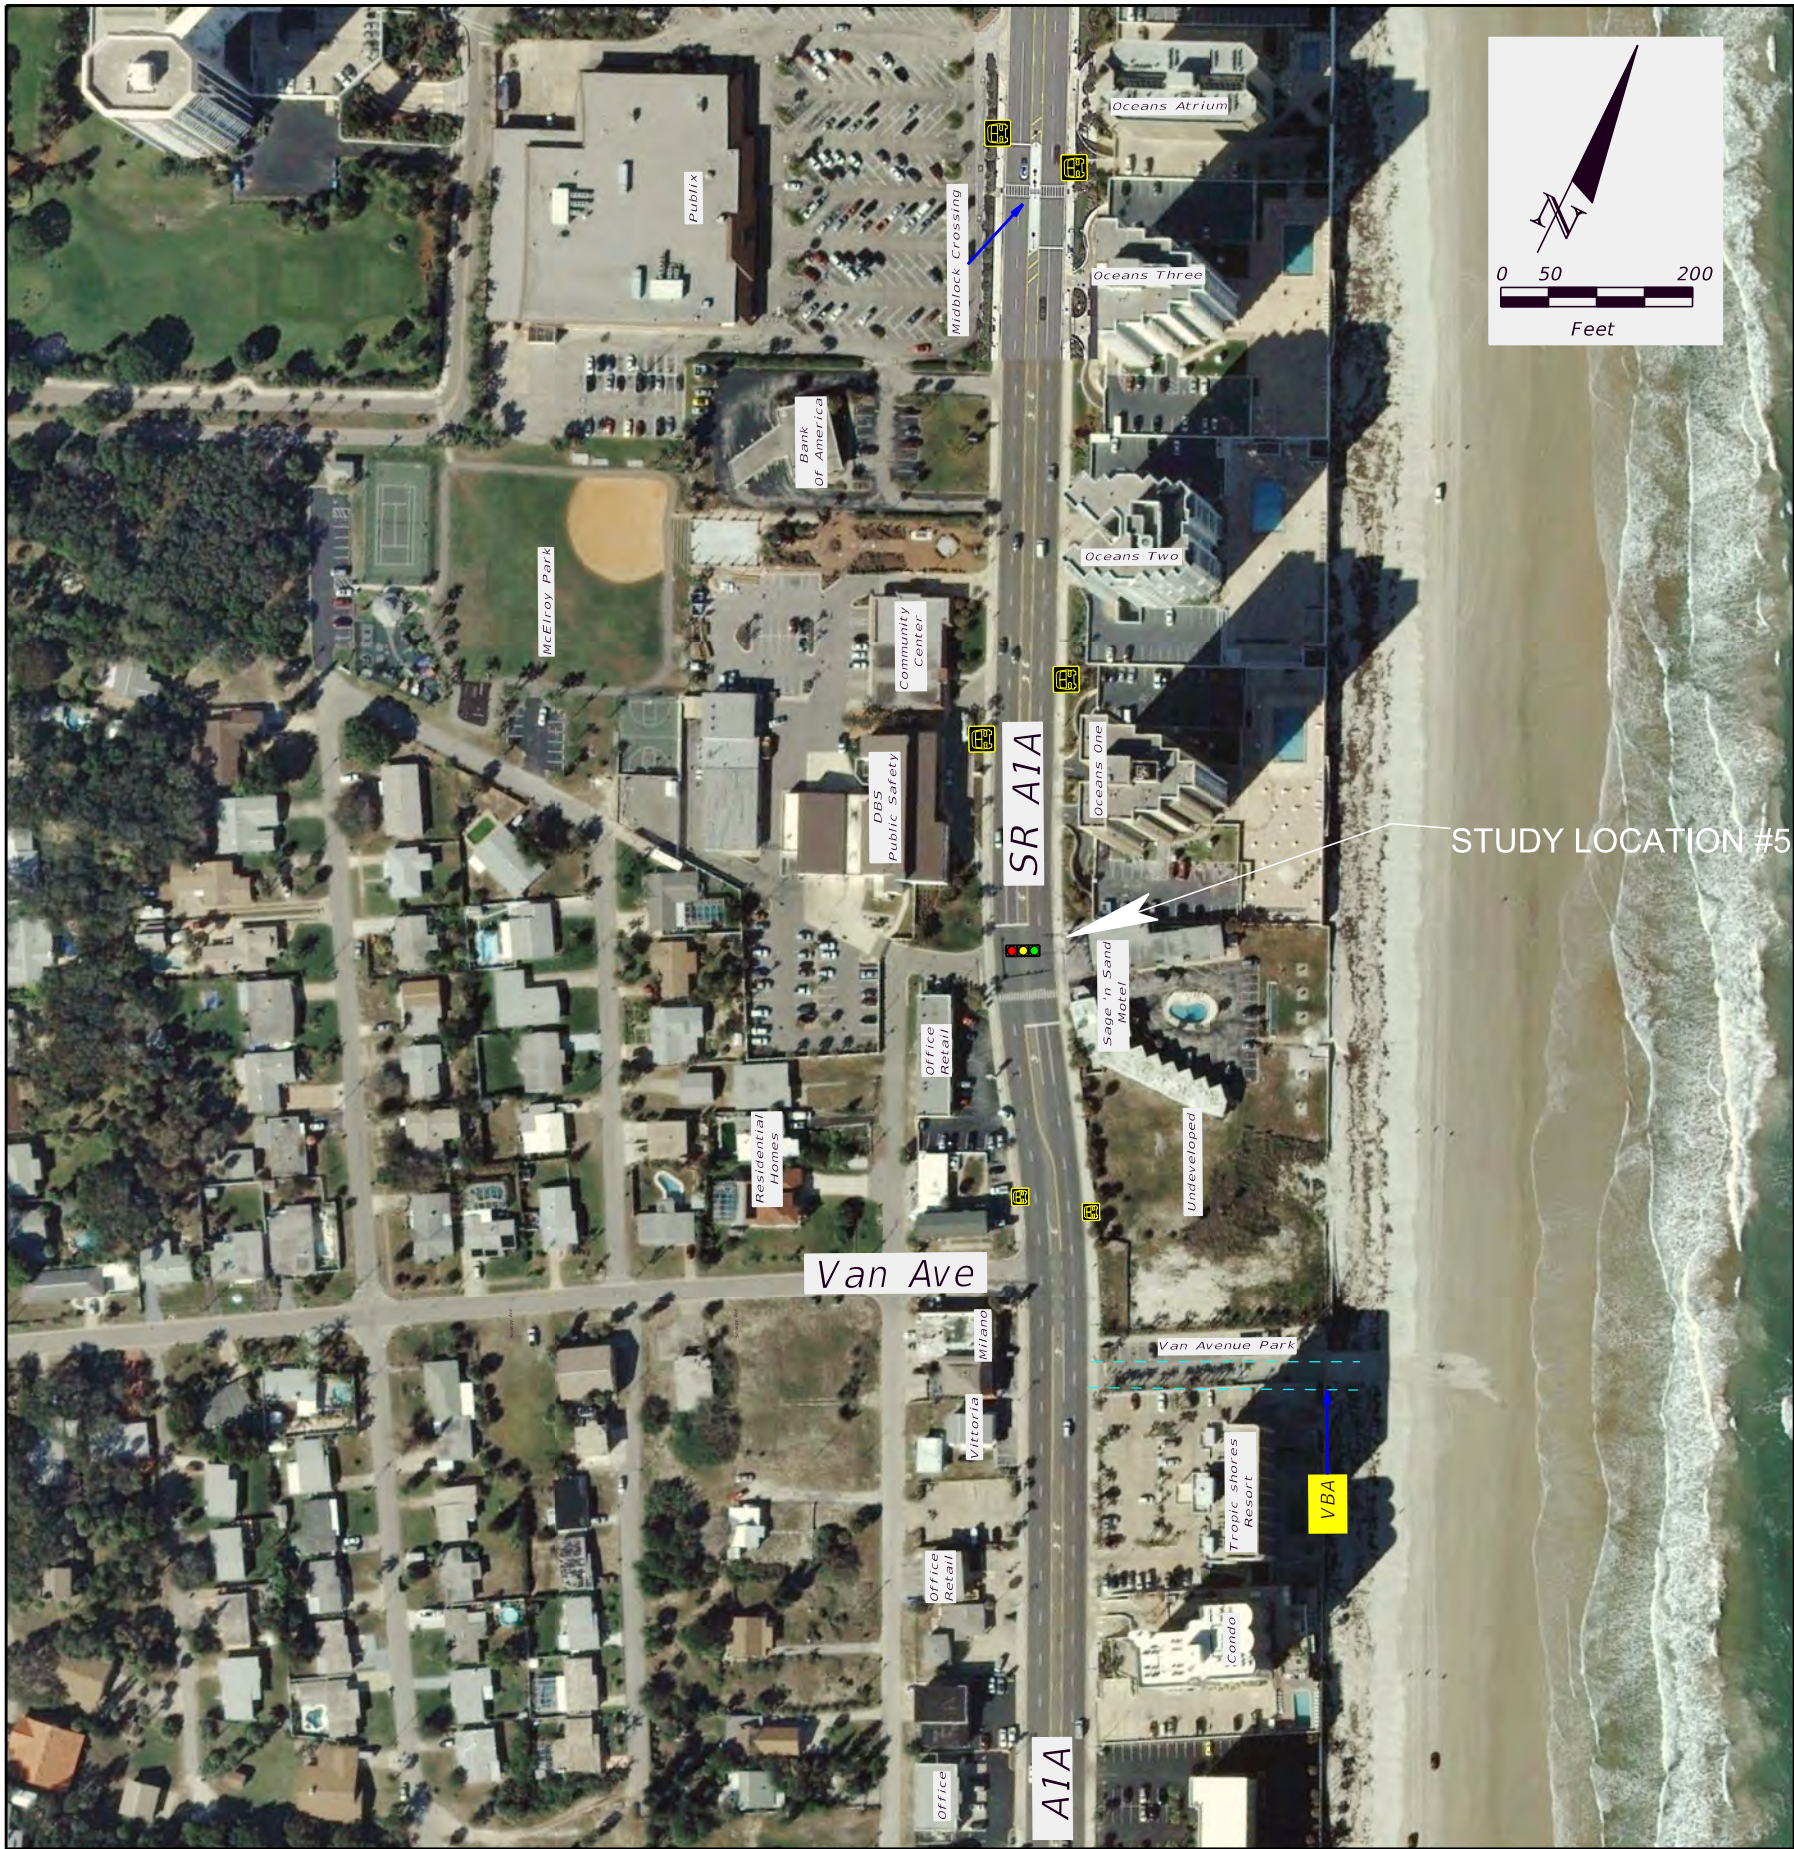
Study location #5 is on State Road A1A adjacent the City of Daytona Beach Shores Public Safety Building where an existing midblock pedestrian crosswalk is located. The crosswalk is currently signalized with activation occurring with pedestrian push-button detectors. **Table 6** provides a summary of the existing conditions at the study location. Photographs in the vicinity of the study location are also provided. An aerial image showing the proximity of the study location with respect to adjacent land uses, and a zoomed in view of the study location is shown in **Figure 8**.

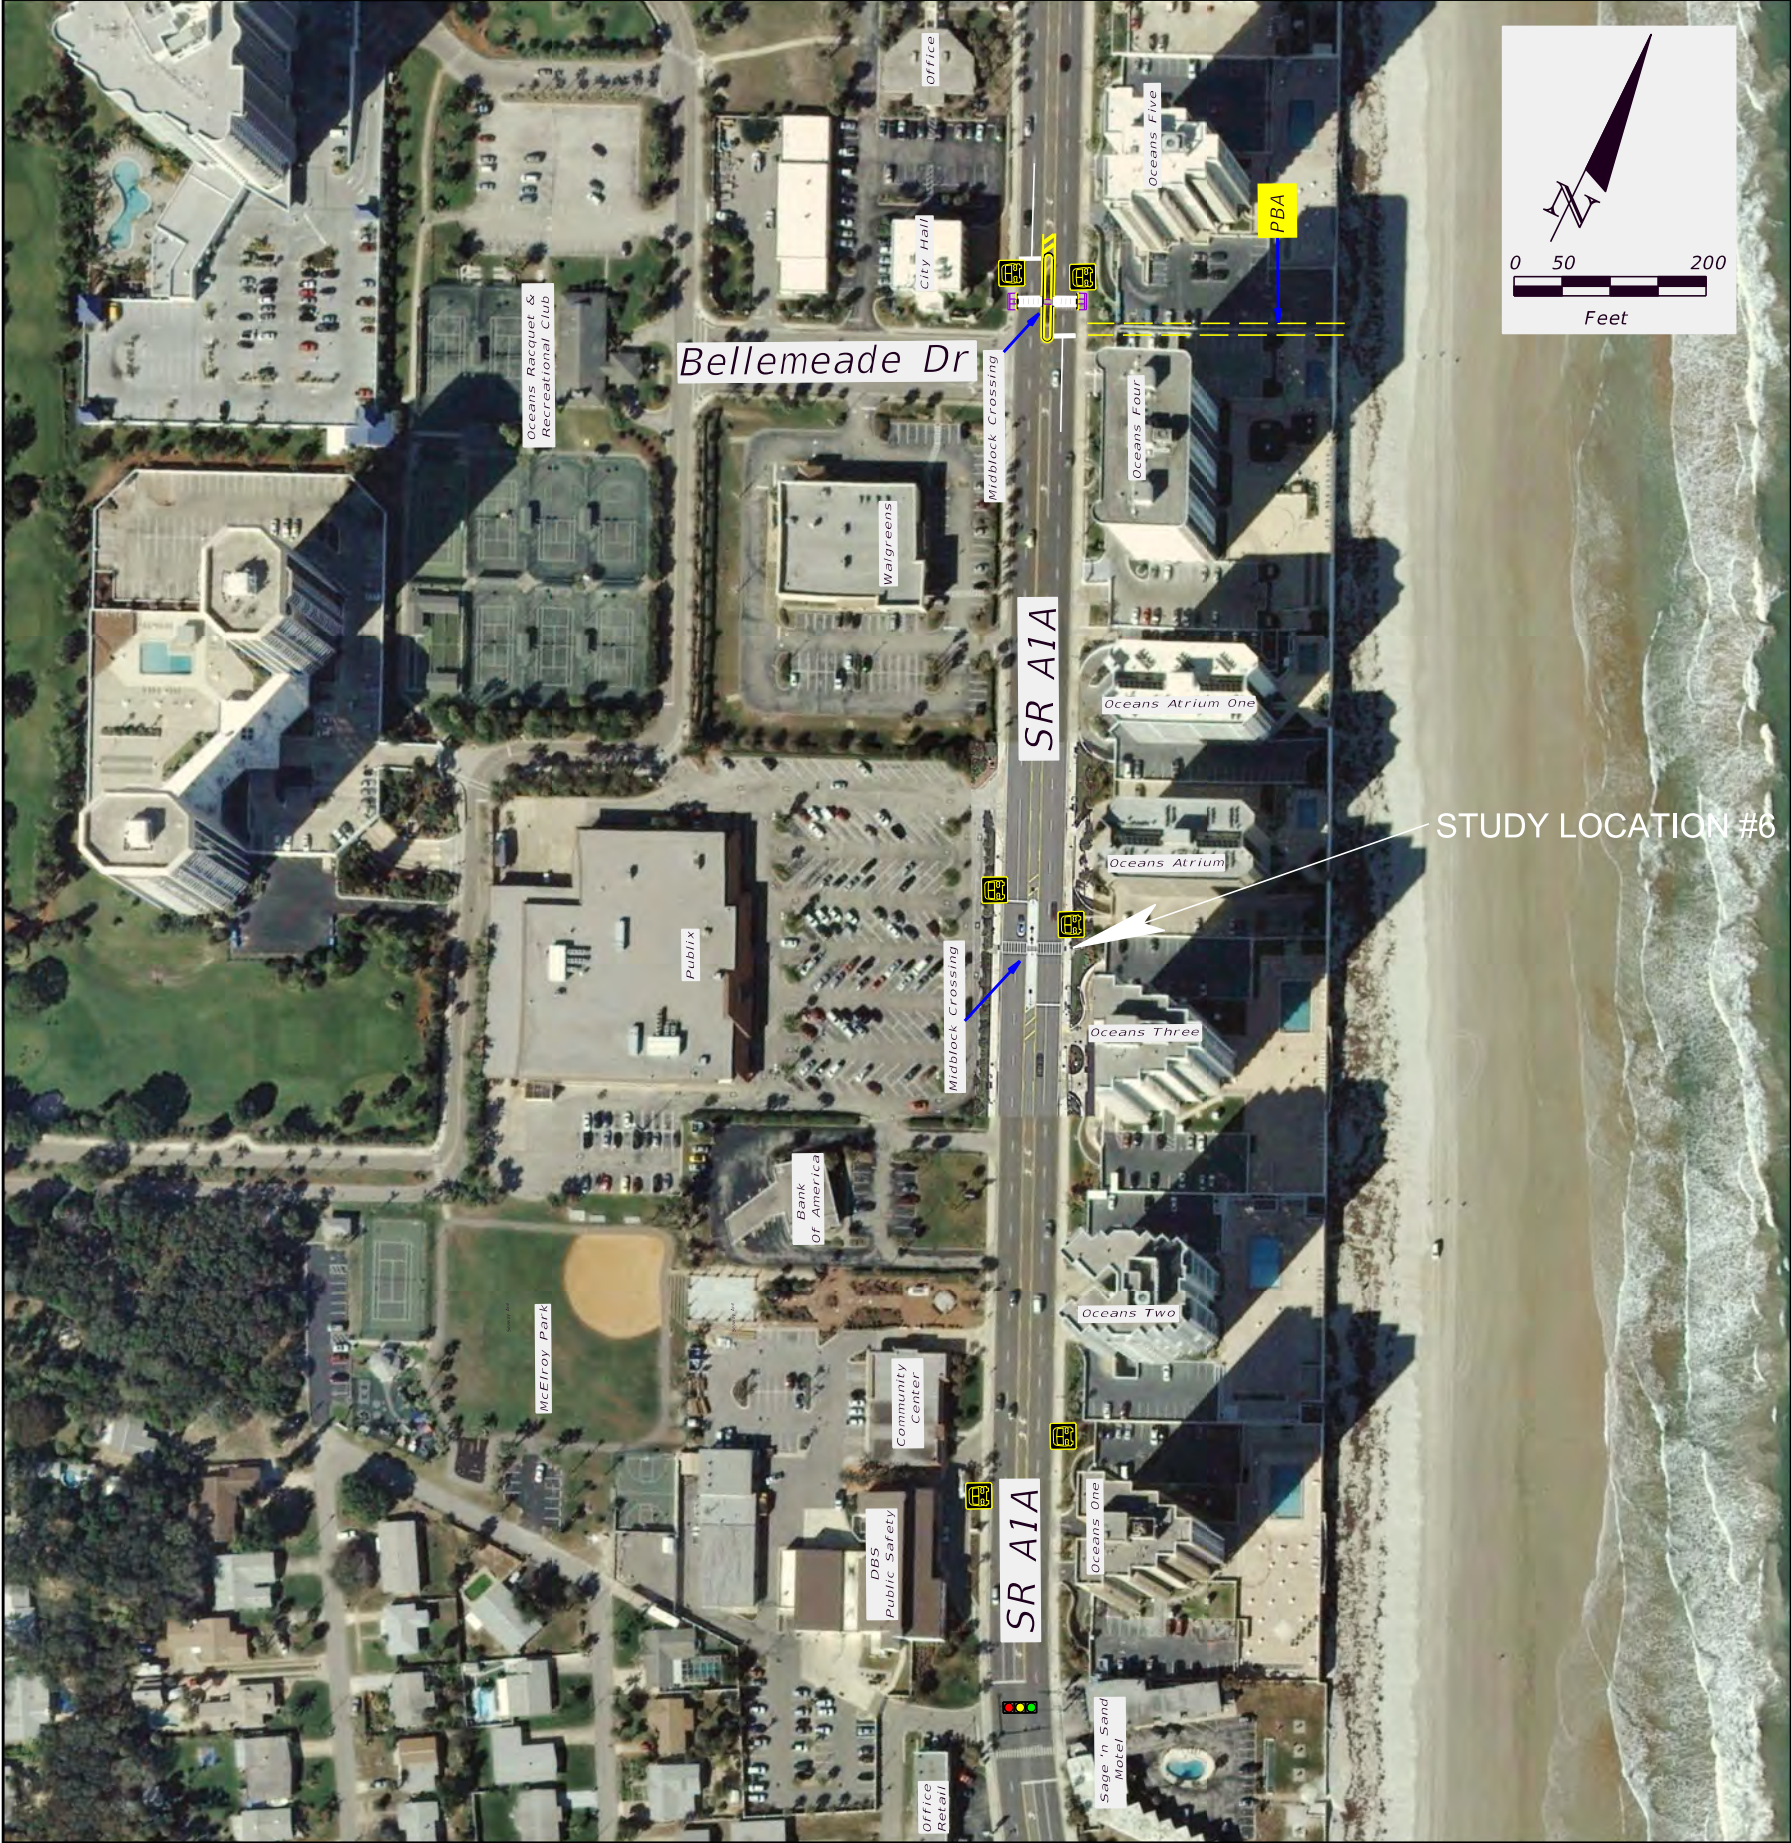
IMPROVEMENTS:  
INSTALL RECTANGULAR RAPID FLASHING  
BEACON (SIGNAGE TO BE PROVIDED IN  
ACCORDANCE WITH TYPICAL  
IN APPENDIX C)

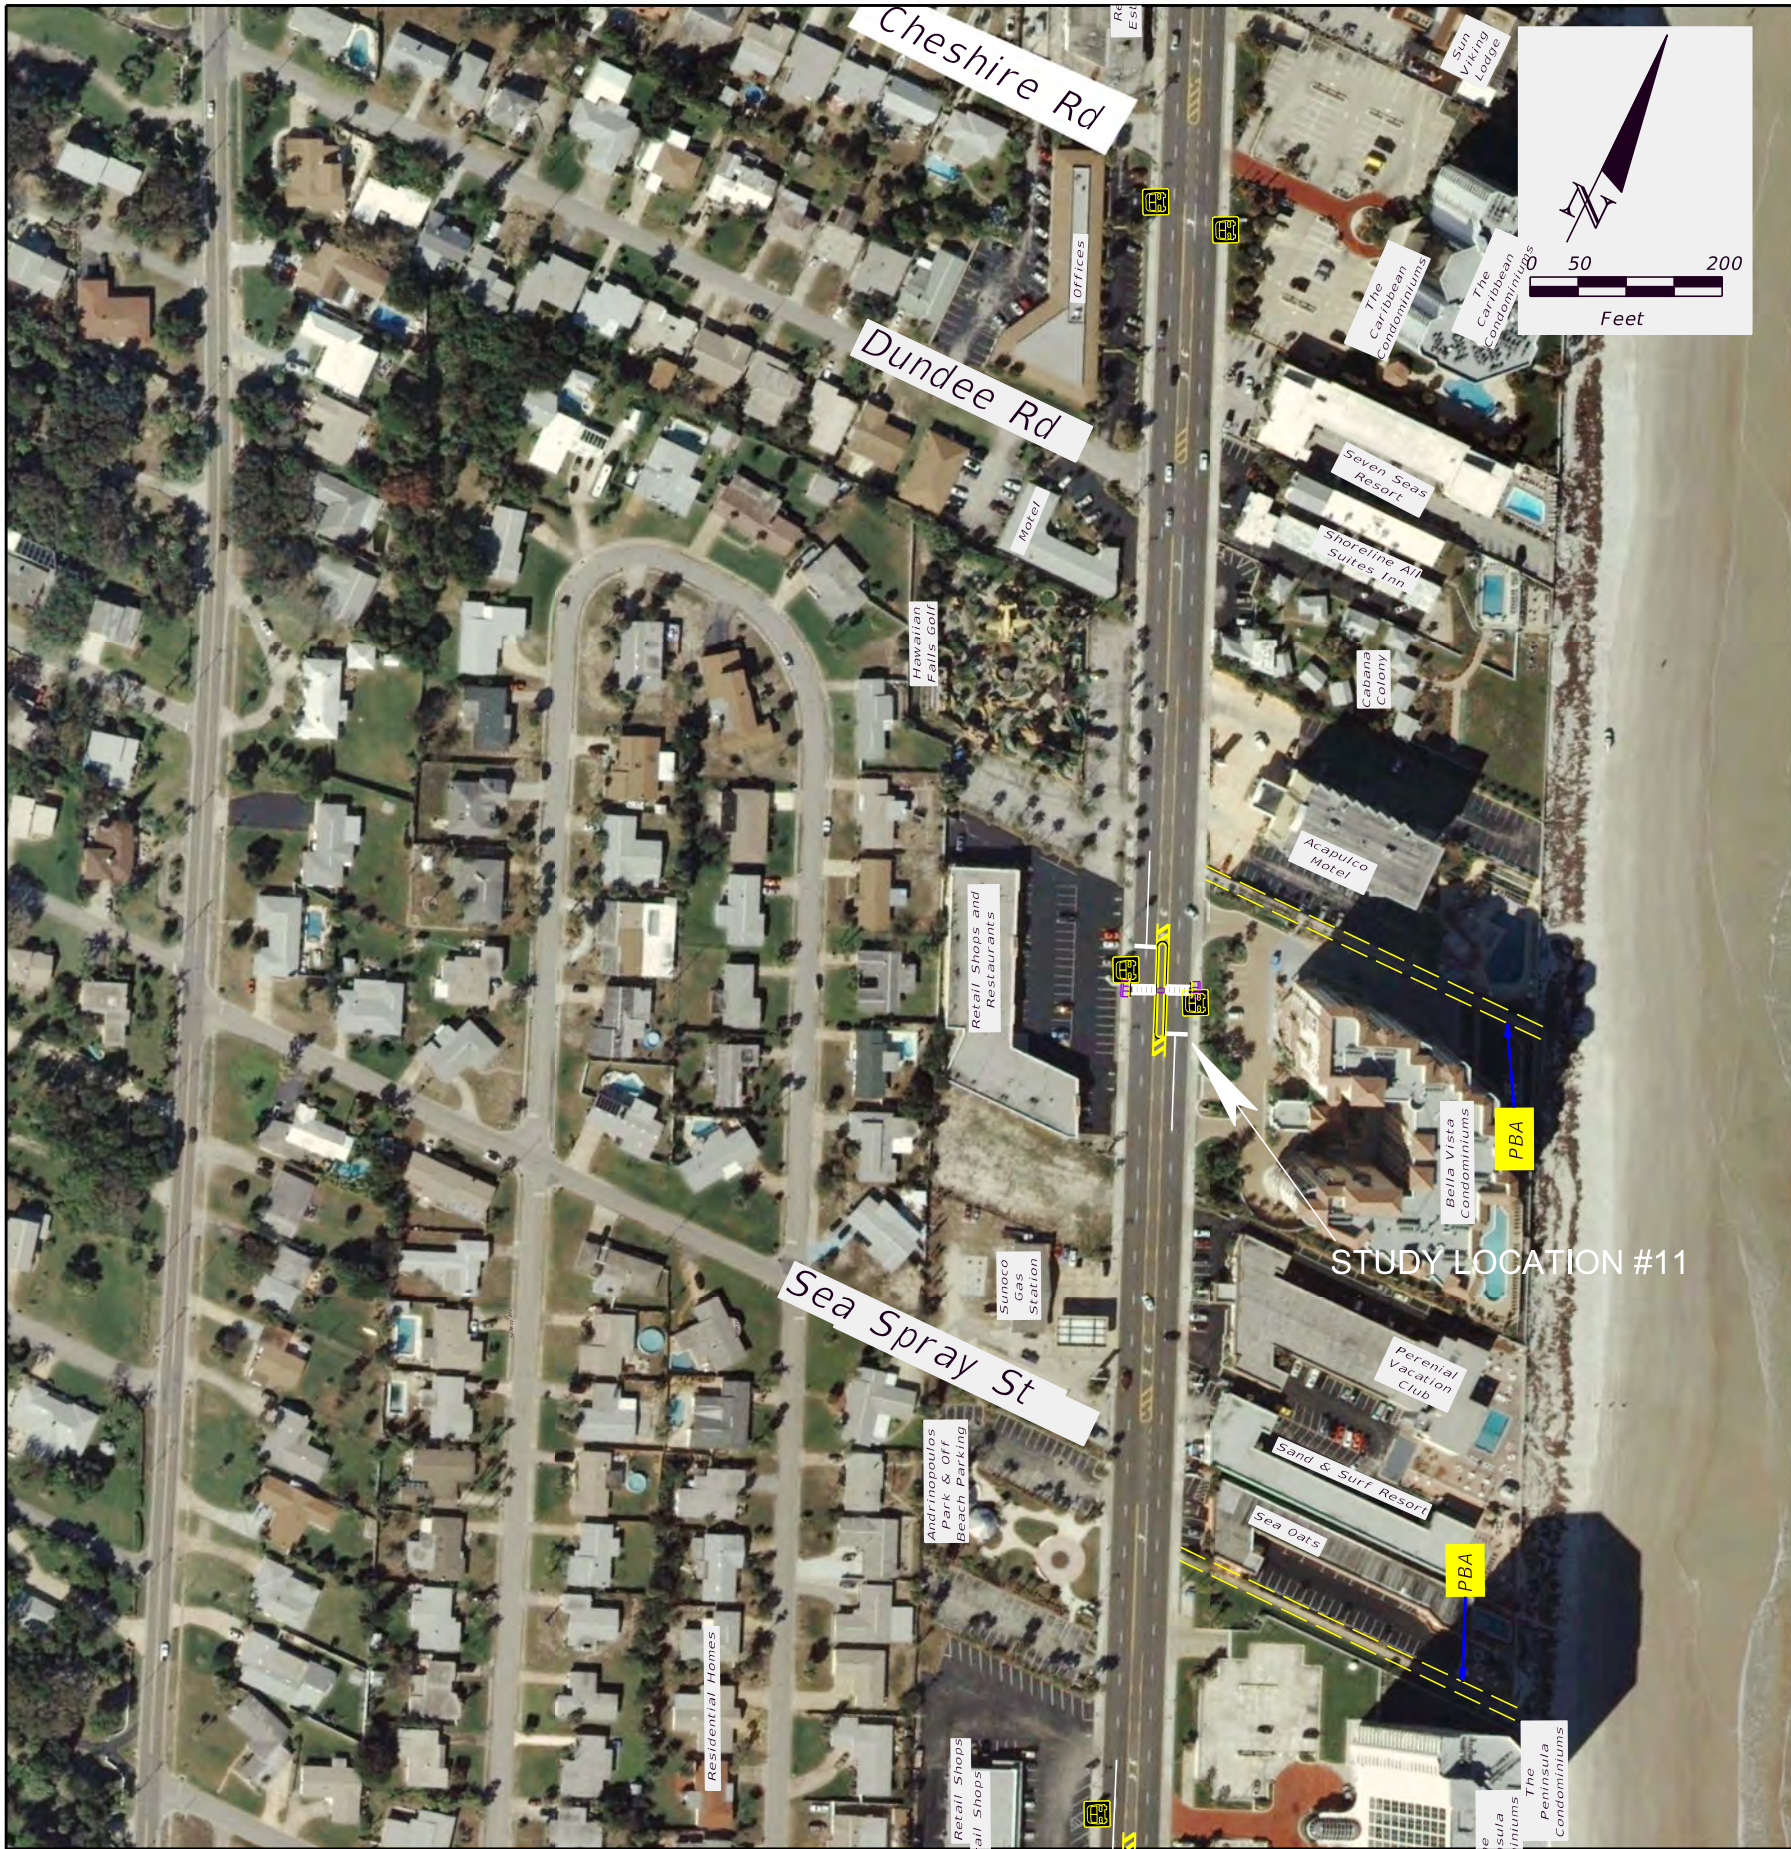
IMPROVEMENTS:  
INSTALL MIDBLOCK PEDESTRIAN CROSSING  
WITH REFUGE ISLAND (SIGNAGE TO BE  
PROVIDED IN ACCORDANCE WITH TYPICAL  
IN APPENDIX C)

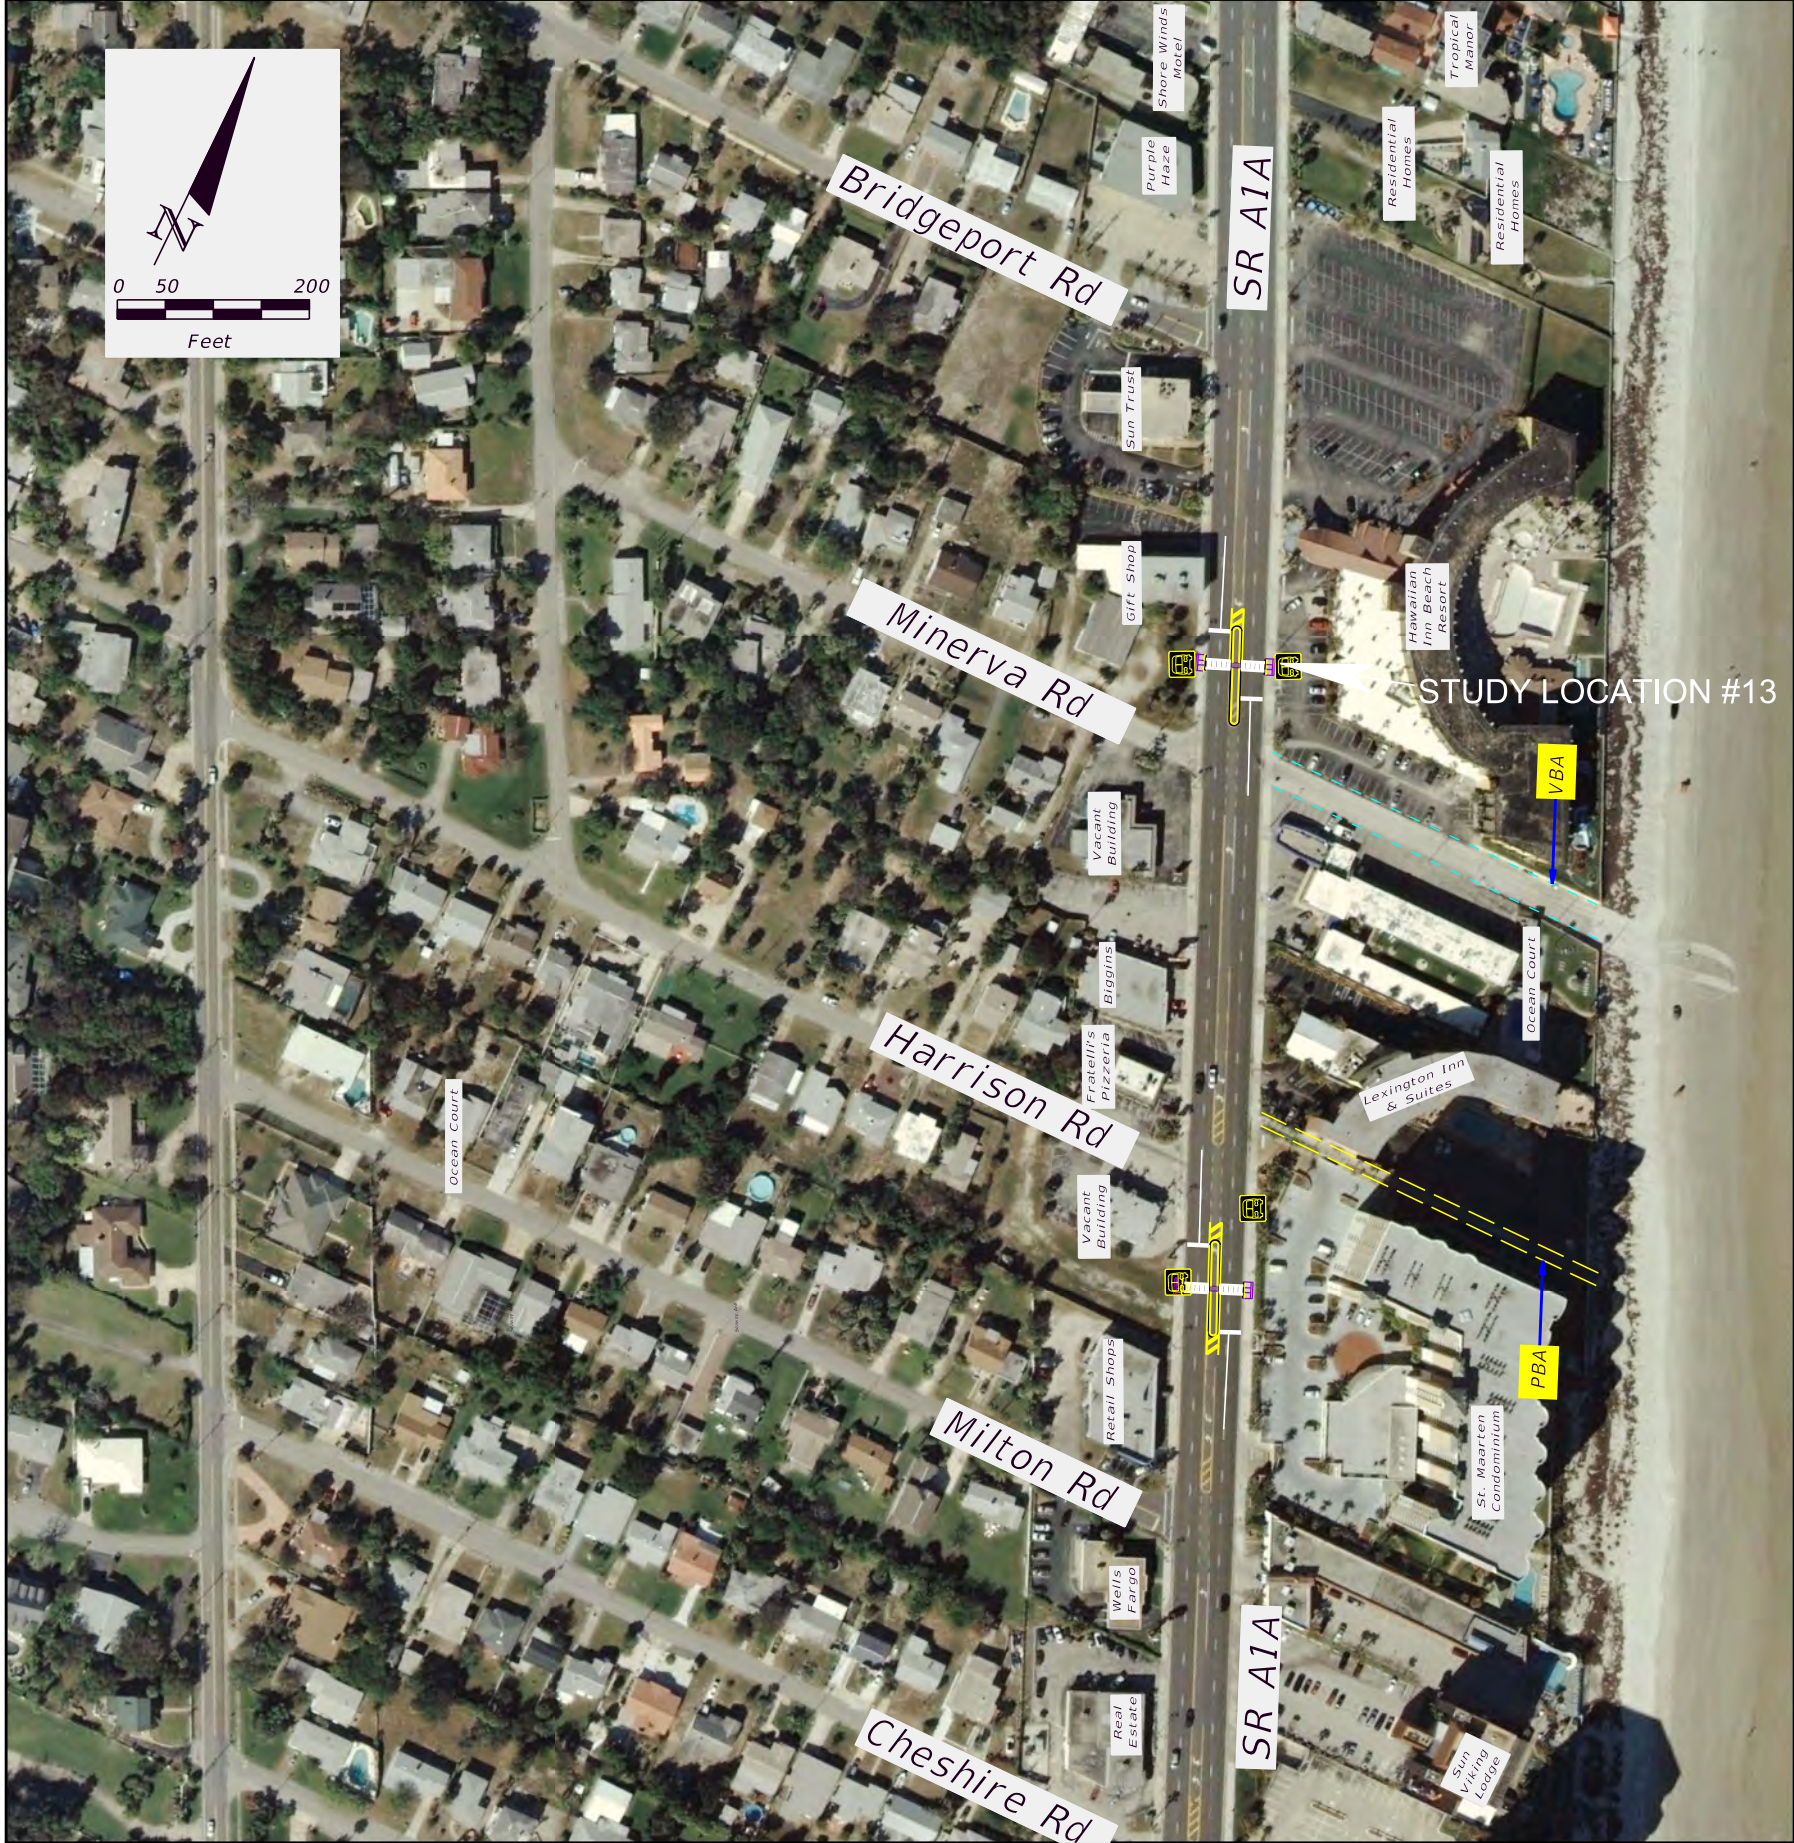
IMPROVEMENTS:  
INSTALL MIDBLOCK PEDESTRIAN CROSSING  
WITH REFUGE ISLAND (SIGNAGE TO BE  
PROVIDED IN ACCORDANCE WITH TYPICAL  
IN APPENDIX C)

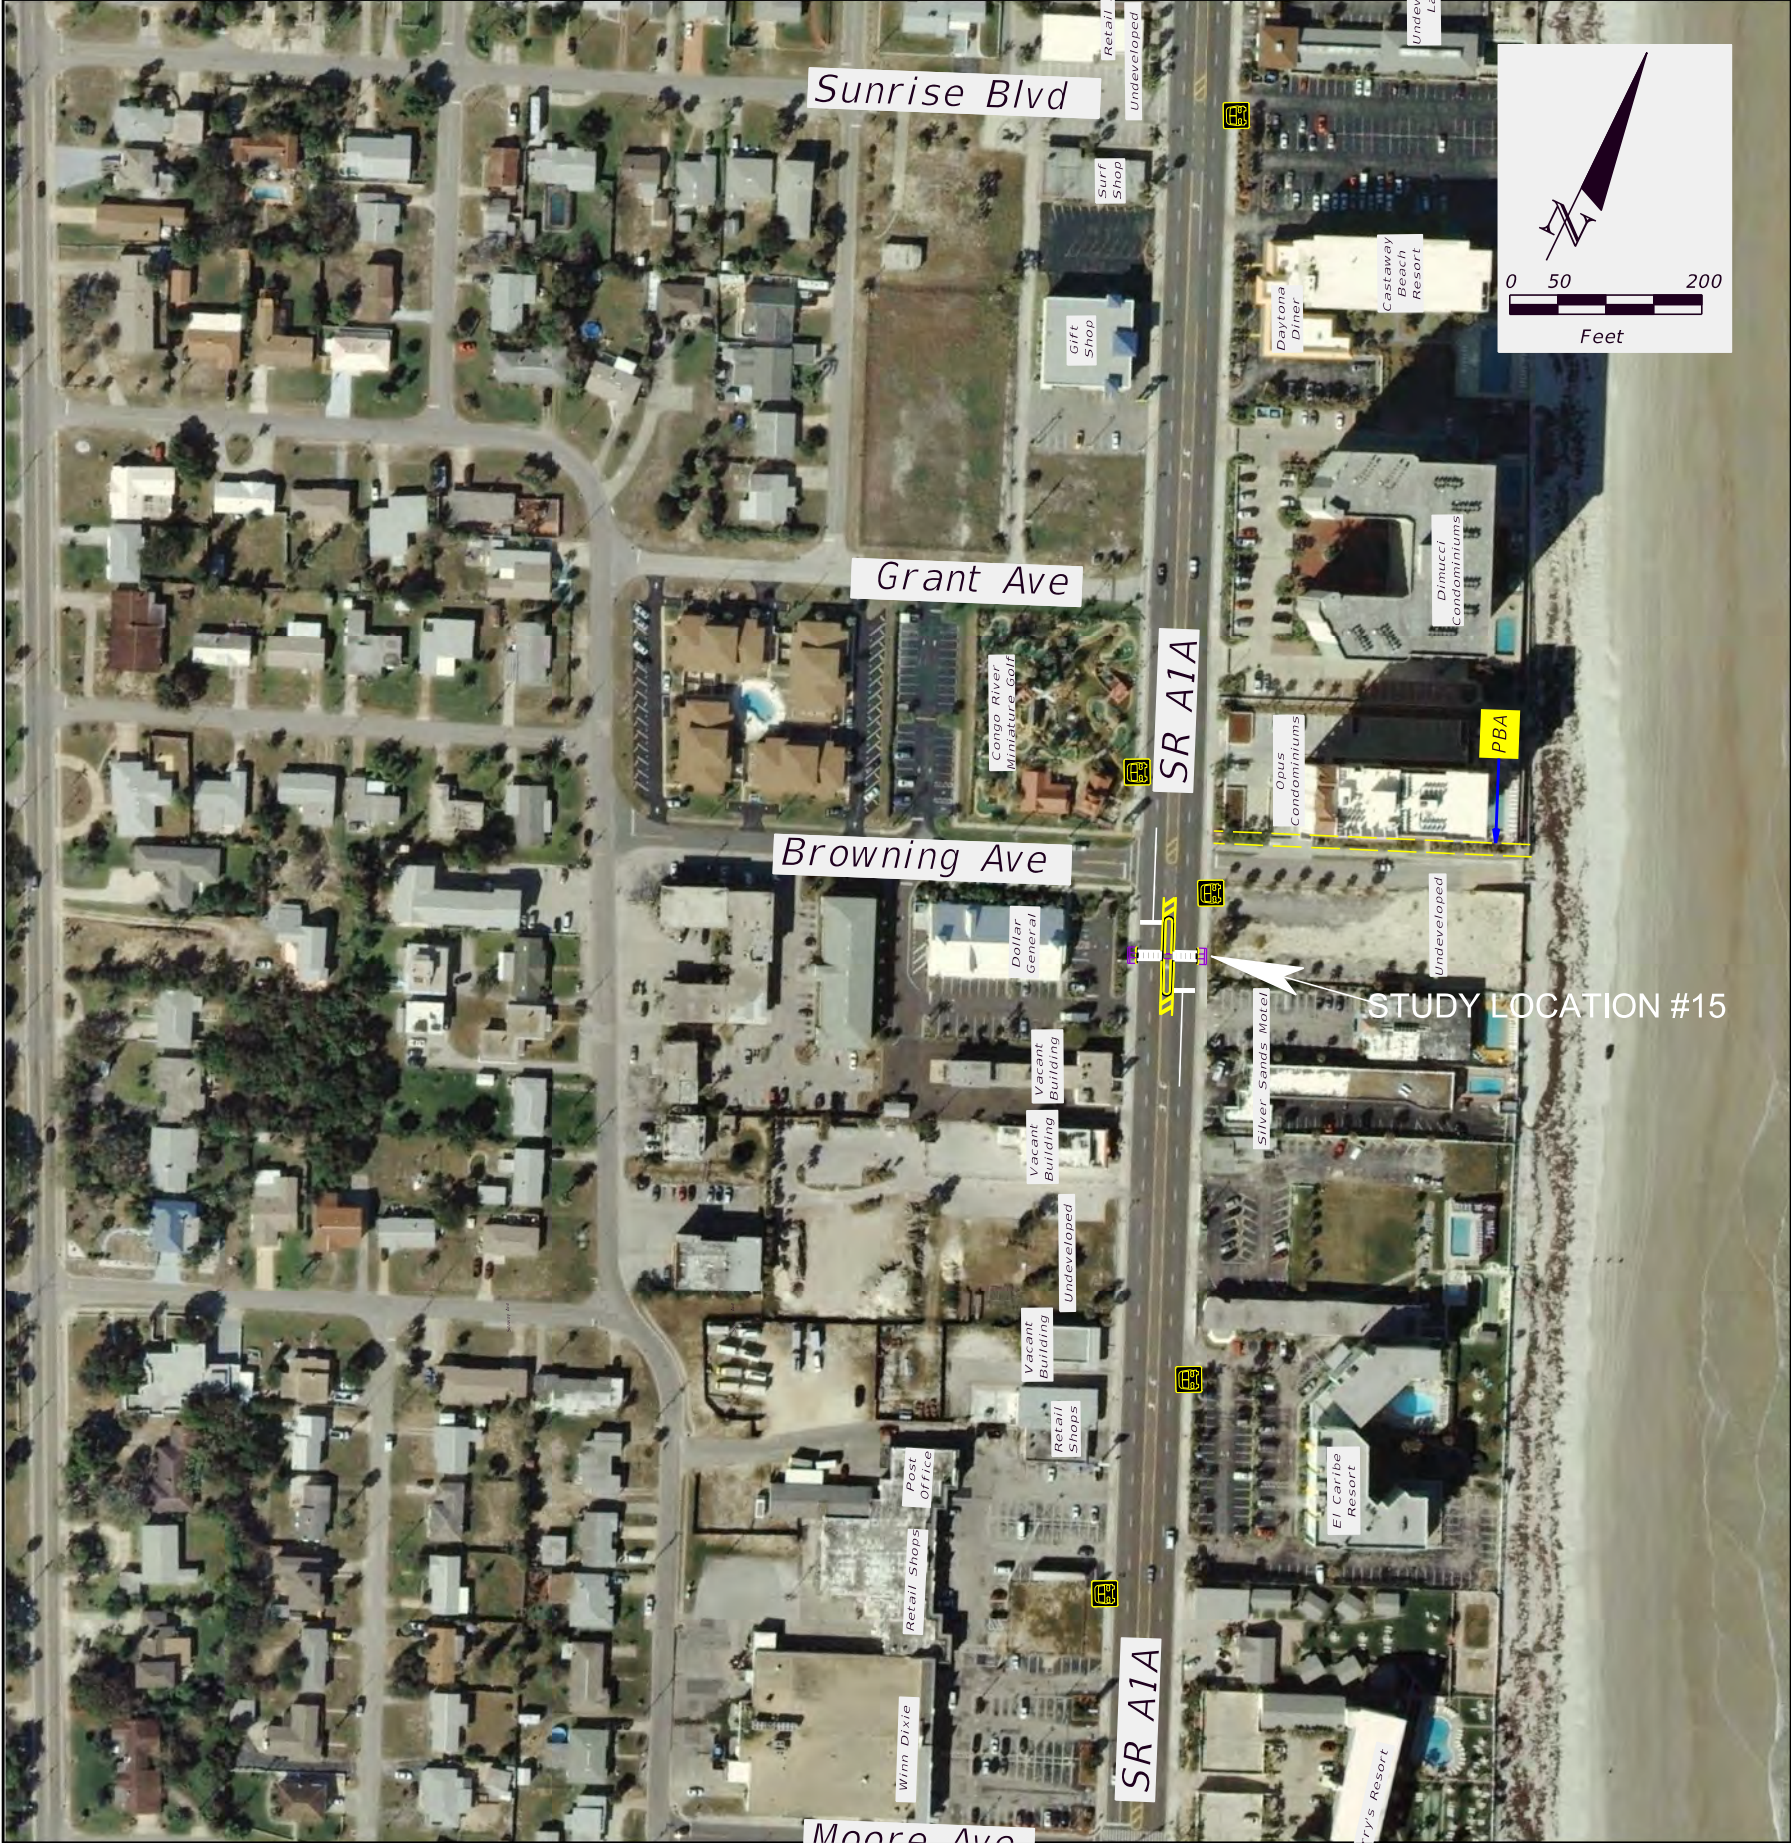
IMPROVEMENTS:  
INSTALL MIDBLOCK PEDESTRIAN CROSSING  
WITH REFUGE ISLAND (SIGNAGE TO BE  
PROVIDED IN ACCORDANCE WITH TYPICAL  
IN APPENDIX C)
