# PEDESTRIAN AND BICYCLE SAFETY STUDY

Dayton Beach Shores, Volusia County

RIVER TO SEA TRANSPORTATION PLANNING ORGANIZATION

July 2015

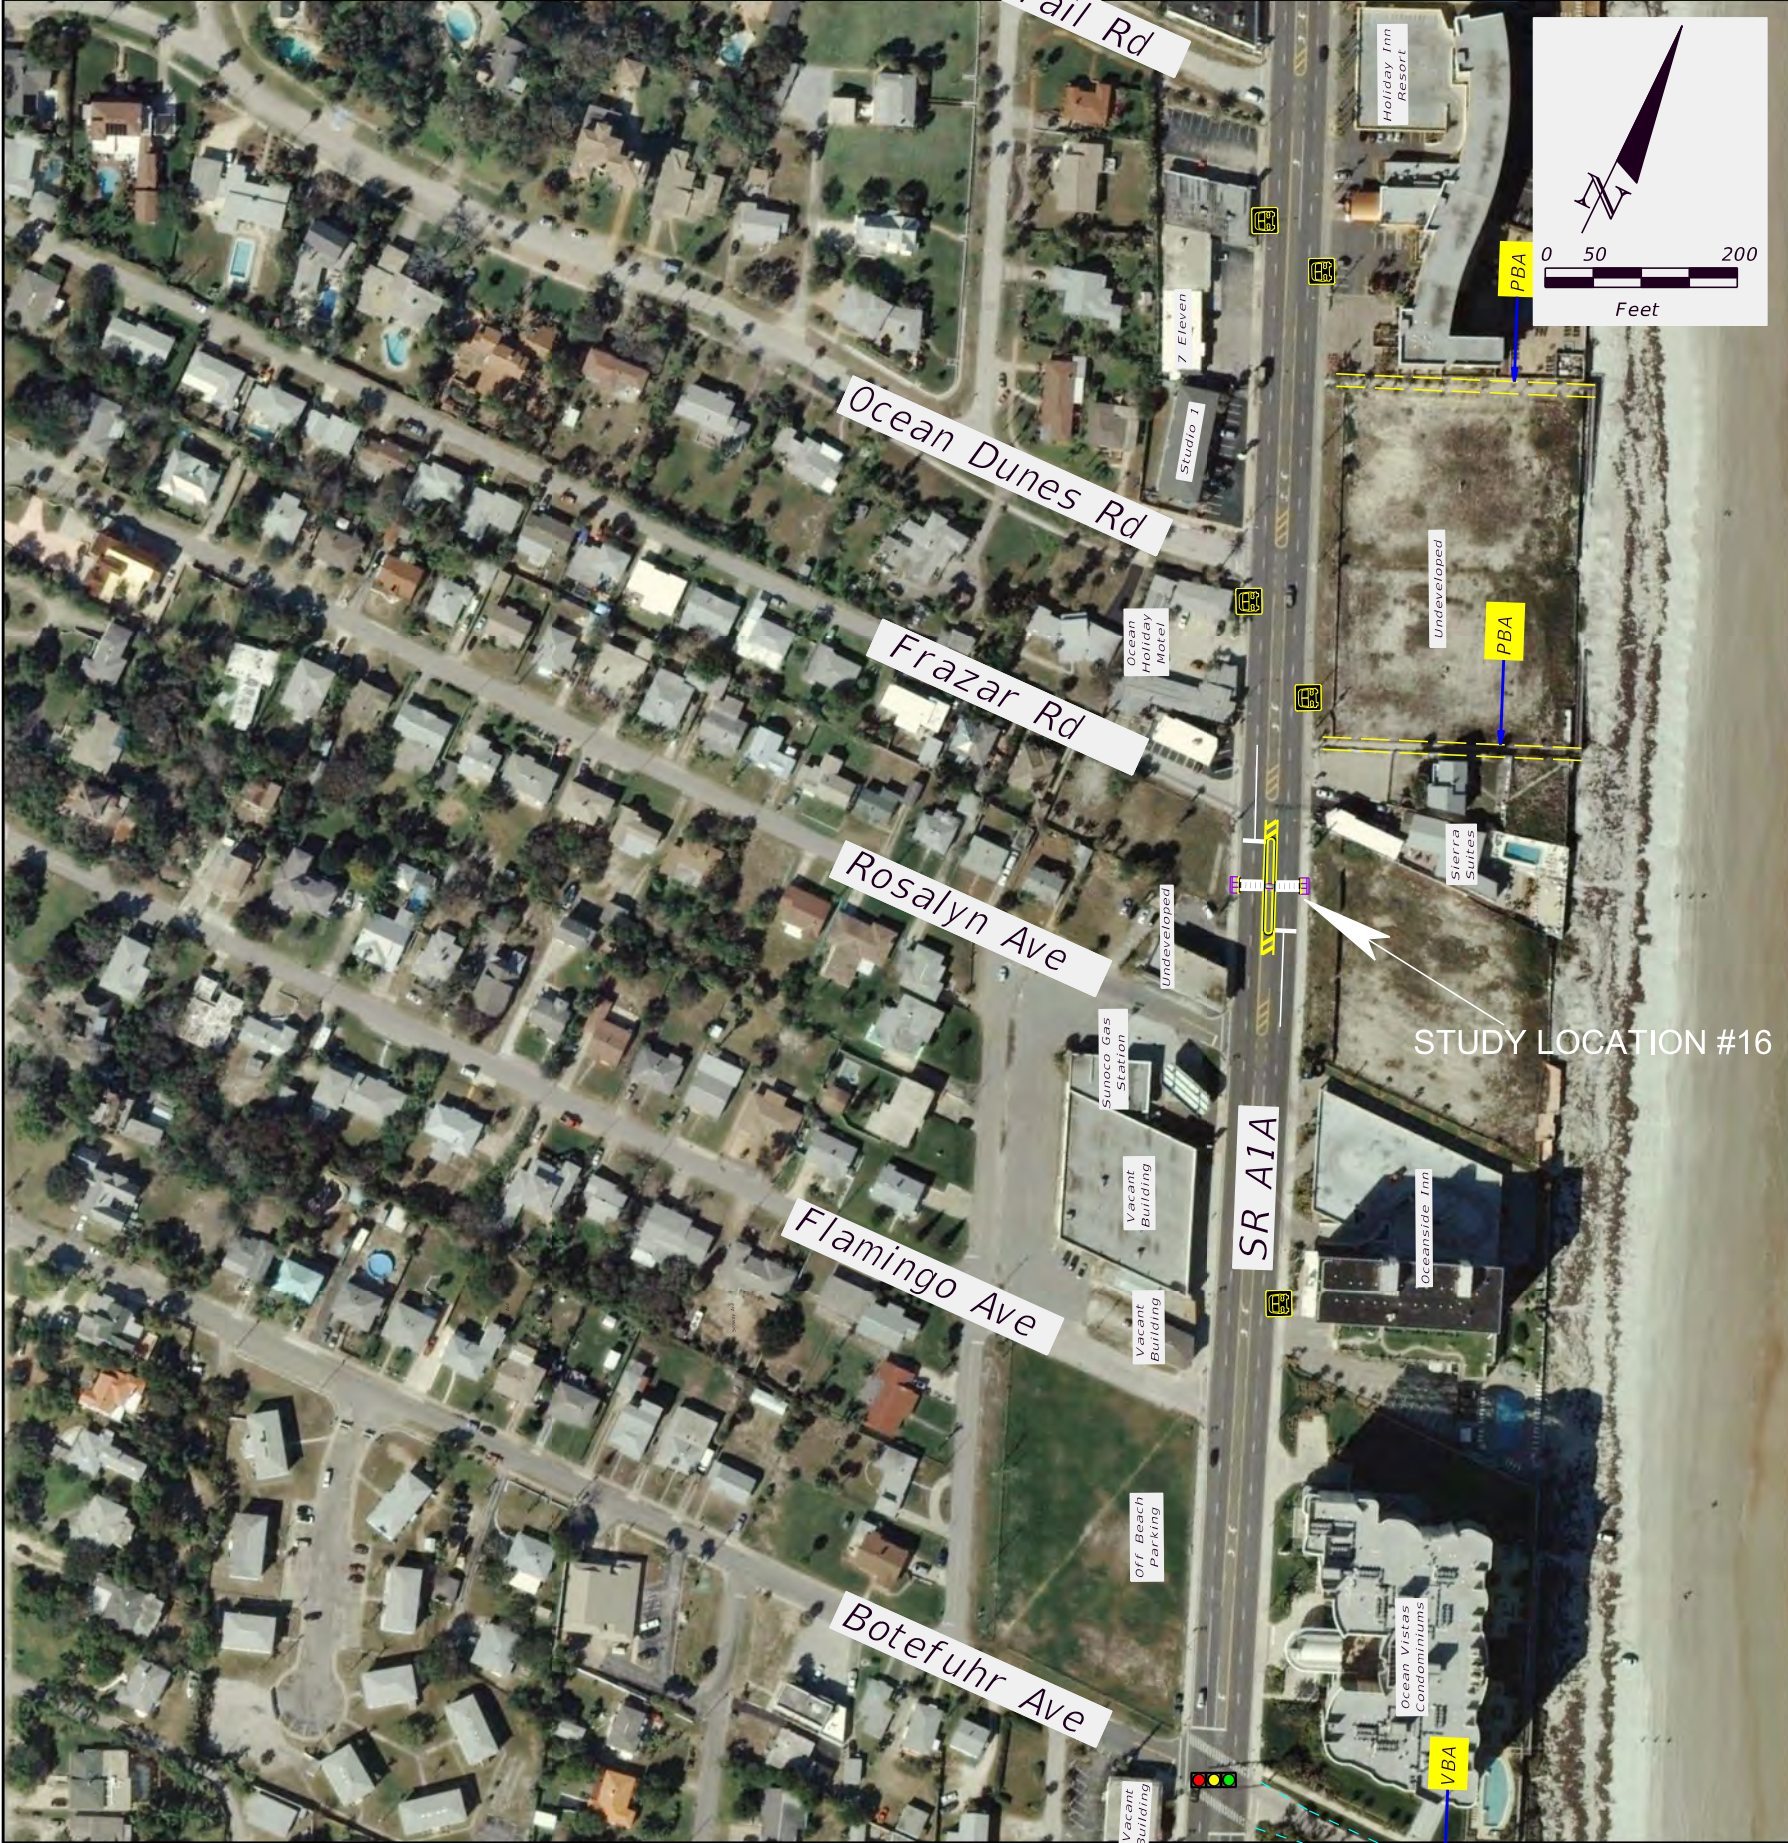
IMPROVEMENTS:  
INSTALL MIDBLOCK PEDESTRIAN CROSSING  
WITH REFUGE ISLAND (SIGNAGE TO BE  
PROVIDED IN ACCORDANCE WITH TYPICAL  
IN APPENDIX C)
