## BICYCLE AND PEDESTRIAN SCHOOL SAFETY REVIEW STUDY

# OLD KINGS ELEMENTARY SCHOOL

PALM COAST, FLAGLER COUNTY, FL

Assessment & Implementation Report | June 2017

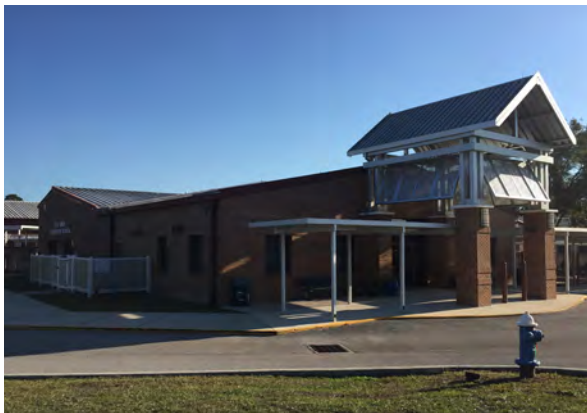
*Main entrance to the Old Kings Elementary School building*

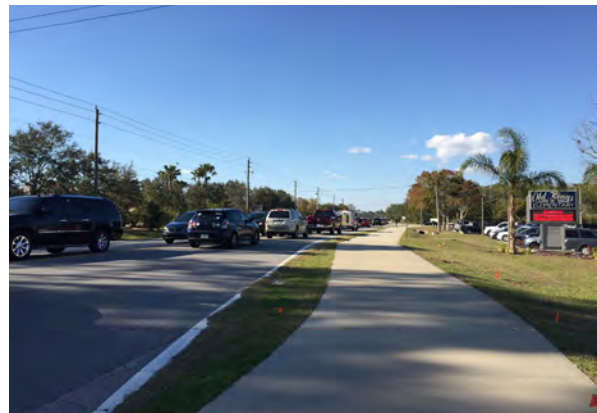
*Old Kings Road with shared use path/trail in front of the school campus.*

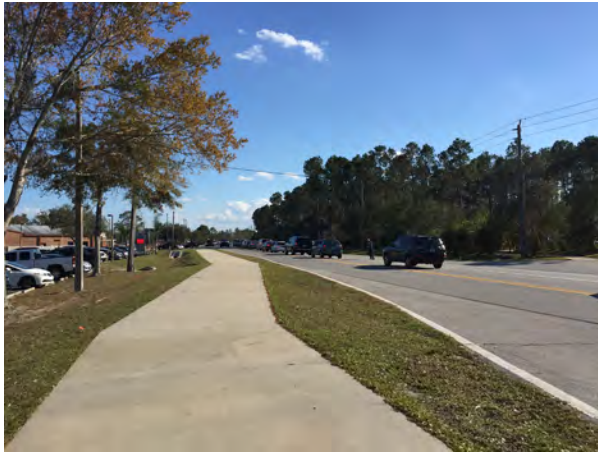
*Shared use path/trail along east side of Old Kings Road.*

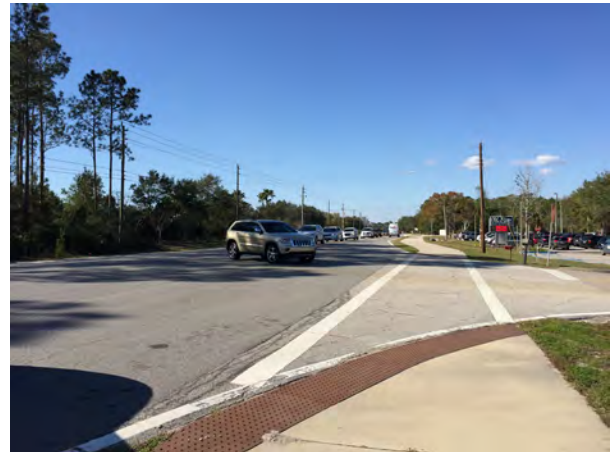
*Crosswalk across the school's middle entrance gate. This is the main gate that parents enter to drop off and pick up students as well by the school buses use to exit the campus.*

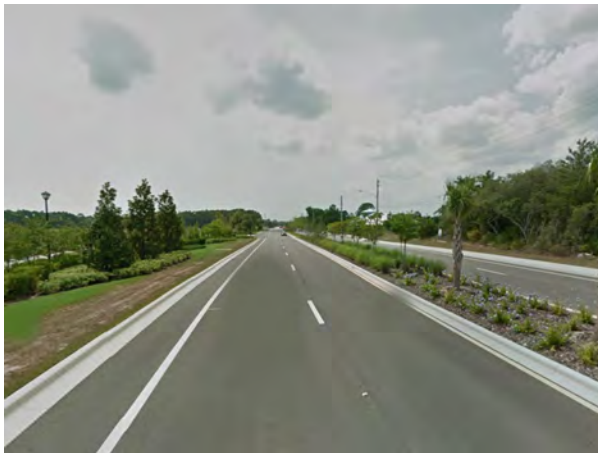
*Old Kings Road, north of SR 100 intersection has bike lanes and shared use path/trails on both sides.*

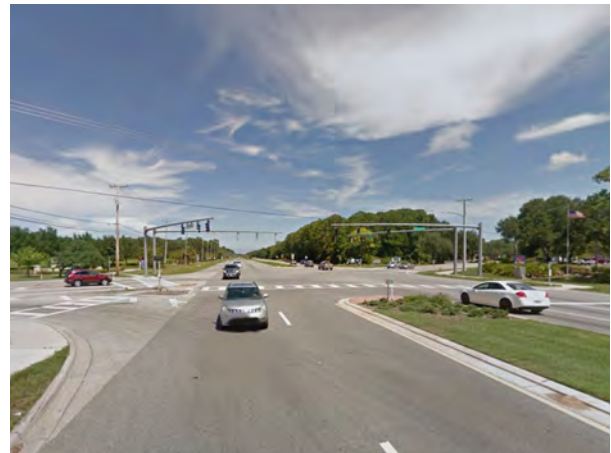
*SR 100 and Old Kings Road intersection.*

**Observation:** Very long queues were observed at the signalized intersection of SR 100 and Old Kings Road during the school drop off and pick up periods.

**Recommendation:** Conduct an intersection operations study to evaluate geometric as well as signal timing changes to reduce long queues.

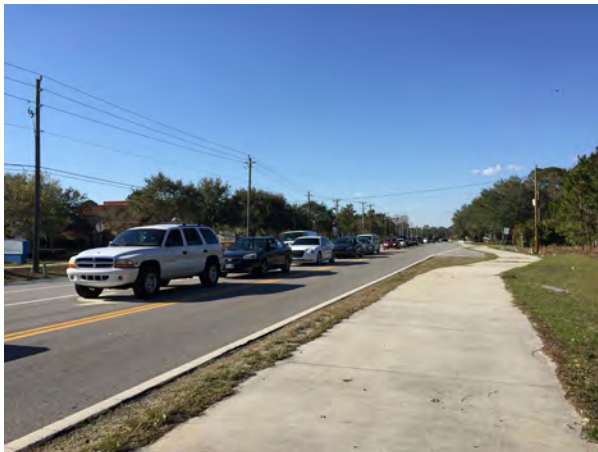
*Long queues were observed, especially in the PM pick up period on Old Kings Road. This image shows queues occupying south-bound left turn lane that backs up till SR 100 intersection.*

- Parents start queueing inside the campus from 12:45 PM for school dismissal at 3:30 PM.
- Long queues are observed for PM pick up period. Longest queues are between 3:15 PM to 3:40 PM and take up entire southbound left turn lane from this entrance to SR 100 intersection.

- Few parents and school staff members mentioned that there are times when the queue backs beyond SR 100 intersection to the north.
- Long queue is also observed taking up the entire northbound right turn lane south of the entrance gate.

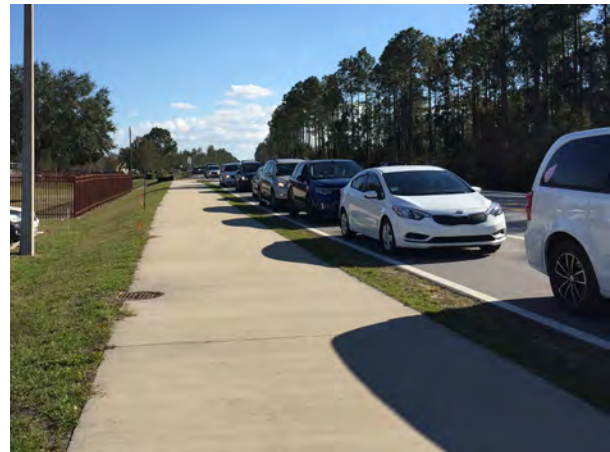
*Long queues were observed, especially in the PM pick up period on Old Kings Road. This image shows queues occupying north bound right turn lane.*

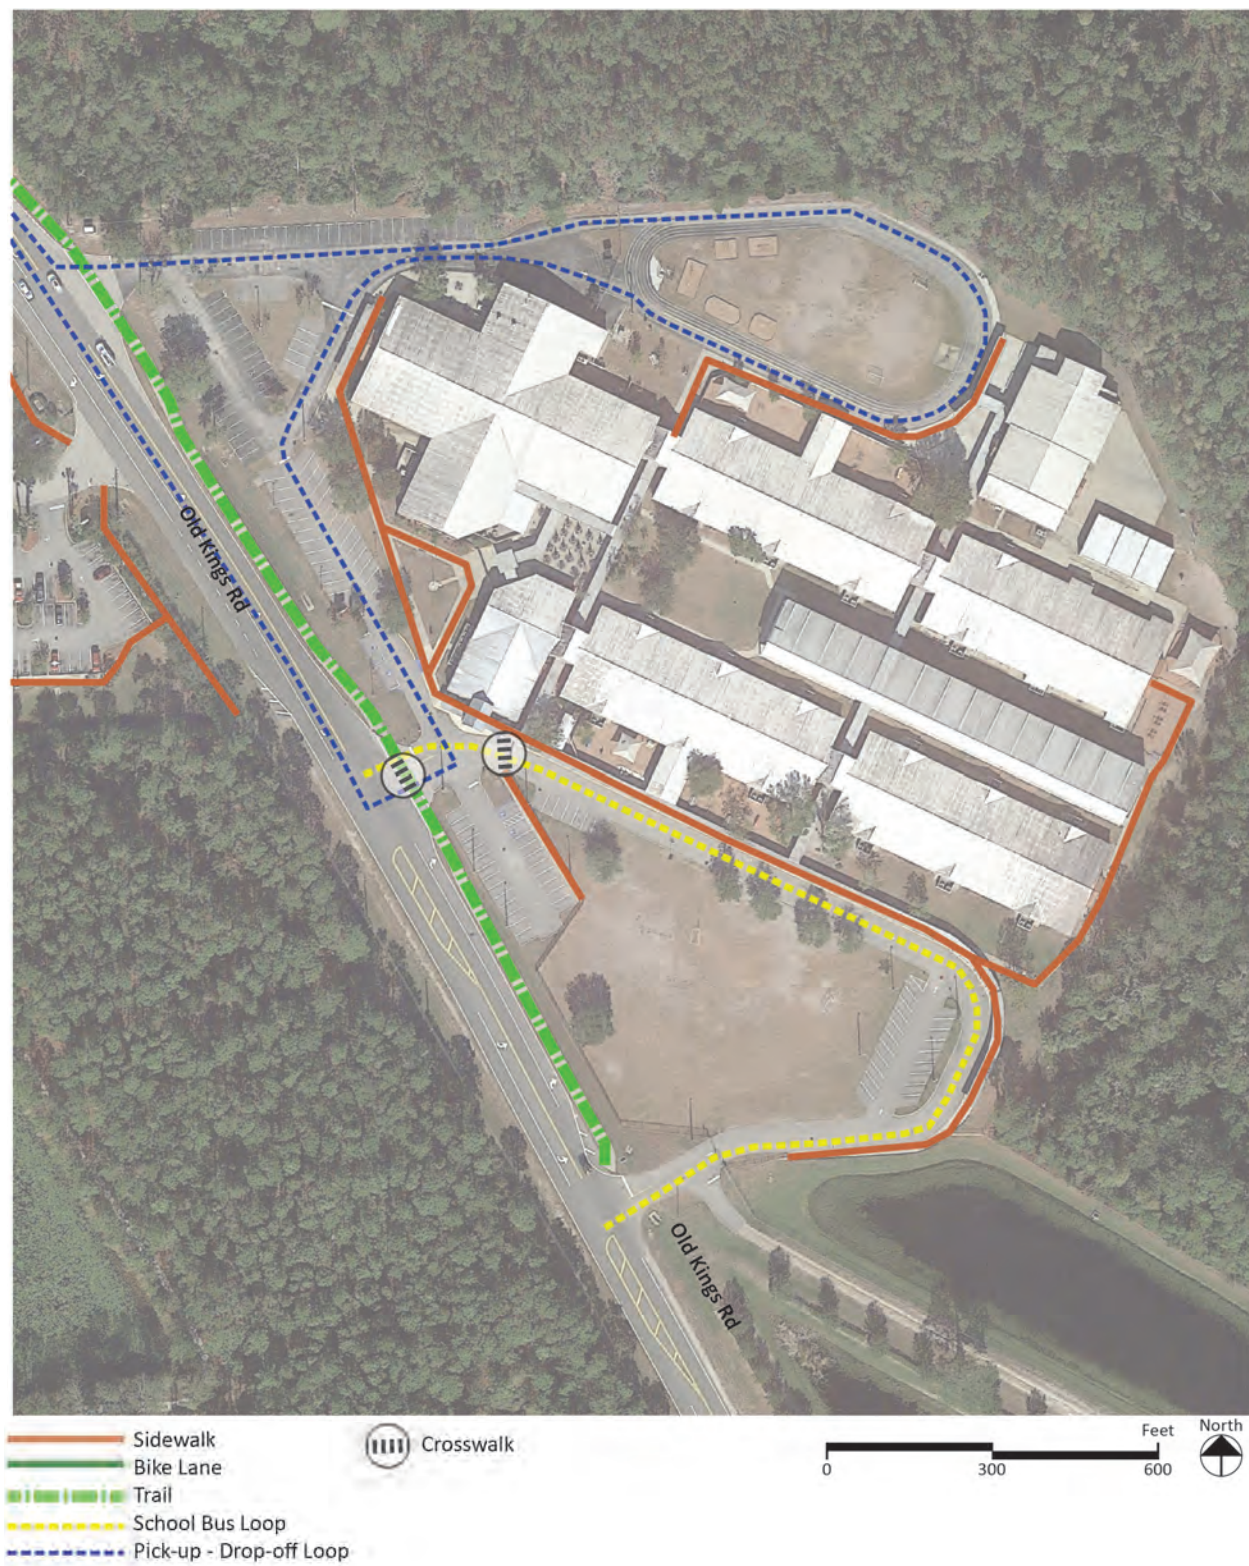
Figure 5: School campus

During the field review, all the pedestrian infrastructure including sidewalks and crosswalks inside the school campus were observed to be in good condition.

There were no significant issues identified on the school campus as part of the co-ordination meeting or as part of the field review. Overall school campus circulation system seemed to work well. All the pedestrian and parking facilities within the school campus were identified as ADA compliant. Therefore, there are no school campus related recommendations as part of this report.

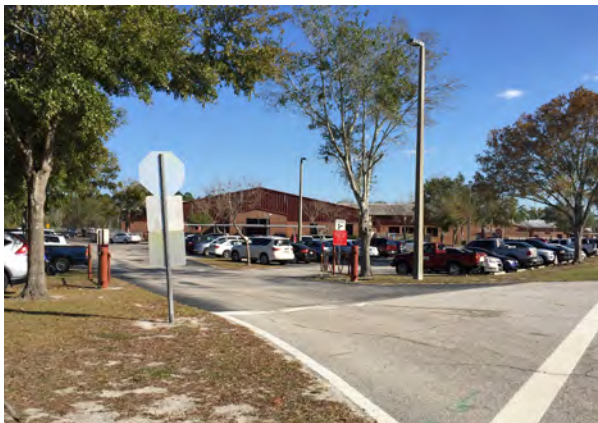
- This gate is used as exist gate by parents after dropping off students. It is also used as an entry and exit gate by school staff and visitors.

*Northern entrance gate is used by parents to exit the campus onto Old Kings Road.*

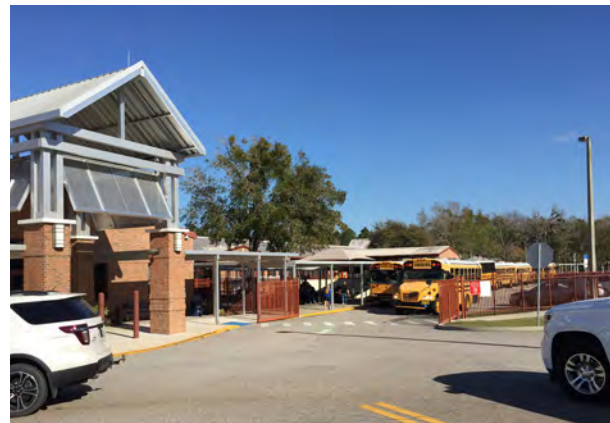
*Internal driveway with marked crosswalk in front of School building's main entrance.*

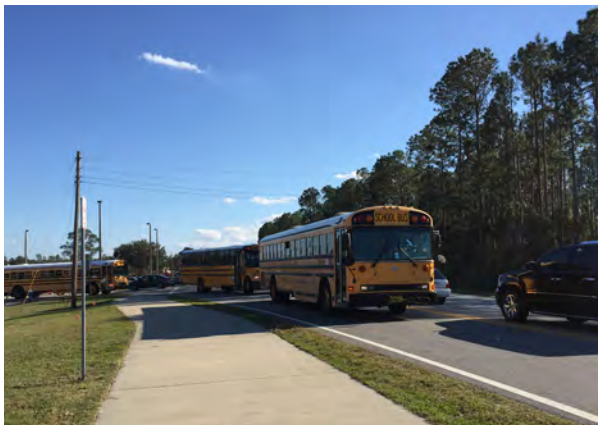
*School Buses exit from the middle gate onto Old Kings Road.*

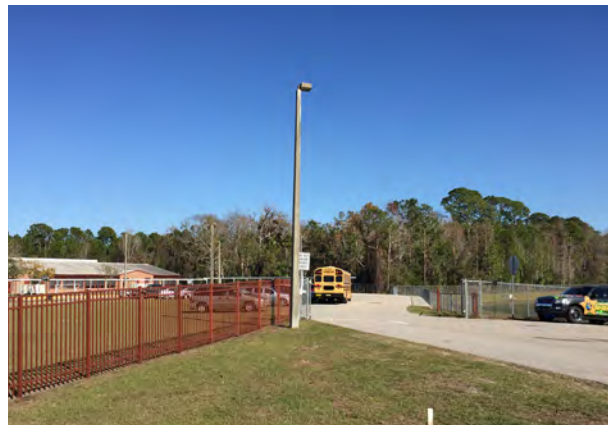
*Southern Entrance Gate is used by School buses to enter the school's campus.*

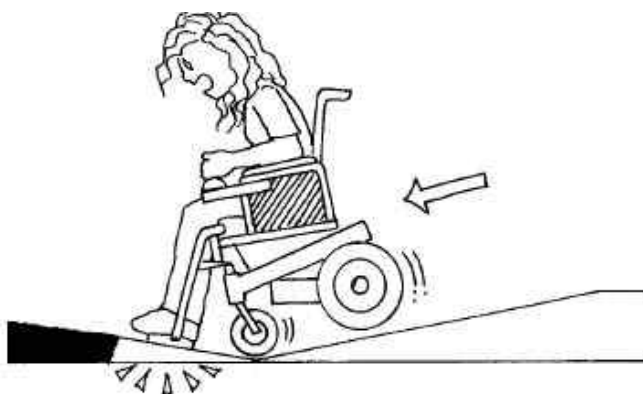
If the rate of change of grade exceeds 13 percent over a 0.610 m (2 ft) interval, the ground clearance of the footrests and or antitip wheels might be compromised. Antitip wheels are placed on the back of some wheelchairs to improve stability and prevent tipping. Even wheelchair users traveling slowly can get stuck if the footrest or antitip wheels get caught.

Figure 4-3: Excessive slope differences between gutter and ramp can cause a wheelchair to tip forward.

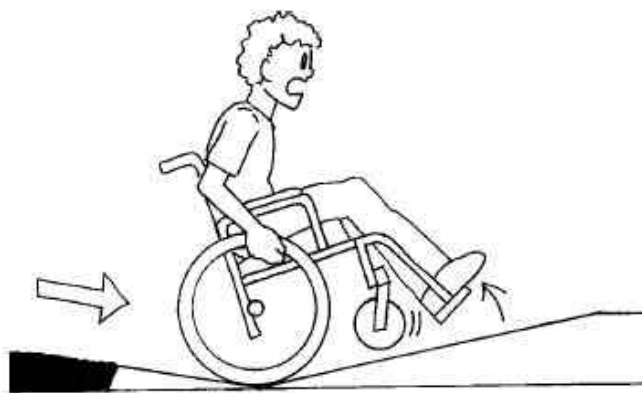
[Figure 4-4: Excessive slope differences between a gutter and a ramp can cause wheelchairs to flip over backward.](#)

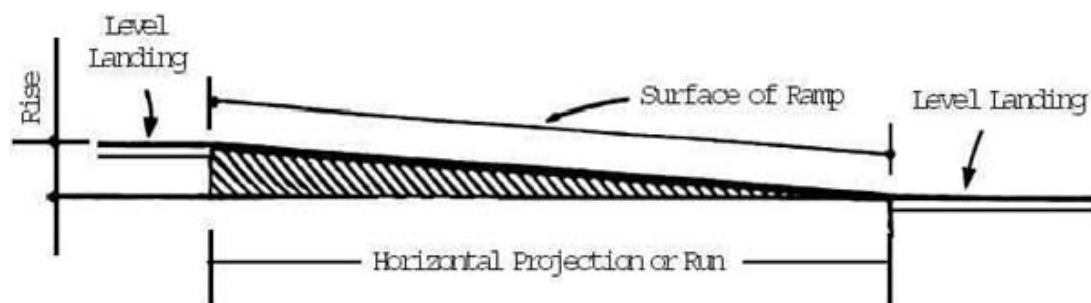
[Figure 4-5: Ramps must have level landings \(based on ADAAG Figure 16, U.S. Access Board, 1991\).](#)

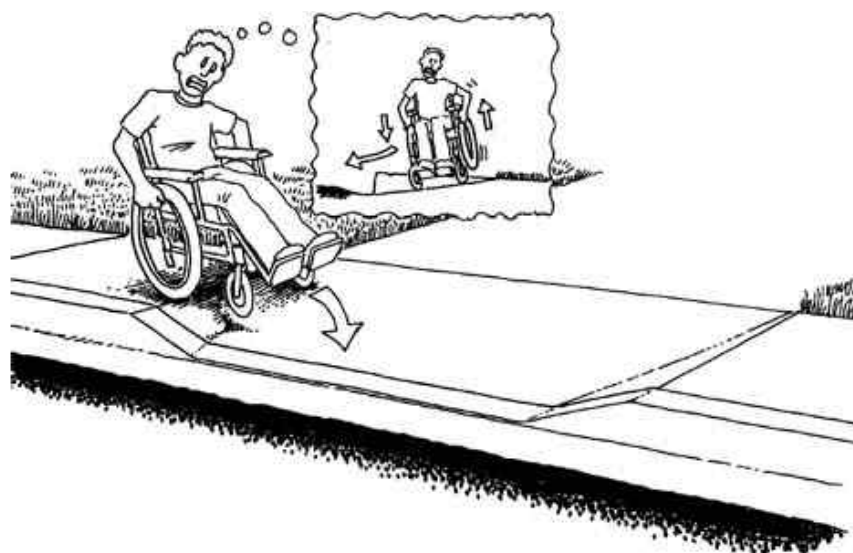
[Figure 4-6: When cross-slopes change rapidly over a short distance, wheelchair use becomes extremely unstable.](#)

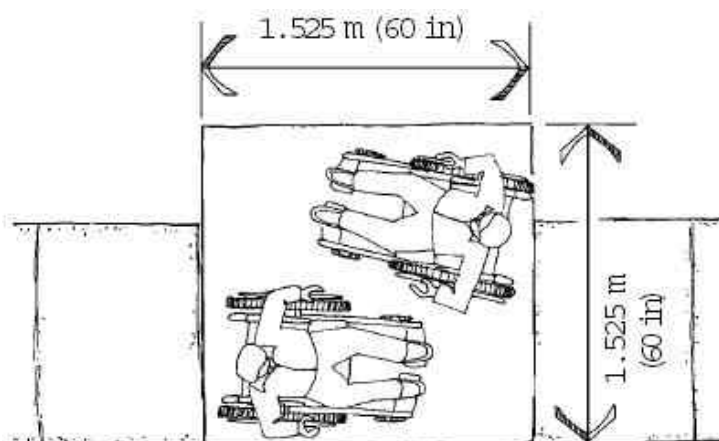
[Figure 4-8: Passing spaces should be included at intervals on narrow sidewalks to allow wheelchair users to pass one another.](#)

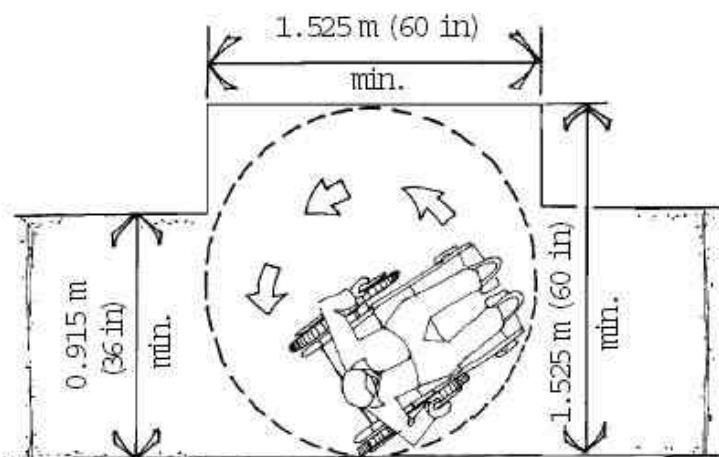
[Figure 4-9: Wheelchair users require 1.525 m x 1.525 m \(60 in x 60 in\) to maneuver in a complete circle.](#)

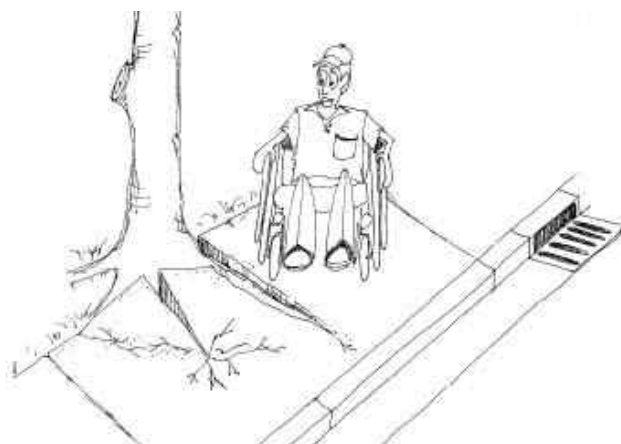
Figure 4-10: Changes in level are often caused by tree roots that break through the sidewalk surface.

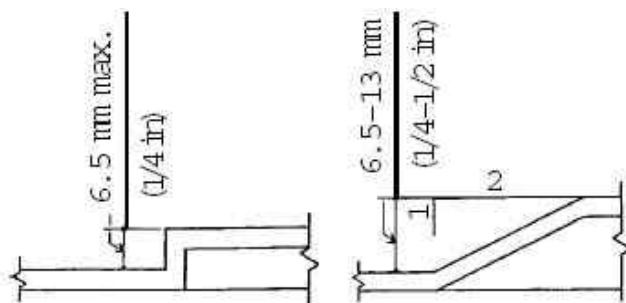
Figure 4-11: Vertical and beveled changes in level [ADAAG, Figure 7 (c, d), U.S. Access Board, 1991].

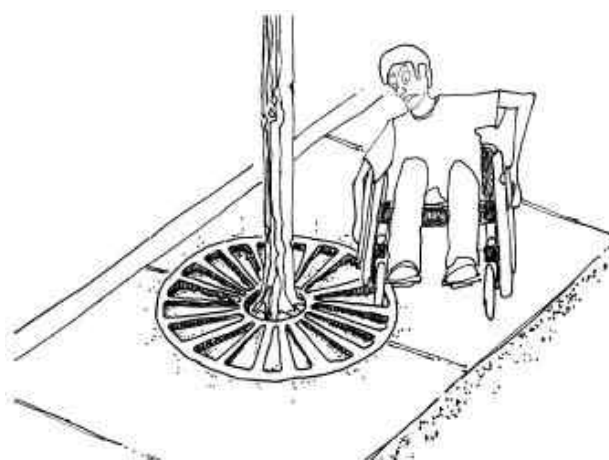
*Figure 4-12: Wheelchair casters and cane and crutch tips can easily get caught in wide grates.*

Wheelchair casters and crutch tips can get caught in poorly aligned grate and gap openings. ADAAG specifies that grates located in walking surfaces should have spaces no greater than 13 mm (0.5 in) wide in one direction. It also states that gratings with elongated openings should be oriented so that the long dimension is perpendicular to the dominant direction of travel (ADAAG, U.S. Access Board, 1991). Although ADAAG does not directly address gaps, the similarity of a gap to a single grate slot suggests that ADAAG's grate specifications also apply to gaps.

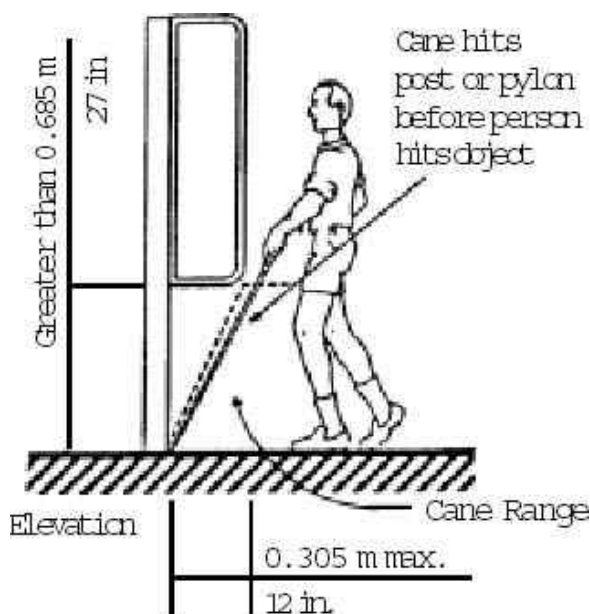
Figure 4-13: Obstacles mounted on posts should not protrude more than 0.305 m (12 in) into a circulation corridor [ADAAG, Figure 8(d), U.S. Access Board, 1991].

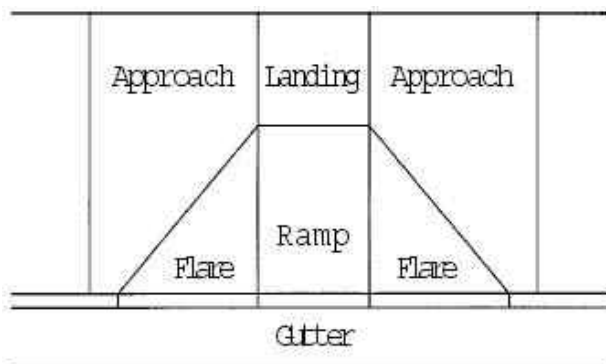
Figure 4-14: Components of a curb ramp.

- Landing — level area of sidewalk at the top of a curb ramp facing the ramp path.
- Approach — section of the accessible route flanking the landing of a curb ramp. The approach may be slightly graded if the landing level is below the elevation of the adjoining sidewalk.
- Flare — sloped transition between the curb ramp and the sidewalk. The path along the flare has a significant cross-slope and is not considered an accessible path of travel. When the sidewalk is set back from the street, returned curbs often replace flares (see Figure 4-20, p. 44).
- Ramp — sloped transition between the street and the sidewalk where the grade is constant and the cross-slope is at a minimum (preferably less than 2 percent).
- Gutter — trough or dip used for drainage purposes that runs along the edge of the street and the curb or curb ramp.

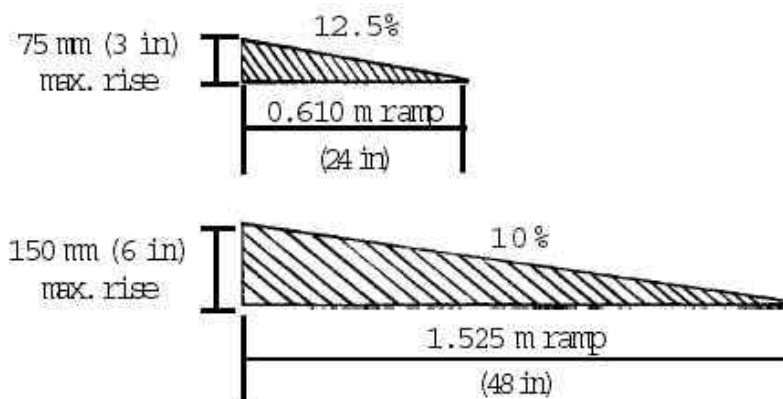
*Figure 4-15: Alternative slope profiles for alterations when an 8.33 percent slope is not achievable.*

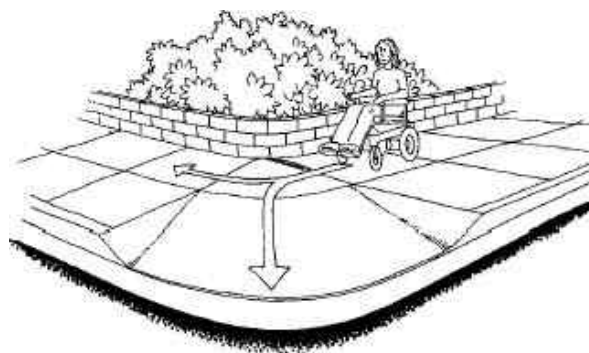
[Figure 4-16: This wheelchair user is maneuvering successfully a curb ramp because a level landing is provided.](#)

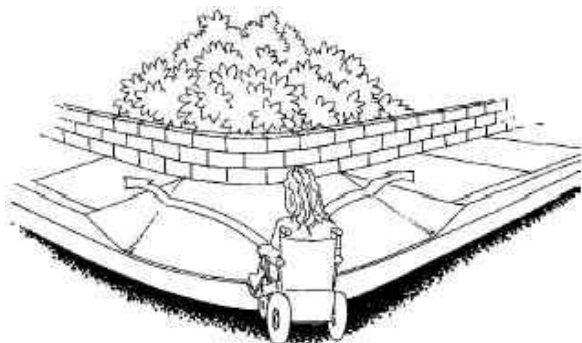
[Figure 4-17: This wheelchair user will have difficulty entering the sidewalk because the curb ramp lacks a landing.](#)

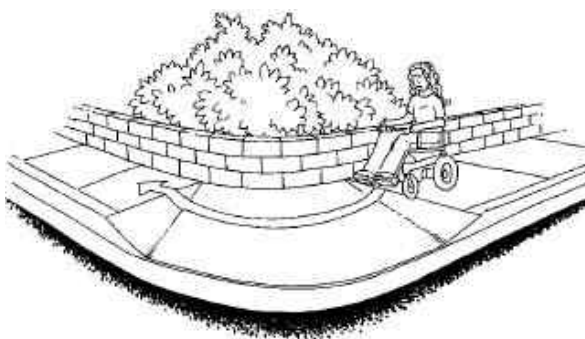
Figure 4-18: This wheelchair user will have difficulty traveling around the corner because the curb ramp lacks a landing.

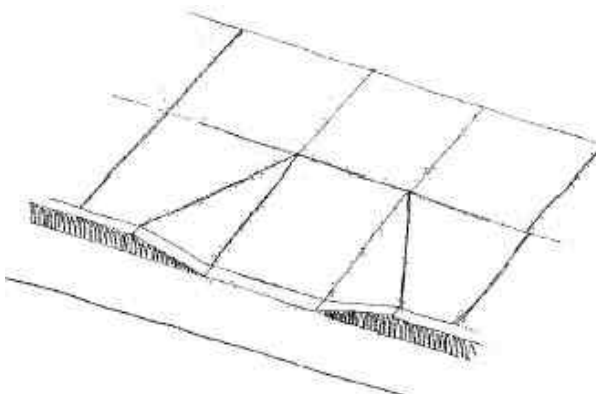
Figure 4-19: Flares provide a sloped transition between the ramp and the surrounding sidewalk and are designed to prevent ambulatory pedestrians from tripping.

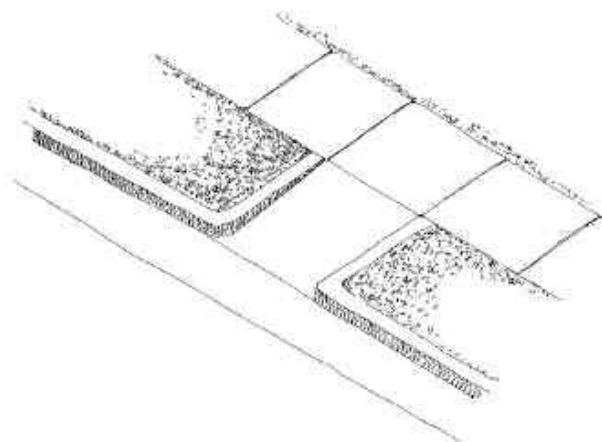
Figure 4-20: Returned curbs may be used when the curb ramp is located outside the pedestrian walkway, such as in a planting strip.

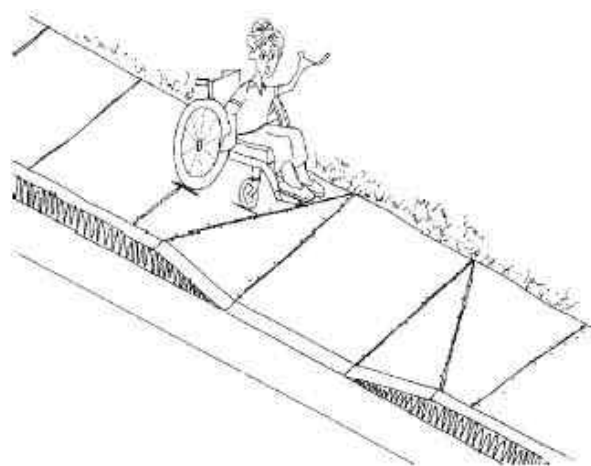
Figure 4-21: Without level landings, perpendicular curb ramps are problematic for wheelchair users and others to travel across.

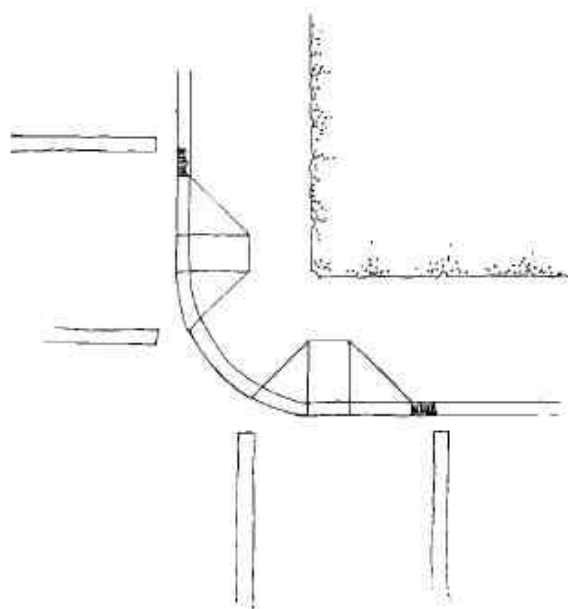
[Figure 4-22: Two perpendicular curb ramps with level landings maximize access for pedestrians at intersections.](#)

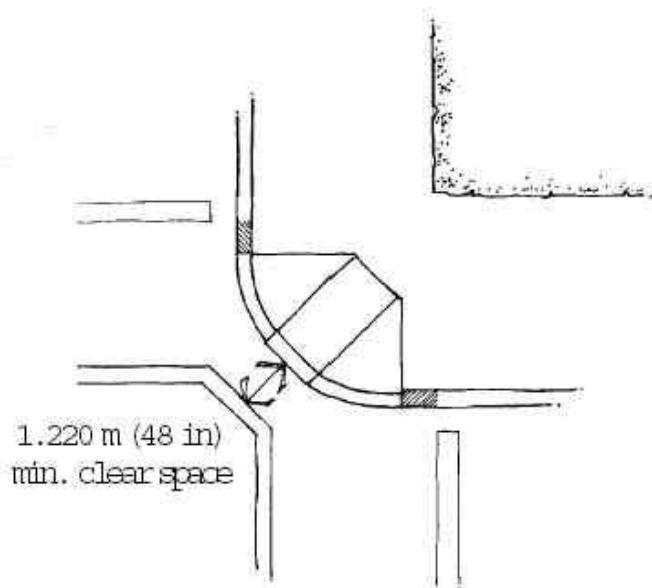
[Figure 4-23: If diagonal curb ramps are installed, a 1.220-m \(48-in\) clear space should be provided to allow wheelchair users enough room to maneuver into the crosswalk.](#)

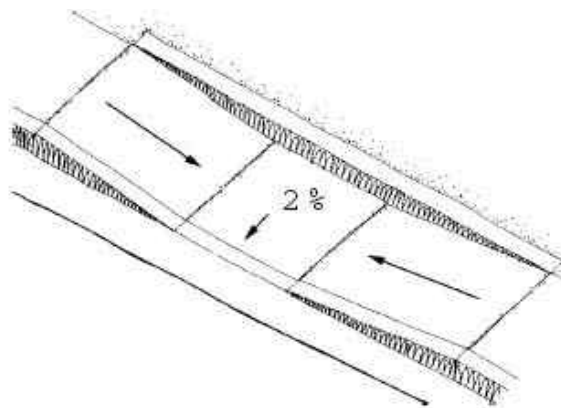
[Figure 4-24: Parallel curb ramps work well on narrow sidewalks but require users continuing on the pathway to negotiate two ramp grades.](#)

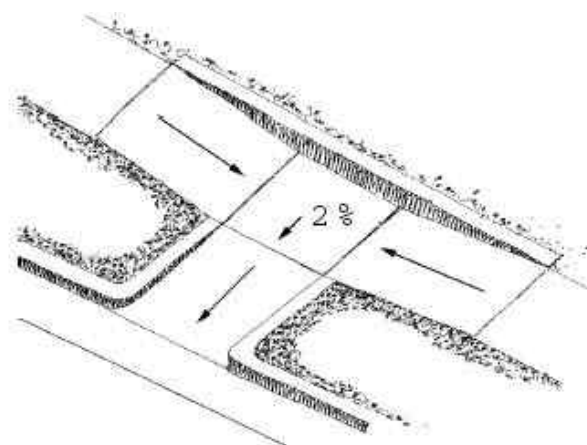
[Figure 4-25: A combination curb ramp is a creative way to avoid steep curb ramps and still provide level landings.](#)

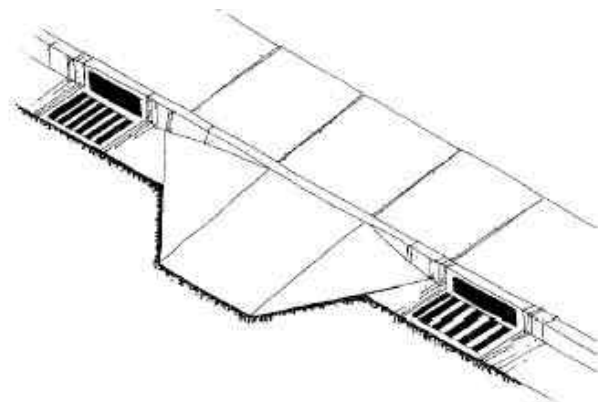
[Figure 4-26: Built-up curb ramp with drainage inlets.](#)

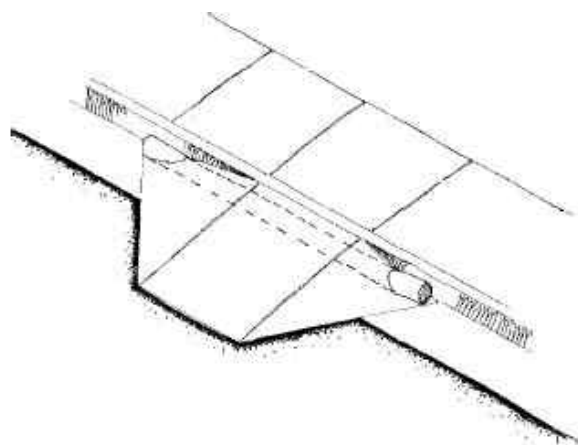
Figure 4-27: Built-up curb ramp with a drainage pipe.

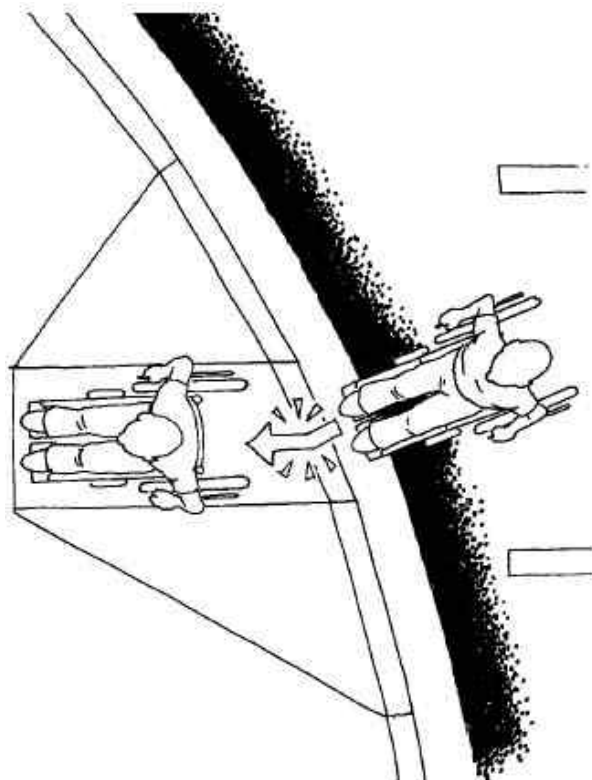
Figure 4-28: To avoid having to negotiate changing grades and changing cross-slope simultaneously, a wheelchair user has to turn at the grade transition.

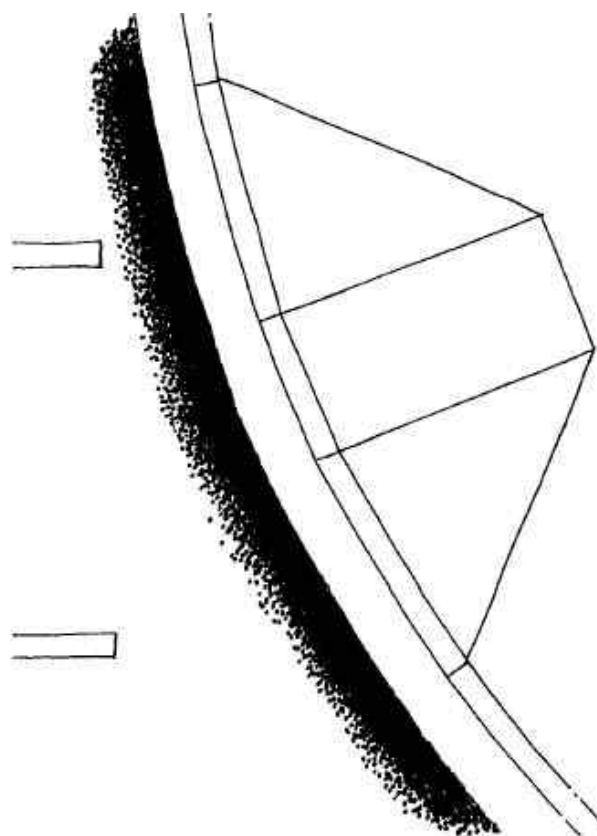
*Figure 4-29: Curb ramps designed with the ramp perpendicular the curb eliminate rapidly changing grades and cross-slopes at the grade transition.*

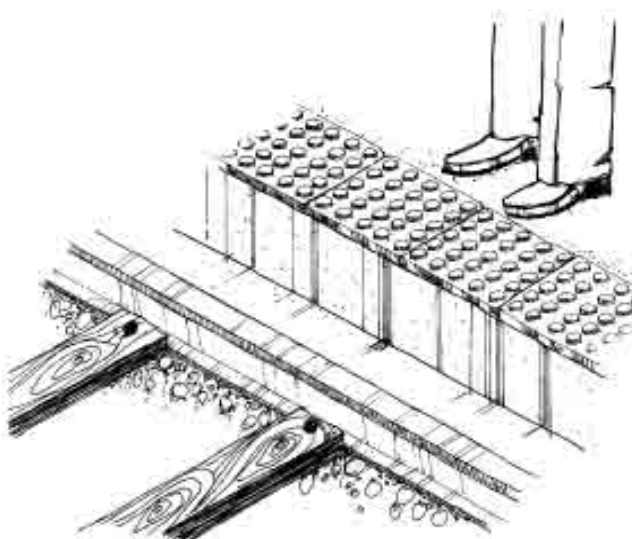
*Figure 4-30: Truncated domes are an effective way of indicating a drop-off at transit platform.*

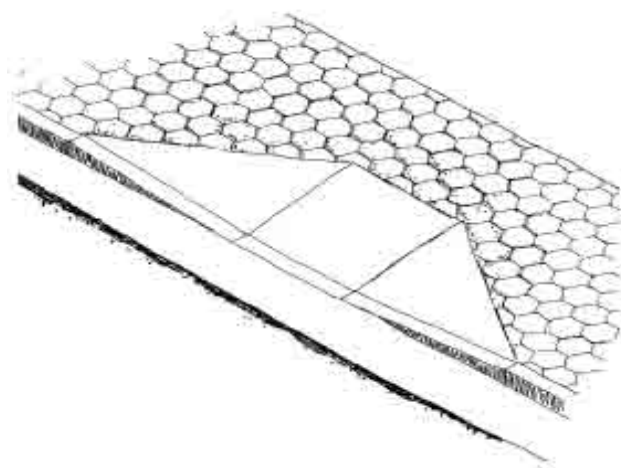
*Figure 4-31: Colored stone sidewalks with concrete curb ramps have a detectable color change.*

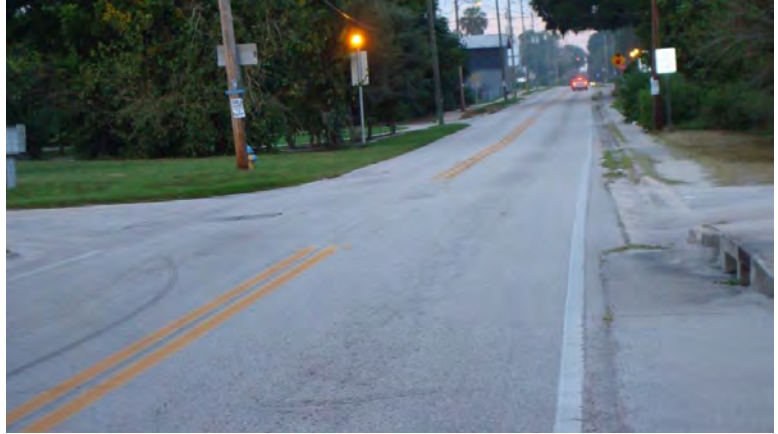
School flashing beacons (Illustration 11) also play an important role in safety. Flashing beacons alert drivers that they are entering a school zone and indicate that the displayed speed limit is in effect. It was observed that school flashing beacons can be operated manually or can be pre-set to turn off/on during pre-programmed timeframes. Manually run school flashing beacons are usually operated by school crossing guards, who are primarily assigned to cross elementary school students. Unfortunately, this does not address the needs of middle school students.

**Illustration 11: Flashing beacon traffic signal control**

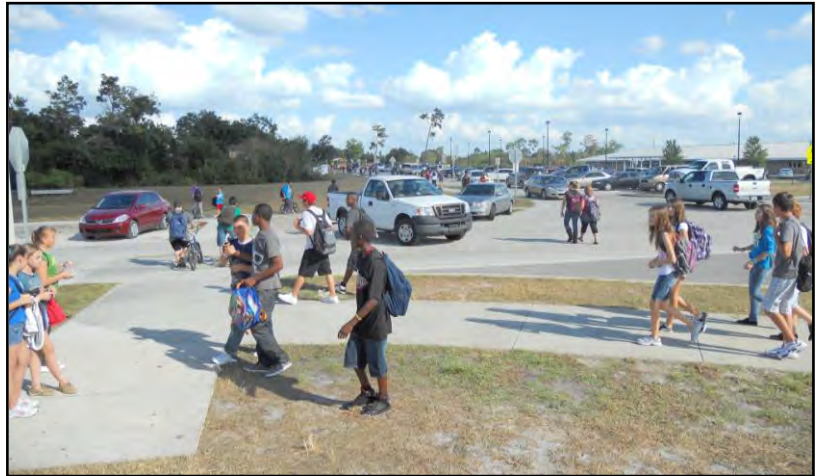
Regulations are not always followed by adults dropping off/picking up students (Illustration 12). Motorists were observed to park in No Parking areas and make prohibited vehicular movements, including u-turns. Some motorists were observed to be speeding within the reduced-speed zone.

**Illustration 12: Intersection of Ohio Avenue and Scholars Path at dismissal**

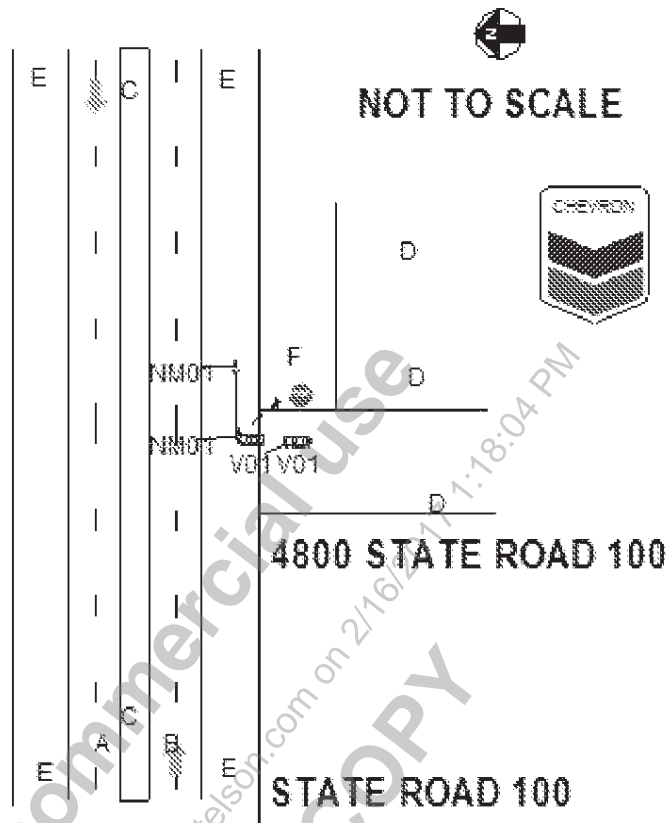
- A. STATE ROAD 100 WB
- B. STATE ROAD 100 EB
- C. RAISED CONCRETE MEDIAN
- D. CHEVRON PARKING LOT
- E. PAVED SHOULDER
- F. GRASS SHOULDER
