SR/CR A1A PEDESTRIAN SAFETY & MOBILITY STUDY FINAL REPORT | MAY 2017

SR/CR A1A Pedestrian Safety and Mobility Study

River to Sea Transportation Planning Organization

May 2017

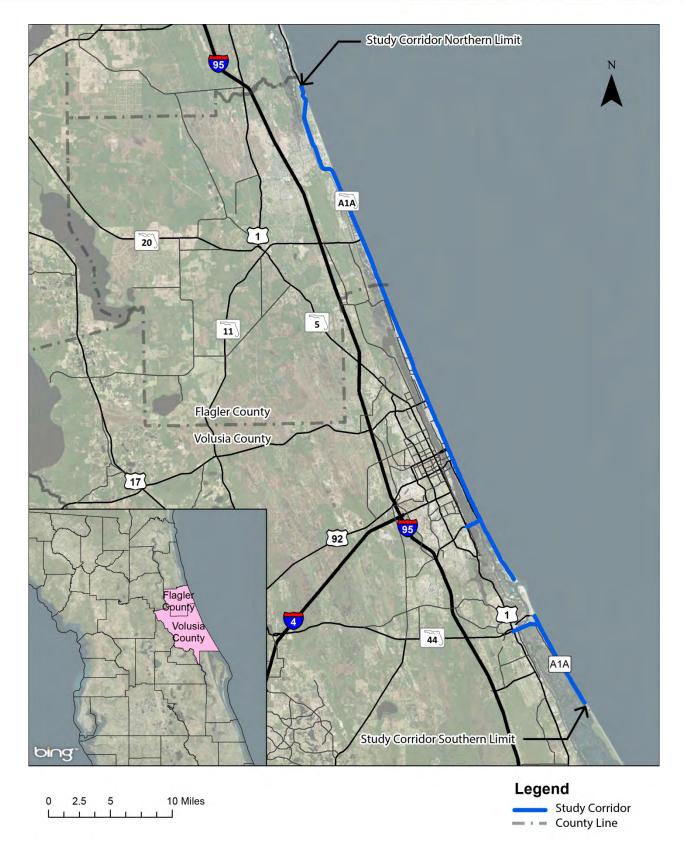
Figure 1 SR/CR A1A Study Area

The project's study limits include SR/CR A1A between the southern limits of Bethune Beach to the south and the southern limits of Marineland to the north. The portions where SR A1A coincides with US 1, between Dunlawton Avenue in Port Orange and 3rd Avenue in New Smyrna Beach, were not included within the study area limits. Certain areas of SR/CR A1A have been studied within the last 5 years were also excluded from the study area in an effort to reduce duplication of efforts, but have been summarized in **Section 3 – Literature Review**. The general study limits for the project are illustrated in **Figure 1**.

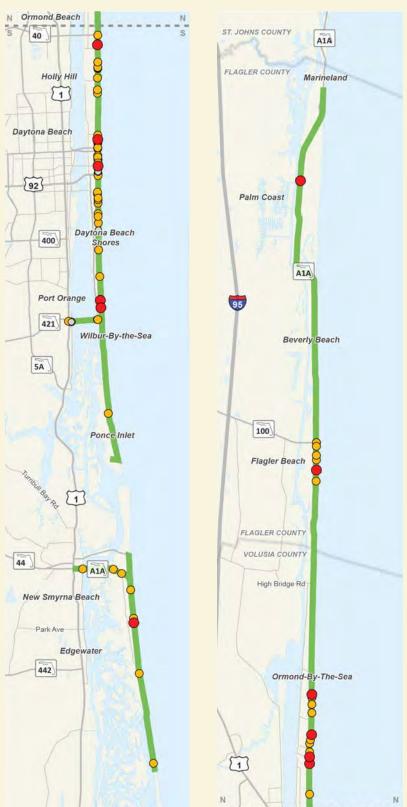
Study Corridor and Crash Locations

Figure 5 displays the pedestrian and bicycle crash locations along the study corridor while **Figure 6** displays the corridor wide crash summary for SR/CR A1A over the six year study period. Detailed tables/charts for the entire SR/CR A1A study corridor can be found in **Appendix C**.

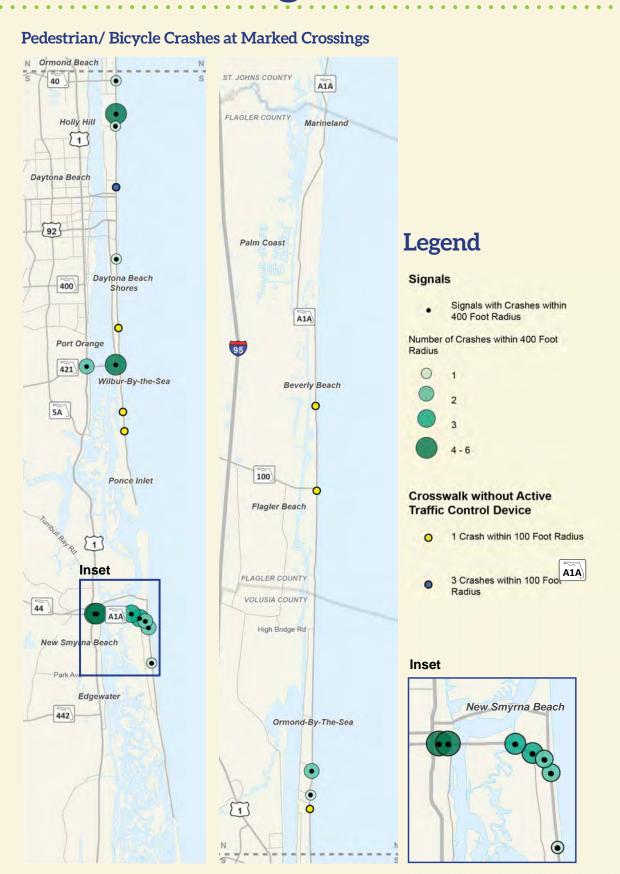
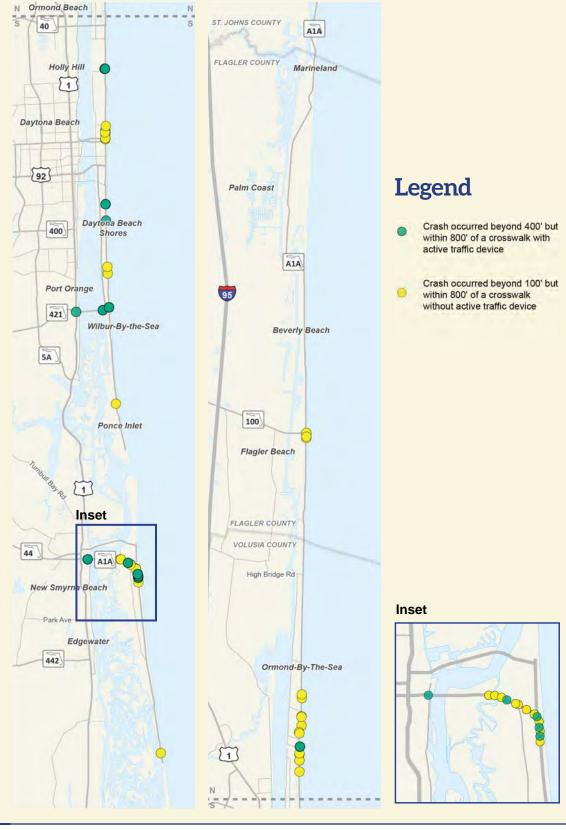
Pedestrian/ Bicycle Crashes near Marked Crossings

Thirty-six (36) crashes occurred within a 100 foot radius of a marked mid-block crosswalk with no active traffic control. An additional 17 crashes occurred between a 100 and 800 foot radius of a marked mid-block crosswalk with no active traffic control.

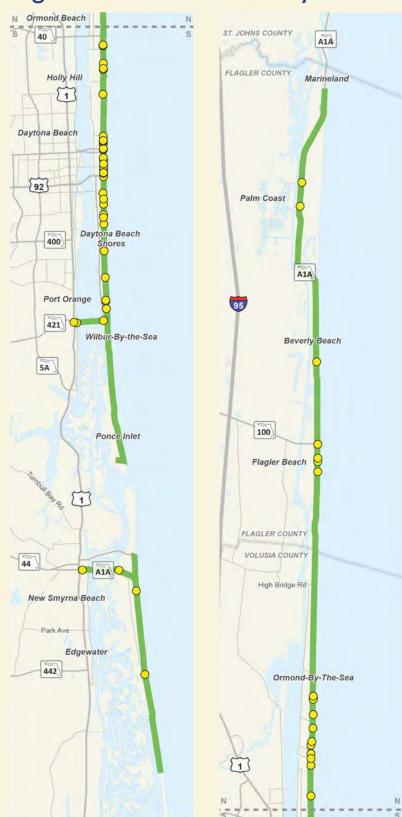
Night Time Pedestrian/ Bicycle Crashes

This figure shows the location of night time crashes on the SR/CR A1A study corridor between 2009 and 2014. Sixty-two (62) of the 158 total crashes occurred during non-daylight conditions (dawn, dusk, dark with a streetlight present, dark without a streetlight present) with a majority of those crashes occurring in the Daytona Beach, Ormond Beach, and Ormond-by-the-Sea areas.
