# INTERSECTION ANALYSIS

US 1 at Turgot Avenue  
Section 79010 – M.P. 14.879  
Volusia County

**RIVER TO SEA TRANSPORTATION PLANNING ORGANIZATION**

November 2015

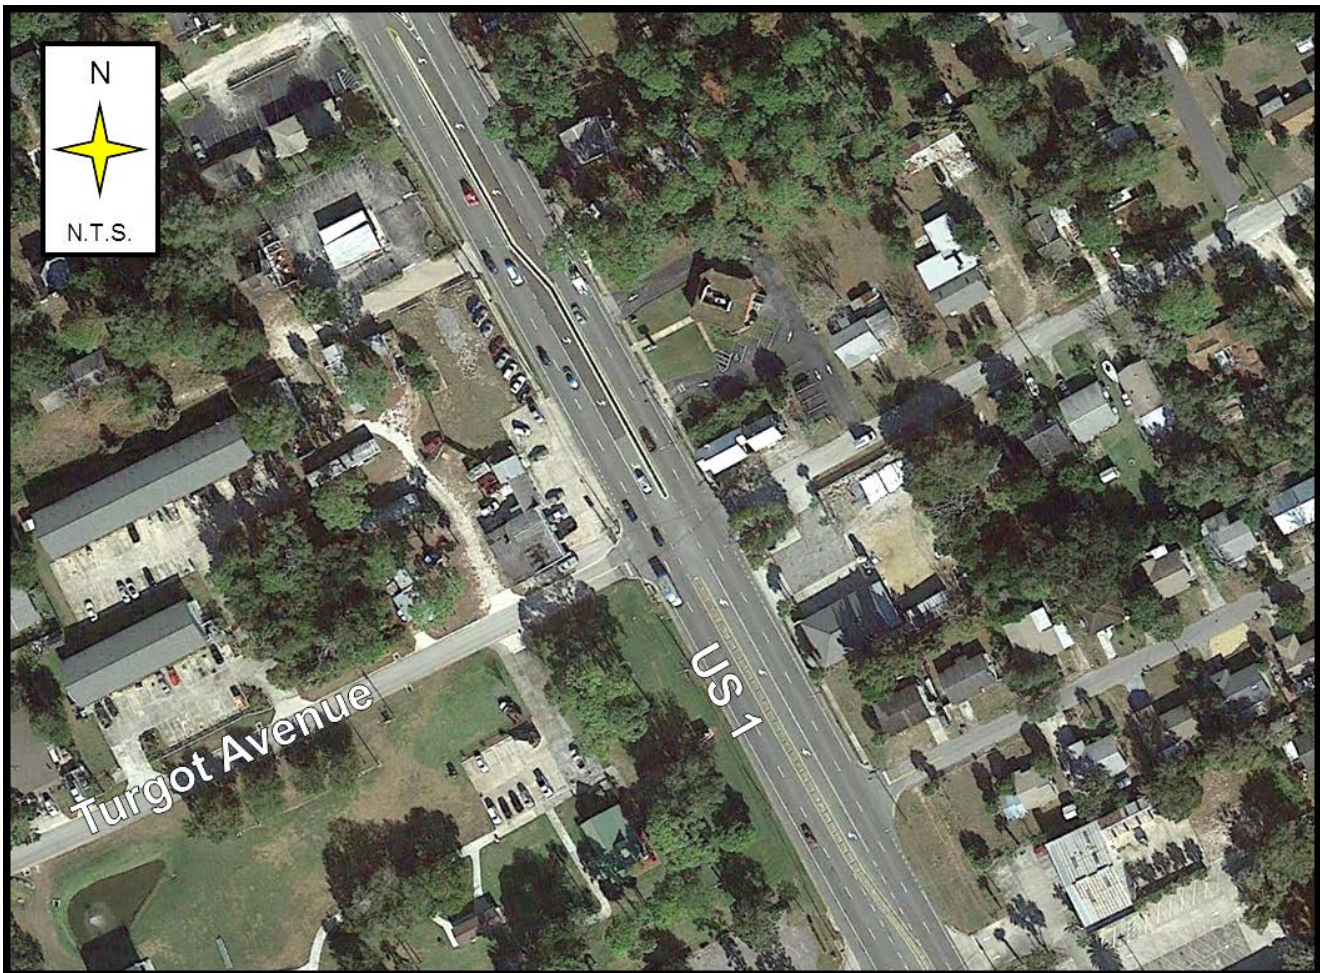
**Figure 2**  
**General Location Aerial**  
**US 1 at Turgot Avenue**

US 1 is a north-south arterial that extends through the eastern side of Volusia County, Florida. As shown in **Figure 2**, at the study intersection US 1 is a four-lane divided arterial. Turgot Avenue is an east-west two-lane undivided roadway extending approximately 0.55 miles. The YMCA/Hawk's Park recreational complex is located approximately 0.24 miles west of the study intersection on the south side of Turgot Avenue and the Edgewater Public School is located approximately 0.30 miles west of the study intersection at the termination of Turgot Avenue. School access is not provided through Turgot Avenue but rather from the north via Ocean Avenue and Old County Road. A large number of cultural and recreational events at the YMCA/Hawk's Park recreational complex occur including team sports and concerts.

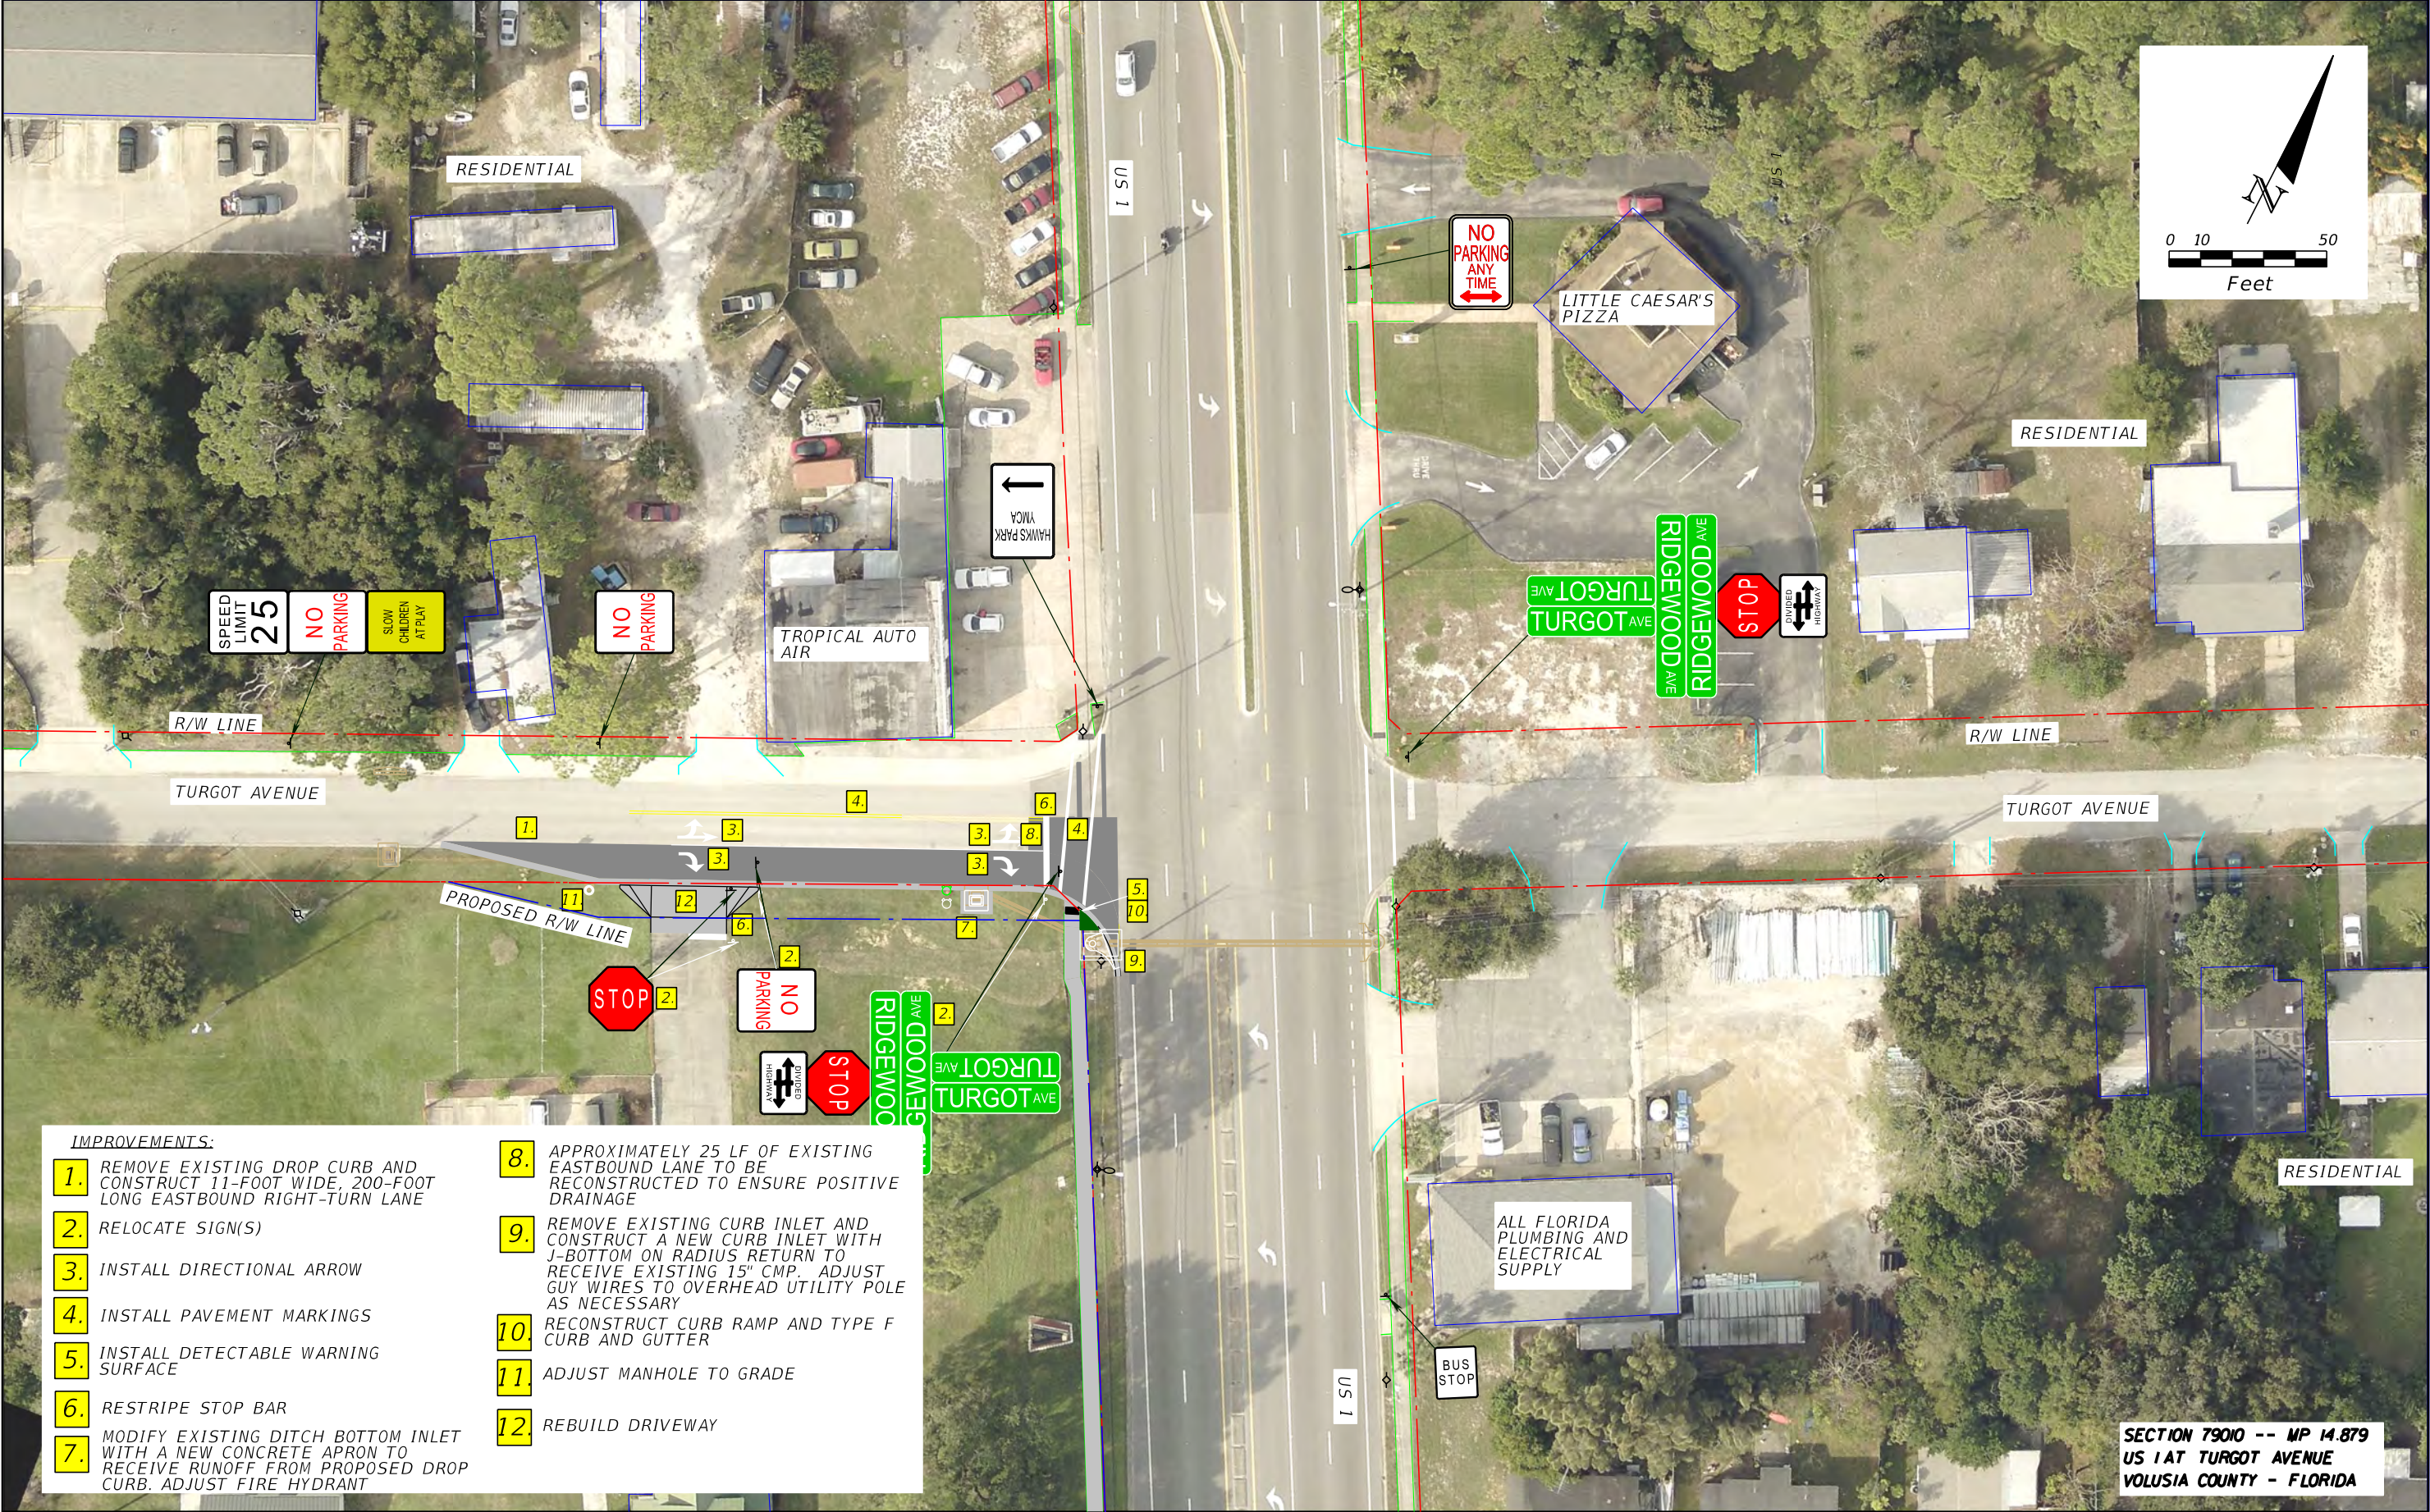
- Remove an existing curb inlet and construct a new curb inlet with j-bottom on radius return to receive existing 15" CMP. Adjust the guy wires on the overhead utility poles as necessary
- Adjust a manhole to grade west of the study intersection on the south side of Turgot Avenue
- Rebuild the City of Edgewater Park and Recreation office's driveway

The overall improvement costs were estimated based on FDOT historical unit prices. The total cost of the improvements, including engineering and CEI, is estimated at approximately \$110,632 and is provided in **Table 6**. It should be noted that right of way will be needed in the southwest quadrant of the intersection to construct the proposed improvements. The parcel from which right of way will be needed (parcel number 33-17-34-07-02-0010) is owned by the City of Edgewater. Recognizing that Turgot Avenue is a City road, the City of Edgewater will thus need to dedicate a portion of this parcel to become Turgot Avenue right of way.

However, based on additional analysis it is recommended to construct an eastbound right-turn lane at the study intersection, as depicted in **Figure 15**. The engineering and construction costs associated with these improvements are estimated at approximately \$110,632. It should be noted that right of way will be needed in the southwest quadrant of the intersection to construct the proposed improvements. The parcel from which right of way will be needed is owned by the City of Edgewater. Recognizing that Turgot Avenue is a City road, the City of Edgewater will thus need to dedicate a portion of this parcel to become Turgot Avenue right of way.
