# Case Studies ∞ Chapter 6

# Serpentine Street Design

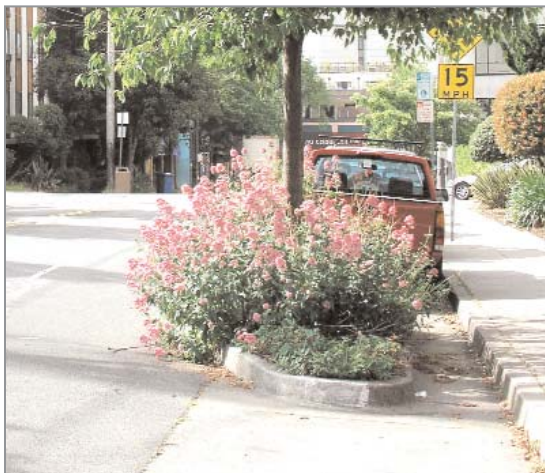
Mid-block landscaped bulb-out with parallel parking.

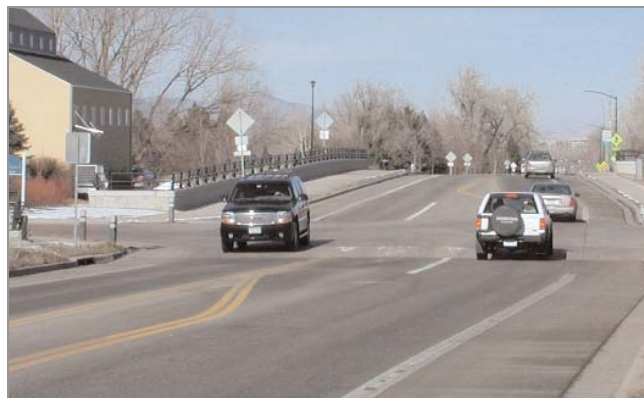
Second Raised Crossing on 55th Street.

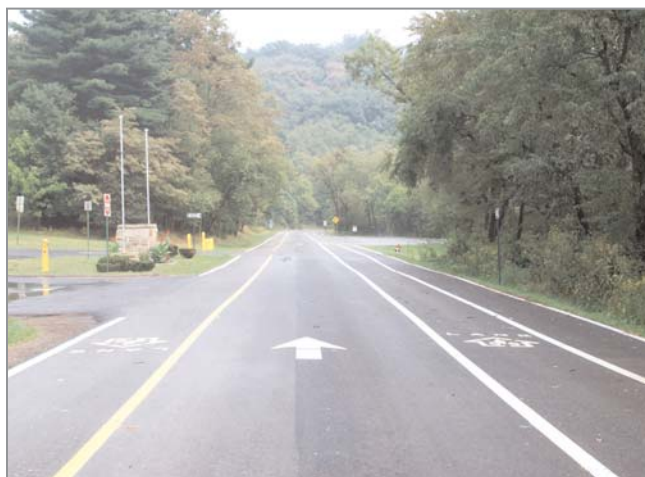
Striping of three travelways—center lane for one-way vehicle flow, a parallel flow bicycle lane on the right, and a contra-flow bicycle lane on the left.

Where space was limited and traffic patterns permitted, the roadway was designated as one-way, allowing continuation of all three travelways for the bicyclists and pedestrians. In this case, a bicycle lane with an adjacent pedestrian path

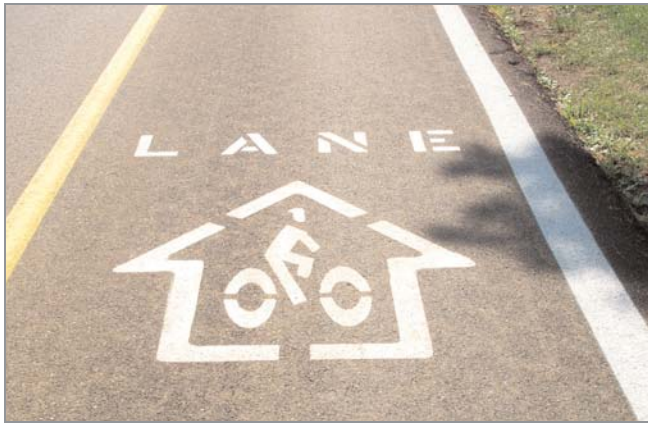
Bicycle lanes are marked with words and symbols as shown to indicate proper travel direction. Note that this symbol is not what is currently recommended in the MUTCD.

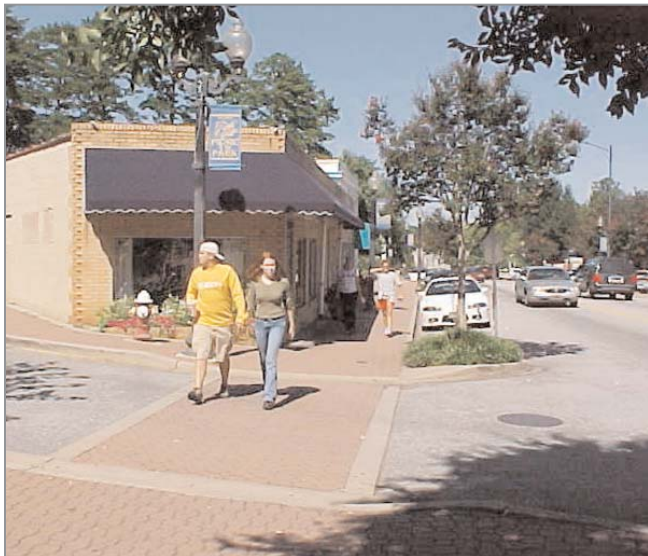
Pedestrian enhancements on College Avenue at Sloan Street include brick pavers, curb ramps, and new landscaping.

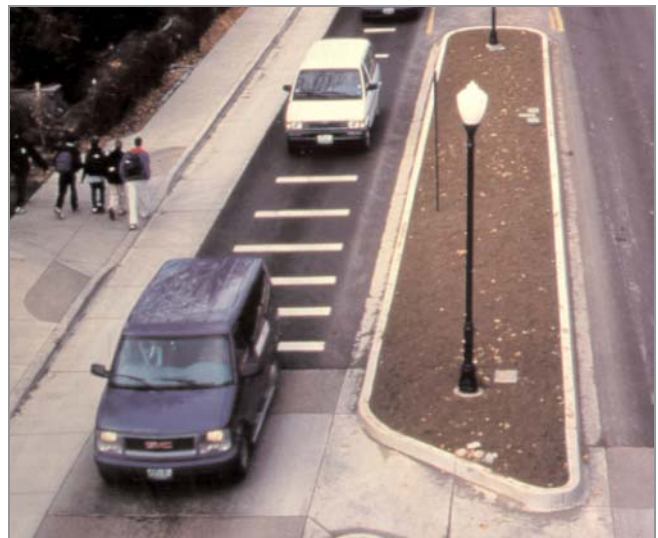
The sidewalks, raised medians, and raised crosswalks on First Street accommodate pedestrians effectively.

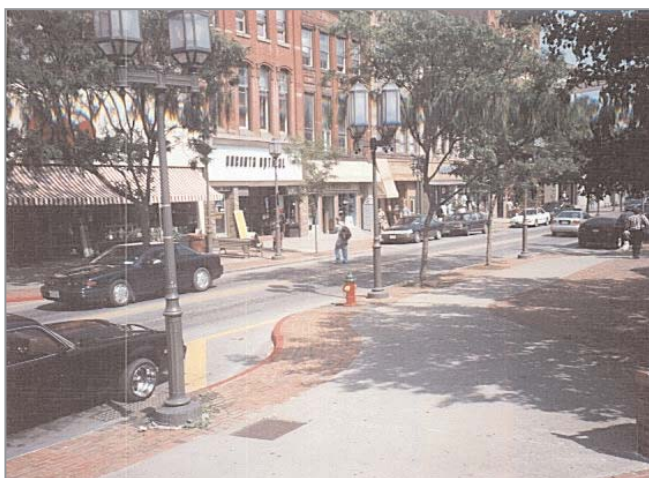
A mid-block curb extension on Main Street in Oneonta, NY narrows the street to two lanes and cuts the pedestrian crossing distance in half.

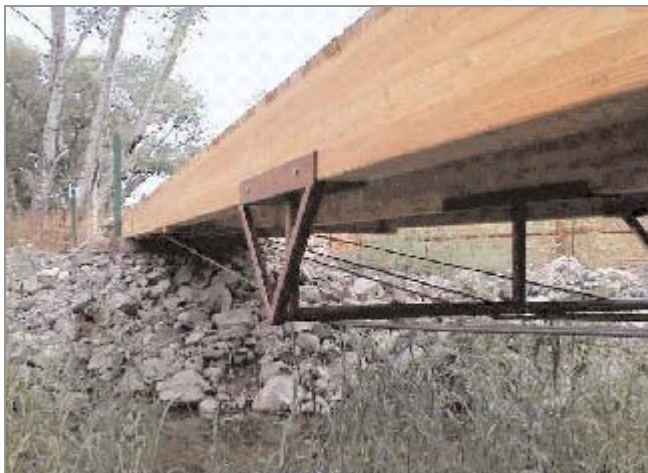
The Miller Creek permanent bridge tension frame was used to steady the bridge for pedestrians and bicyclists

Fortunately, PAT found ways to pay for the trail and creek crossings with limited funds. One new crossing is the Miller Creek permanent bridge. This bridge was constructed using 18.3 m (60 ft) glue-laminated wood beams, set on stone abutments, with Douglass Fir decking. When first installed, this bridge bounced wildly when a pedestrian or bicyclist crossed. Mr. Smith and the Parks Department staff built a tension frame from scrap rebar and plate steel. The plate steel supports the center of the bridge from below, holding tension at the two ends by way of bolts welded to the rebar tightened with nuts. They jacked up the center of the bridge with car jacks until it could not bow any further, installed the tension frame and tightened the nuts before releasing the jacks. The tension frame removed 80 percent of the bounce

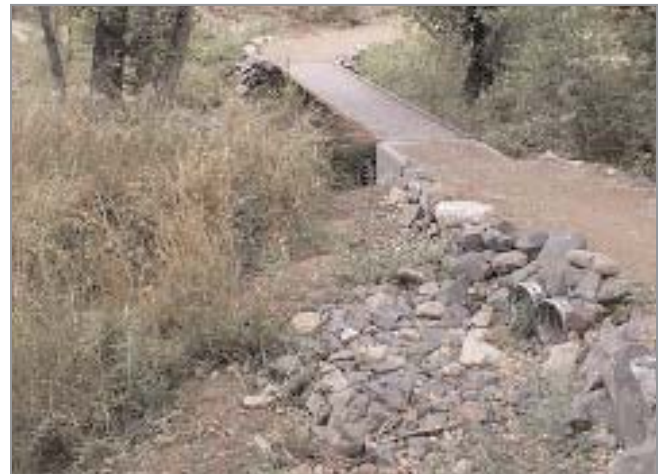
The Granite Creek bridge takes advantage of an existing sewer pipe as its foundation.

Another bridge was also created over Granite Creek using an existing sewer pipe. When Granite Creek water levels rose above a few feet, this abandoned sewer pipe served as the only possible creek crossing for pedestrians. Though unsafe in its original form, it offered a sturdy foundation for the Granite Creek Eagle Scout sewer pipe bridge. This bridge is constructed by anchoring 9.1 m (30 ft) of 51 mm x 305 mm (2 in x 12 in) wooden boards to the concrete sides and abutments of the sewer pipe structure. These provided the base for the 1.2 m (4 ft) wide Trek artificial wood decking. The narrow pipe prevented the bridge from being widened beyond 1.2 m (4 ft). Concrete curbing for the trail approaches preserves the trail surface where it connects to the bridge. The Eagle Scouts donated their labor, and the total cost was \$2,000.

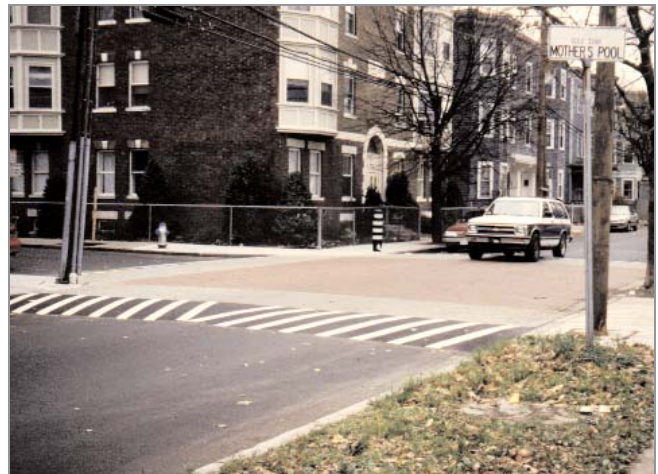
Raised intersection at Berkshire and Marcella Streets.

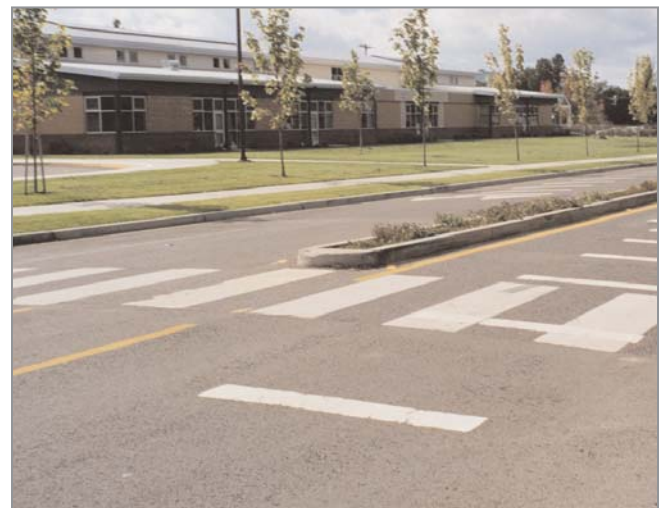
View of the emergency response speed hump on the east end of the project.

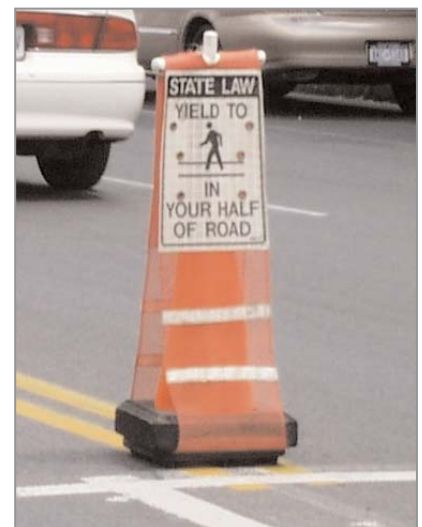
A SPCCD was placed at a ladder crosswalk on Fall Street in Downtown Seneca Falls, New York.

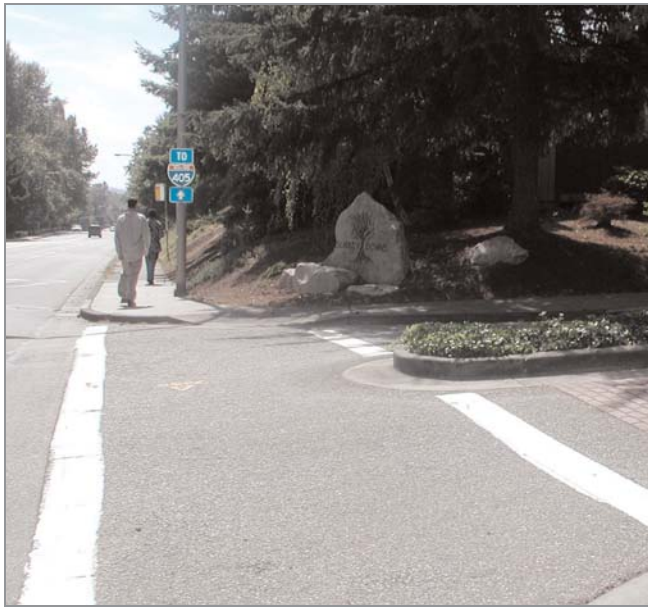
A landscaped island with pavement treatments at the entrance to the Surrey Downs neighborhood.

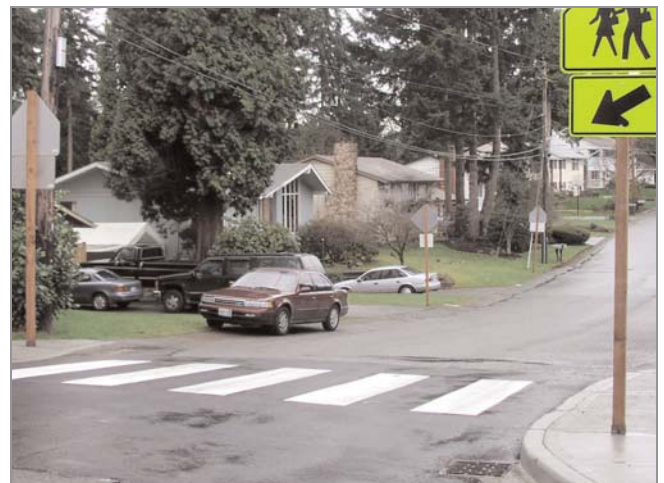
A raised crosswalk and curb extension along a street in the Bennett Elementary School Area.

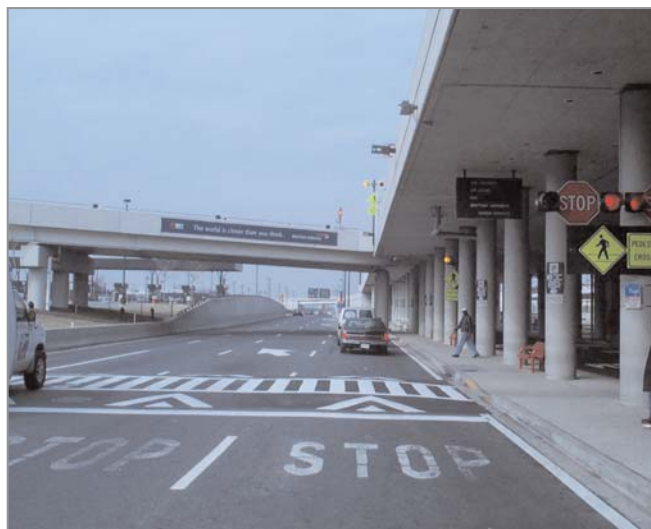
The speed tables at BWI improve crossing conditions for pedestrians. Note that the speed table is complemented by strong yellow-green pedestrian markings and STOP signs with flashing lights and pavement markings, which typically are not used in combination with speed tables.

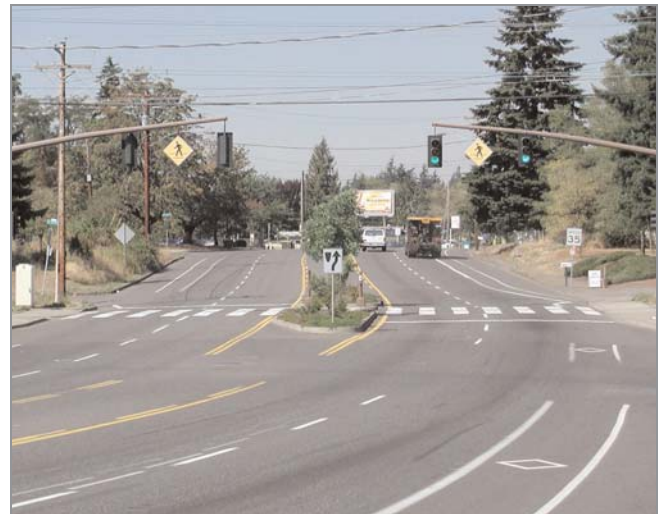
A typical major intersection treatment.

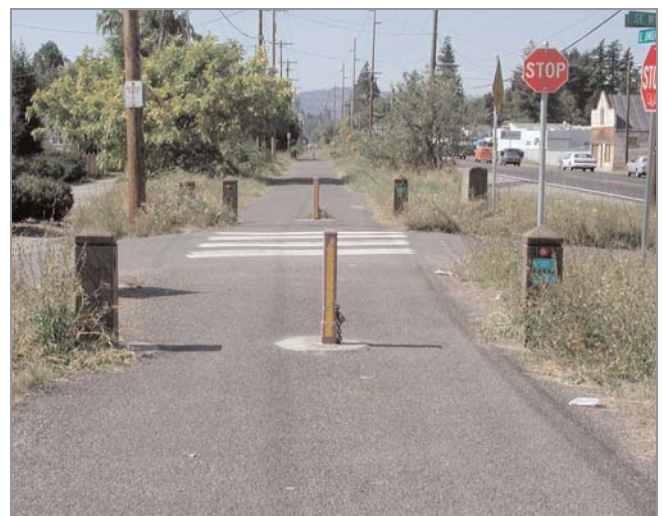
A typical minor intersection treatment.

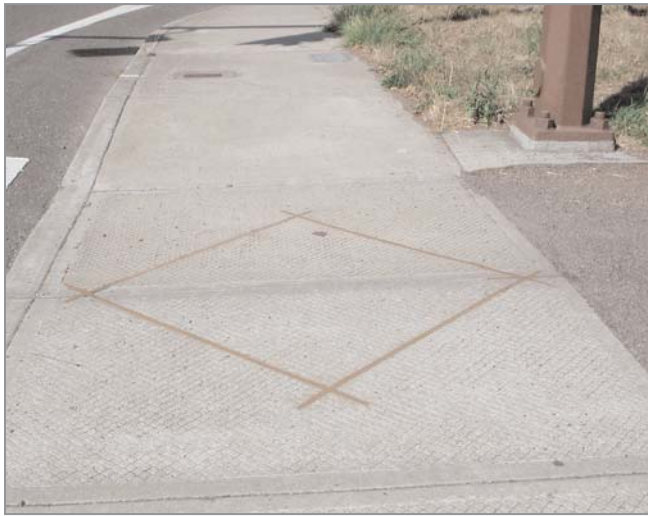
A bicycle-activated Signal Loop Detector.

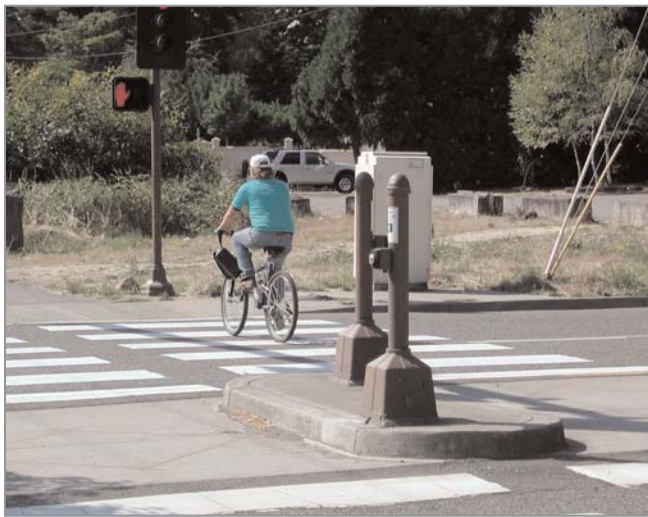
A pedestrian-activated signal button in a refuge island.

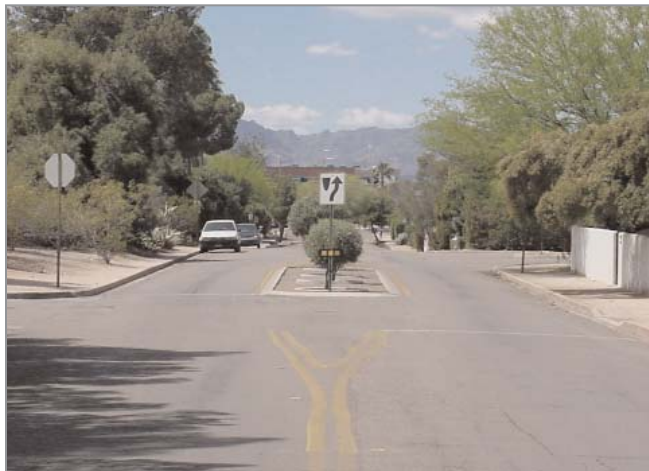
Tree-lined medians and small chicanes reduce drivers' perceived speeds on Elm Street.

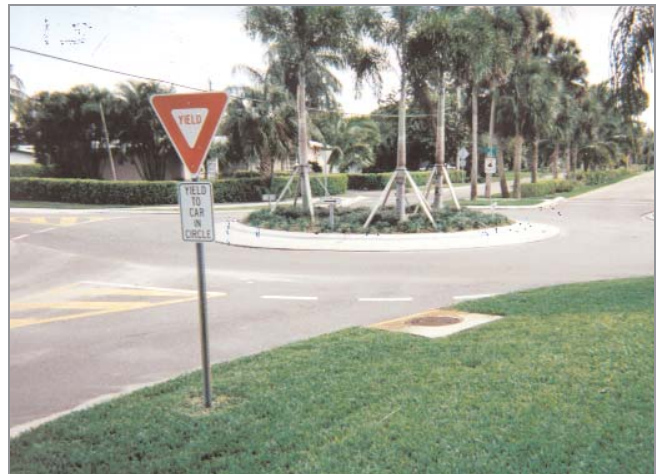
Median island and intersection roundabouts were installed on 7th Avenue.

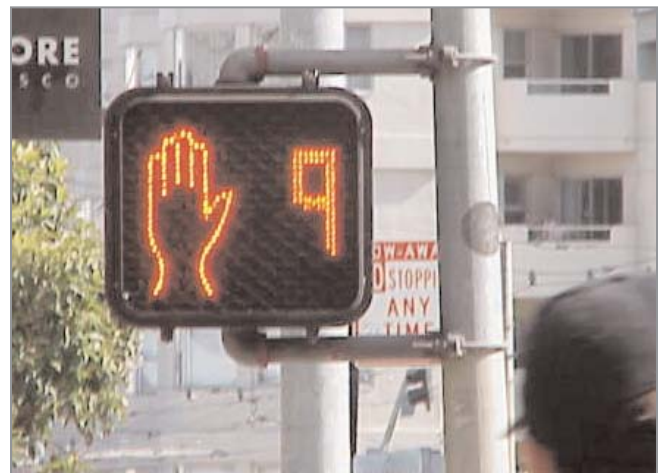
Pedestrian countdown signal heads show the time remaining for each phase.

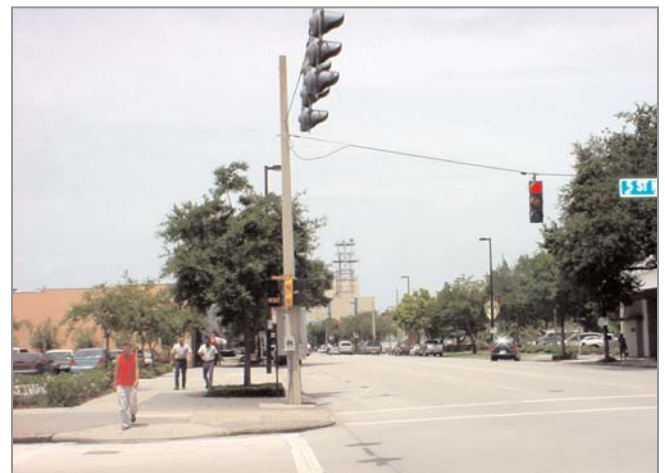
Pedestrians are given a WALK signal three seconds before parallel traffic is given a green light.
