SR/CR A1A PEDESTRIAN SAFETY & MOBILITY STUDY

PEDESTRIAN / BICYCLE SAFETY REVIEW

Focus Area A / Peninsula Avenue to E 3rd Avenue (New Smyrna Beach)

Project Title: Focus Area A Pedestrian/Bicycle Safety Field Review

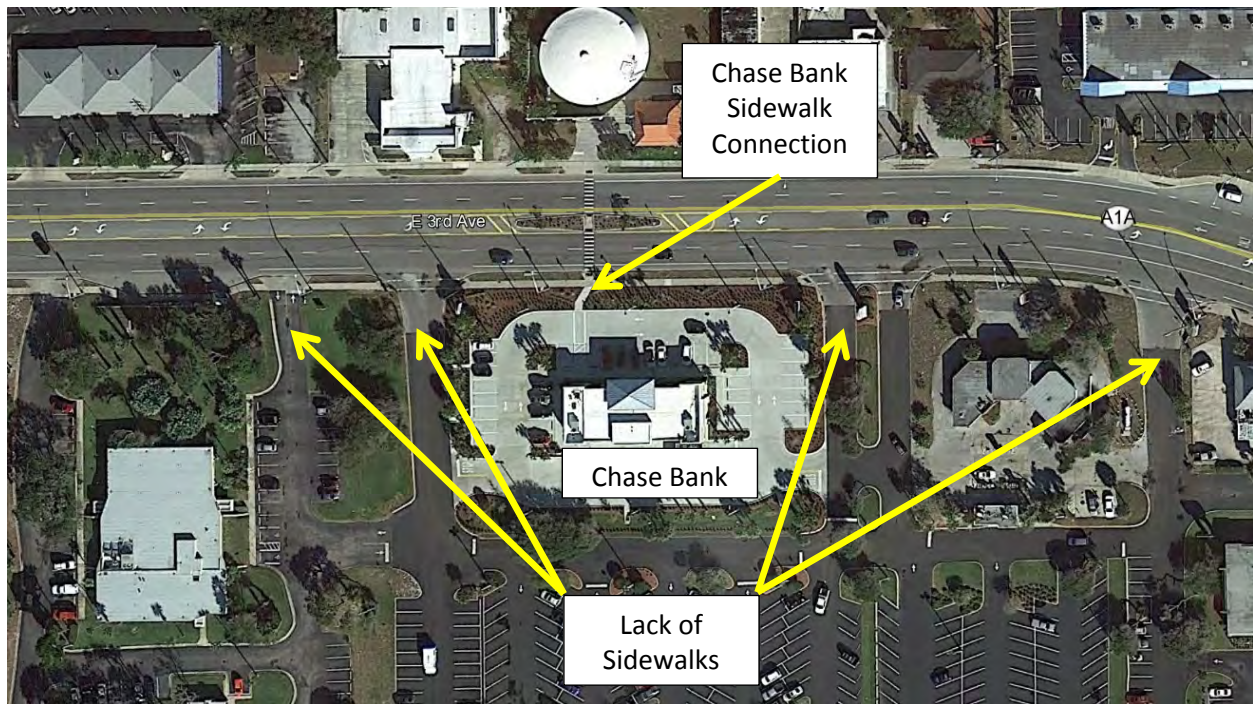
Figure 12**Description of Issue:**

Sidewalks are provided along both sides of SR A1A for the entire limits of the study corridor, but there is limited sidewalk access to the commercial properties on the north and south sides of the roadway. The limited sidewalk connectivity creates situations where pedestrians must use the entrance/exit roadway for a hard surface to get to/from SR A1A leading to potential pedestrian/vehicle conflicts. Examples of some commercial properties that lack sidewalks are presented in **Figure 12**.

As properties redevelop along the corridor, consider requiring the property owner to construct sidewalks that connect to SR A1A. When the Chase Bank was constructed, the property provided a connection to the SR A1A south side sidewalk as displayed in **Figure 12**.

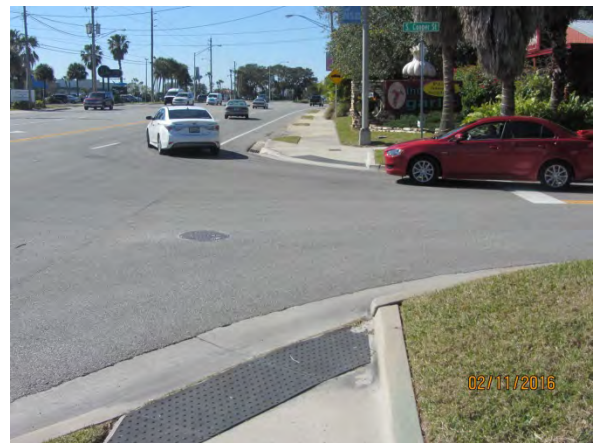
**Figure 16****Description of Issue:**

Overall, the existing crosswalk markings along the corridor were faded, as displayed in **Figure 13**, **Figure 14**, and **Figure 15**. At the signalized intersections, the crosswalk markings are the old special emphasis style. Cooper Street is missing crosswalk markings, as shown in **Figure 16**. The study team observed limited retro reflectivity of the crosswalk markings during nighttime conditions. Six of the nine corridor crashes occurred within marked crosswalk areas either at signalized intersections or at minor streets/driveways.

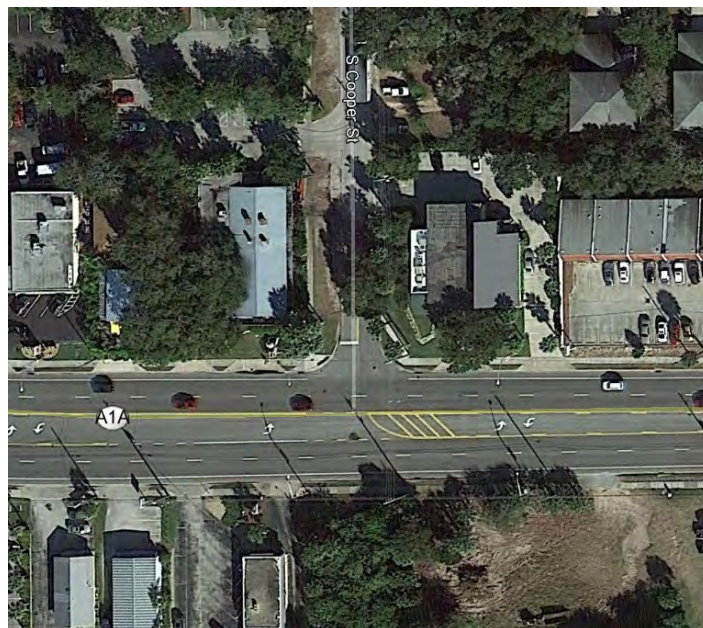
Figure 31

As described in **Issue #1: Vehicular Speed**, the pavement width between Peninsula Avenue and Horton Street/Saxon Drive is wide (**Figure 30**) and presents a challenge for pedestrians attempting to cross SR A1A. Cooper Street is the only unsignalized intersection along the corridor (**Figure 31**), located approximately 650' west of Horton Street/Saxon Drive. One mid-block pedestrian crash occurred just west and one mid-block bicycle crash occurred just east of Cooper Street. Pedestrians/bicyclists were observed coming from Cooper Street and crossing SR A1A.

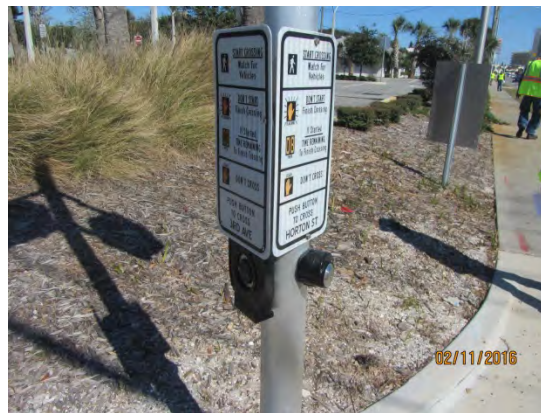
Figure 36

The intersection also had APS installed for the east leg crosswalk (**Figure 36**).

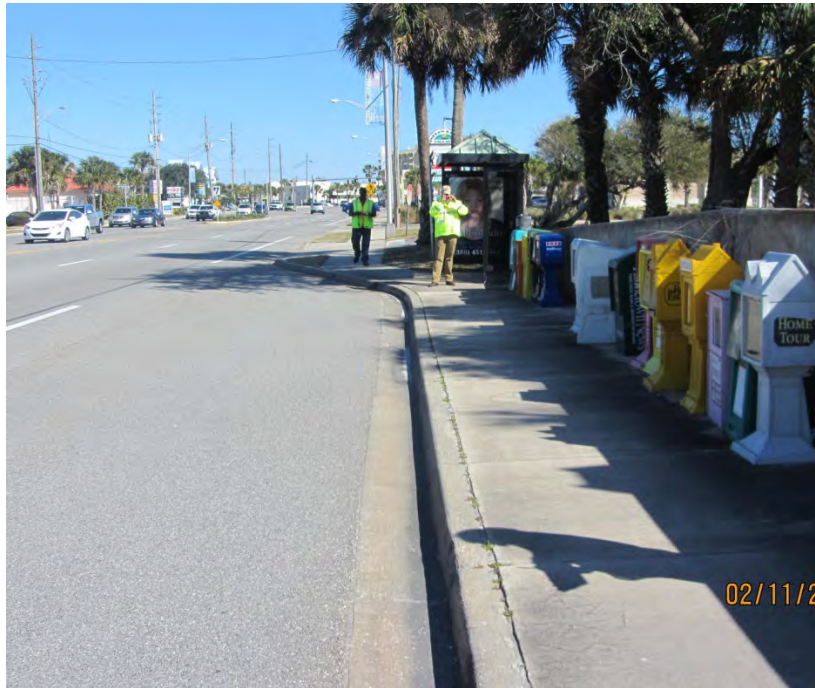
Figure 39

Newspaper/magazine stands are located within the sidewalk on the south side of the roadway next to the unused Votran bus stop/pullout just east of Horton Street/Saxon Drive (shown in **Figure 39**). While the sidewalk width in this area meets standard, the newspaper/magazine stands reduce the effective sidewalk width.
