SR/CR A1A PEDESTRIAN SAFETY & MOBILITY STUDY

PEDESTRIAN / BICYCLE SAFETY REVIEW

Focus Area B / Park Avenue to Ribault Avenue (Daytona Beach Shores/Daytona Beach)

Pedestrian/Bicycle Safety Review Report for Focus Area B: SR A1A from Park Avenue to Ribault Avenue (Daytona Beach Shores/Daytona Beach)

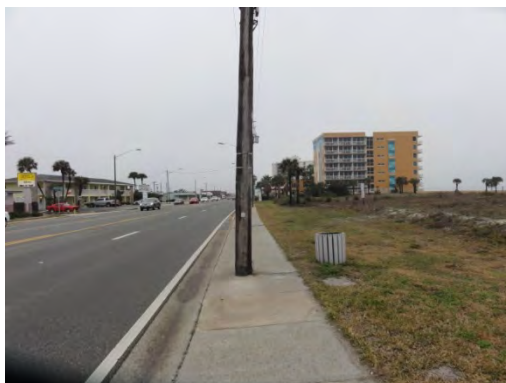
Figure 17

- Power poles (**Figure 17**) and trash cans were located in the sidewalk (mainly on the east side), reducing the sidewalk width to less than the minimum 4' according to ADA PROWAG section R302.3.

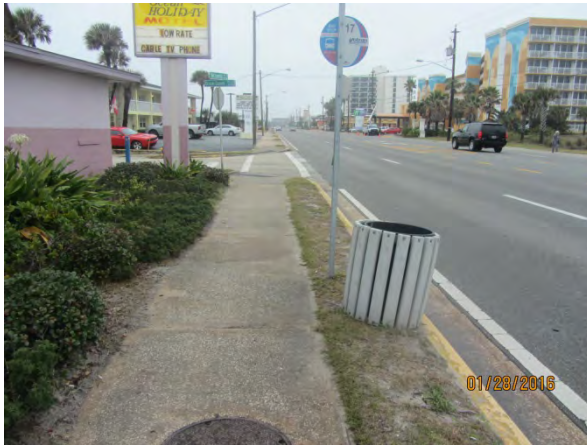
Figure 19

Votran bus stops (**Figure 19** and **Figure 20**) are present along the study corridor on both the east and west sides of the roadway. A 5' wide by 8' deep concrete landing pad is not present on the west side due to the landscape buffer strip or on the east side because the sidewalk adjacent to the curb is only 5' to 6' deep.

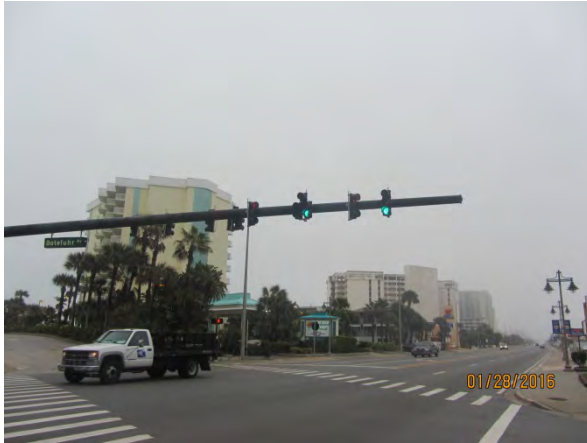
Figure 26

No street name sign is present for SR A1A at the intersection (**Figure 26**). Pedestrians at the intersection may get confused as to which pedestrian detector to push in order to cross SR A1A.

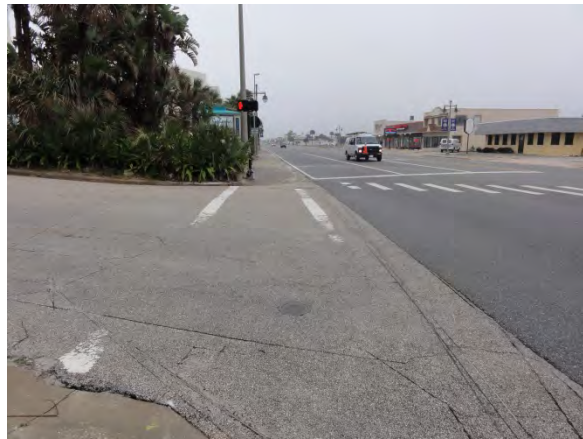
Figure 27

No stop bar is present on the westbound approach (east leg) at the intersection (**Figure 27**). One pedestrian crash occurred in the north leg crosswalk with a westbound right turning vehicle.

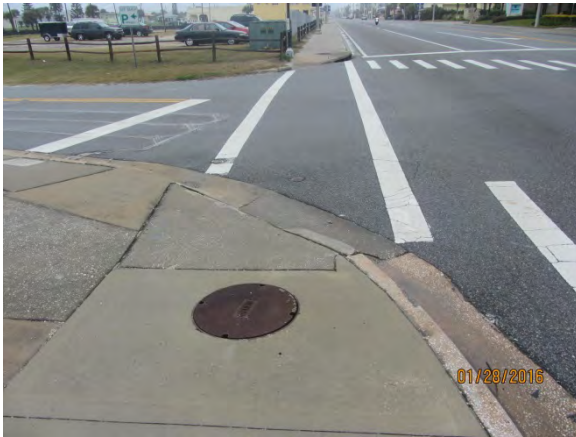
Figure 28

The crosswalks were faded on the four legs of the intersection and the crosswalk striping style was inconsistent between the Botefuhr Avenue approach standard markings (**Figure 28**) and the SR A1A old special emphasis markings (**Figure 29**). One pedestrian crash occurred in the north leg crosswalk with a westbound right turning vehicle. No detectable warning surfaces were present for any of the curb ramps at the intersection (**Figure 30** and **Figure 31**).

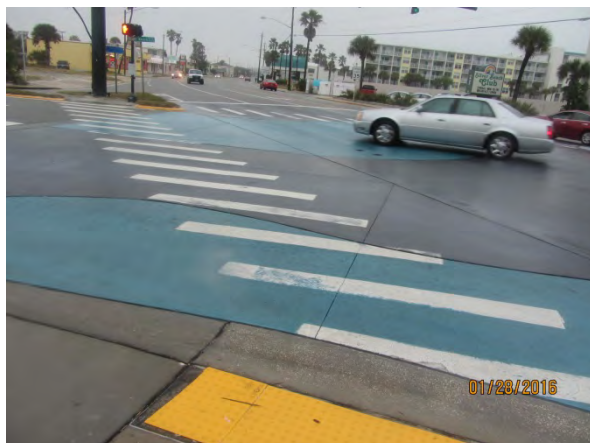
Figure 40

The crosswalks were faded on the four legs of the intersection (**Figure 40**) and the crosswalk striping was not retro reflective. One pedestrian crash occurred in the north leg crosswalk with an eastbound left turning vehicle.

Due to the skew of Silver Beach Avenue, crosswalks on all four legs (**Figure 40** and **Figure 41**) are skewed creating longer crossing distances for pedestrians.

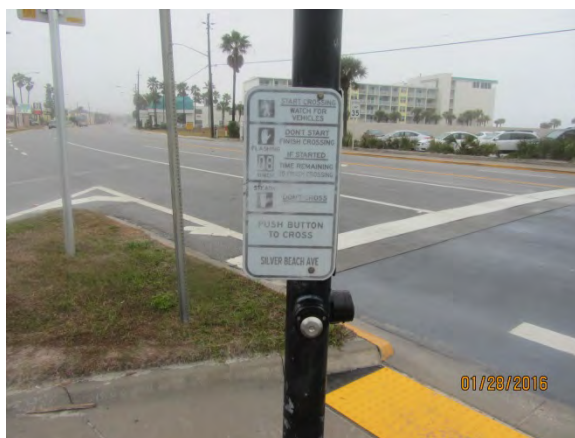
Figure 42

Pedestrian detector signage at the intersection was faded as displayed in **Figure 42**.

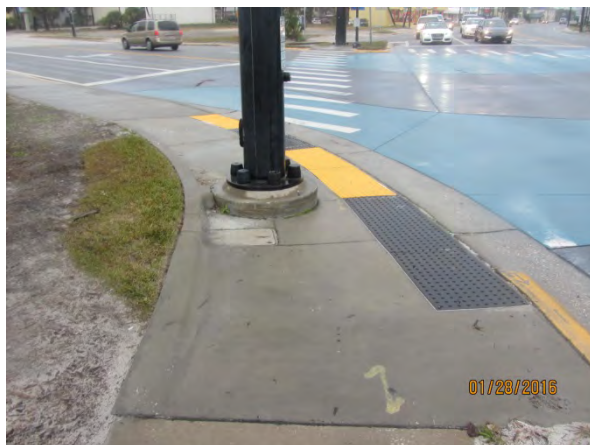
Figure 43

The mast arm in the southwest corner of the intersection is located within the sidewalk/curb ramp area as displayed in **Figure 43** and **Figure 44**. Adequate 4' continuous clear width for the sidewalk is not provided based on ADA PROWAG section R302.3.

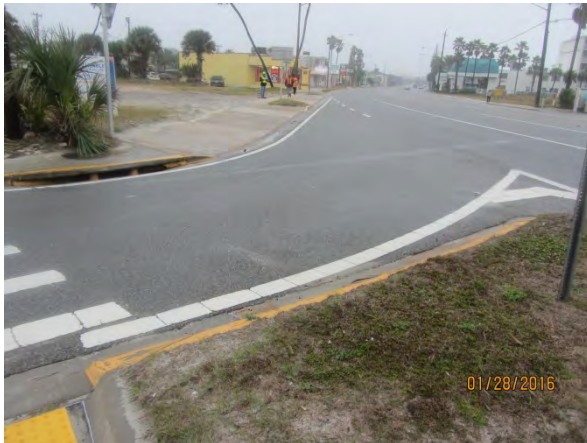
Figure 45

A marked pedestrian crosswalk is located across the channelized southbound right turn lane in the northwest corner of the intersection (**Figure 45**). This movement is a relatively high speed turn and the crosswalk markings are difficult to see from the driver's perspective (**Figure 46**).

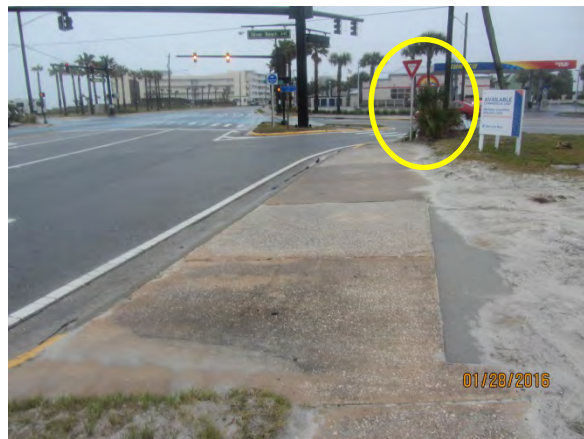
Figure 46

Pedestrians standing on the corner waiting to cross to the channelized island are visually obstructed by the palmetto tree (yellow circle in **Figure 46**).
