# SR/CR A1A PEDESTRIAN SAFETY & MOBILITY STUDY

## PEDESTRIAN / BICYCLE SAFETY REVIEW

Focus Area C / International Speedway Boulevard to South of Earl St. and  
North of Oakridge Boulevard to North of University Boulevard (Daytona Beach)

## **Project Title: Focus Area C Pedestrian/Bicycle Safety Field Review**

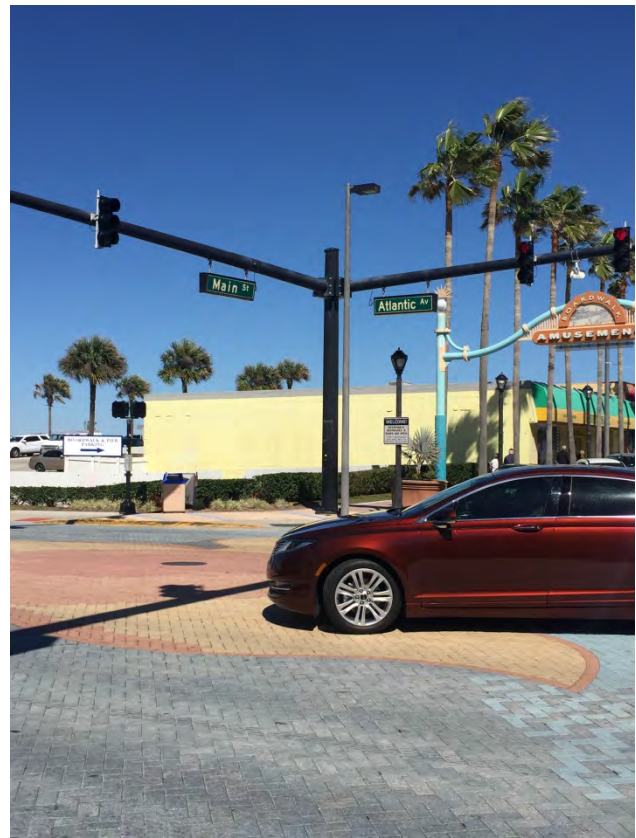
Figure 18

The study review team observed an inconsistency between the street names on push button signage and the existing street name signage. In some cases the push button signage directs pedestrians to cross SR A1A (**Figure 17**), but the existing street name signage present at the intersection states the local street name (Atlantic Avenue – shown in **Figure 18**). The high level of tourists unfamiliar with the state road designation may lead to confusion at the crossings.

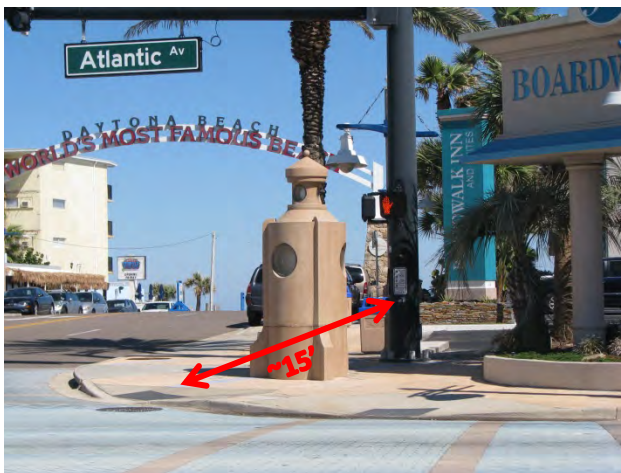
Figure 21

The decorative structures on the northeast and southeast corners of the intersection (shown in **Figure 21** and **Figure 22**) obstruct pedestrian visibility of the pedestrian push buttons. The obstructions may encourage pedestrians to disregard the pedestrian push buttons and cross against the pedestrian signal.

The push button on the southeast corner of the intersection is located more than 10' away from the curb ramps as illustrate in **Figure 21** and **Figure 22**.

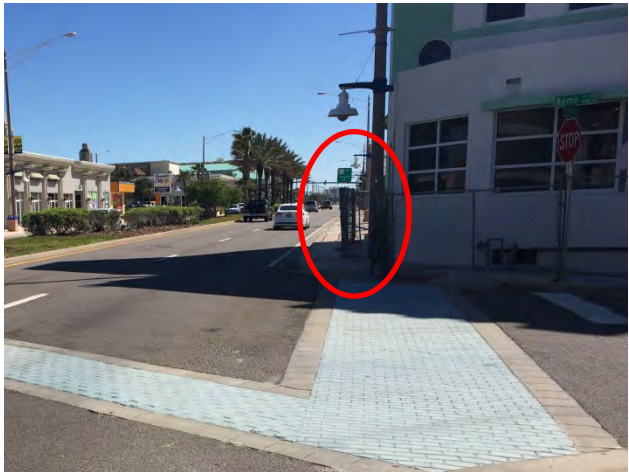
A hotel is currently undergoing renovations on the southwest corner of SR A1A and Kemp Street. The construction fencing and its footings shown in **Figure 25** extend over the west sidewalk along SR A1A and reduce the effective sidewalk width. This forces pedestrians using the sidewalk to be walking closer to vehicles traveling along SR A1A. The construction fencing takes up the entire sidewalk width of the south sidewalk along Kemp Street (illustrated in **Figure 26**). A Sidewalk Closed Cross Here sign (R9-11a) is provided on the southwest curb ramp.

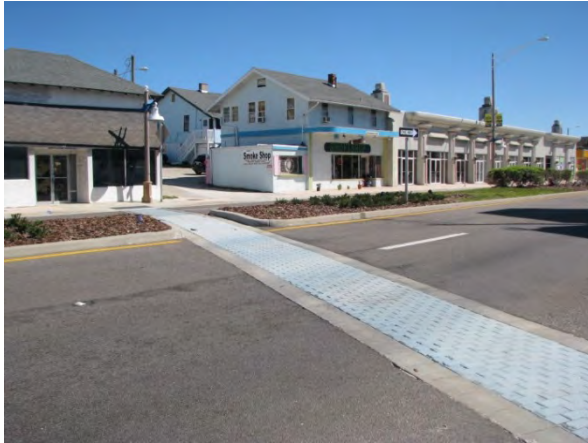
An unsignalized crossing is located on the north leg of the SR A1A and Kemp Street intersection as shown in **Figure 27** and **Figure 28**. The review team noted the following observations at this crosswalk location:

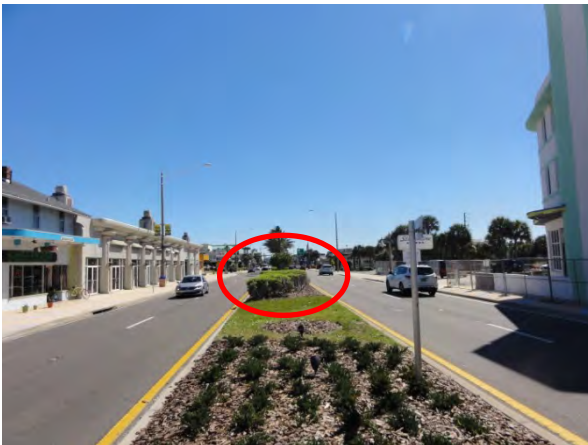
**Figure 29**

- There is low vehicular yield compliance at the crossing.
- Bushes located in the median obstruct sight distance between pedestrians standing in the median refuge and northbound vehicles approaching the crosswalk (**Figure 29** and **Figure 30**).

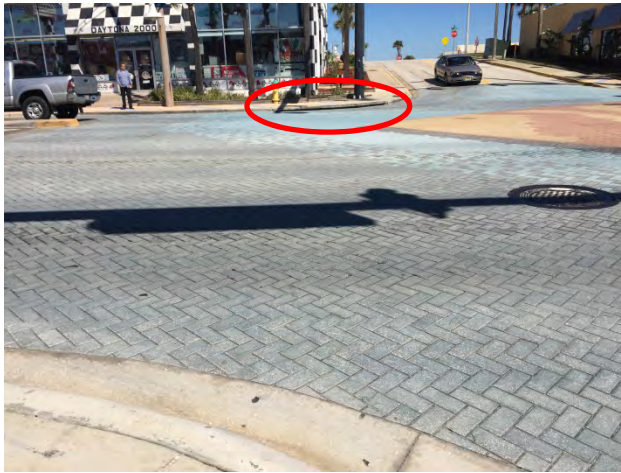
Figure 31

The northeast corner pedestrian ramp is offset from the SR A1A sidewalk alignment as illustrated in **Figure 31**. The sidewalk alignment (shown in **Figure 31** and **Figure 32**) drops into the drainage inlet on the northeast corner. One pedestrian was observed stepping off the curb into the inlet gutter and nearly fell. Local business owners indicated that people accidentally step off into the drainage inlet frequently. This poses a hazard for pedestrians to injure themselves or fall into the street.

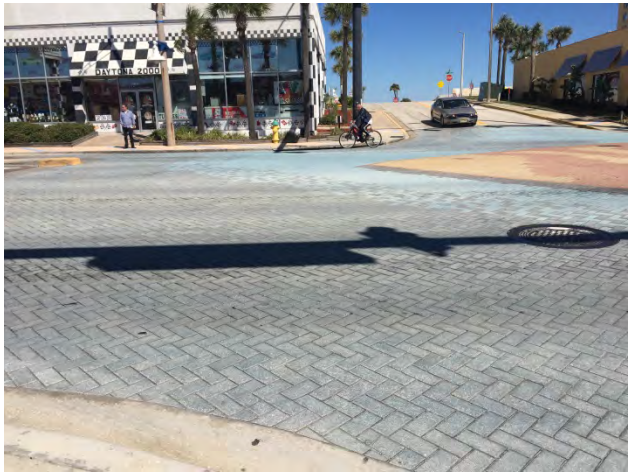
Figure 33

- A marked crosswalk is not provided on the north leg of the intersection (**Figure 33**).
- The pedestrian push buttons on the southeast and southwest corners are greater than 10' away from the ramp and a traffic signal controller box is located between the push button and curb ramp on the southeast corner (see **Figure 34**).
- Pedestrian push button signage is outdated and does not indicate instructions for the pedestrian

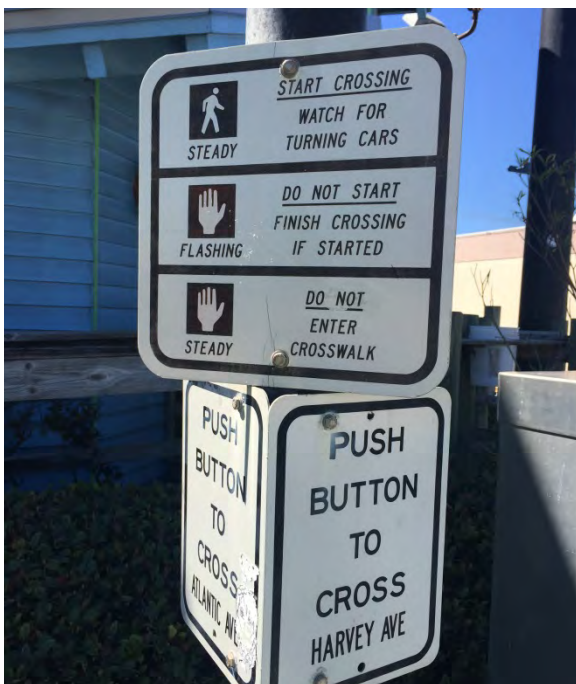
Figure 35

countdown phase (shown in **Figure 35**).

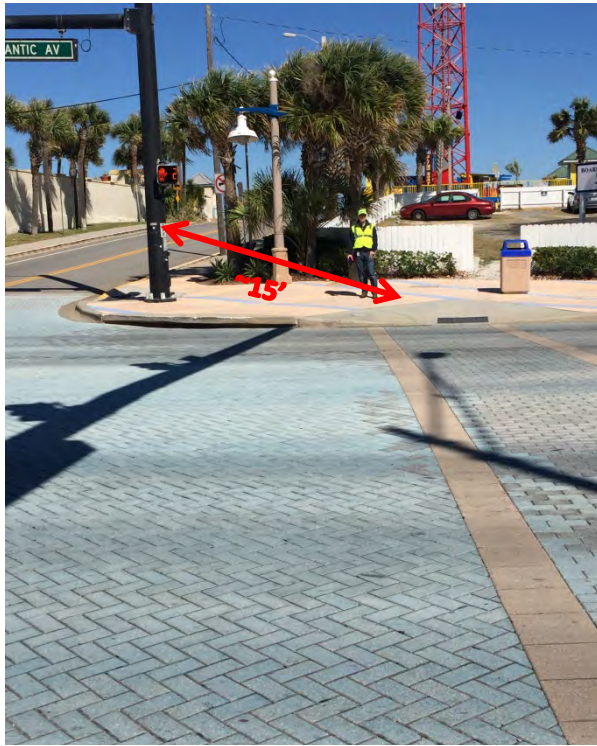
Figure 41

- The pedestrian signal and push button on the southeast corner is not aligned with the south leg crosswalk, located approximately 15 feet from the crosswalk and curb ramp as shown in **Figure 41**. This exceeds the 10' minimum distance to the curb ramp as defined in section 4E.08 of the 2009 MUTCD.
- Pedestrian push button signage is outdated and does not indicate instructions for the pedestrian countdown phase. **Figure 42** also shows that some of the signage has been peeled away on the northwest corner. Part of the signage on the southwest pole has been peeled away also.

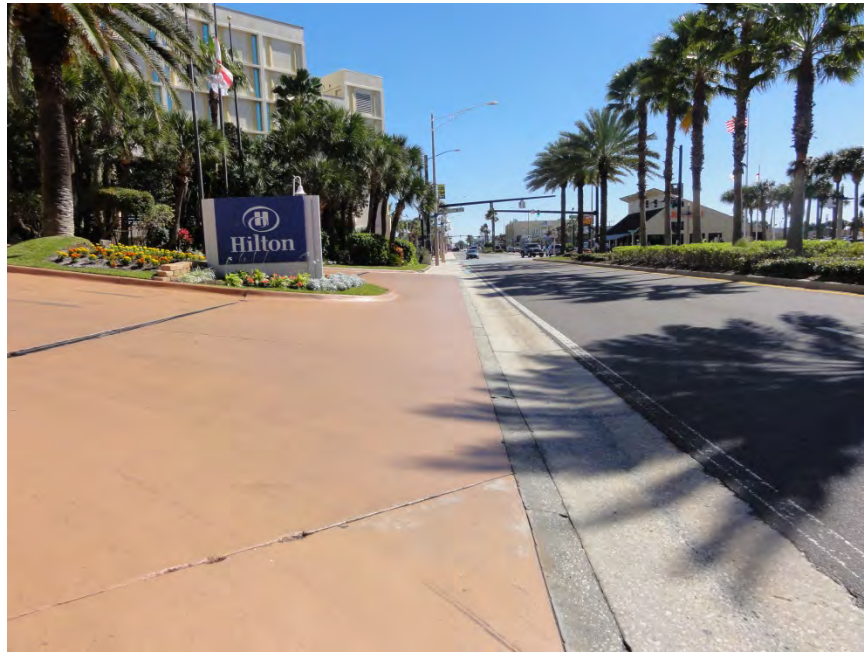
The Hilton driveways just north of the Auditorium Boulevard intersection are long (approximately 100 feet) and do not include a stop bar or crosswalk markings. Vehicles entering or exiting the Hilton are not provided direction as to where to stop or yield to pedestrians. The driveways are shown in **Figure 43**

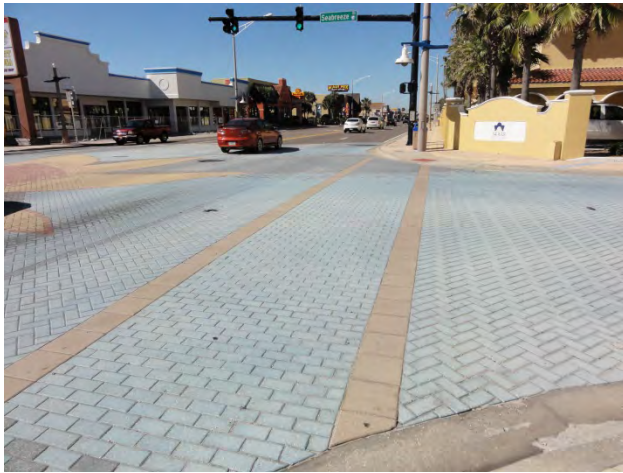
**Figure 44**

There are inconsistencies between the crosswalk markings at the two signalized intersections within the north section. The signalized intersection of Seabreeze Boulevard and the unsignalized intersections of Glenview Boulevard and Riverview Boulevard have the decorative paver patterns (**Figure 44** and **Figure 45**) described in **Issue #1**. As described earlier, the decorative pavers in the intersection make the marked crosswalks less distinguishable to drivers and do not provide retro-reflectivity at night (see **Figure 46**).

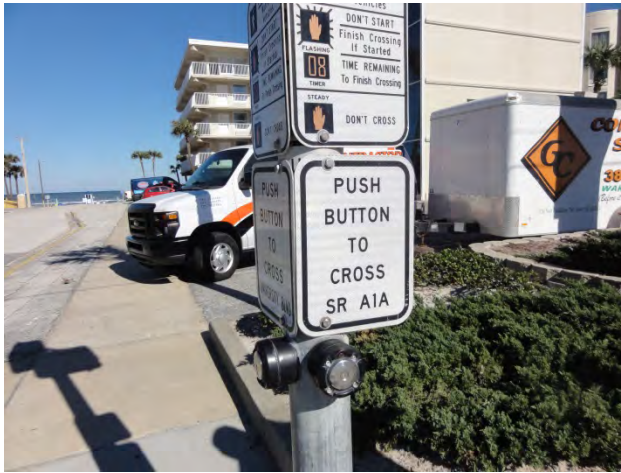
**Figure 52**

The study review team observed an inconsistency between the street names on push button signage and the existing street name signage along the north section. In some cases the push button signage directs pedestrians to cross SR A1A (**Figure 52**), but the existing street name signage present at the intersection states the local street name (Atlantic Avenue – shown in **Figure 53**). The high level of tourists unfamiliar with the state road designation may lead to confusion at the crossings.

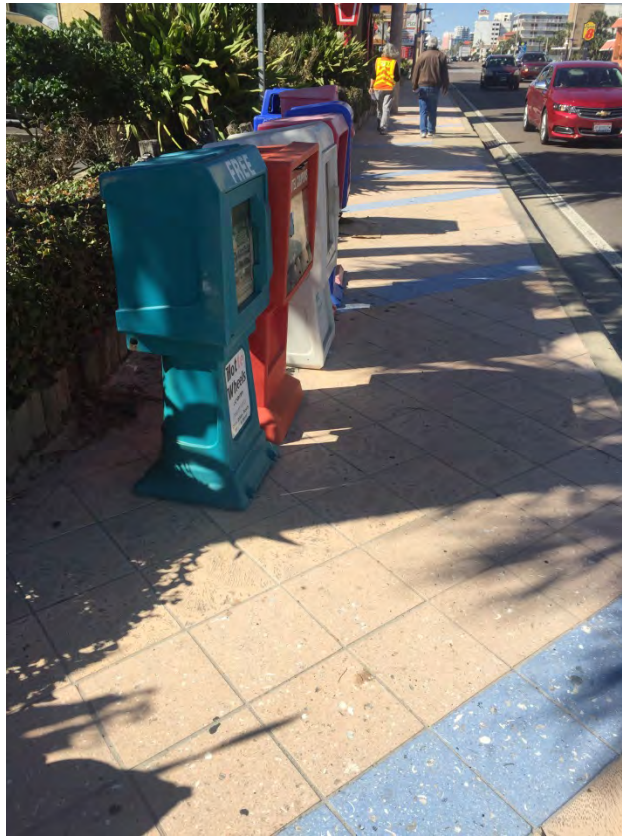
**Figure 57**

**Issue #24: Sidewalk Clutter**

There was one location on the western sidewalk where newspaper/magazine stands are located within the sidewalk. The sidewalk is eight feet wide in the north section, but the stands reduce the effective sidewalk width to 3 to 5 feet as shown in **Figure 57**.

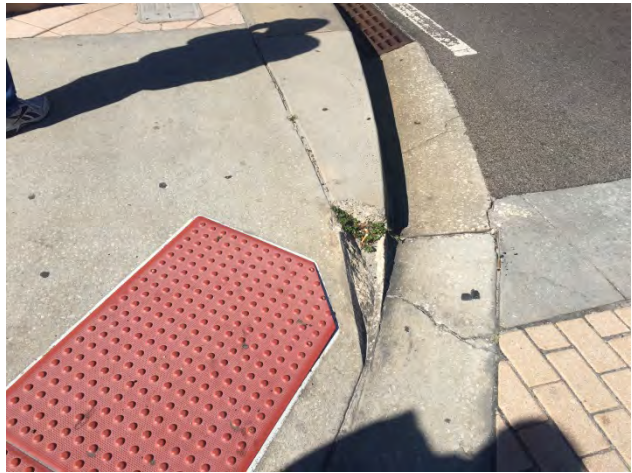
Figure 59

- No pedestrian crossing signage is provided on the uncontrolled intersection approaches as illustrated in **Figure 58**. Vehicular yield compliance was observed to be low in the field.
- There are trip hazards on the northwest and northeast corners. There is a broken curb in the northwest corner and a utility cover that is not flush with the curb ramp on the northeast corner (shown in **Figure 59** and **Figure 60**, respectively).
- Pedestrian-level lighting is present on each corner with the exception of the northeast corner and there is a street light on the southwest corner. During the nighttime review, the northeast corner appeared to be darker than the rest of the intersection. **Figure 61** illustrates the lighting at the northeast corner looking towards the southwest corner.

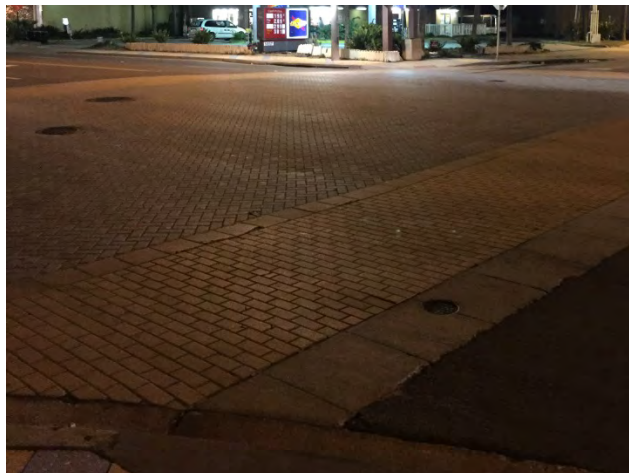
Figure 61

- As described in **Issue #18**, there is no retro-reflectivity at the crosswalk markings, making it difficult to see the crosswalks at night (see **Figure 61**).

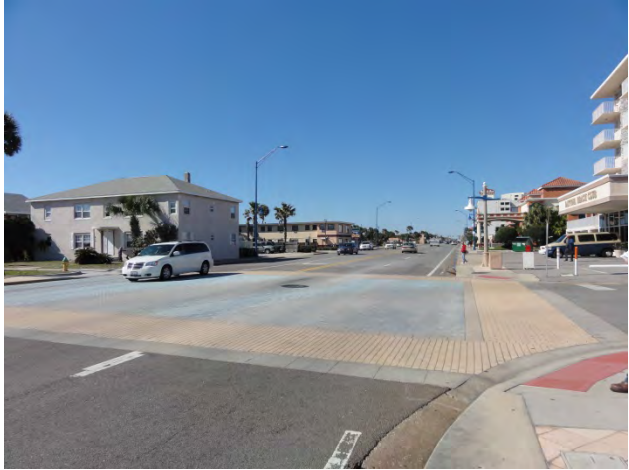
**Figure 62**

- No pedestrian crossing signage is provided at the intersection as illustrated in **Figure 62**.
- As described in **Issue #18**, there is no retro-reflectivity at the crosswalk markings, making it difficult to see the crosswalks at night (see **Figure 63**).

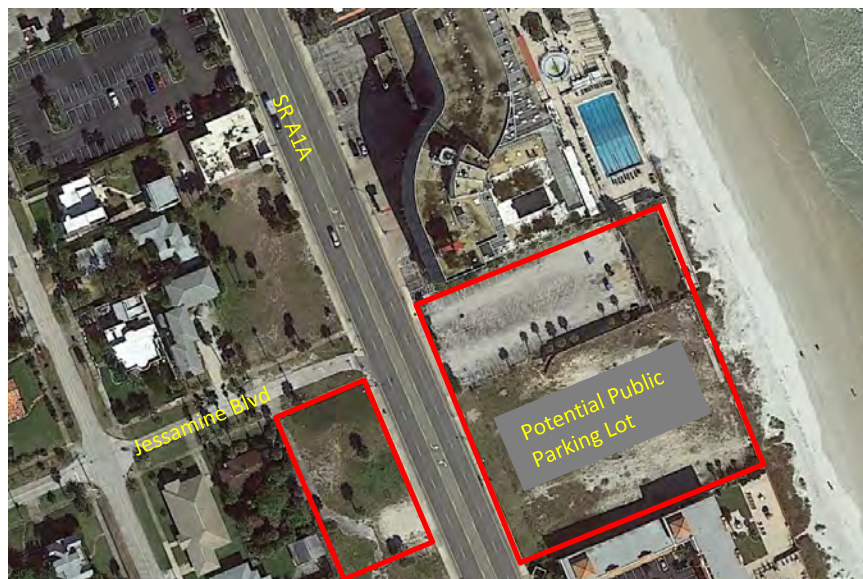
Figure 65

The Desert Inn (located on the northeast corner of the intersection of SR A1A and Jessamine Boulevard), is being rehabilitated and will become a Westin Hotel. The new hotel plans to include an off-site overflow parking lot on the southwest corner of the intersection (shown in **Figure 65**). A public parking lot is planned for the southeast corner of the intersection (also illustrated in **Figure 65**).

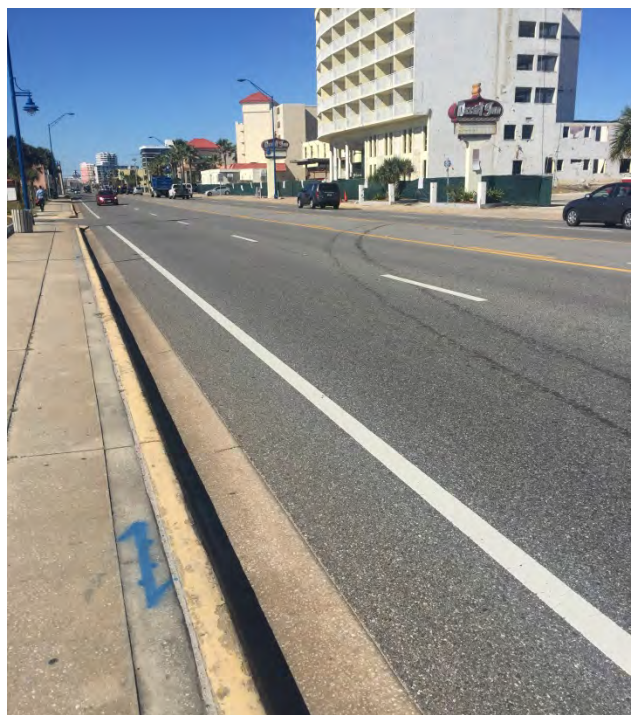
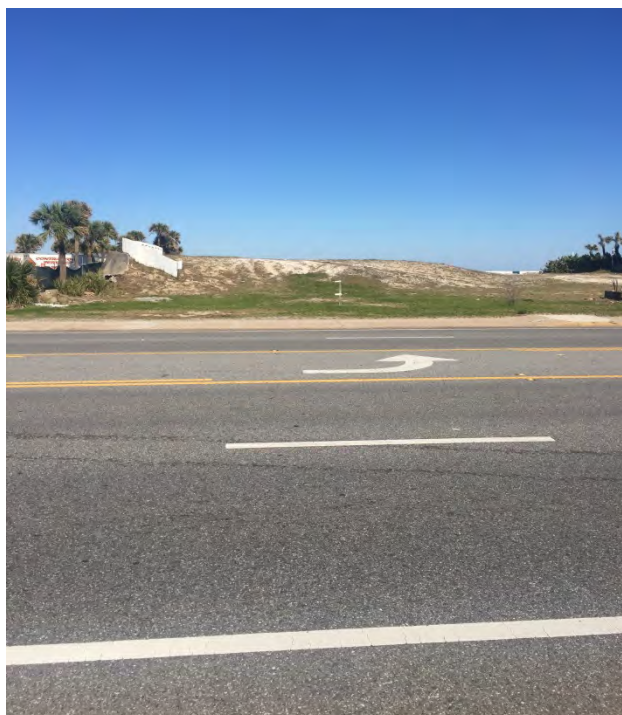
Currently there are no marked crosswalks at the intersections. **Figure 66** and **Figure 67** show the existing cross section of SR A1A in the vicinity of the intersection. Two transit stops are located near the intersection (northeast and southwest corners). One fatal pedestrian crash and one injury pedestrian crash were reported within the vicinity of Jessamine Boulevard. Both occurred at night and involved pedestrians crossing SR A1A.

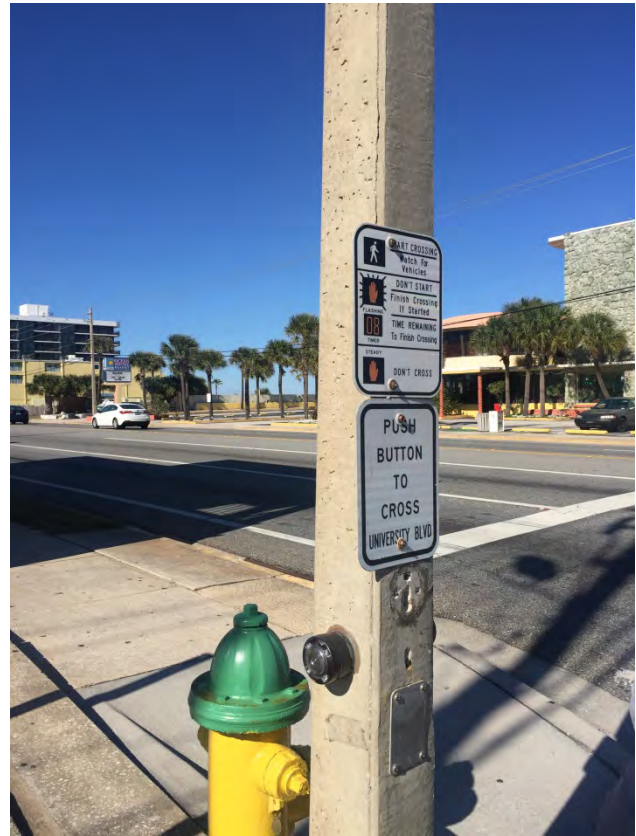
Figure 69

- The span wire pole in the southwest corner is missing a pedestrian push button sign indicating to push the button to cross Atlantic Avenue (shown in **Figure 68**).
- The push button and push button signage on the span wire pole located on the northwest corner is not on the same side of pole as depicted in **Figure 69**.
- Parts of the detectable warning surface on the southeast corner are missing (**Figure 70**).

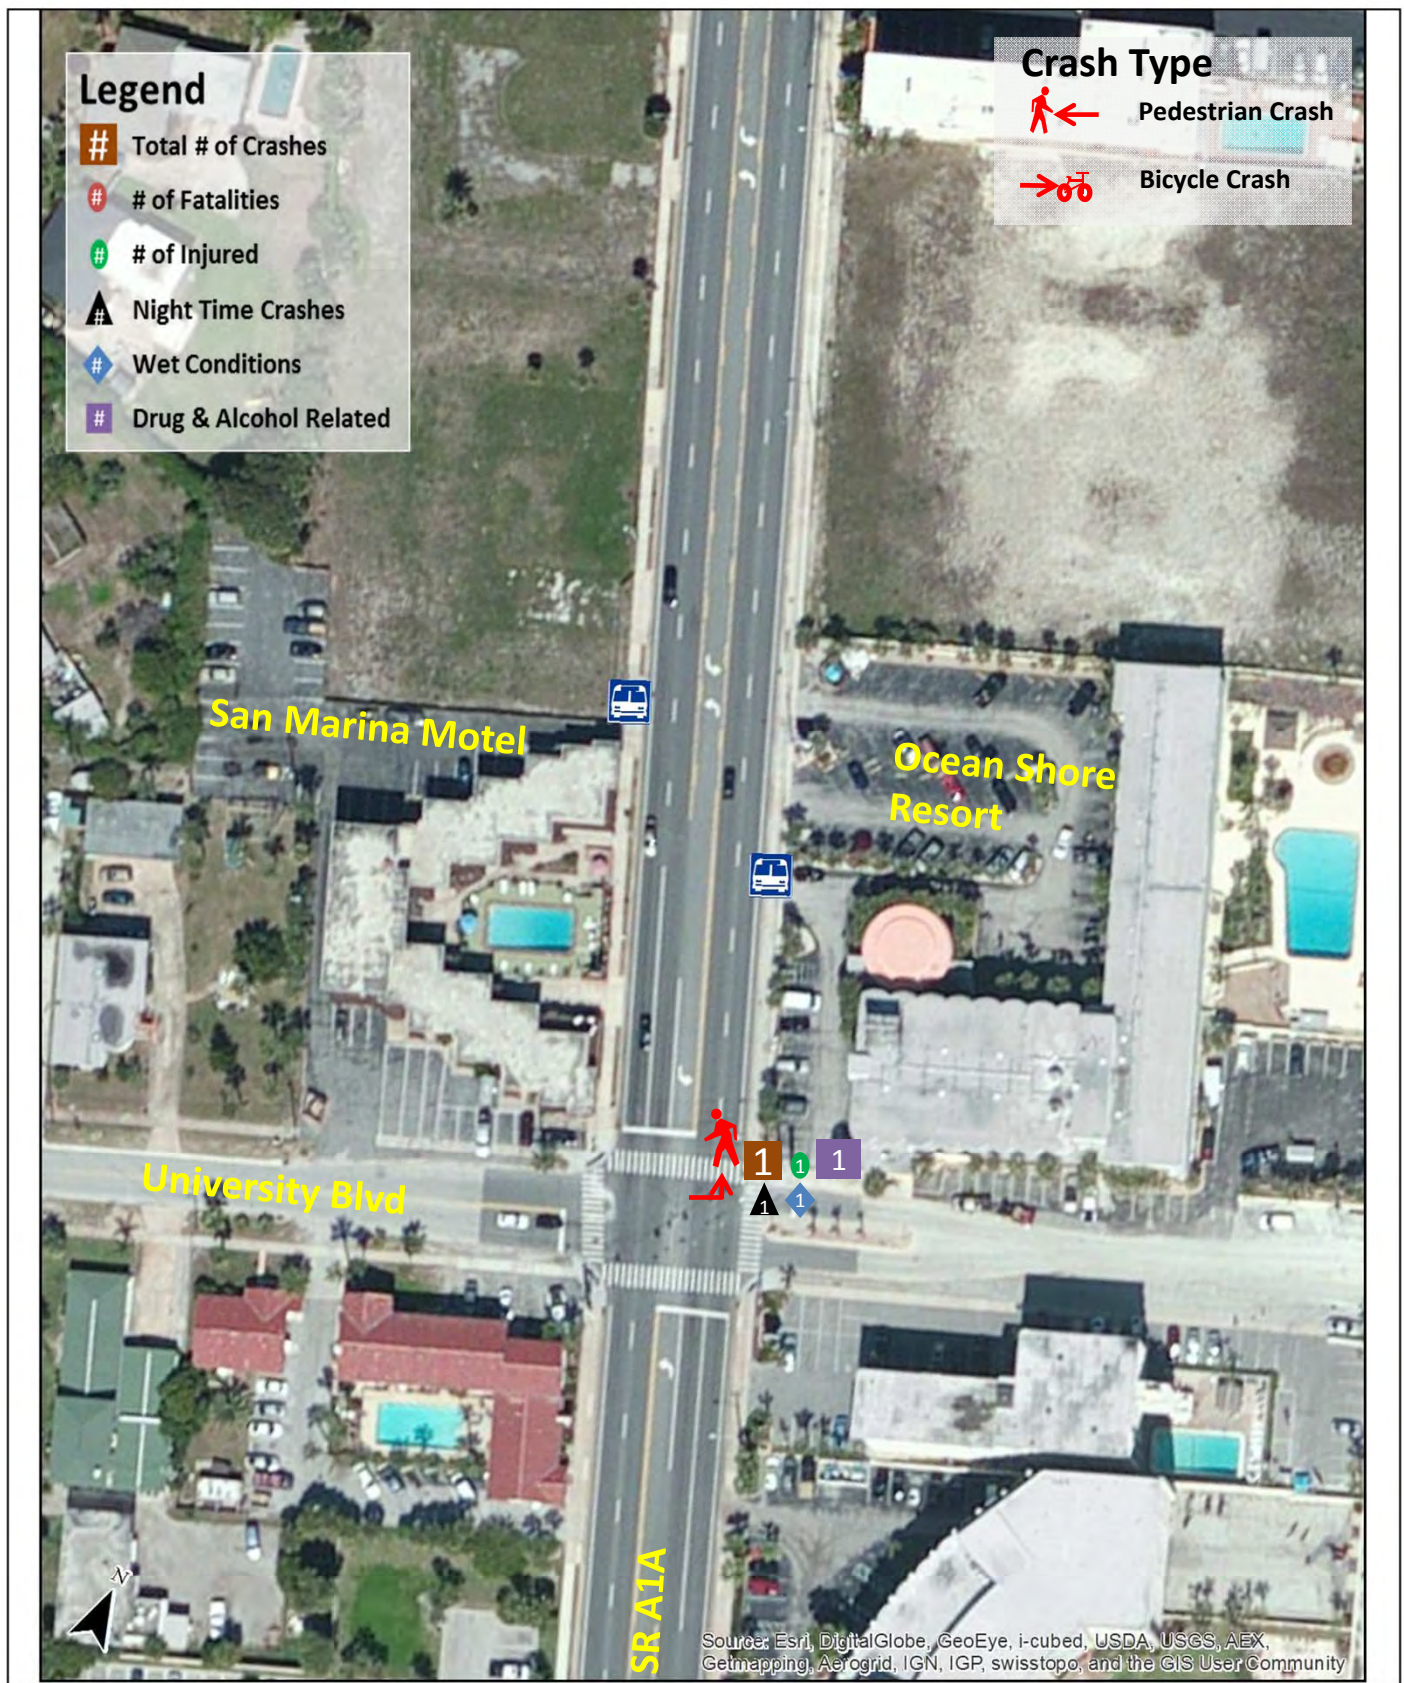
Figure  
10

SR/CR A1A Pedestrian Safety & Mobility Study  
Collision Diagram (2009 – 2014)  
Location C North: Jessamine Blvd. to University Blvd.
