# SR/CR A1A PEDESTRIAN SAFETY & MOBILITY STUDY

## PEDESTRIAN / BICYCLE SAFETY REVIEW

Focus Area D / SR A1A from Plaza Boulevard to Rockefeller Drive (Daytona Beach/Ormond Beach)

October 2016

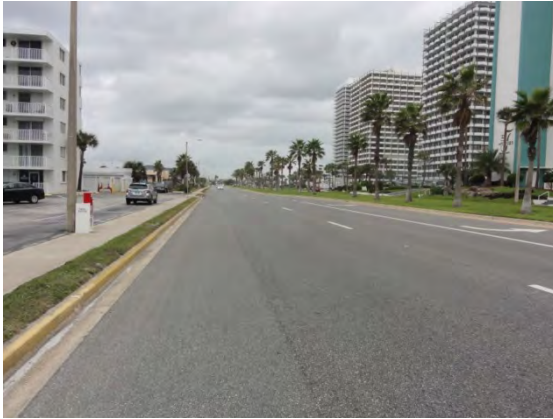
Figure 2

SR A1A is a four-lane divided cross section from Plaza Boulevard to Milsap Road. The outside lanes in the northbound and southbound directions are approximately 20-21 feet in width as illustrated in **Figure 2**. This outside width includes intermittent areas marked as parking or loading zones. **Figure 3** shows an example of a loading zone in the southbound outside lane to the south of Milsap Road. There are no marked bicycle lanes along SR A1A within this four-lane divided cross section.

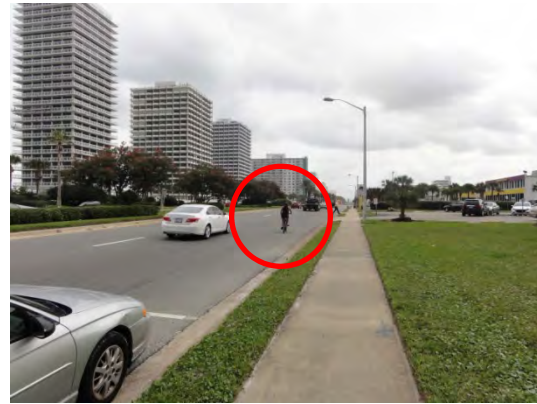
Figure 3

Other than the markings for the parking/loading zones, there are no pavement markings defining the outside lane in this section. The combination of extra pavement width and a lack of pavement markings create an issue for bicyclists and drivers traveling along SR A1A. Without pavement markings, it is unclear who should be using the extra width, which creates conflicts between the road users. The study team observed drivers using the extra width as a de facto right-turn lane as well as bicyclists using the extra width as a bicycle lane (see **Figure 3**).

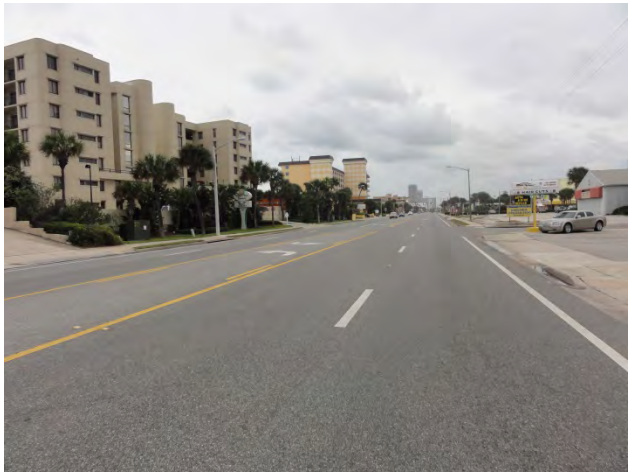
Figure 4

A 12-foot center two-way left-turn lane (TWLTL) is provided along SR A1A from Milsap Road to Rockefeller Drive (illustrated in **Figure 4**). The center TWLTL ends approximately 0.35 miles north of the study limits (Rockefeller Drive) and changes back to a four-lane divided cross section. The center TWLTL is an area of potential conflict between pedestrians/bicyclist and vehicles as pedestrians were observed using the center TWLTL as a refuge to cross SR A1A as shown in **Figure 5**. Conflicts arise when drivers utilize the center TWLTL while pedestrians or bicyclists are using it as a crossing refuge.

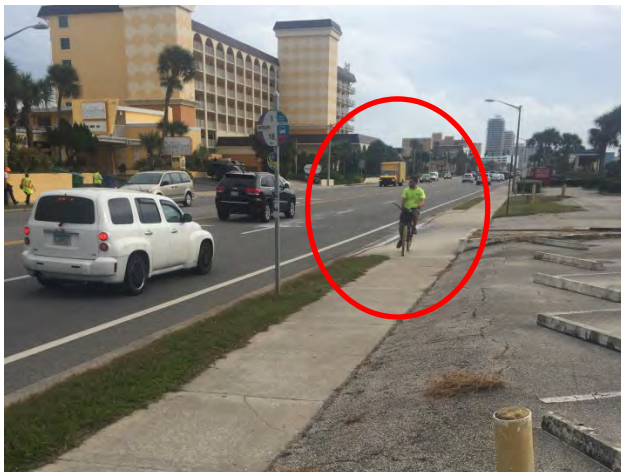
Figure 8

Half of the bicycle crashes involved bicyclists riding along the sidewalk and against the flow of traffic (example shown in **Figure 6** and **Figure 8**). In the field, some bicyclists were observed riding along the roadway, but most bicyclists were observed riding along the sidewalks. Examples of the observed bicycle activity are illustrated in **Figure 6** through **Figure 9**. As described in **Issue #1: Four-Lane Divided Section** and **Issue #2: Five-Lane Undivided Section**, marked bicycle lanes are not provided in either cross section. The bicycle crash history and observations from the field suggest that bicyclists prefer riding on the sidewalks rather than in the roadway alongside vehicles traveling around 35 mph.

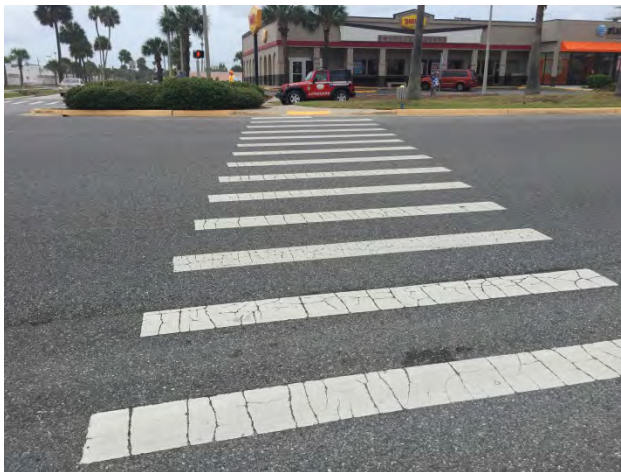
Figure 12

Crosswalk markings at the three signalized intersections are beginning to wear (illustrated in **Figure 12** and **Figure 13**).

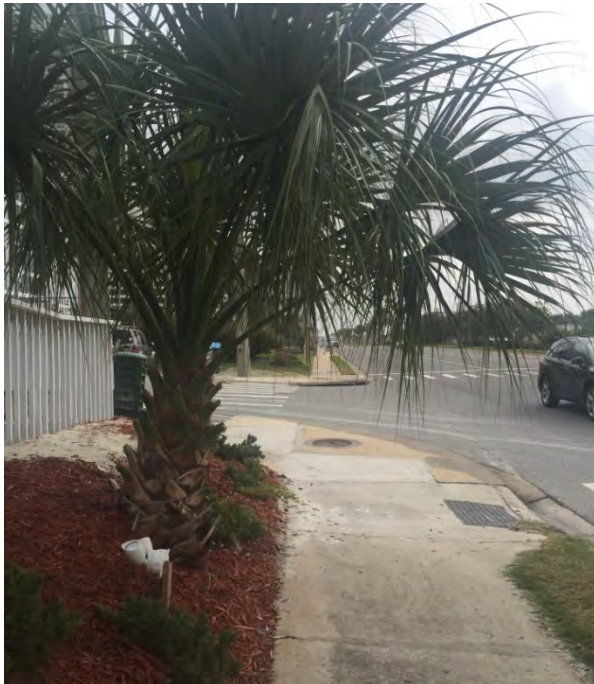
Figure 18

There were several locations along the corridor that had hedges, bushes, or trees have overgrown onto the sidewalks. Examples of some of these locations are shown in **Figure 18** and **Figure 19**. In some cases, the landscaping obstructs sight distance, while other locations include signage blocked by landscaping (shown in **Figure 20** and **Figure 21**). The signage is blocked on the east side of SR A1A at Ormond Shores Drive (**Figure 20**) and on the east side of SR A1A at River Beach Drive (**Figure 21**).

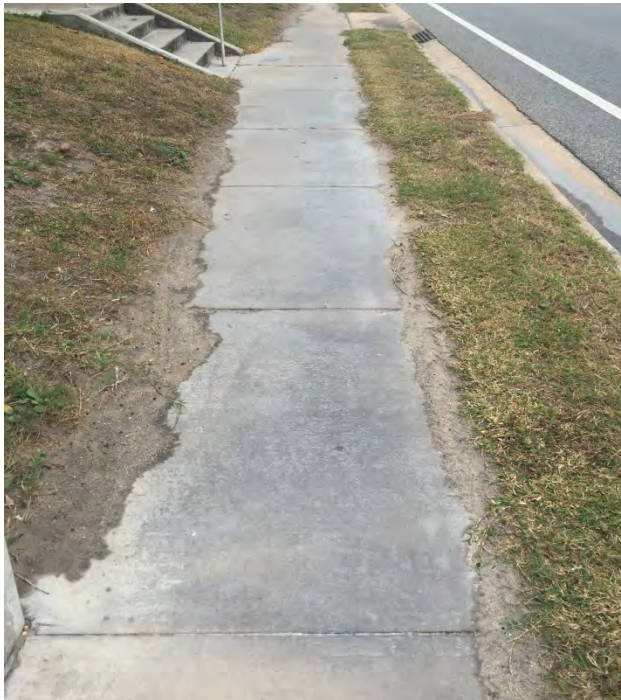
Figure 22

There were instances where sand had washed onto the sidewalk, reducing the effective walking width of the sidewalk (shown in **Figure 22** and **Figure 23**). This was a very common occurrence on the east side walk as the beach is close by. There were also two locations where newspaper/magazine stands are located within the sidewalk. These locations were both on the west sidewalk along SR A1A just north of the McDonald's and south of Milsap Road. These are shown in **Figure 24** and **Figure 25**, respectively. The sidewalk is five feet wide along the corridor so the sand/debris and newspaper/magazine stands reduce the effective sidewalk width by 2 to 3 feet.

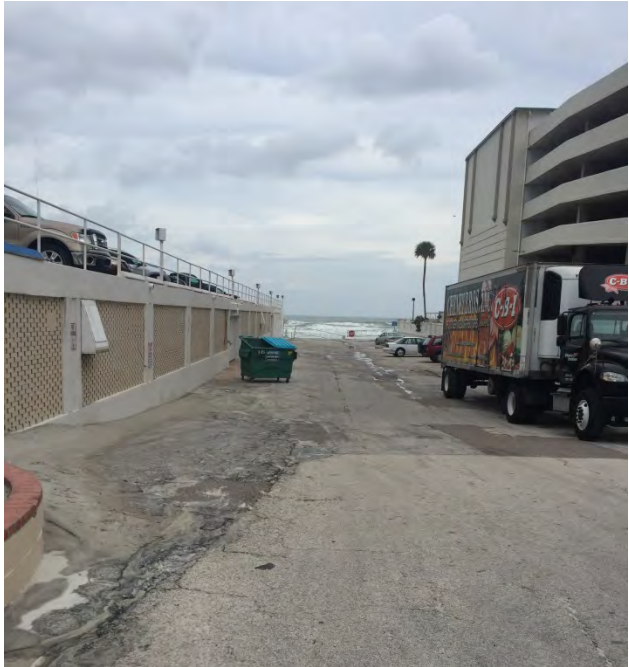
Figure 26

Many of these locations do not include pedestrian facilities as illustrated in **Figure 26** and **Figure 27**. The beach accesses often do not accommodate a way to cross SR A1A in the vicinity. The Cardinal Drive beach access includes sidewalks on the north side of the access and the Milsap Drive beach access includes sidewalks on the south side of the access as part of the Andy Romano Beachfront Park. Some of the beach accesses provide parking spaces, while others do not.

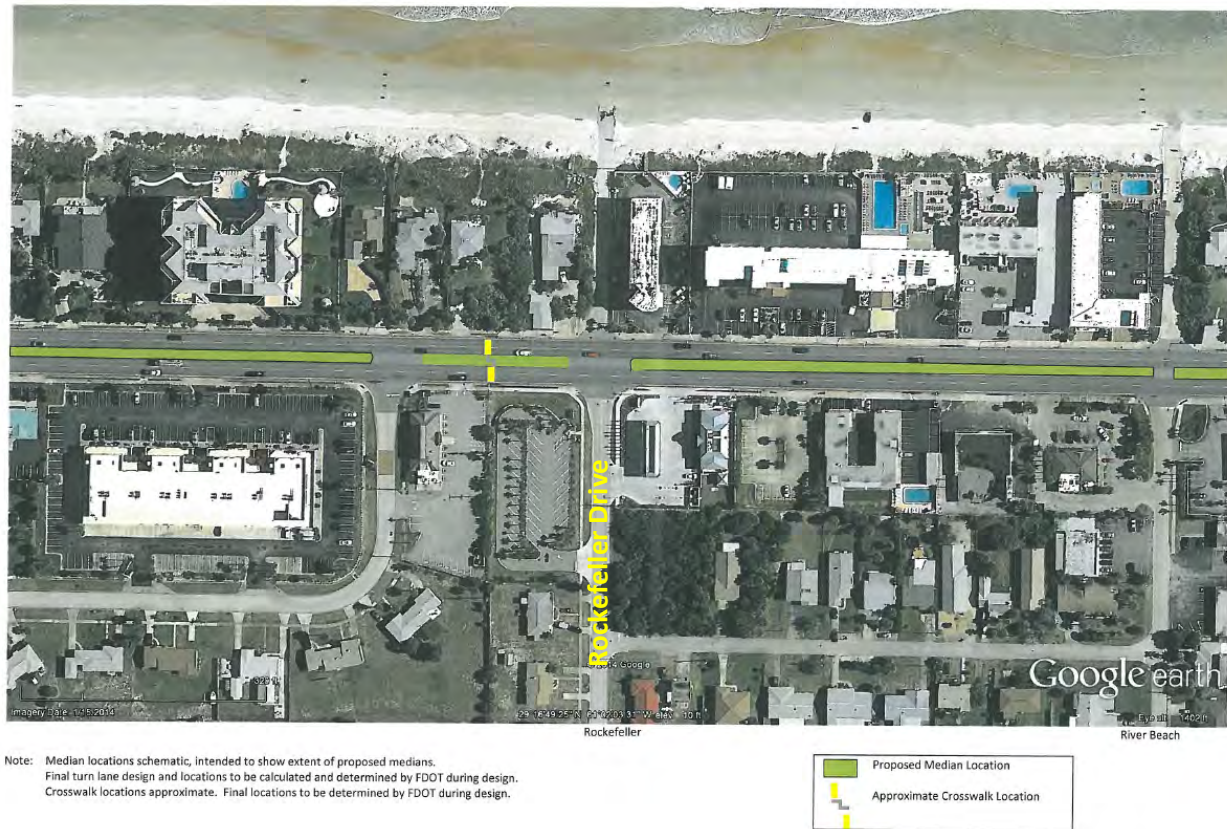
The City of Ormond Beach has identified some potential locations along the SR A1A corridor where medians could be installed to provide a z-crossing median refuge for pedestrians along with marked mid-block crosswalks. **Figure 29** illustrates a potential location for a mid-block to the north of Rockefeller Drive that connects the off-beach parking lot to the beach access. The preliminary locations identified by the City are included in **Appendix B**. Specific mid-block locations identified for further consideration are summarized later in this document in **Issue #34: Marked Crosswalk at River Beach Drive** and **Issue #36: Potential Marked Crosswalk at Rockefeller Drive**.

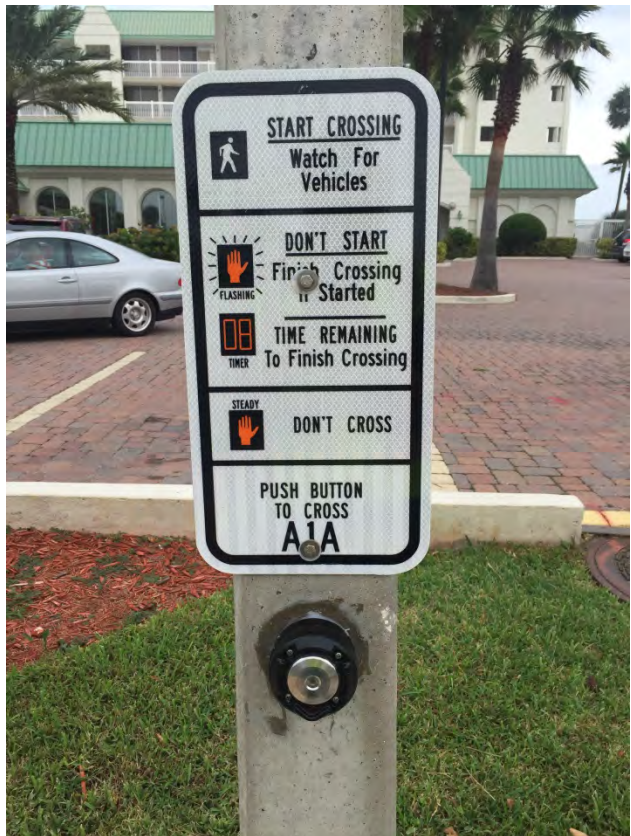
Figure 32

Pedestrian countdown signals and pedestrian pushbuttons are provided at each signalized location. A variety of pedestrian pushbuttons along the corridor is shown in **Figure 32** and **Figure 33**. However, none of the signals are equipped with accessible pedestrian signals (APS). FDOT reported official requests have been made to install APS at the Plaza Boulevard and Harvard Drive intersections. Installing APS at the signalized intersections could improve crossing performance for visually impaired pedestrians.

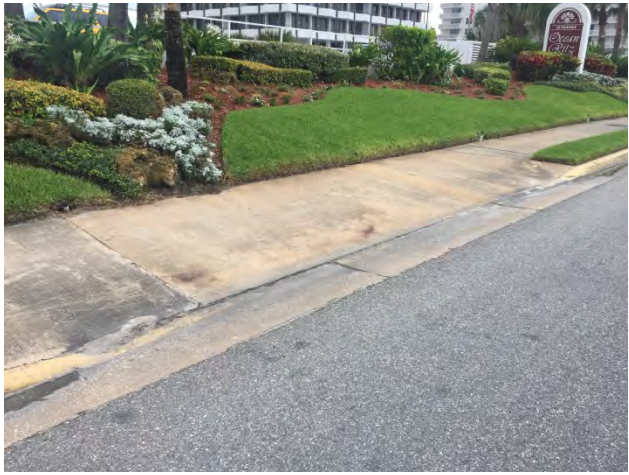
**Figure 34**

Three locations along the east side of the SR A1A corridor have abandoned driveway cuts:

- Near the Ocean Ritz (**Figure 34**)
- Near Benjamin Drive (**Figure 35**)
- Approximately 250 feet north of Wren Road (**Figure 36**)

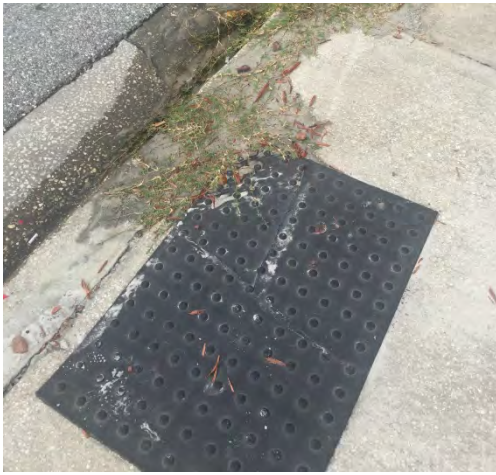
**Figure 46**

Sand and debris have built up on the detectable warning surfaces located on the northeast and southeast corners of the intersection (**Figure 46** and **Figure 47**, respectively).

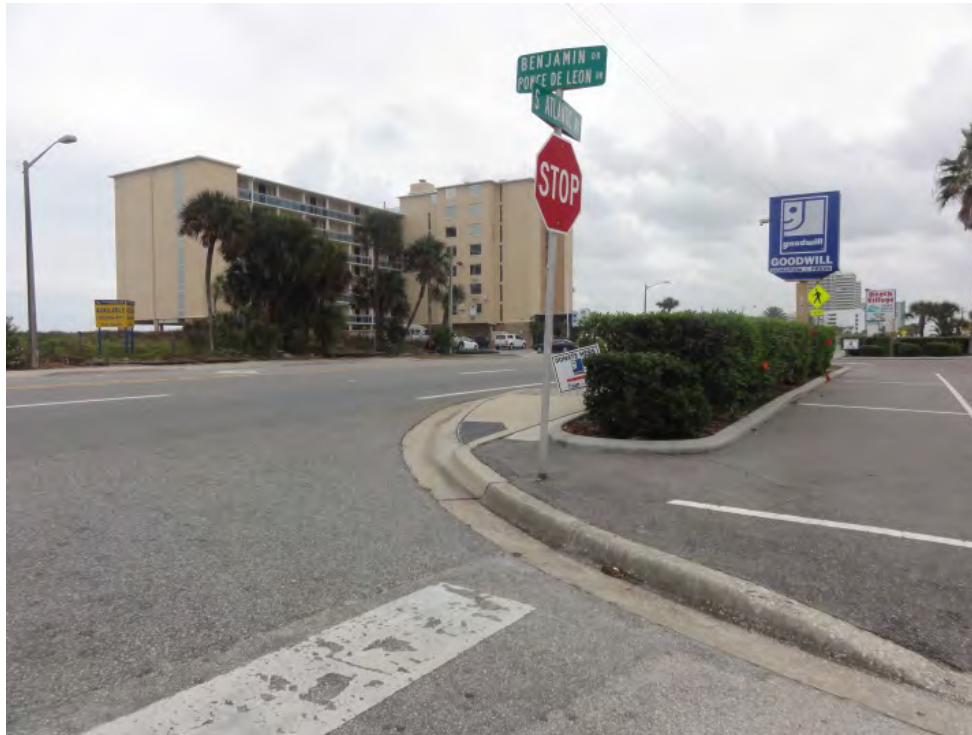
**Figure 53**

**Issue #25: Benjamin Drive Intersection Sight Distance**

The existing hedges on the southwest corner restrict the available sight distance for a vehicle attempting an eastbound left-turn (shown in **Figure 53**). Vehicles have to pull past the stop bar and into the effective crossing area used by pedestrians and bicyclists (no marked crosswalk present) to see past the landscaping.

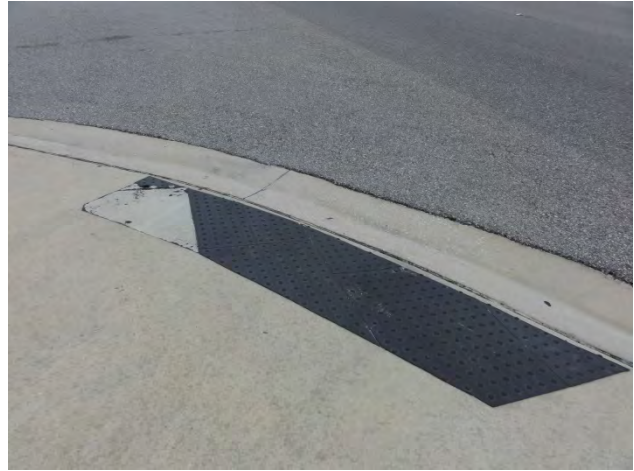
**Issue #26: Wren Road Missing Stop Sign and Detectable Warning Surface**

No stop sign or street name signage is provided along the eastbound approach at the intersection of Wren Road. This is illustrated in **Figure 54**. Part of the detectable warning surface on the southwest corner shown in **Figure 55** is missing.

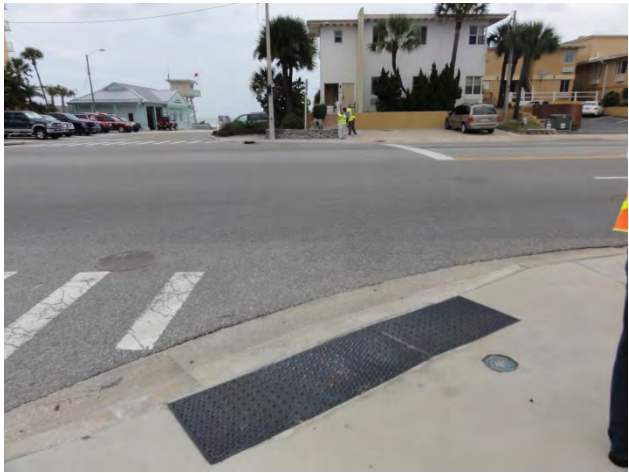
Figure 56

- No crosswalk is provided on the south side of the intersection (**Figure 56**).
- The pedestrian push button on the southwest corner is greater than the 10' maximum distance to the curb ramp (**Figure 57**), as defined in section 4E.08 of the 2009 MUTCD.
- As illustrated in **Figure 58**, a continuous flat surface surrounding the pedestrian push button is not provided on the northwest corner of the intersection. According to section 4E.08 of the 2009 MUTCD, the push button should be located at a location unobstructed and adjacent to a level all-weather surface to provide access to a wheelchair.
- There is a utility box within the detectable warning surface on the southeast corner of the intersection. The utility box shown in **Figure 59** is not flush with the concrete curb ramp or detectable warning surface. This poses a potential trip hazard.

FDOT has identified this location for a signal upgrade which is planned to include a conversion from strain wire to mast arms, basic ADA upgrades, and implementation of APS. These upgrades would address the issues illustrated in **Figure 56** through **Figure 59**. It is likely that FDOT will conduct the signal design at this location.

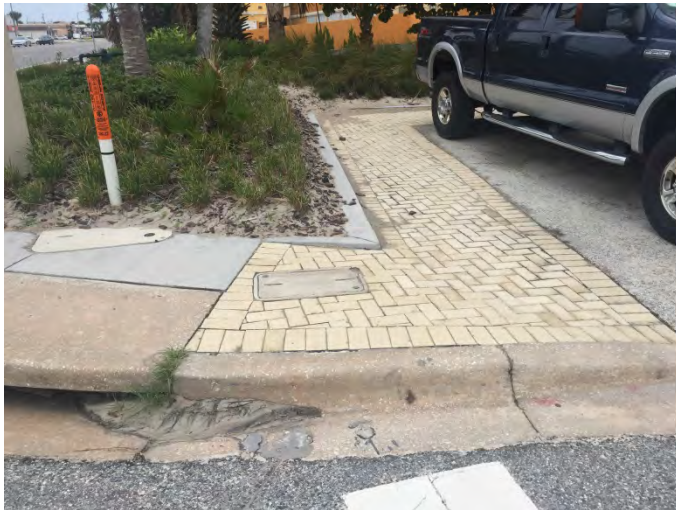
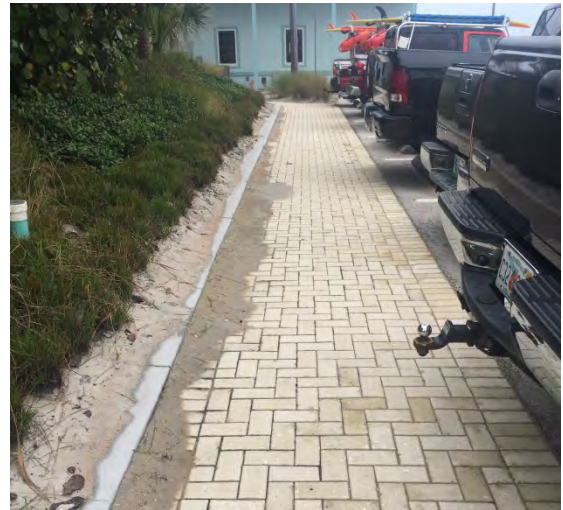
**Issue #29: Beach Access**

The east leg of the Cardinal Drive currently serves as a beach access. There is a sidewalk provided on the north side of the beach access as shown in **Figure 61** and **Figure 62**. No pedestrian facilities are provided on the south side of the beach access. There were no reported crashes on the south side of the intersection during the study period; however, one pedestrian crash occurred within the crosswalk on the north leg and another pedestrian crash occurred to the north of the marked crosswalk.

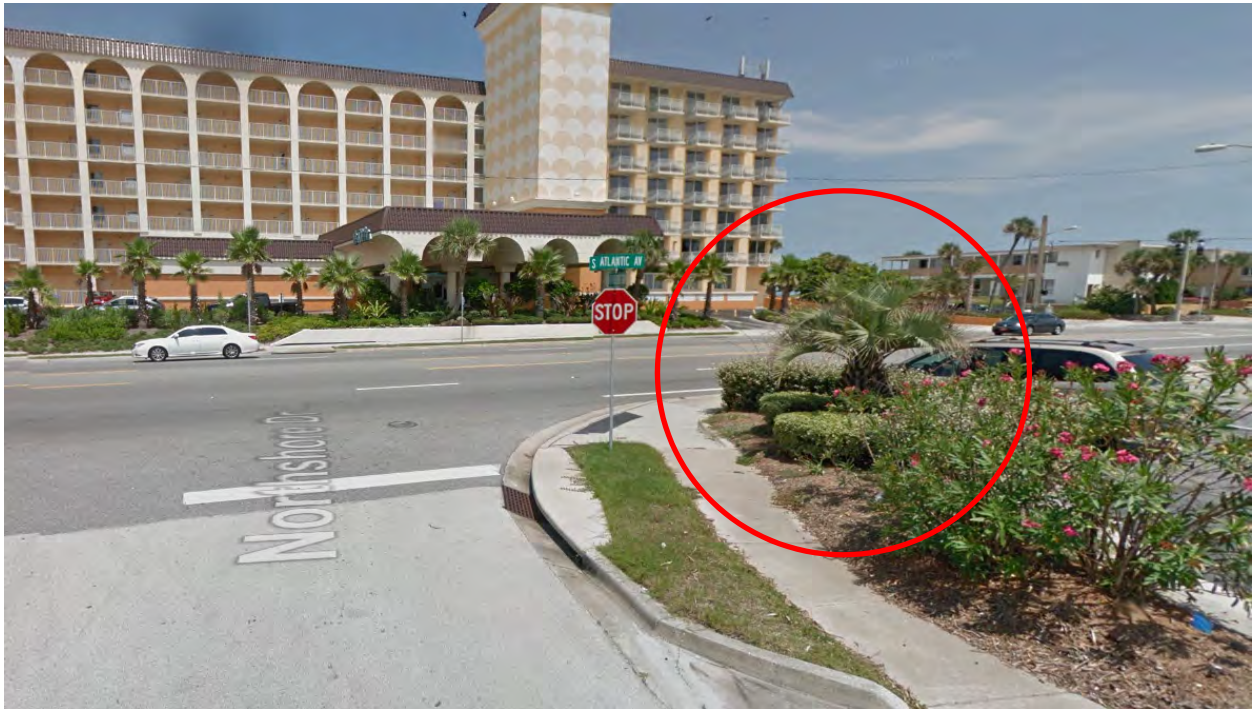
**Figure 64**

**Issue #30: Northshore Drive Intersection Sight Distance**

Consider trimming the landscaping back and consider conducting a sight distance evaluation to determine the available sight distance at the intersection.

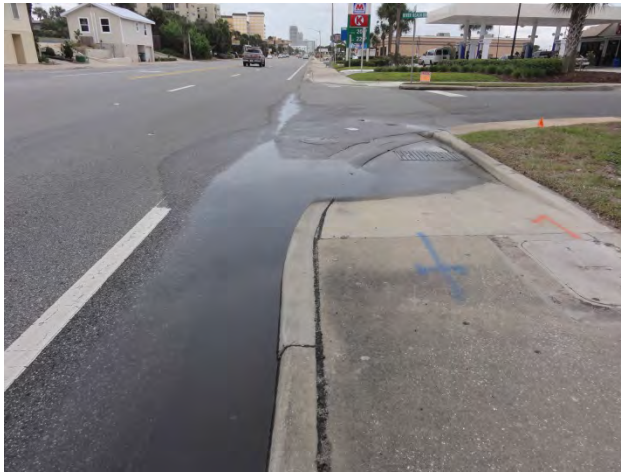
Water ponds onto the curb ramp and detectable warning surface on the north side of the eastbound River Beach Drive approach (northwest corner of the River Beach Drive intersection). This issue is displayed in **Figure 67** and **Figure 68**. This poses an issue to pedestrians, bicyclists, and vehicles as they cross the approach or make a southbound right-turn maneuver. There is a curb inlet around the corner, directly adjacent to the curb ramp; however, it appears that not all of the water is flowing to the inlet.

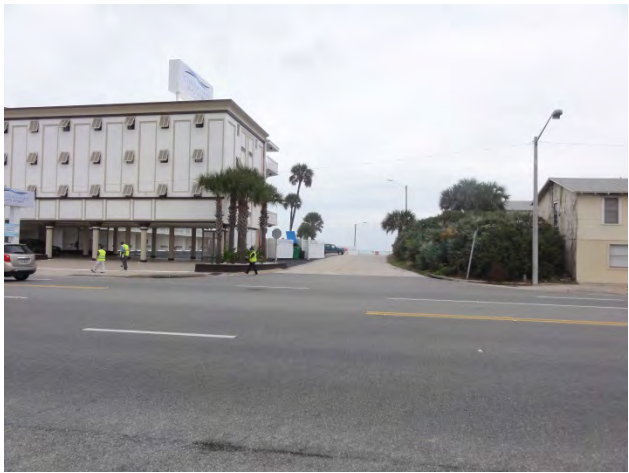
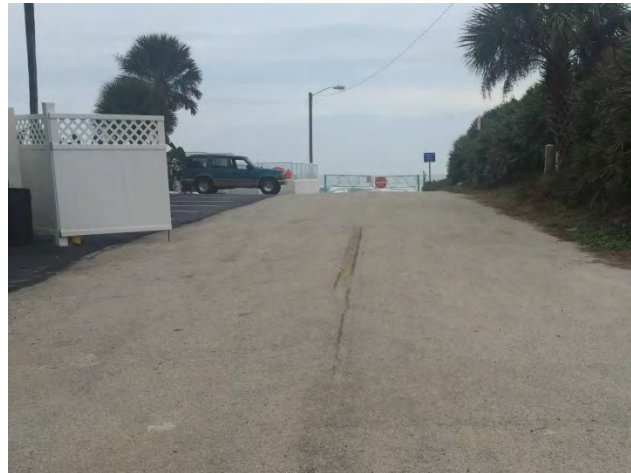
**Issue #34: Marked Crosswalk at River Beach Drive**

As mentioned in **Issue #8: Pedestrian Beach Access** and **Issue #9: Potential Mid-Block Crossings**, locations with beach access should be considered for a marked crosswalk. There are residential neighborhoods down River Beach Drive, west of SR A1A, and the beach serves as an attractive destination for pedestrians and bicyclists. No marked crosswalk is provided within the vicinity of the beach access and no pedestrian facilities are provided along the beach access (shown in **Figure 69** and **Figure 70**, respectively). The crash history indicates that there were two mid-block pedestrian crashes in the vicinity of this beach access.

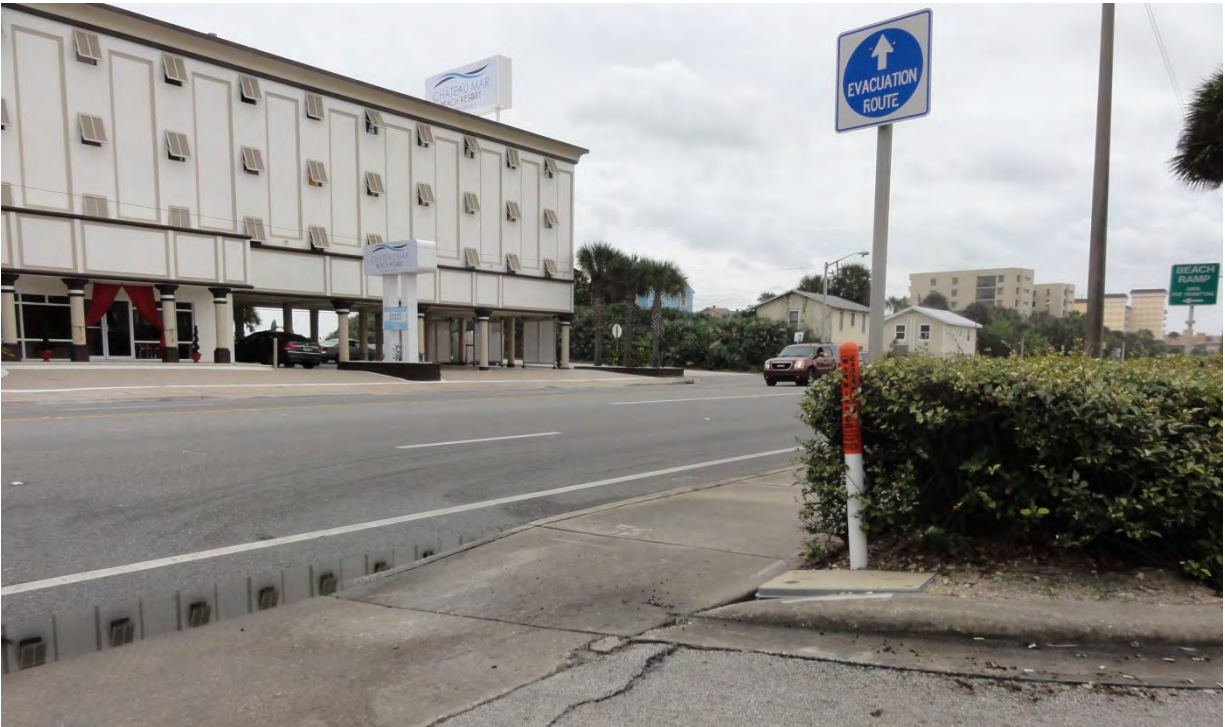
**Figure 71**

**Issue #35: Intersection Sight Distance**

The existing hedges on the southwest corner restrict the available sight distance for eastbound vehicles attempting to make a left-turn movement (illustrated in **Figure 71**). Vehicles have to pull into the sidewalk to see past the landscaping.

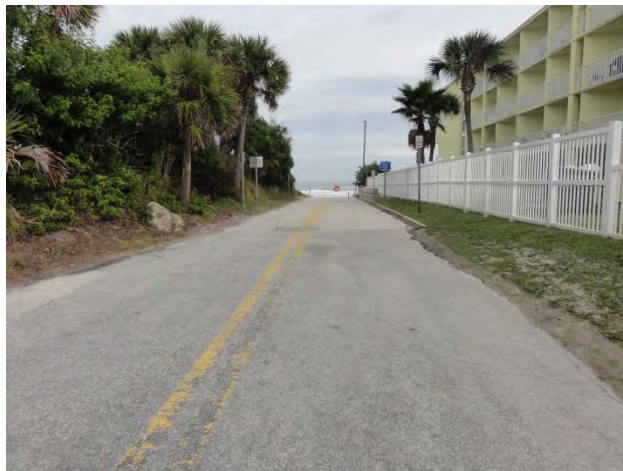
Figure 73

The east leg of the Rockefeller Drive intersection serves as a beach access. An off beach public parking lot is located on the northwest corner of the intersection (see **Figure 72**). This off beach public parking lot was constructed by Volusia County to facilitate the use of the beach access and a sidewalk is provided connecting to the sidewalk on the west side of SR A1A. However, no marked crosswalks are provided in the vicinity of the off beach parking lot and beach access. Similar to the majority of the beach accesses reviewed as part of this study, no pedestrian facilities are provided along either side of

the beach access (illustrated in **Figure 73**).
