# SR/CR A1A PEDESTRIAN SAFETY & MOBILITY STUDY

## PEDESTRIAN / BICYCLE SAFETY REVIEW

Focus Area E / Sandcastle Drive to Holland Road (Ormond Beach/Ormond-by-the-Sea)

## **Pedestrian/Bicycle Safety Review Report for Focus Area E: SR A1A from Sandcastle Drive to Holland Road (Ormond Beach/Ormond-by-the-Sea)**

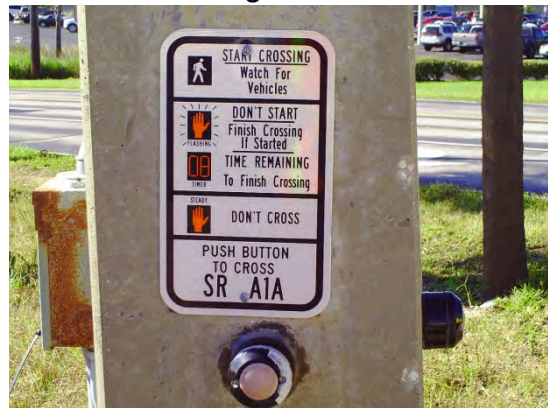
**Figure 28****Description of Issue:**

The sign legend shown in **Figure 28** directs pedestrians to cross SR A1A. The roadway signs provided at the signal indicate SR A1A as Oceanshore Boulevard. The discrepancy may lead to pedestrian confusion about which push button to use.

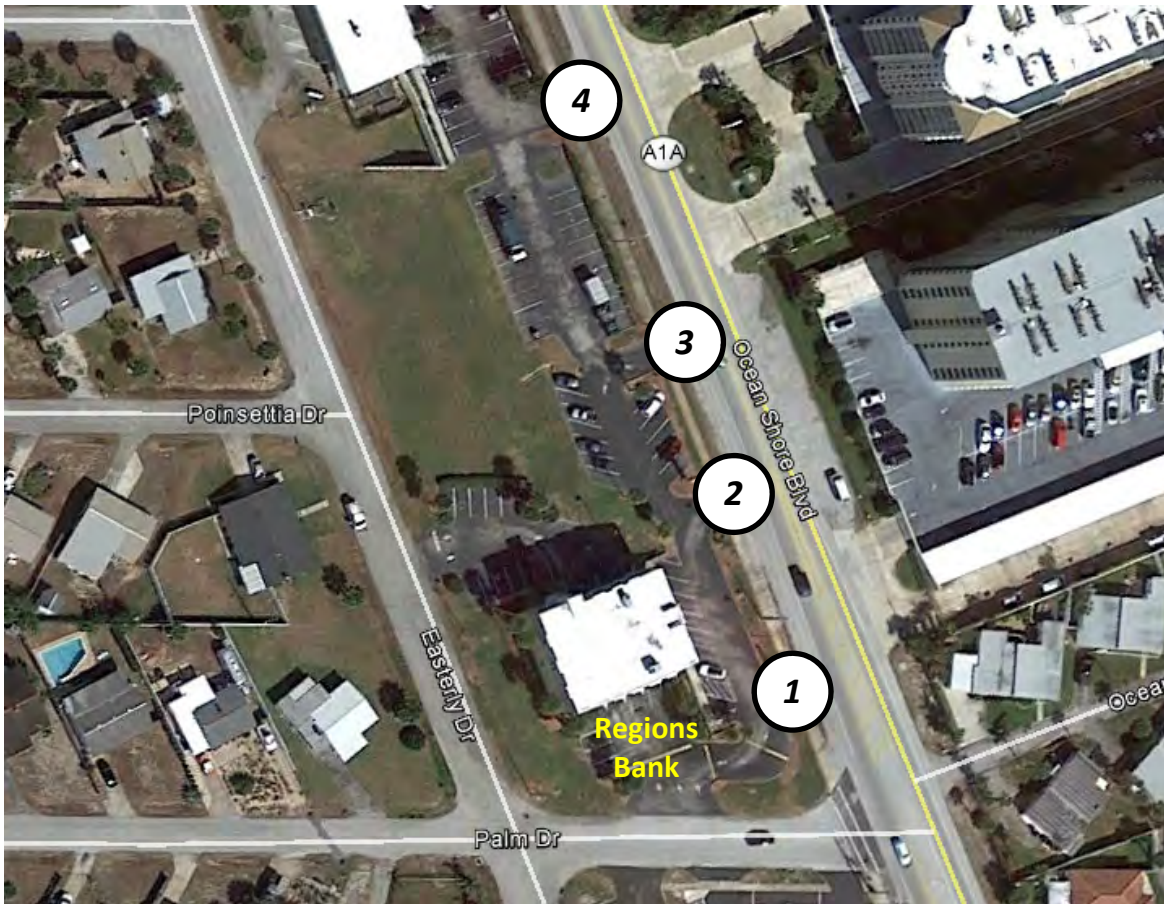
Figure 33

The Regions Bank has three exclusive driveways on SR A1A and shared access to an additional driveway just north of the site, for a total of four access points to SR A1A (see **Figure 33**). The site also has driveways on Palm Drive and Easterly Drive. Driveways are conflict points between pedestrians/bicyclists utilizing the sidewalk and vehicles exiting the property or turning from SR A1A. The higher the number of driveways along a corridor, the higher the potential for crashes between a pedestrian/bicycle utilizing the sidewalk and a vehicle exiting/entering a property.

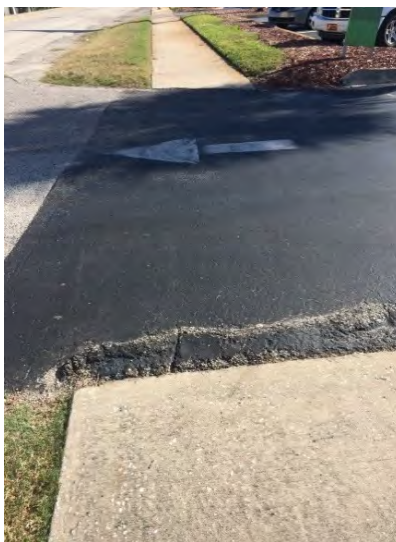
Figure 34

As shown in **Figure 34**, driveway crossings at this location have asphalt mounded up where the sidewalks connect.

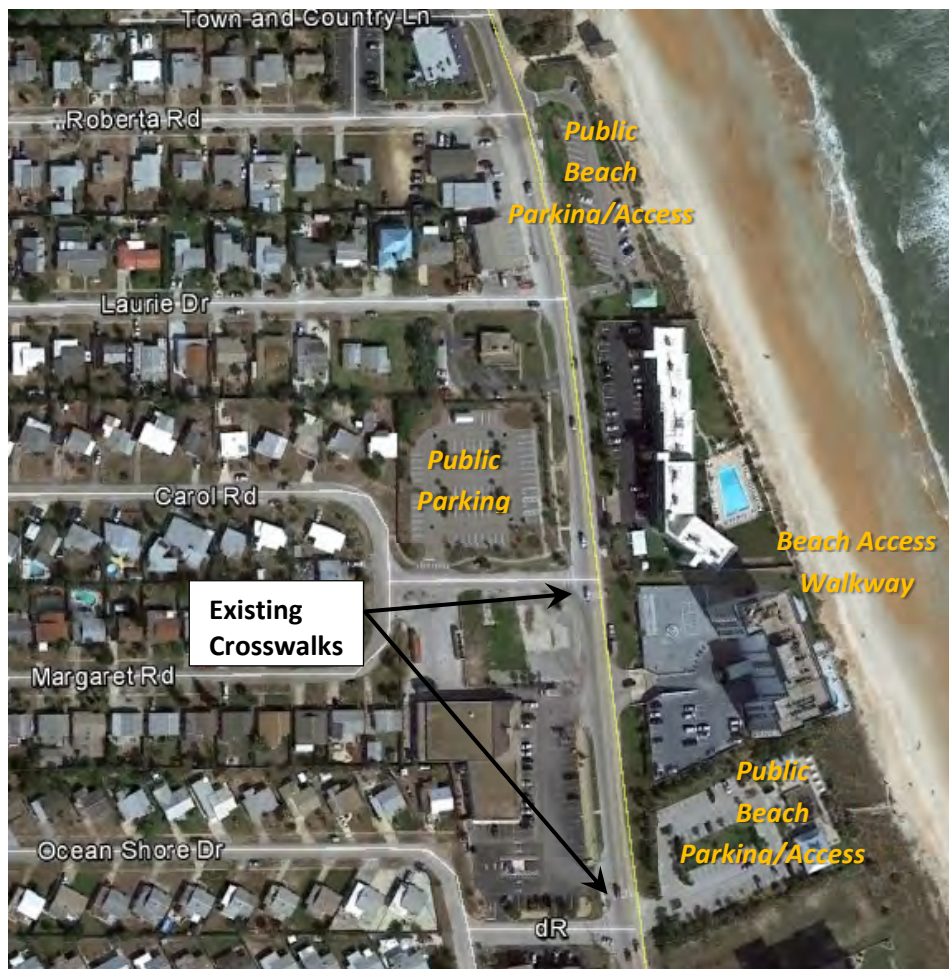
Figure 39

As shown in **Figure 39**, public parking on the west side of SR A1A can serve as overflow parking when the parking areas to the east are full. However, the crosswalks on SR A1A do not connect to sidewalks on the east side of SR A1A.

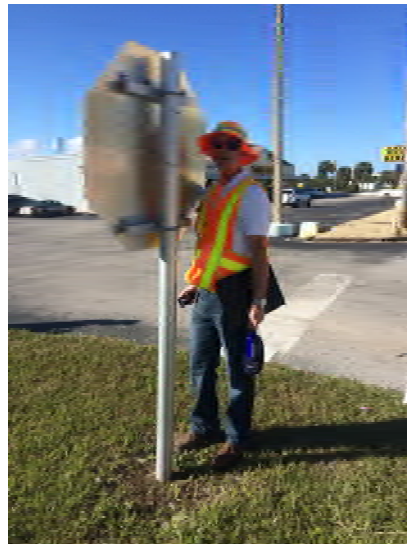
**Figure 42**

The pedestrian crossing signs at the existing crosswalk serving Tom Renick Park are not located at the crosswalk and the STOP sign on the eastbound approach of Rivershore Drive & SR A1A is shorter than standard and potentially blocks motorist view of pedestrians in the crosswalk (see **Figure 42**). The crosswalk markings are also faded.

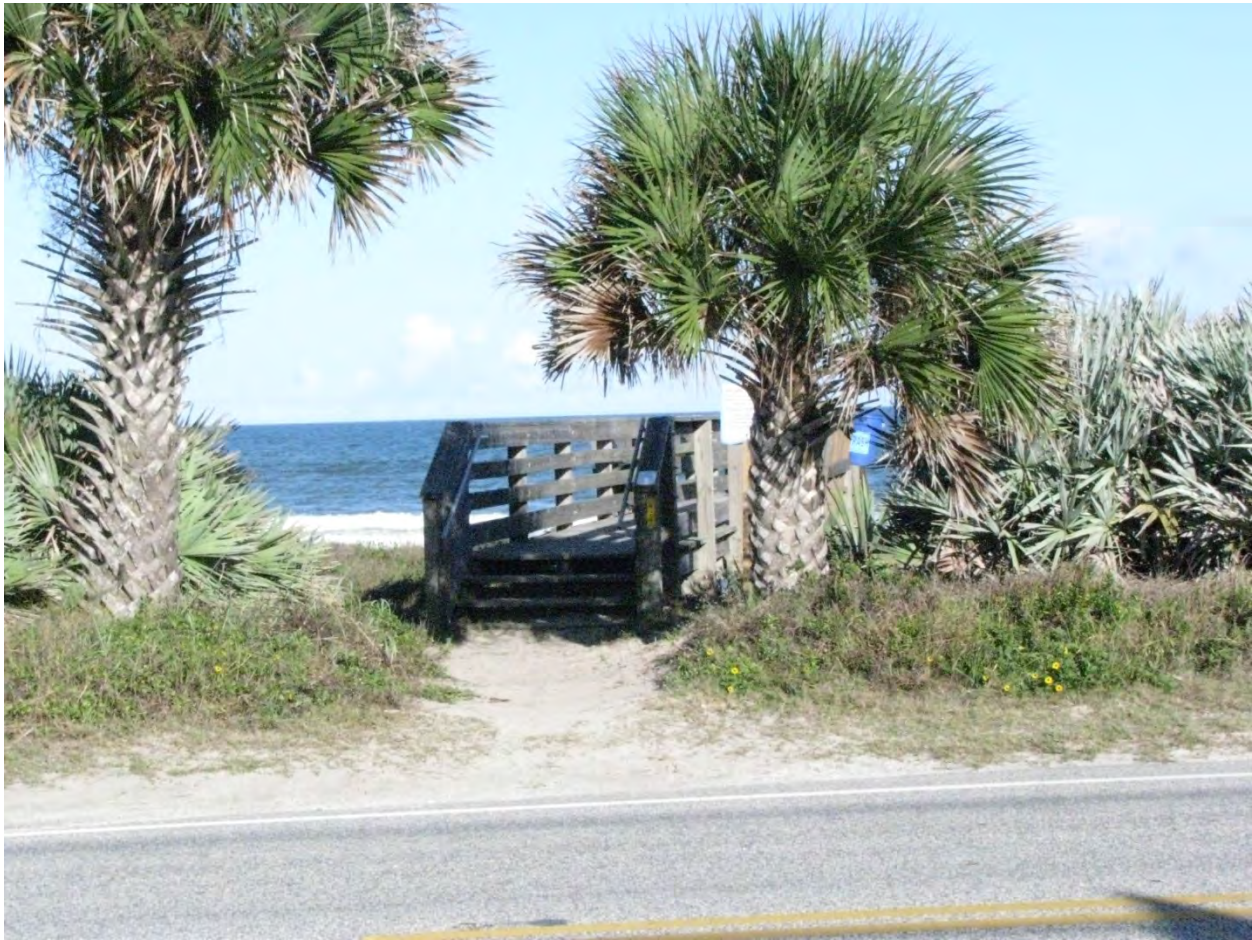
**Figure 45**

A beach crossover is present, but vegetation shields the stairs, obstructing motorist view of pedestrians (Figure 45).
