SR/CR A1A PEDESTRIAN SAFETY & MOBILITY STUDY

PEDESTRIAN / BICYCLE SAFETY REVIEW

Focus Area F / Kathy Drive to Wisteria Drive (Ormond-By-The-Sea)

Pedestrian/Bicycle Safety Review Report for SR A1A from Kathy Drive to Wisteria Drive (Ormond-by-the-Sea)

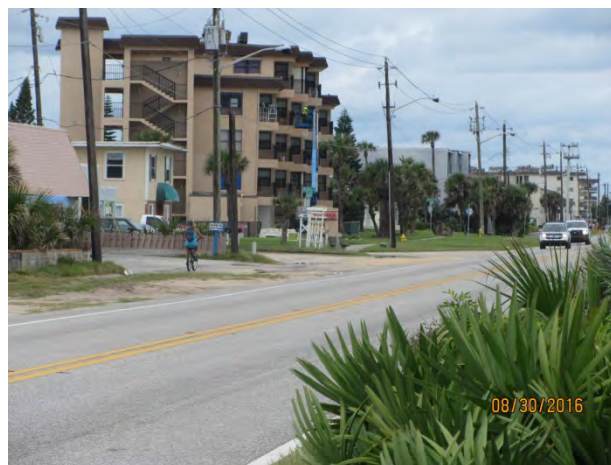
Figure 4

On the west side of the roadway, an approximate 4'-5' shoulder is present along the length of the study limits (**Figure 3**). The study team observed bicyclists riding off the roadway either on the sidewalk or within paved driveways on the west side of SR A1A (**Figure 4**). Two bicycle crashes occurred during the crash analysis period with one bicyclist crossing SR A1A and one being struck at a driveway while traveling on the sidewalk against the flow of traffic.

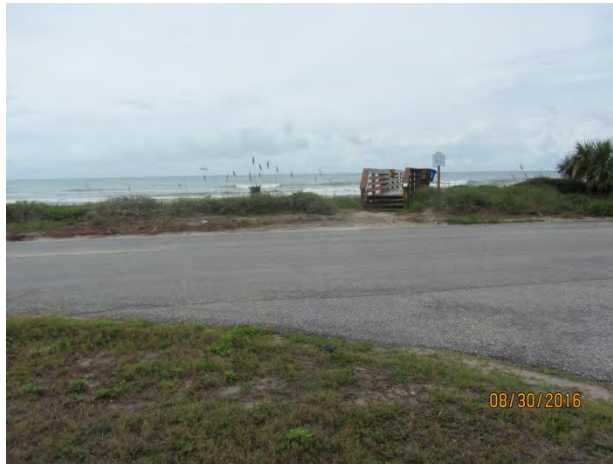
In addition to numerous private beach access points, three public beach access points are located along the study corridor at Kathy Drive, Ocean Breeze Circle, and Sunrise Avenue. The Kathy Drive and Ocean Breeze Circle locations are shown in **Figure 8** and **Figure 9**, respectively. Four of the five pedestrian crashes occurred with a pedestrian crossing SR A1A at or near a beach access point with one occurring near Kathy Drive, one near Berkeley Road, and two near Wisteria Drive. Even though the roadway is only two lanes wide, the 45 MPH speed limit may make it difficult for pedestrians to judge gaps when attempting to cross the roadway (**Figure 10**).

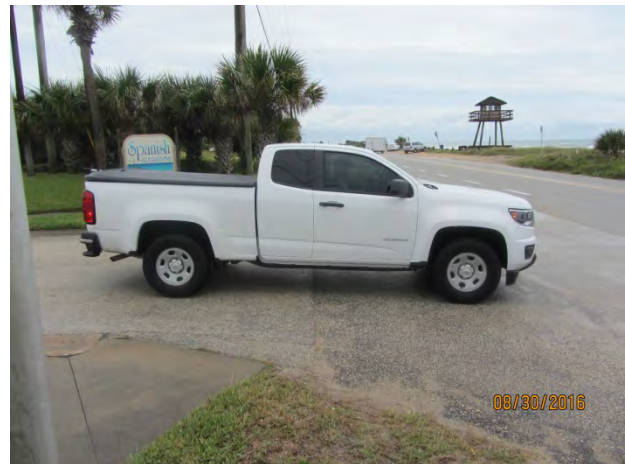
Figure 21

The study team observed the stop bars at the minor streets to be set back 20' to 25' from the edge of the travel lane, as displayed on **Figure 20**. The stop bar is set back due to the location of the sidewalk which creates sight distance issues for vehicles turning from the minor street. The sight distance was observed to be restricted by landscaping along SR A1A. Because the sight distance is restricted, vehicles were seen driving through the stop bar and stopping near the roadway often on the unmarked crosswalk (**Figure 21**). This creates a conflict with pedestrians and bicyclists who may be attempting to cross the minor street as a vehicle is pulling out to make a turn onto SR A1A.

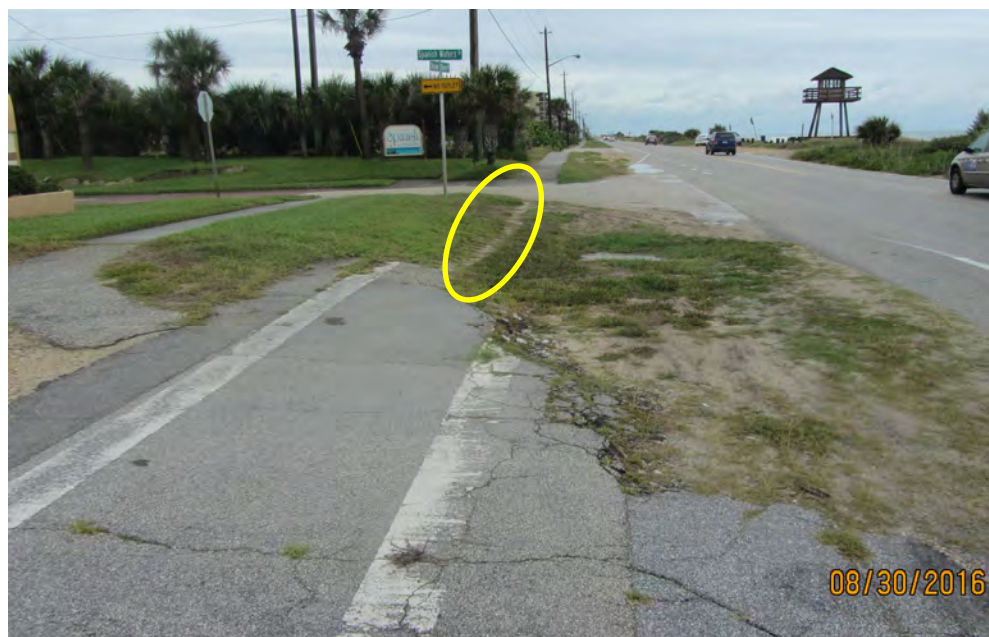
Figure 26

The study team observed a striped sidewalk area on the west side of SR A1A between Kathy Drive and Spanish Waters Drive, as displayed in **Figure 24** and **Figure 25**. The pavement markings are beginning to fade and in some cases are no longer present due to some patch work. As shown in **Figure 26**, the markings terminate on the southeast corner of the intersection of Spanish Waters Drive and SR A1A. A paved surface is provided adjacent to the asphalt, but a worn trail through the grass was observed. This worn trail is directly across from the sidewalk on the northwest corner of the intersection.

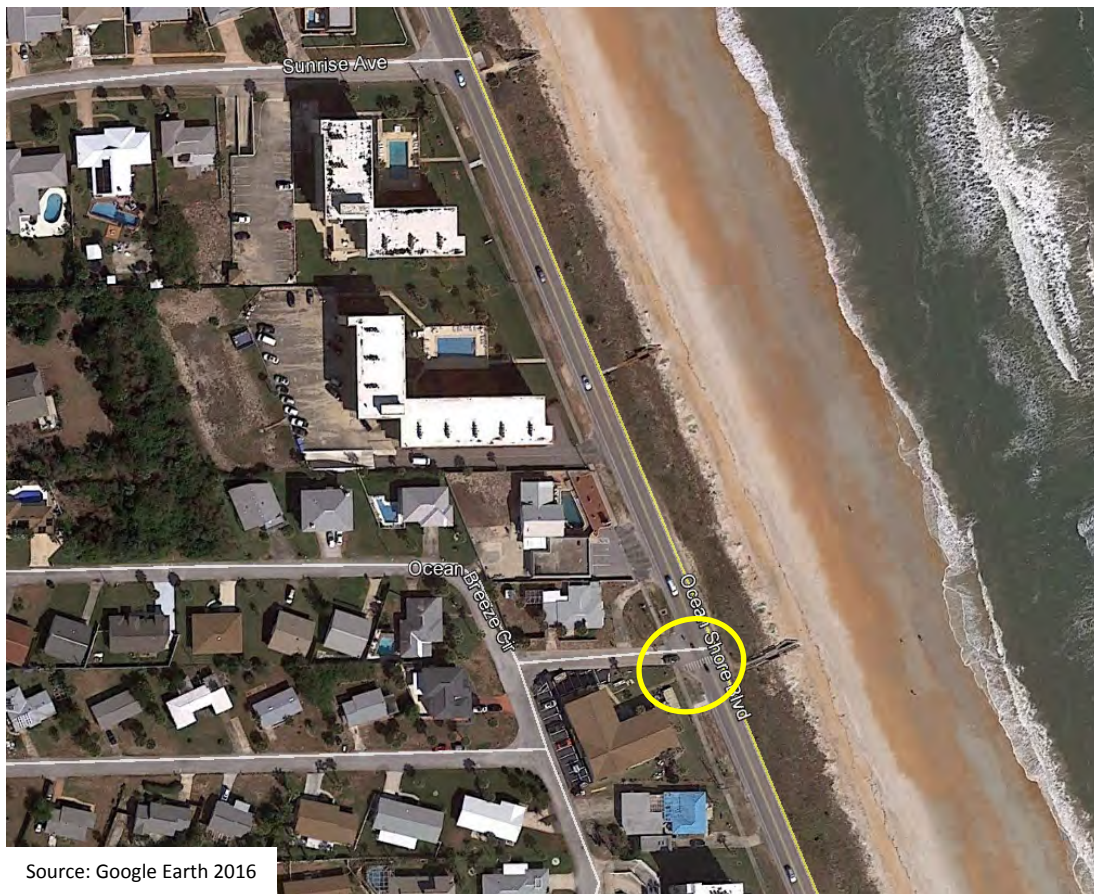
Figure 35

There is one existing unsignalized, marked crosswalk along the corridor on the south leg of the SR A1A at Ocean Breeze Circle intersection (location shown in **Figure 35**). The crosswalk is striped with old special emphasis crosswalk markings and has pedestrian warning signs (W11-2) with downward arrows (W16-7P) at the crosswalk (**Figure 36** and **Figure 37**). No advanced warning signs are present on either of the approaches to the crossing. The crosswalk location does not include a paved surface leading to the crosswalk, curb ramps, or detectable warning surfaces (**Figure 37**).

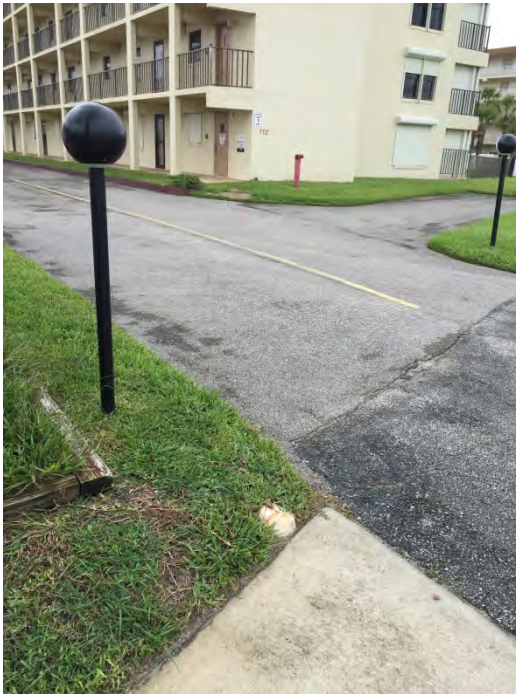
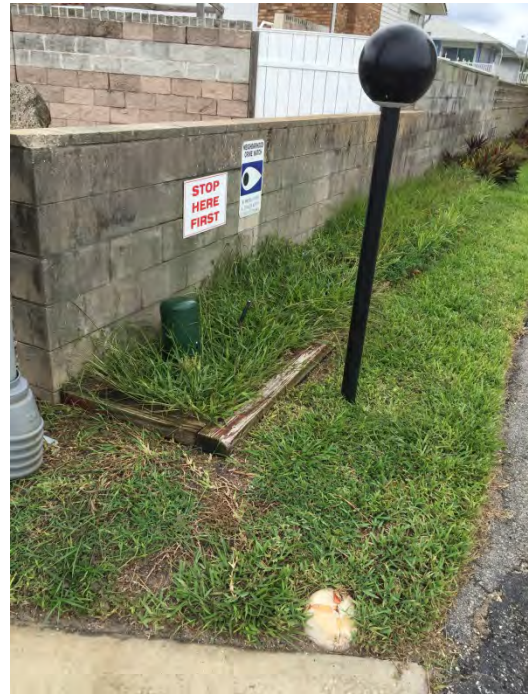
The existing concrete wall on the southwest corner of the driveway (**Figure 40** and **Figure 41**) creates conflict between vehicles and pedestrians/bicyclists. The wall restricts the driver's ability to see pedestrians or bicyclists heading northbound on the sidewalk as the driver attempts to turn onto SR A1A.

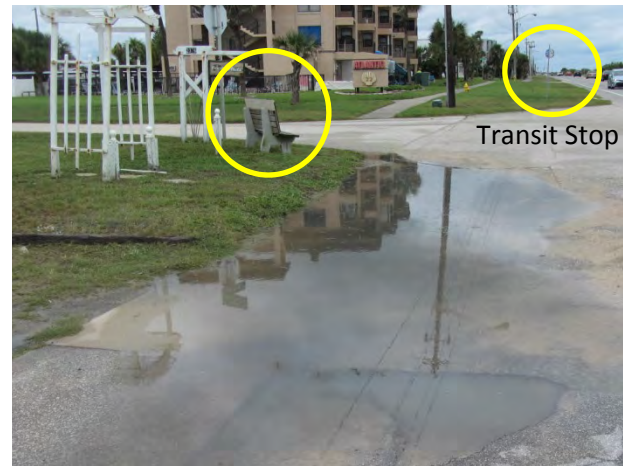
Figure 45

The study team observed a transit stop bench on the southwest corner of the intersection of Briggs Avenue (**Figure 44**). Votran has recently upgraded the transit facilities along the study corridor and the new bus stop is located on the northwest corner of the intersection (**Figure 45**). Transit riders wishing to sit on the bench while waiting for the bus are not waiting at the actual transit stop and could be overlooked by the bus driver.
