SR/CR A1A PEDESTRIAN SAFETY & MOBILITY STUDY

PEDESTRIAN / BICYCLE SAFETY REVIEW

Focus Area G / S 23rd Street to S 11th Street and at the Beverly Beach Camptown RV Resort (Flagler Beach)

Project Title: Focus Area G Pedestrian/Bicycle Safety Field Review

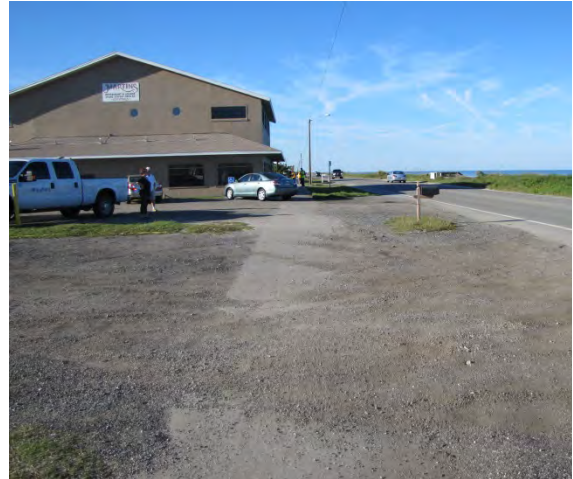
Many residential properties along the west side of the corridor had paved driveways but no formal driveway connection onto SR A1A, as displayed in **Figure 24**. Some properties did not have a paved driveway but the study team observed missing grass where it looked like vehicles had consistently turned from SR A1A, driven over the sidewalk, and parked on a property (**Figure 25**). In situations like these, a vehicle turning from SR A1A may not see a pedestrian or bicycle on the sidewalk. Also vehicles backing out from these properties will have a tough time seeing pedestrians or bicyclists on the sidewalk. In addition to the vehicular/non-motorist conflict, the vehicles driving over the unpaved portion of the driveway will track dirt, sand, and other debris onto the sidewalk.

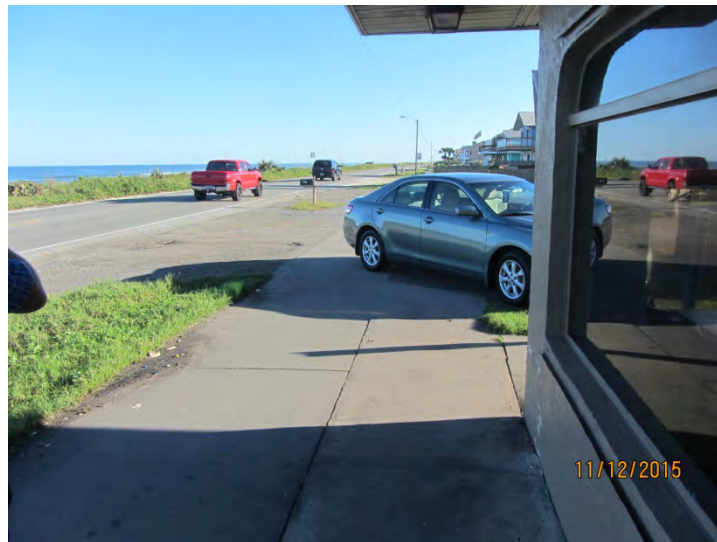
Figure 30

Due to the angled parking for the Martin's Restaurant & Lounge, the handicapped spot forces drivers to park their vehicle over the sidewalk as displayed in **Figure 30**. Clear width for the sidewalk must be maintained per the Americans with Disabilities Act (ADA) Public Rights-of-Way Accessibility Guidelines (PROWAG).

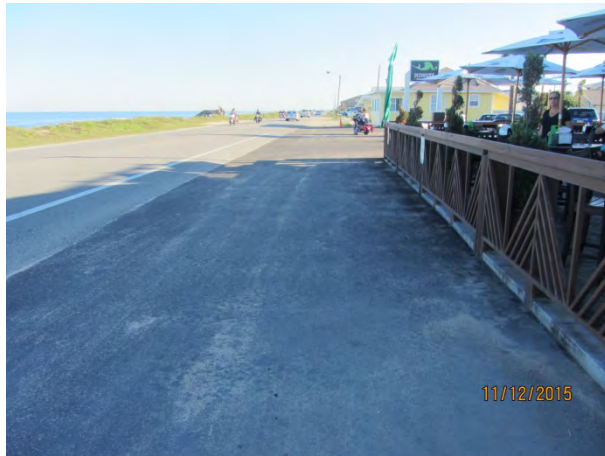
Figure 31

- In front of the Oceanside Bar (**Figure 31**) and Pope Plaza (**Figure 32**) – 1800 block of SR A1A; and
- In front of Beach House Beanery and Café (**Figure 33** and **Figure 34**) – 1100 block of SR A1A.

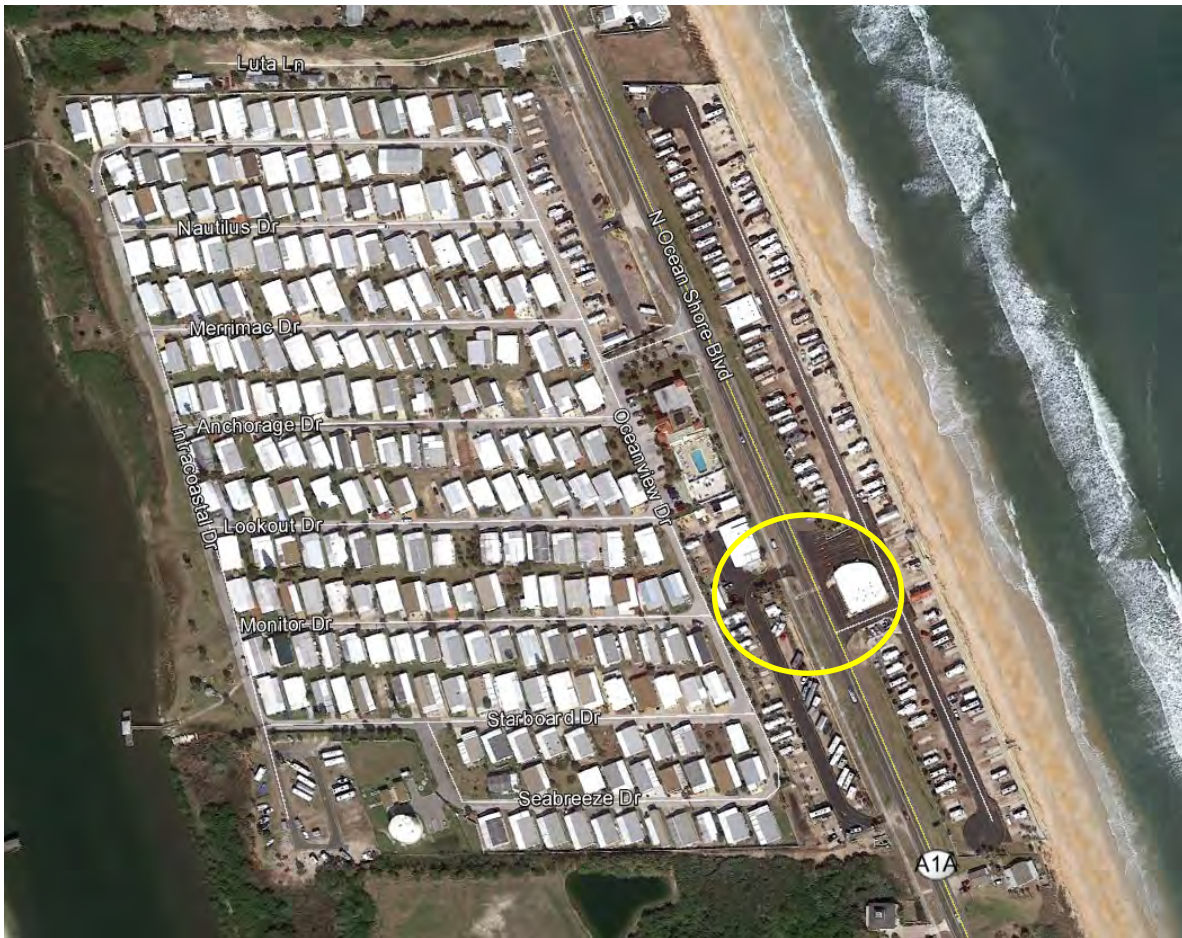
Figure 36

The mid-block crossing at the Beverly Beach Camptown RV Resort is a heavily utilized crossing in Beverly Beach (general area and crosswalk location displayed in **Figure 36**). The crossing is striped with old special emphasis crosswalk markings and has pedestrian warning signs (W11-2) with downward arrows (W16-7P) at the crosswalk (**Figure 37** and **Figure 38**). Pedestrian warning signs with continuously flashing beacons are located approximately $\frac{1}{4}$ mile north and south of the crossing (**Figure 39**). The roadway has 12' wide lanes along with a 4'-6' paved shoulder and has a posted speed of 45 MPH (**Figure 40**). The crosswalk does not have lighting, as displayed in **Figure 41**).
