# **SR/CR A1A PEDESTRIAN SAFETY & MOBILITY STUDY** PEDESTRIAN / BICYCLE SAFETY REVIEW Focus Area I / 19th Road to Apache Drive (Flagler County)

## Pedestrian/Bicycle Safety Review Report for SR A1A from 19<sup>th</sup> Road to Apache Drive (Flagler County)

Section Number: 73030000 (SR A1A) Mile Post: 13.095 to 14.771 Flagler County

## Project Title: Focus Area I Pedestrian/Bicycle Safety Field Review

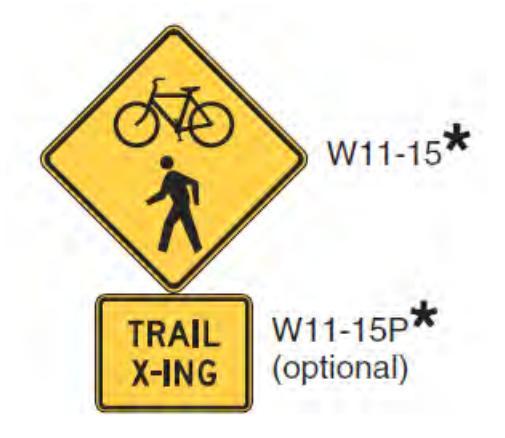
In addition to the yield signage/markings for the trail, consider installing trail crossing warning signs (W11-15) and plaques (W11-15P) that would draw the motorist's attention to the presence of pedestrians or bicycles on the shared use path.
